# Hydrogeologic Susceptibility and Vulnerability Assessment for Alyeska Chalet Condo HOA Public Drinking Water Well, Girdwood, Alaska

DRINKING WATER PROTECTION PROGRAM REPORT 4

August 2000

By MICHAEL J. CROTTEAU

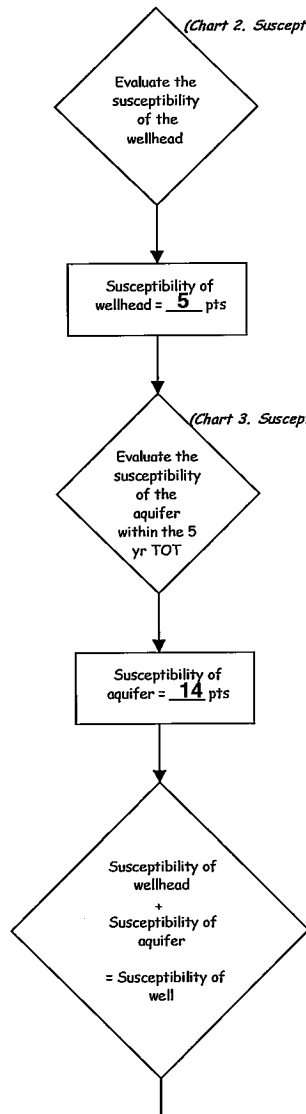
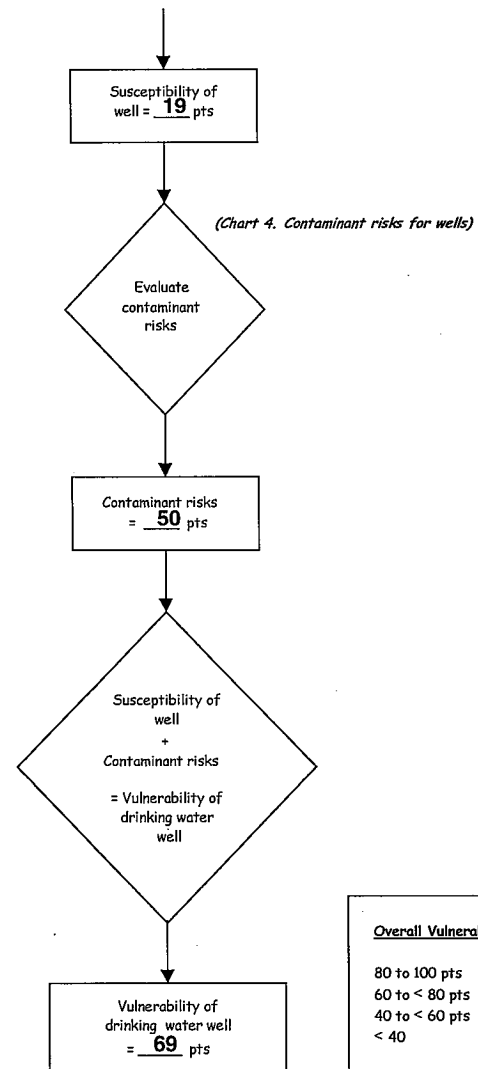
**Chart 1. Vulnerability analysis for Bacteria & Viruses – Alyeska Chalet Condo HOA**

| Category | Score | Rating |
|---|---|---|
| Bacteria & Viruses | <del>70</del> 20/15 | <del>High</del> Low |

A *Source Water Assessment* has been performed for the Alyeska Chalet Condo HOA's source of public drinking water. The overall vulnerability of this source to contamination is high by bacteria and viruses, and low for nitrates/nitrites, volatile organic chemicals, heavy metals, synthetic organic chemicals, and other synthetic organic chemicals. This assessment of contaminant risks can be used as a foundation for local voluntary protection efforts as well as a basis for the continuous efforts on the part of agencies to protect public health. It is anticipated that *Source Water Assessments* will be updated every five years to reflect any changes.

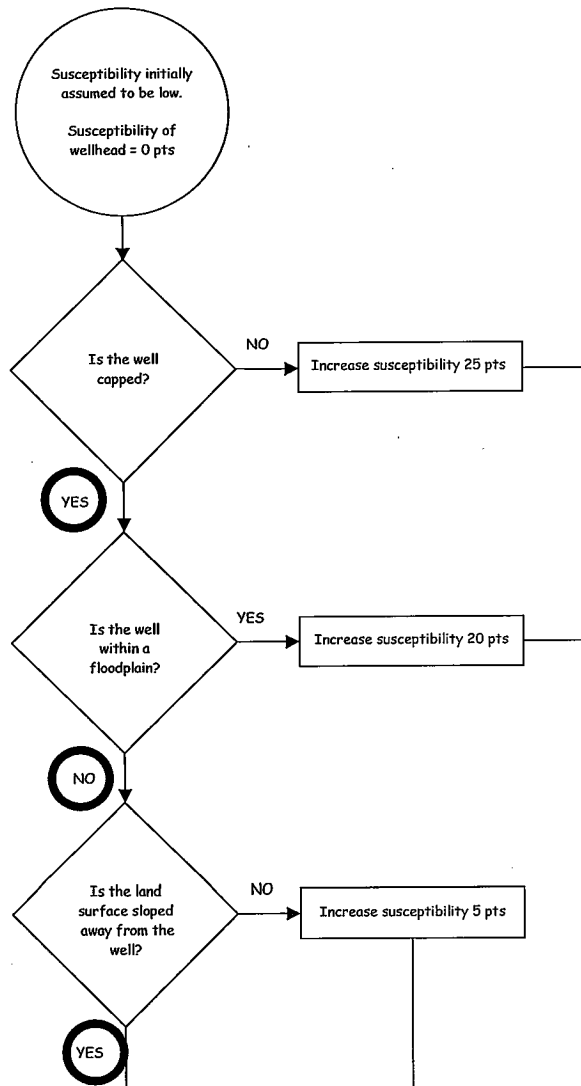
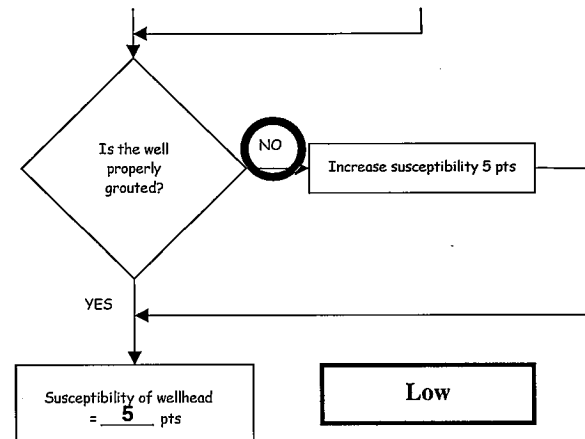
Chart 2. Susceptibility of the wellhead

A score for the susceptibility of the aquifer and the well to contamination is achieved by analyzing the properties of the aquifer and the well. The Alyeska Chalet Condo HOA well penetrates only gravel layers, which provide little if any protective barrier for the movement of contaminants in the subsurface. The well appears not to be properly grouted, which can lead to contaminant movement along the well casing. Combining the

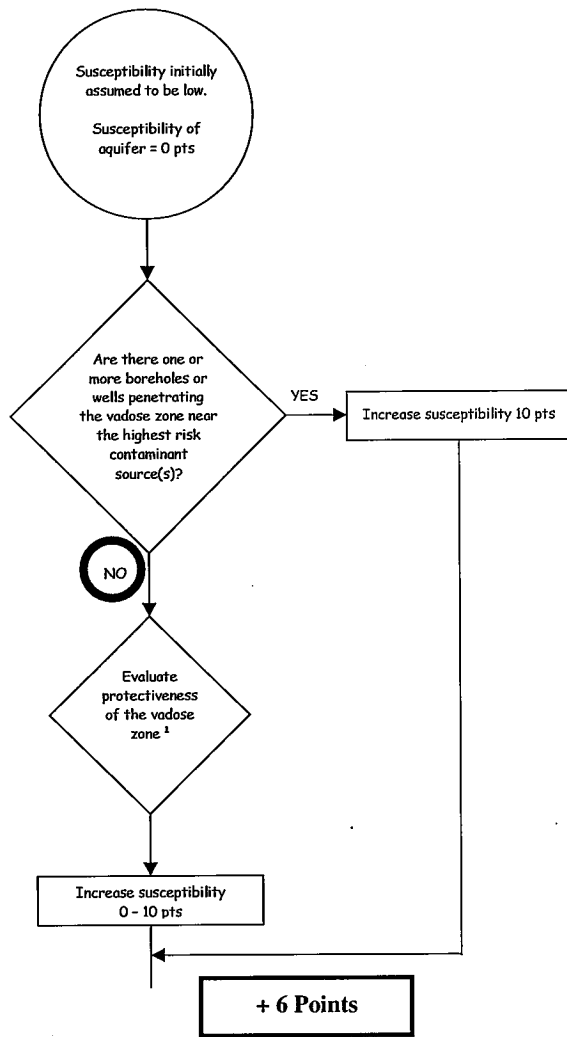
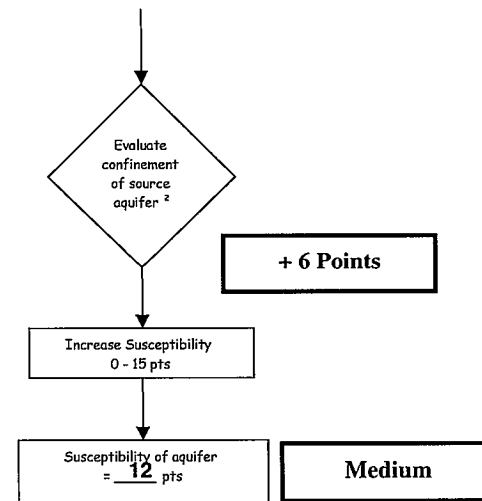
Chart 3. Susceptibility of the aquifer

**Medium**

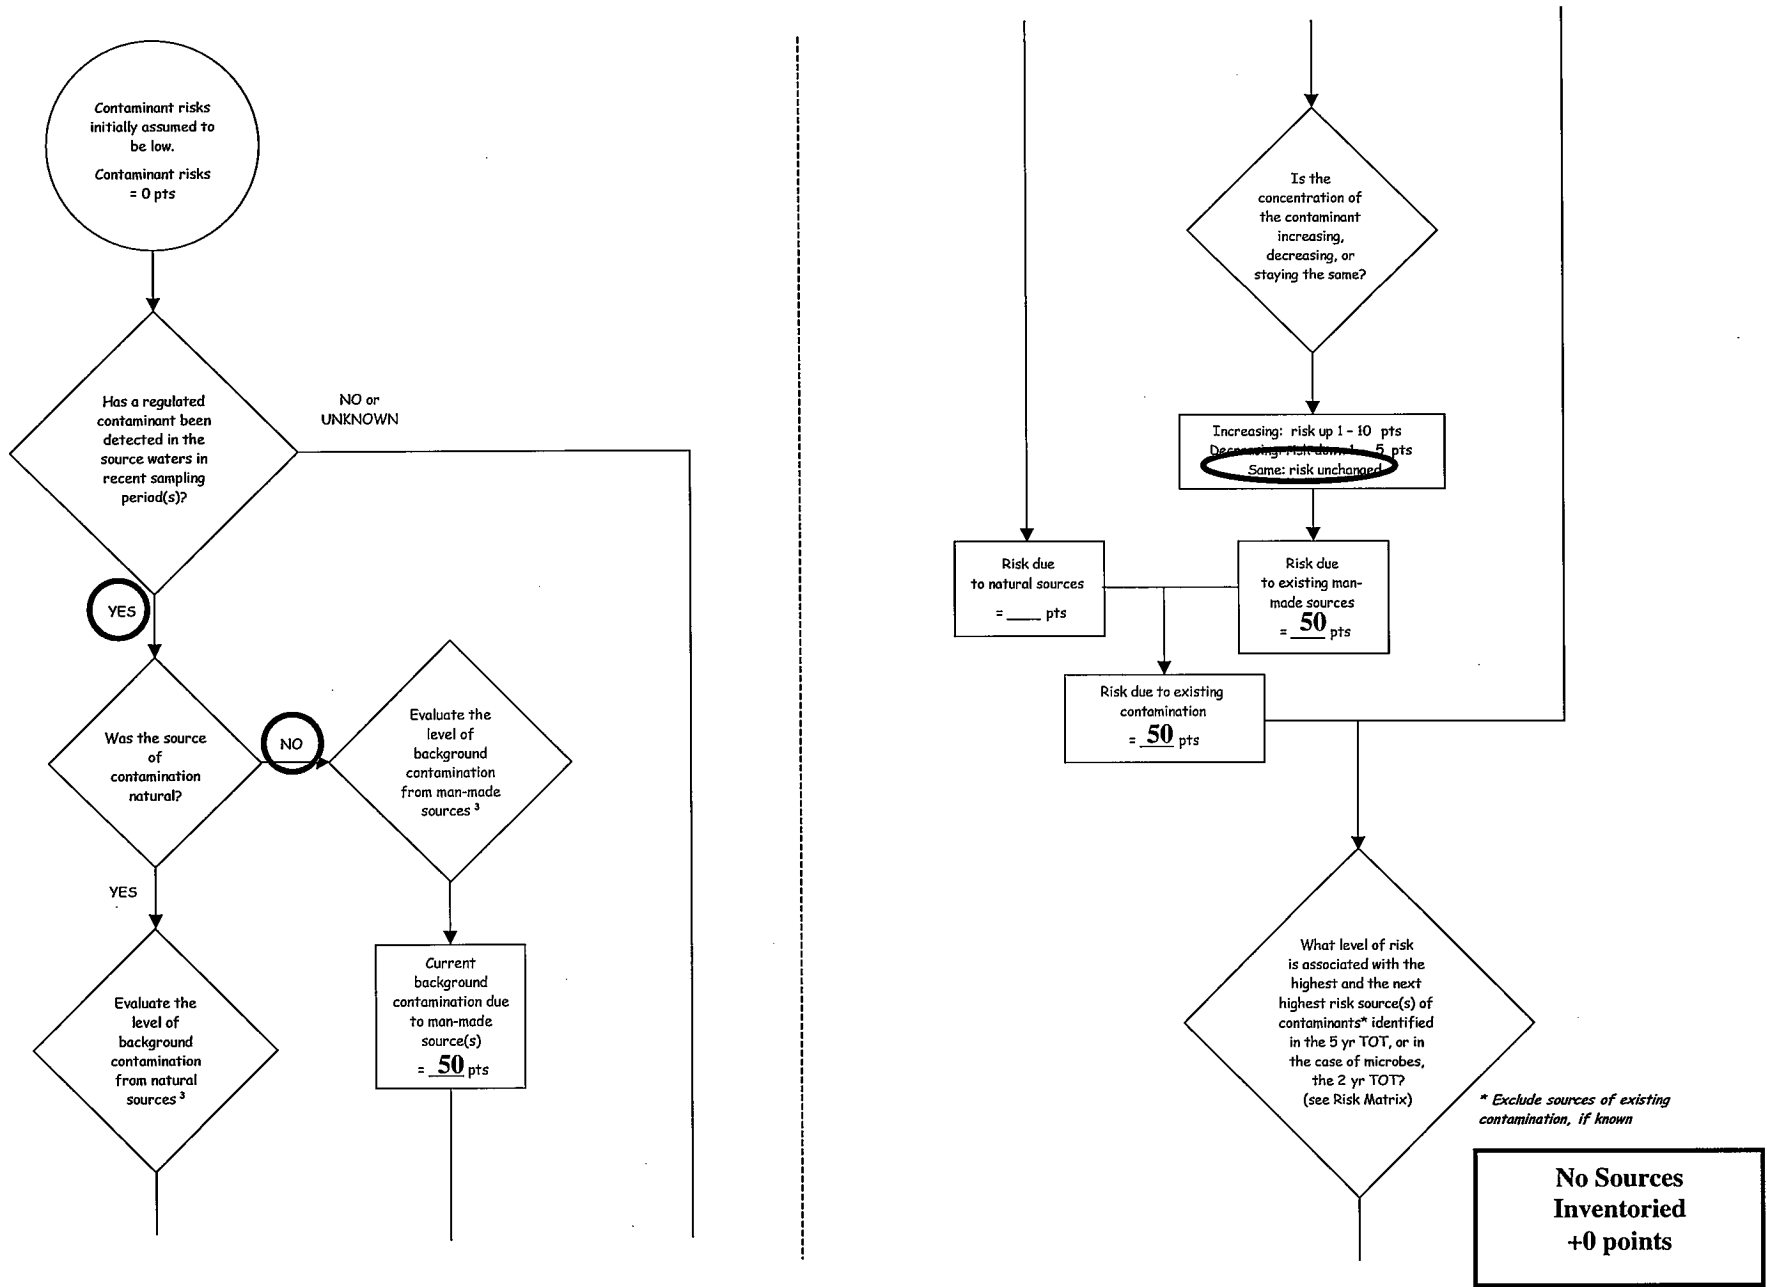
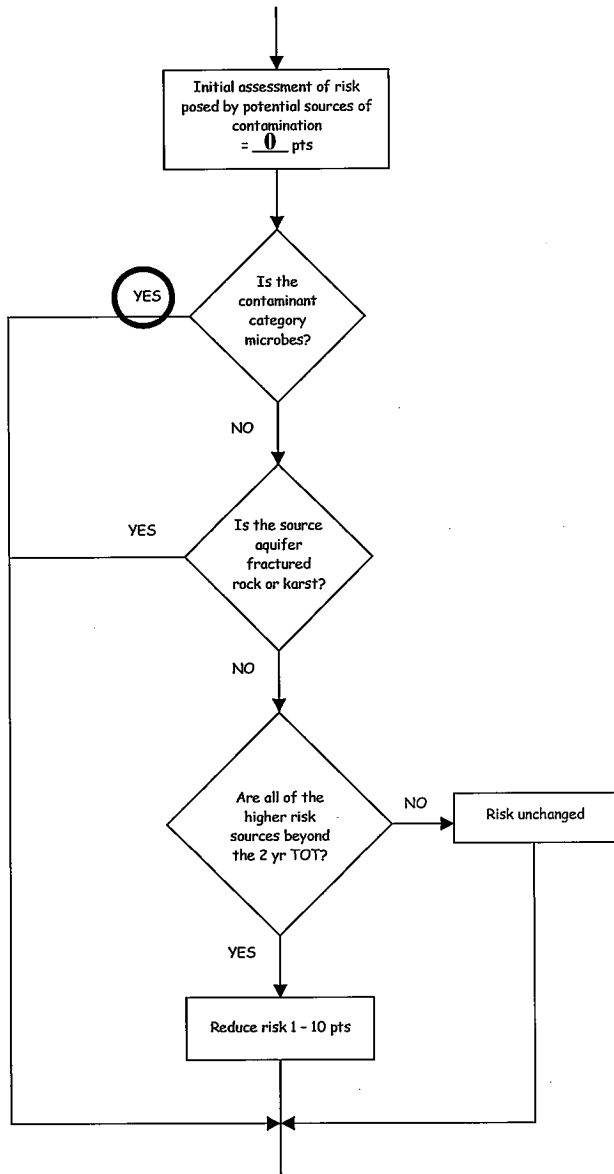
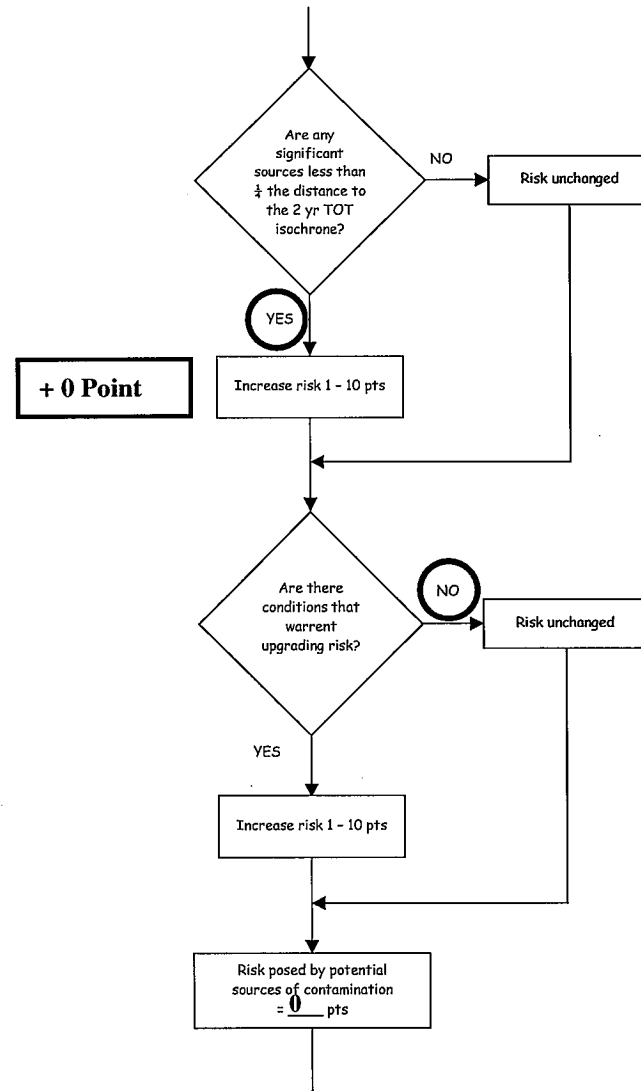
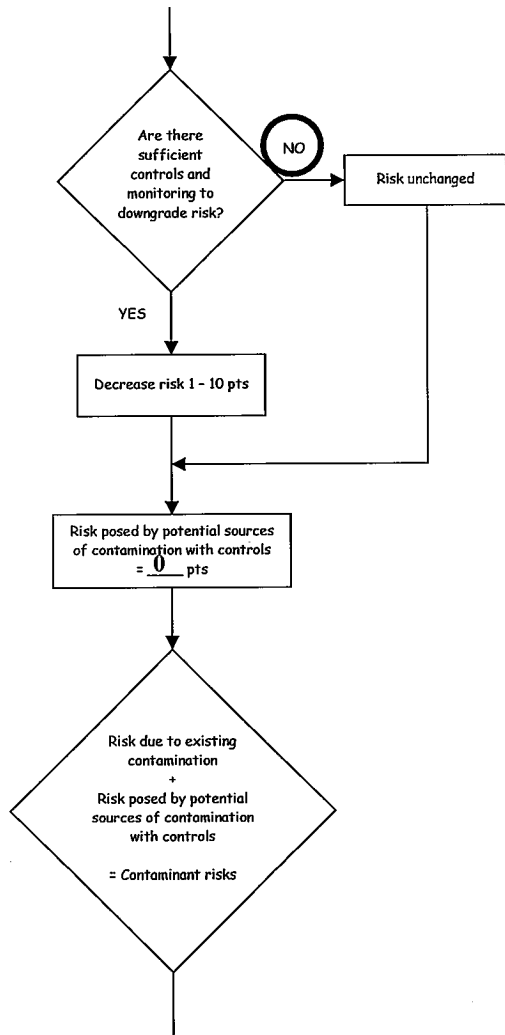
Chart 4. Contaminant risks for Alyeska Chalet Condo HOA – Bacteria & Viruses

Contaminant Risks to a drinking water source depends on the type, number/density, and distribution of contaminant sources. No existing or potential sources of contamination were inventoried for this system. However, water quality sampling may suggest the presence of human or animal waste discharges within the area contributing water to the well.

Contaminant risks\* = 50 pts

**Very High**
