## Hydrogeologic Susceptibility and Vulnerability Assessment for The Laundry and Pioneer Pizza Drinking Water Well, Palmer, Alaska

DRINKING WATER PROTECTION PROGRAM REPORT 117

By Michael Baxter, B.E.S.T. Resource

ALASKA DEPARTMENT OF ENVIRONMENTAL CONSERVATION: 2001

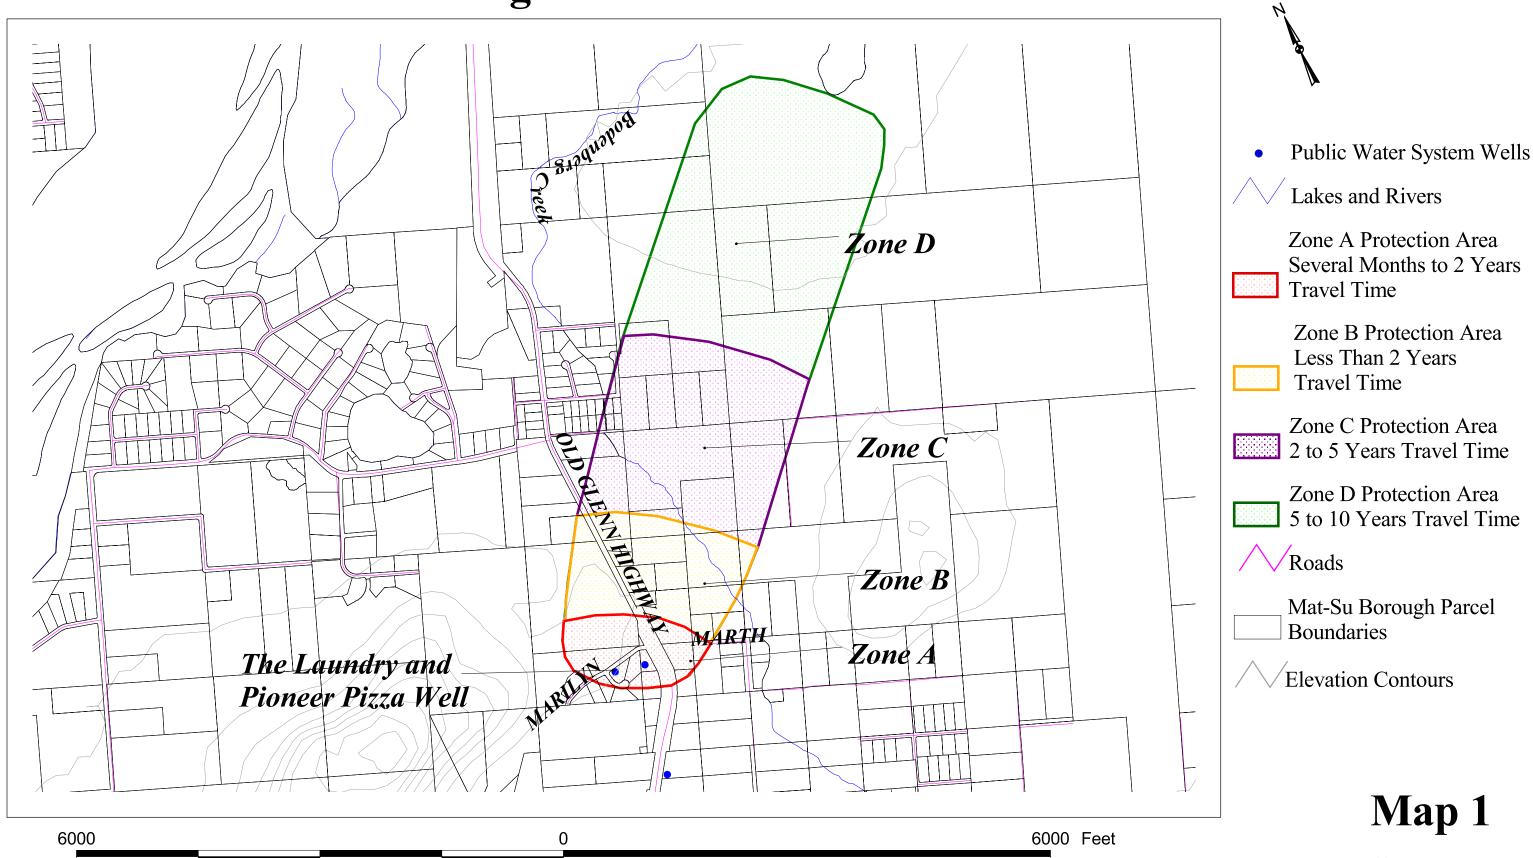
## The Laundry and Pioneer Pizza (PWSID 227663) Drinking Water Protection Areas

The Drinking Water Protection and Assessment Area that has been established for The Laundry and Pioneer Pizza is the area that is most sensitive to contamination. This area has served as a basis for assessing the risk of the drinking water source to contamination. This zone around the drinking water source is the most critical area for the preservation of the quality of the drinking water for this source. For simplicity, this area will be known as your Drinking Water Protection Area and will serve as the area of focus for voluntary protection efforts.

The Zone B protection area for The Laundry and Pioneer Pizza corresponds to a time-of-travel of less than two years and extends toward to base of the Chugach Mountains. Lastly, the Zone C protection area extends from Zone B to Zone D, which extends north paralleling the Matanuska River and heading towards the Chugach Mountains.

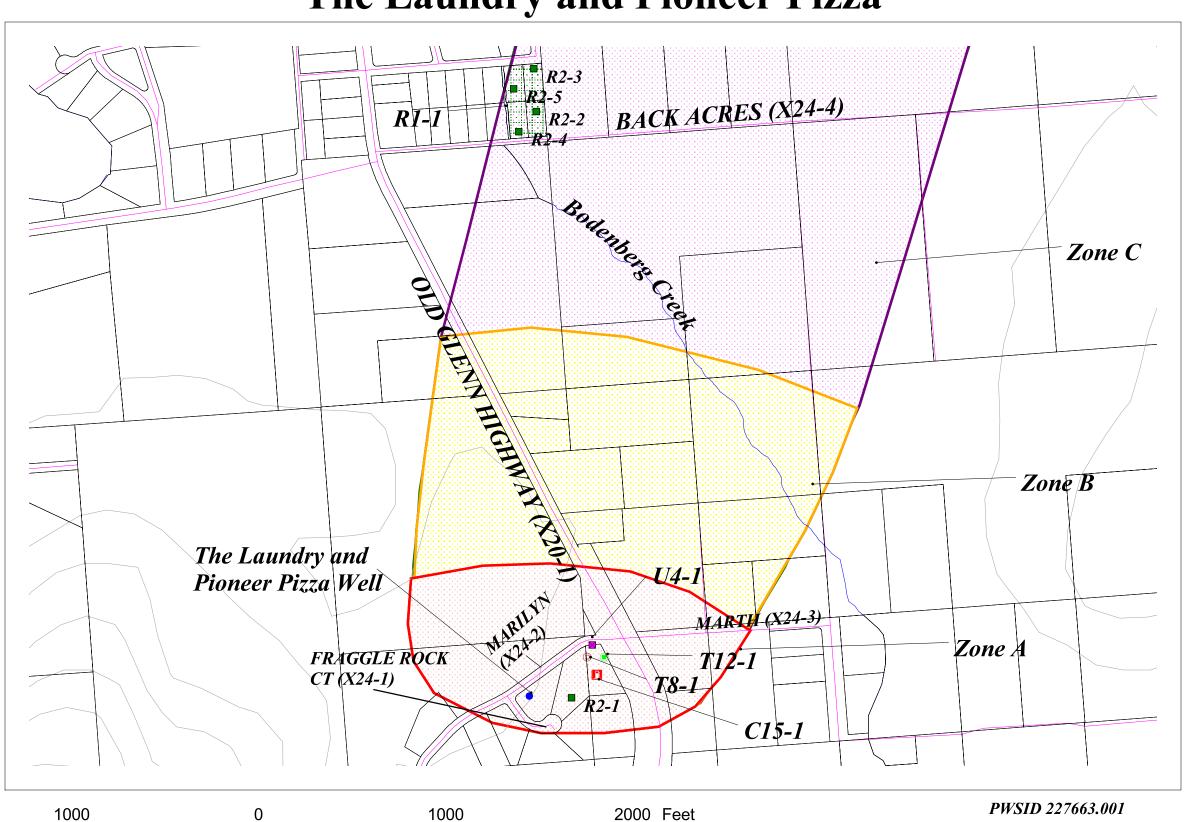
Map 2

Map 1 in Appendix C depicts the Contaminant Source Inventory for The Laundry and Pioneer Pizza. Inventoried potential sources of contamination within Zones A through Zone B were associated with residential activity. Zones C & D contains only natural wilderness. On account of natural wilderness in Zones C & D, this potential source of contamination was not considered in determining the vulnerability of this drinking water source to contamination. Below is a summary of the contaminant sources inventoried within The Laundry and Pioneer Pizza protection area:

- Residential acreage
- Gas Station with underground gas and diesel tanks
- Roads
- Septic systems
- Contaminated site:

This potential contaminant source presents risks for all three categories of drinking water contaminants for The Laundry and Pioneer Pizza drinking water source.

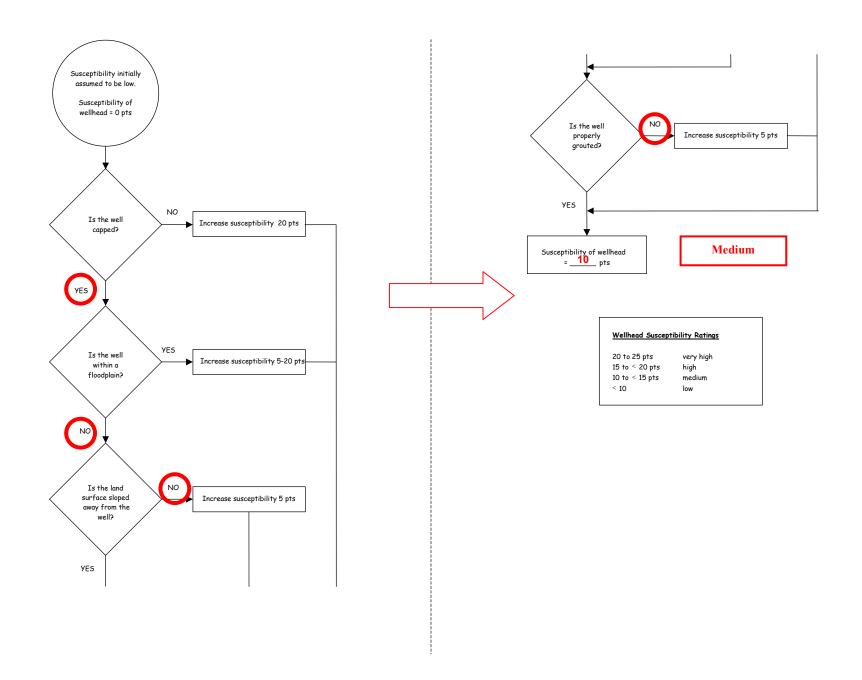
Chart 1. Susceptibility of the wellhead – The Laundry and Pioneer Pizza

The Laundry and Pioneer Pizza is completed in an unconfined aquifer setting. The well penetrates 80 feet of sand and gravel layers. These layers may provide somewhat of a protective barrier for the movement of contaminants in the subsurface. However, near the base of the Chugach and Talkeetna Mountains, the clay and till layers tend to be discontinuous and thin toward the mountains. Therefore, contaminants that enter the subsurface near the base of the mountains may enter the confined aquifer uninhibited by the absence of any protective layer. This well does not appear to be properly grouted as indicated previously from information obtained from ADEC records. The absence of grouting can promote the transport of contaminants

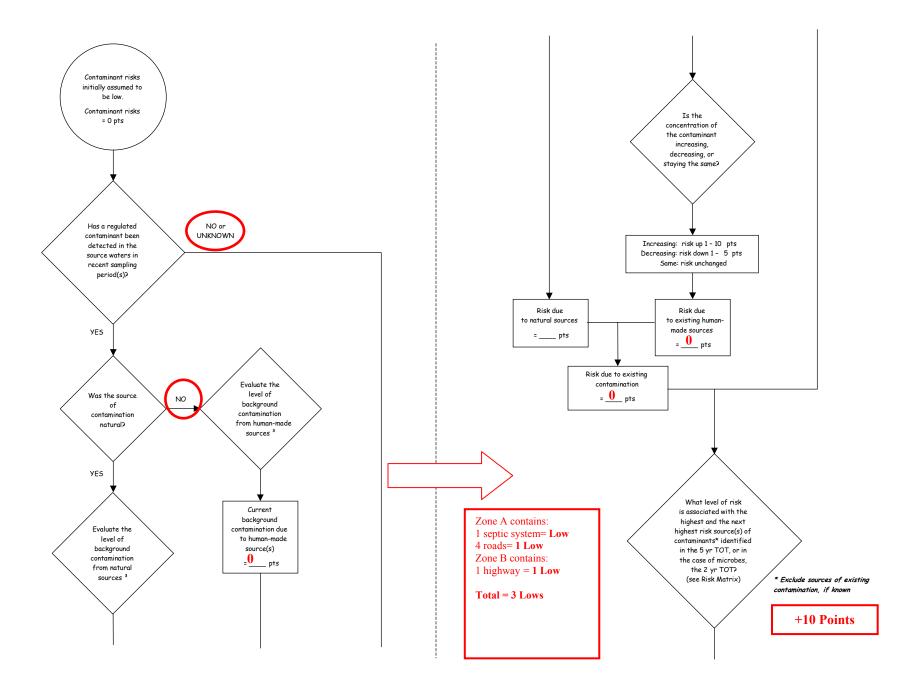
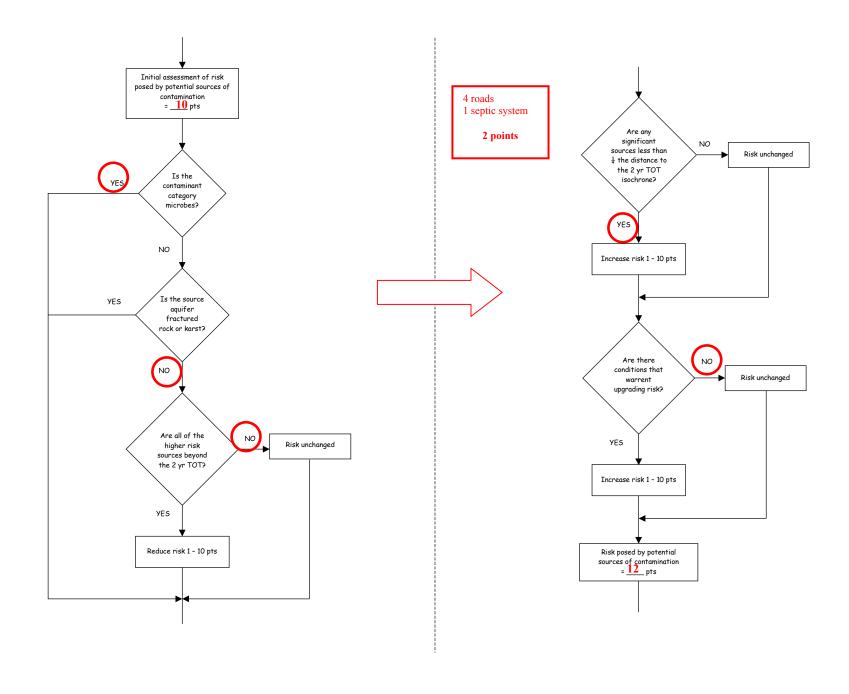
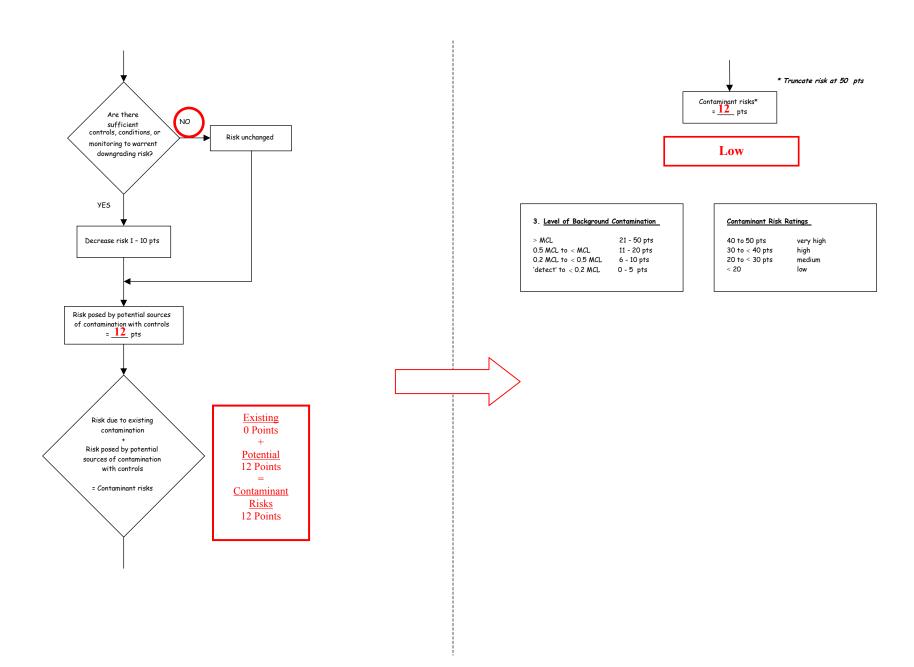
Chart 3. Contaminant risks for The Laundry and Pioneer Pizza – Bacteria & Viruses

Bacteria and Viruses were not detected in the source waters of The Laundry and Pioneer Pizza. Overall, contaminant risk for the bacteria and viruses is low due to the roads, septic systems, gas station with underground storage tanks and an ADEC recognized contaminated site. This rating combined with the susceptibility of the well yields an overall low vulnerability to contamination in this category.

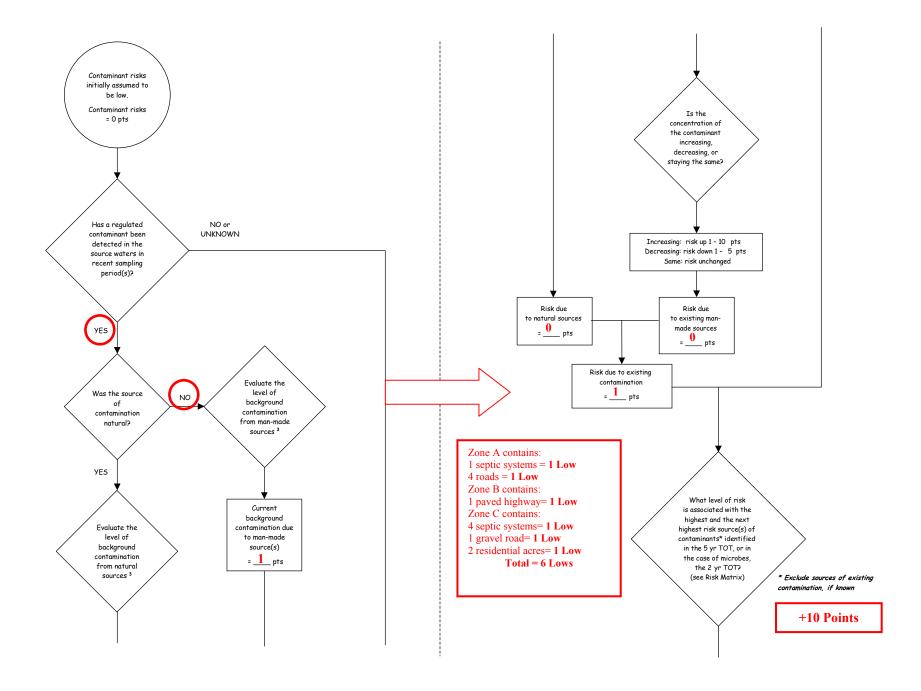
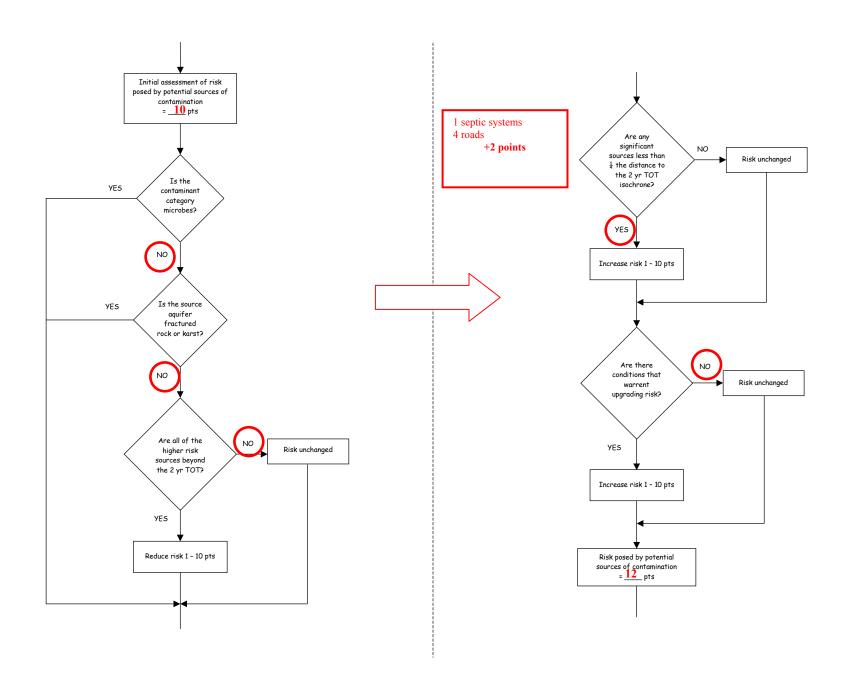
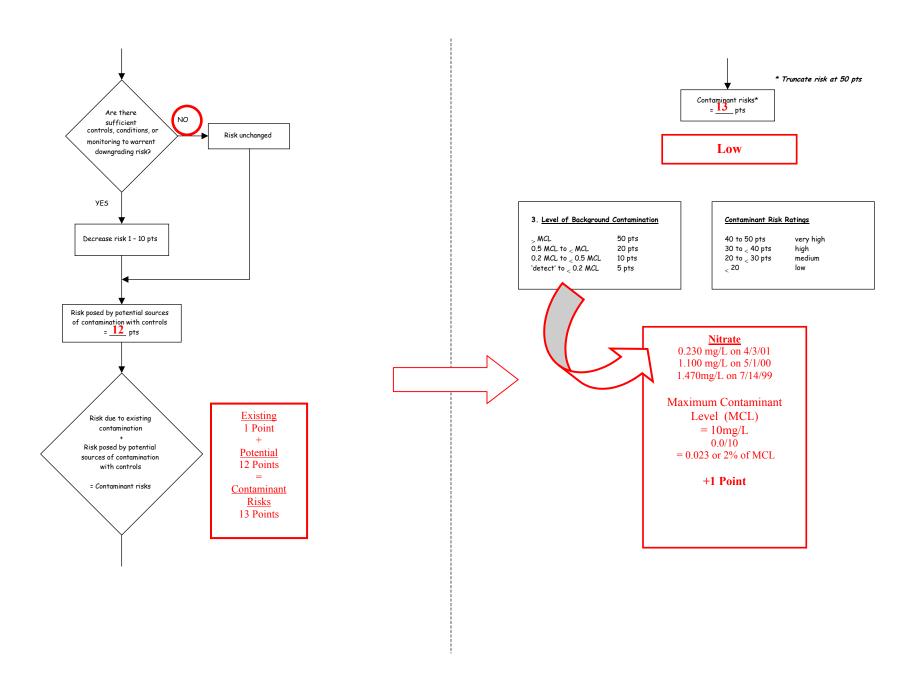
Chart 5. Contaminant risks for The Laundry and Pioneer Pizza- Nitrates and Nitrites

Overall, contaminant risk for the nitrate/nitrite category is low due to the roads, septic systems, gas station with underground storage tanks and an ADEC recognized contaminated site present up gradient from the well. Combining potential nitrate and/or nitrite contamination risk with the susceptibility of the well yields an overall medium vulnerability to contamination in this category.

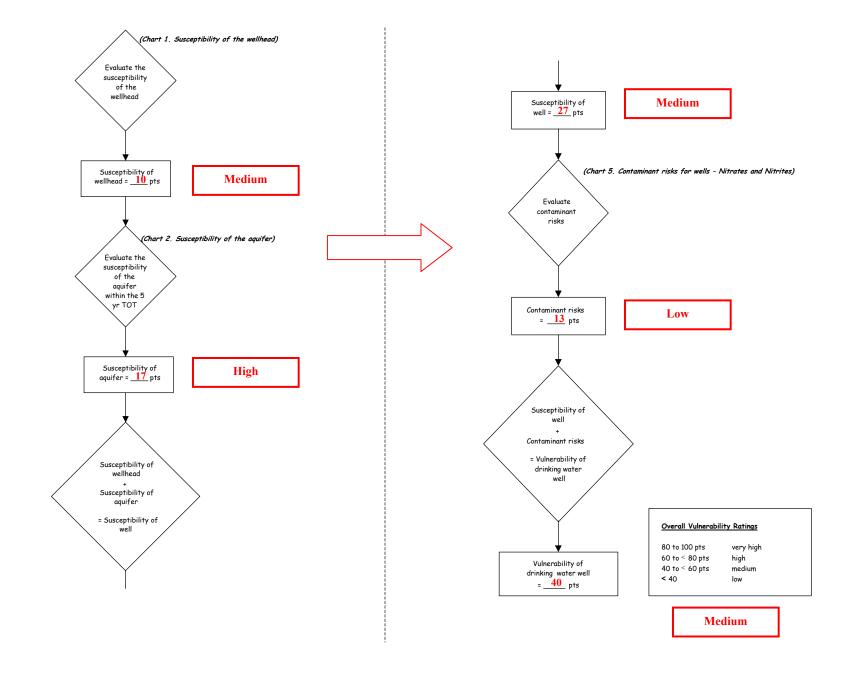
Chart 6. Vulnerability analysis for The Laundry and Pioneer Pizza-Nitrates and Nitrites

Sampling history of The Laundry and Pioneer Pizza source waters indicate concentrations of nitrate (See Chart 6 – Contaminant Risks for Nitrates/Nitrites in Appendix D). Existing nitrate contamination is approximately 2% of the allowable limit (MCL) for this contaminant. Due to the high solubility and weak

retention by soil, nitrates are very mobile in soil, moving at approximately the same rate as water. The current nitrate concentration in The Laundry and Pioneer Pizza remains at safe levels with respect to human health.

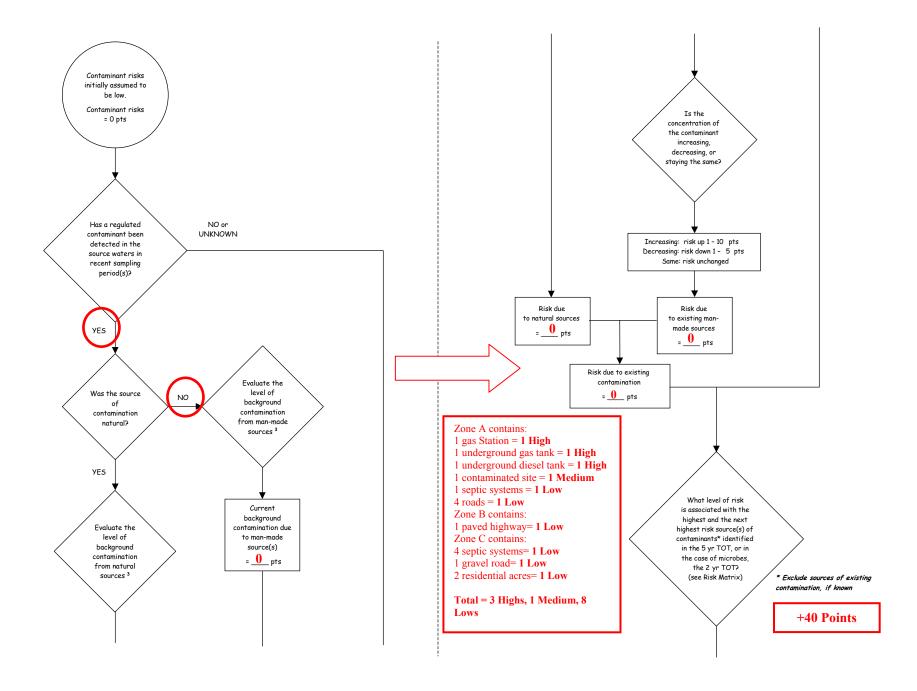
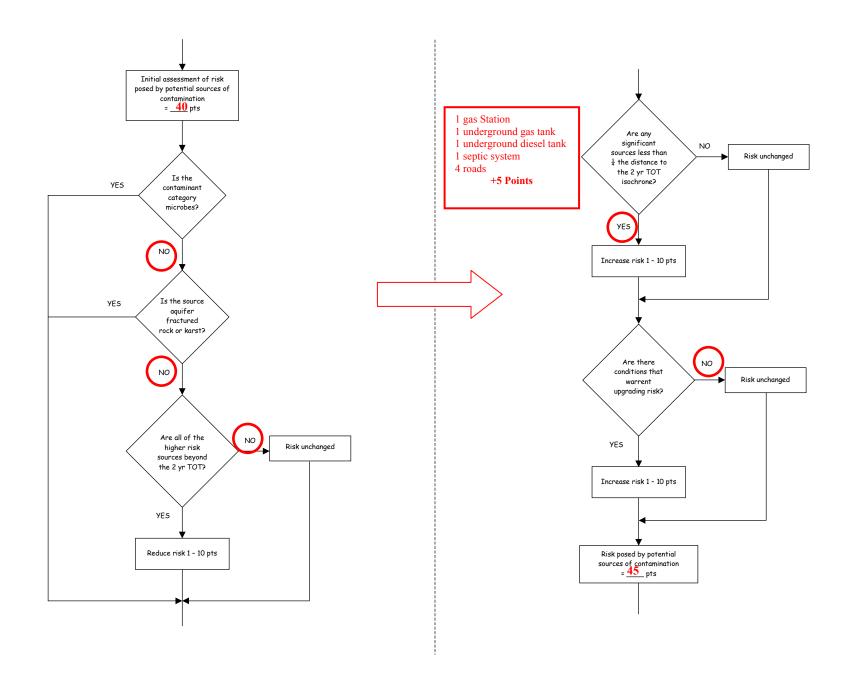
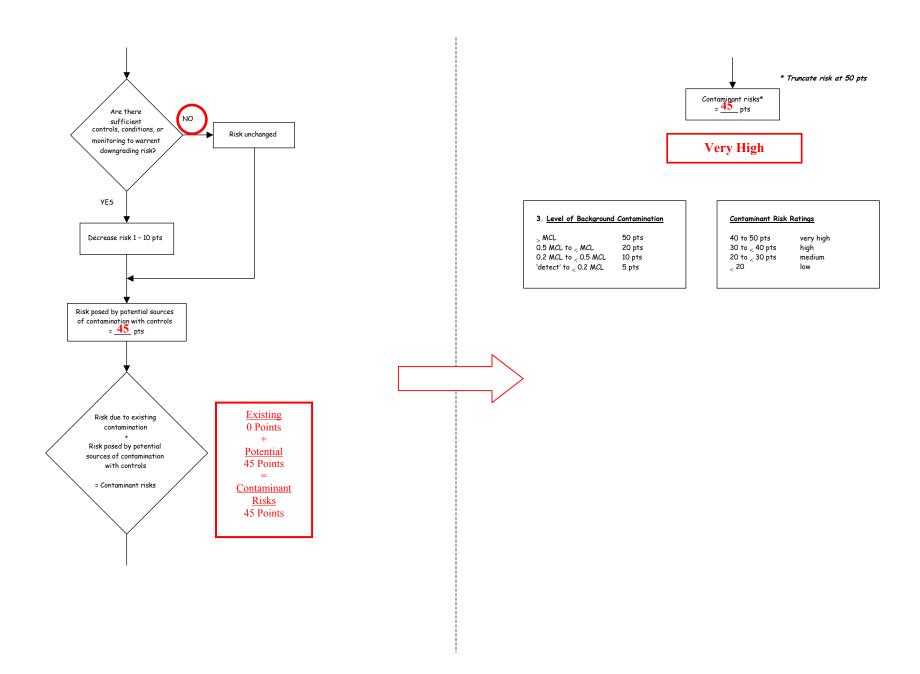
Chart 7. Contaminant risks for The Laundry and Pioneer Pizza – Volatile Organic Chemicals

Volatile Organic Chemicals were not detected in the source waters of The Laundry and Pioneer Pizza. Overall, a contaminant risk for the volatile organic chemicals category is high due to the roads, septic systems, gas station with underground storage tanks and an ADEC recognized contaminated site present up gradient from the well. Combining the contaminate risk with the susceptibility of the well yields an overall high vulnerability to contamination for Volatile Organic Chemicals.
