Reference: Eareckson Air Force Station (EAS) SWA Addendum

**DRINKING WATER SOURCE ASSESSMENT
INFILTRATION GALLERY**

**EARECKSON AIR STATION
SHEMYA, ALASKA**

**UPDATED 05/14/2021
BY GOLDSTREAM
ENGINEERING INC.**

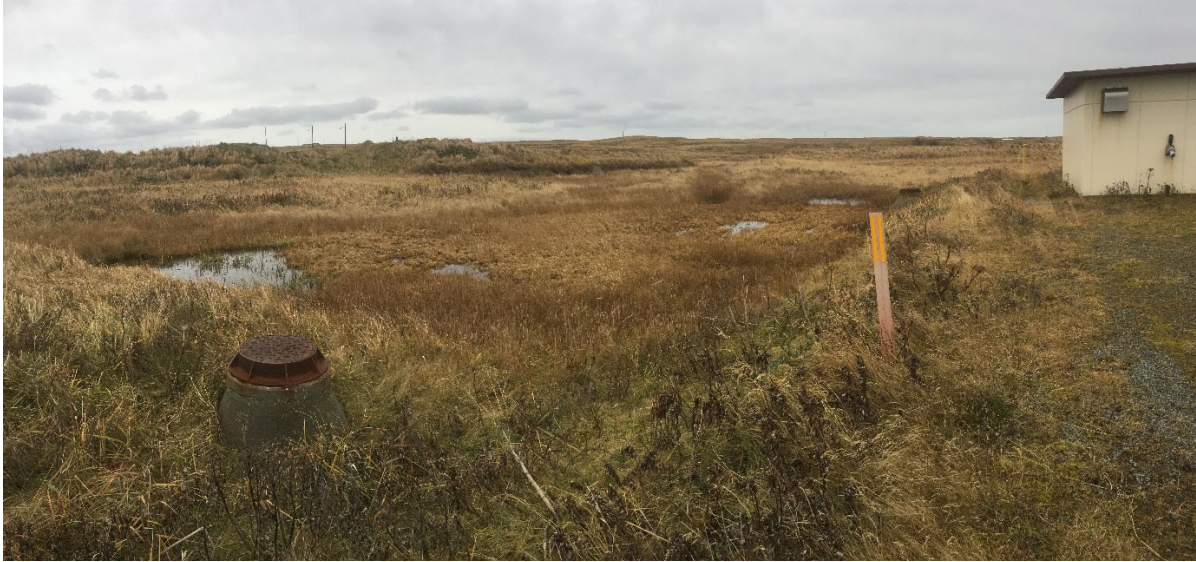
Photo No. 1 Water Gallery Looking Northeast

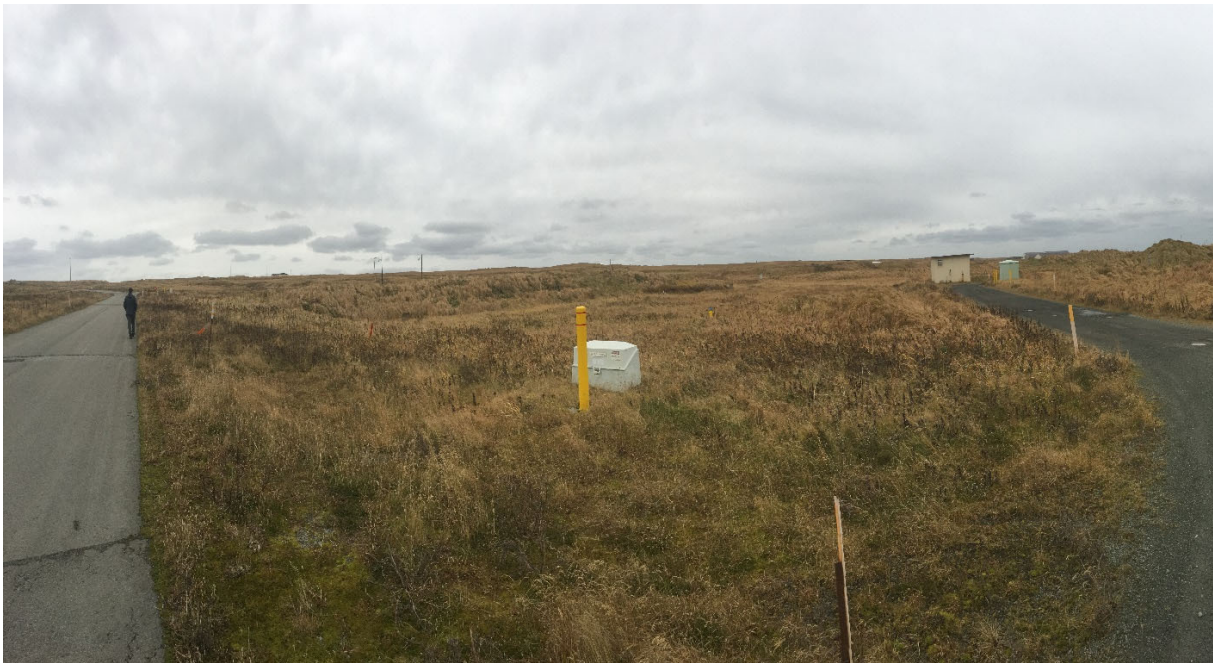
Photo No. 2
Water Gallery Looking East

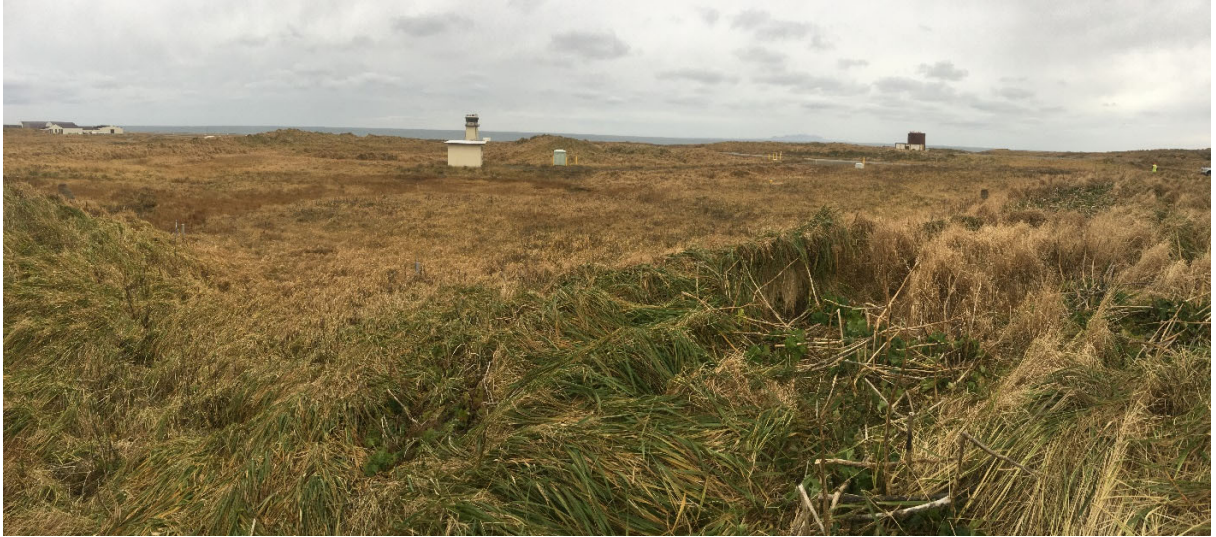
Photo No. 3 Water Gallery View
Looking South

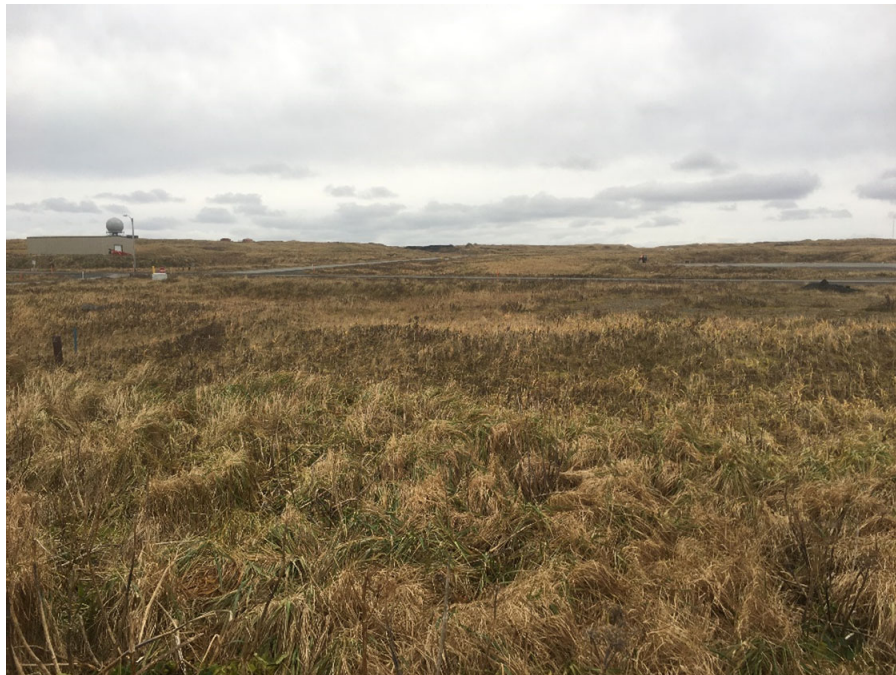
Hangar 4 was a large building just north of the infiltration gallery. This hangar has been removed and the only thing visible was remnants of the foundation. Therefore, based on the field observations and available data, remnants from Hangar 4 are not a significant potential source of contaminants. The cold storage building (Building 700) is a light tan building with two locking doors and no windows. It is located northwest of the infiltration gallery, and west of Hangar 4 (removed) off Tower Road. It is our understanding that hazardous material and waste was discovered inside the building by an unknown contractor and the USAF is in the process of remedying the situation. The floor is reported to be concrete. No hazardous materials, hazardous waste, POL products, or any liquid substances are allowed inside this building. A small parking lot is in front of the building; while the remaining three sides of the building are surrounded by grassy vegetation. This building is designated for storage of non-

Photo No. 4 Building 700 and
Hangar 4 Pad,
View Looking North

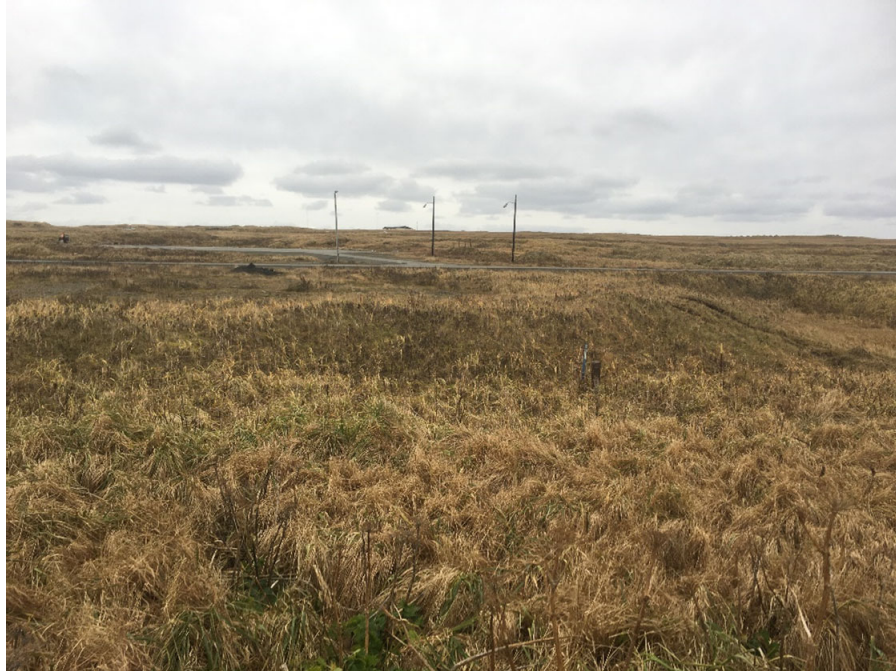
Photo No. 5 Water Gallery
View Looking North, Hangar 4 Pad

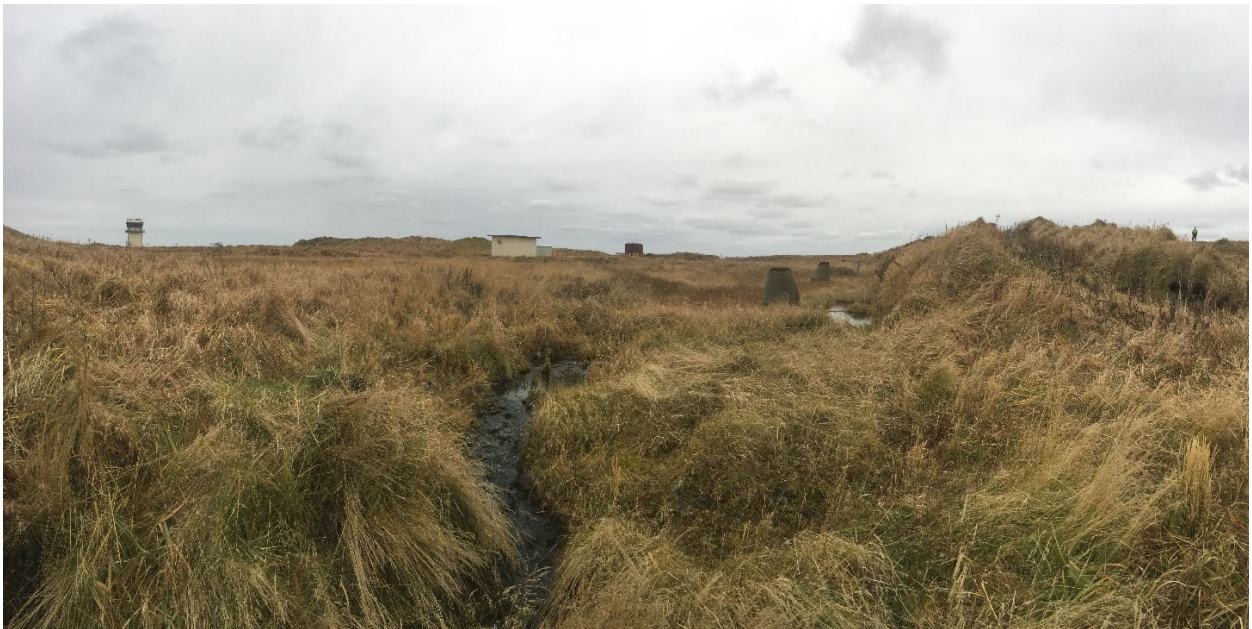
Photo No. 6 Water Gallery
View Looking West, Gallery Creek
