**UNITED STATES AIR FORCE  
611TH AIR SUPPORT GROUP  
611TH CIVIL ENGINEER SQUADRON**

**DRINKING WATER SOURCE ASSESSMENT  
INFILTRATION GALLERY**

**EARECKSON AIR STATION  
SHEMYA, ALASKA**

**FINAL  
MAY 2010**

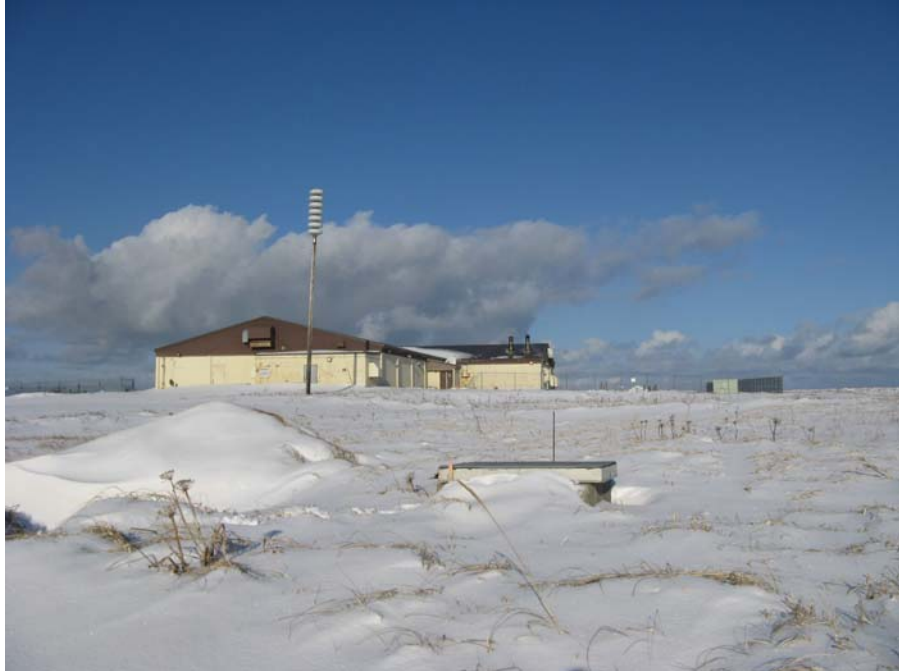
Photo No. 9  
Building 110  
Looking North

Building 110 is located in the northern part of the watershed, just north of North Road. It was used by the Navy for Classic Owl radar operations, and is currently in an inactive state of use and is mostly empty. The building and the immediate area around it are in the northern part of the watershed. The building is light tan, has a sloped roof, many doors, and a concrete floor (Appendix A, Photo No. 14). No hazardous materials, hazardous waste, POL products, or any liquid substances were found inside or around the outside of this building. There is an AST located on the north side of the building. Based on the above information and conversations with base personnel, this building is not a significant source of contaminants.

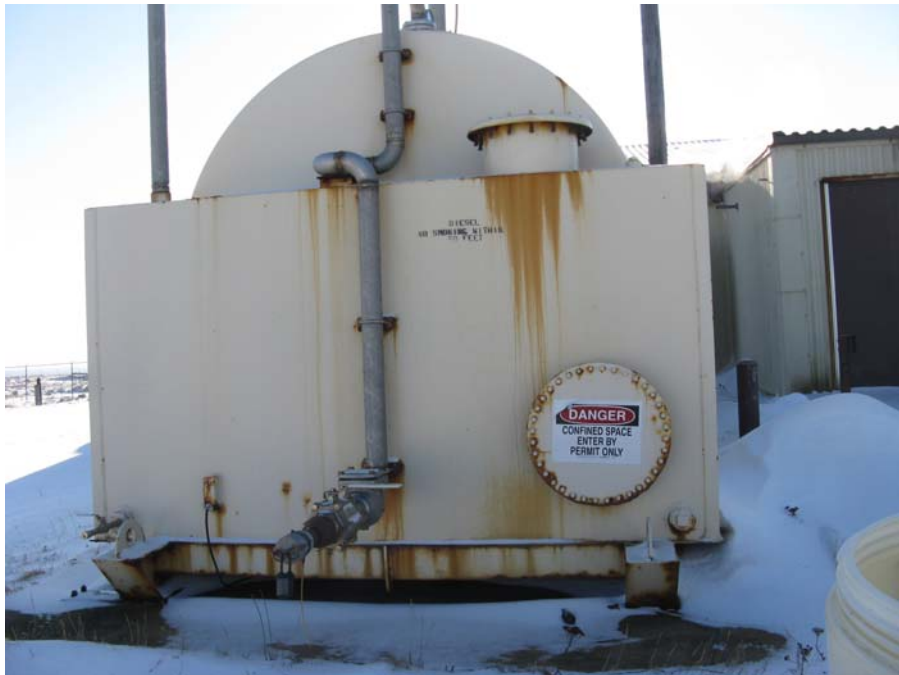
Photo No. 10  
Building 110 AST

Building 110 and associated USTs are the major features of ST 39 (Jacobs 1997). UST 110-2 and UST 110-3 were located on the eastern side of the building; they were removed in 1993. UST 110-1 was located north of the building, and was removed in 1992. UST 110-4 was never found; it is believed to have been removed or abandoned before the IRP investigation.

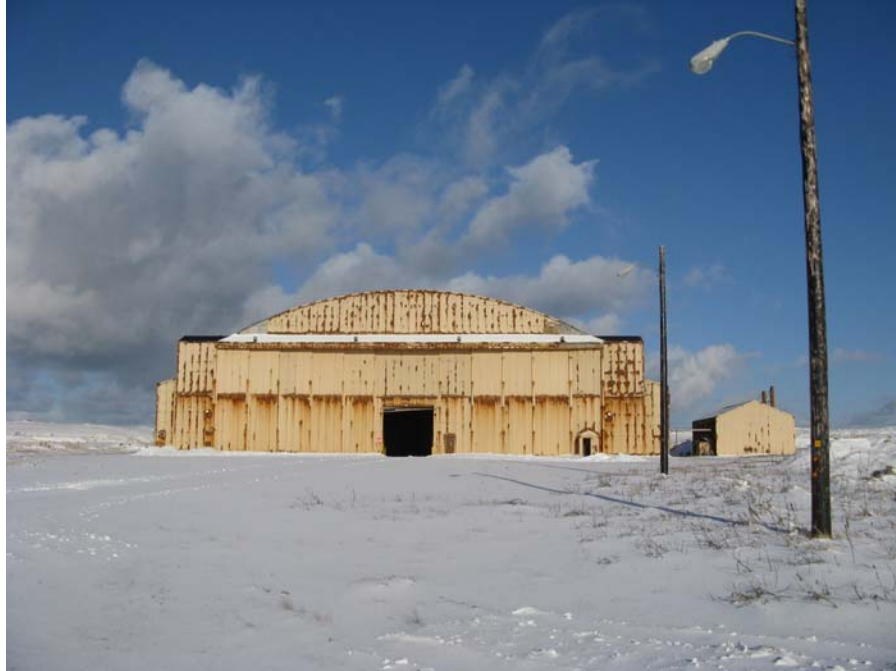
Photo No. 13  
Hangar 4

Hangar 4 is a large building just north of the infiltration gallery (Appendix A, Photo No. 13). A visual inspection inside and in the immediate vicinity outside Hangar 4 was conducted on 19 January 2009. Large amounts of cargo such as furniture, household appliances, ice melt, and miscellaneous construction items were inside the building. There was no evidence of hazardous materials, hazardous waste, any liquid substances, or petroleum, oil and lubricant (POL) products, or either inside or outside the building. There was no evidence of staining on the concrete and gravel areas around the outside of the building. In addition, the Air Force has no intention of using the building for industrial purposes in the future. Therefore, based on the available data, Hangar 4 is not a significant potential source of contaminants.
