MPU DIESEL SPILL VEGETATION MONITORING: 2001 A REPORT

*Relating to:
Milne Point Unit Spill No. 97-027M
Post-burn Sampling and Revegetation Plan, 22 August 1997*

**TO: BP EXPLORATION (ALASKA), INC.
ANCHORAGE, ALASKA**

JANUARY 2002

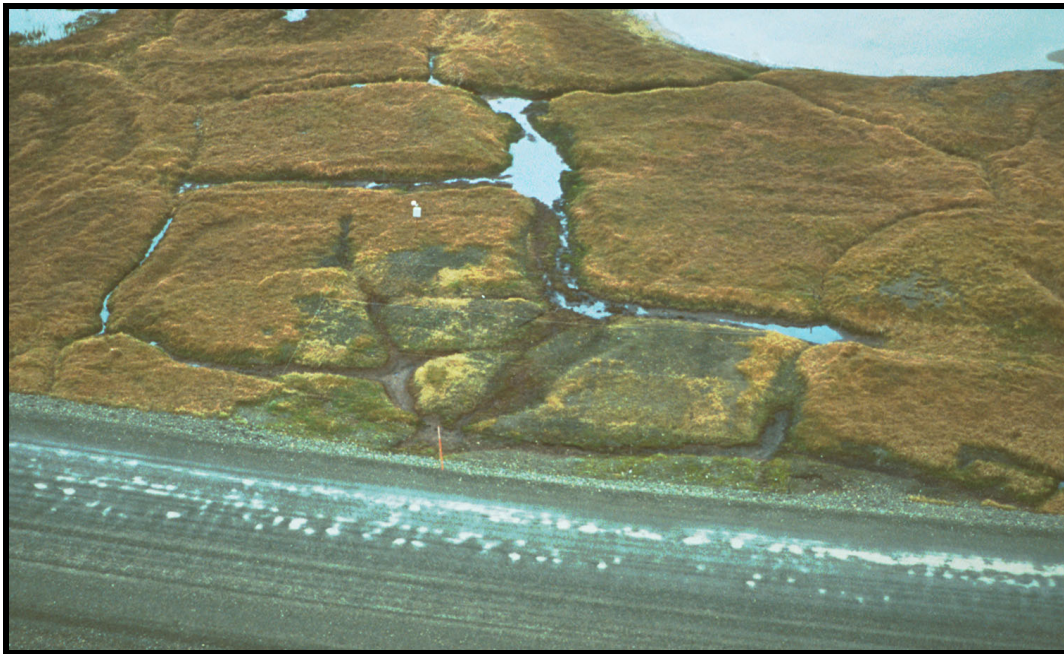
FRONT COVER:

*Aerial oblique of the Milne Point Diesel Spill site, 4 July 2001. This view shows the road with the spill site on the east side. Polygon troughs have deepened and widened from thermokarst since the spill and cleanup occurred. The light-colored box just beyond the spill is a data recorder for measuring soil and air temperatures at this location. Notice the vegetation has not become green by this date. The green surface next to the road is moss growing in the unseeded strip. Seeding strips are left to right in this image. Fertilizer strips are arranged perpendicular to the seed applications and extend foreground to background. The light colored grass within the spill area is *Puccinellia borealis*, northern alkaligrass, which was included in experimental seeding on the site. Even though much of the spill site appears barren in this image, by the end of the growing season, it was relatively well covered with vascular plants. The most prominent seeded grass was the Umiat collection of northern alkaligrass. The seed source developed from a collection at ERA Helicopters, Deadhorse, was slower to develop than the Umiat collection, but the ERA source produced an acceptable stand of plants, whose heights were shorter than those of the Umiat seed source. The poorest seeded grass was *Puccinellia augustata*, which was hand collected in WOA and coated with phosphorus fertilizer, clay and talc to facilitate handling and distributing the seed.*

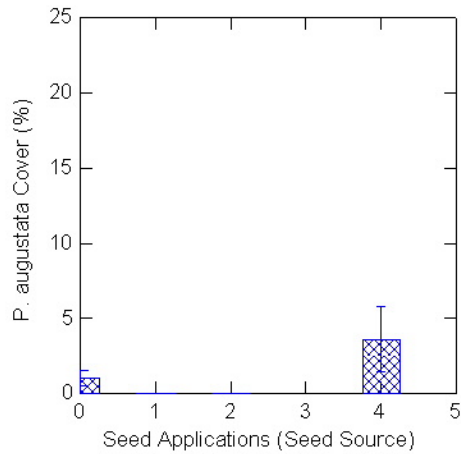
Figure 5. *P. augustata* cover by seed applications.

Seeding *P. augustata* increased cover of that species also (Figure 5). However, the cover averaged less than five percent, only slightly more than cover for that grass in the unseeded treatment. *P. augustata* occurs naturally in the vicinity. Some plants within the spill area may have originated from seed produced locally.

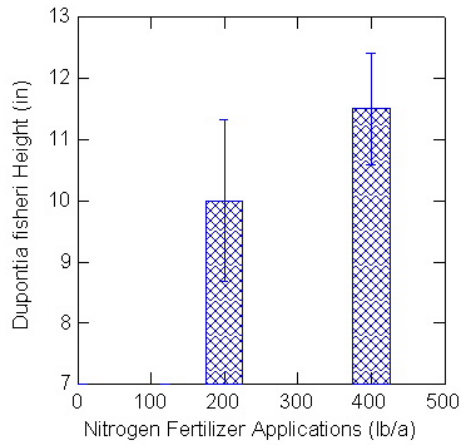
Figure 6. *Dupontia fisheri* heights and nitrogen fertilizer applications.

The most obvious effects from nitrogen fertilizer applications were to increase plant heights and palatability of grasses, as indicated by grazing. *Dupontia fisheri* heights were notably greater at the higher nitrogen applications (Figure 6). *P. augustata* heights increased at the 400 lb/a nitrogen application, but not at lower applications (Figure 7). There was a positive trend for *P. borealis* heights to increase with nitrogen fertilization (Figure 8). Grazing percentages were greater in treatments receiving 200 or more lb/a nitrogen (Figure 9).

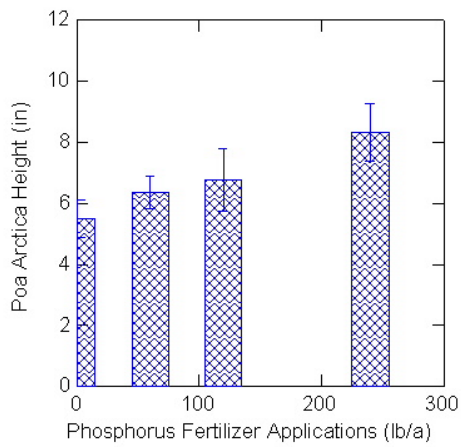
Figure 10. *Poa arctica* heights and phosphorus fertilizer applications.

Phosphorus fertilizer increased grass heights and grazing, but decreased species diversity on these plots. *Poa arctica* heights were increasingly greater as phosphorus fertilizer applications increased (Figure 10). *Dupontia fisheri*, *Puccinellia augustata* and *Puccinellia borealis* heights all responded positively to phosphorus (Figures 11 through 13). Grazing intensity generally increased with phosphorus fertilization through the 120 lb/a treatment, but not with the 240 lb/a application (Figure 14). The total plant species number declined as phosphorus application levels increased (Figure 15). The occurrence of mushrooms increased at the lowest phosphorus fertilizer application (60 lb/a) and then declined at the 120 lb/a application (Figure 16).

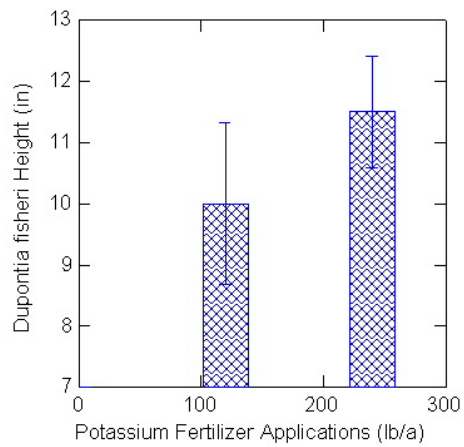
The most consistent response observed from potassium fertilization was plant height increases in *Dupontia fisheri* and *Poa arctica* (Figures 17 and 18). Heights of *Puccinellia augustata* and *Puccinellia borealis* also exhibited a positive response to potassium (Figures 19 and 20). There appeared to be a general decline in species diversity with increasing levels of potassium fertilization (Figure 21).

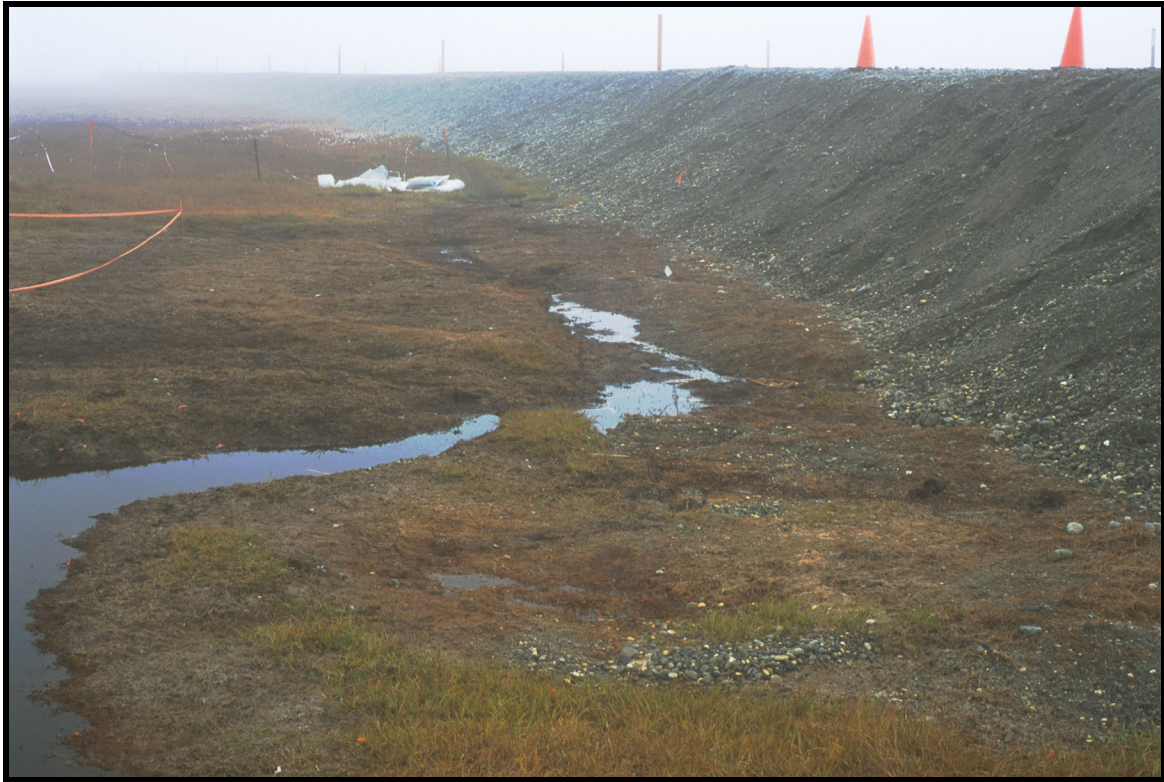
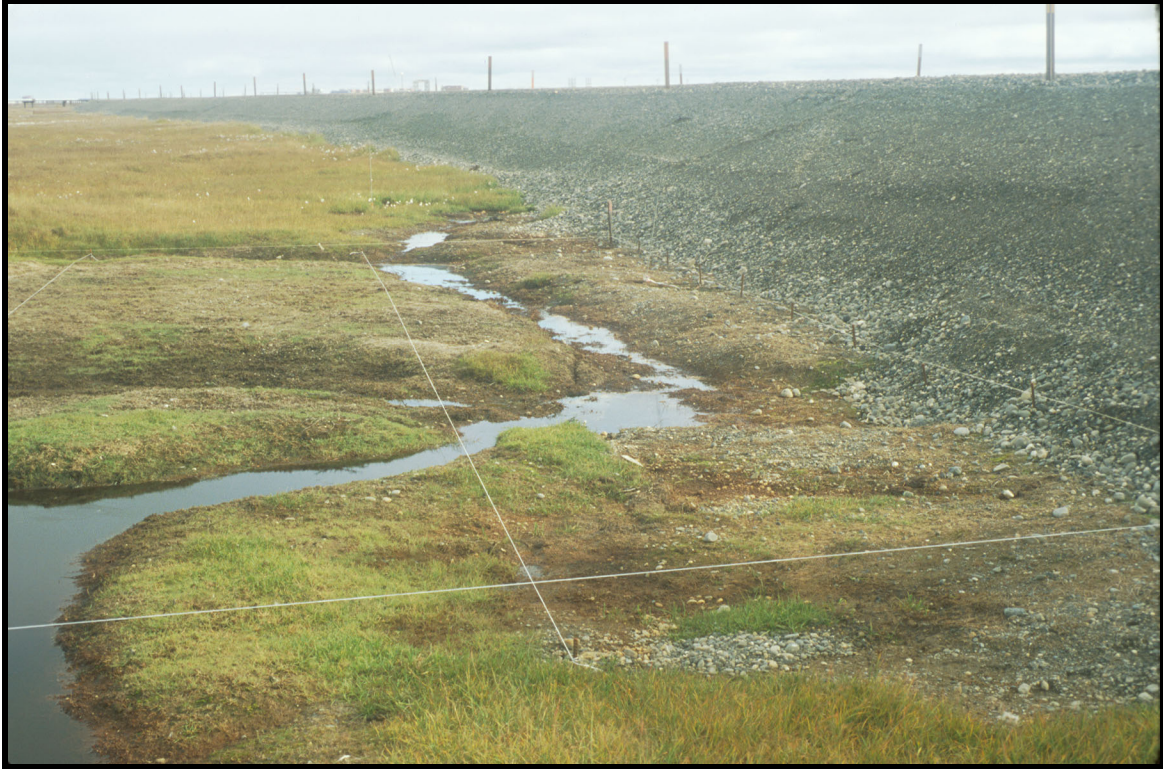
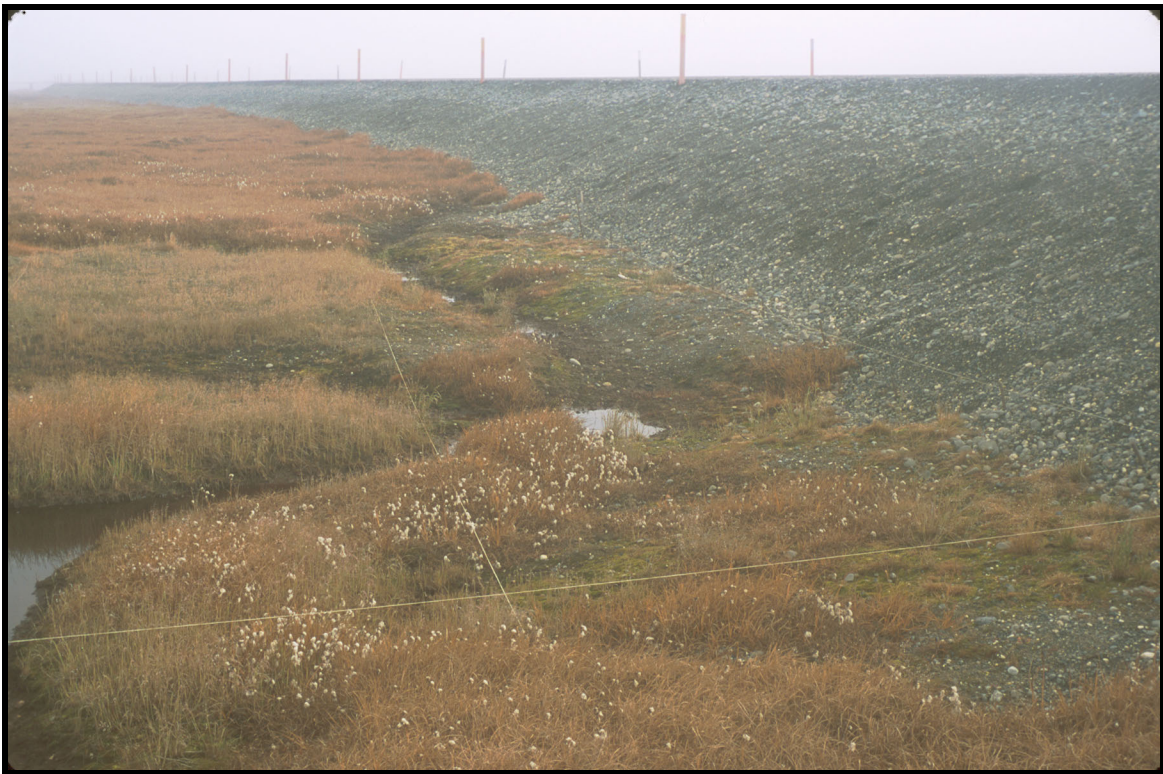
PHOTO SERIES 1

A series of images showing the vegetation recovery at the NE corner of the spill site, 1997 through 2001. Plants increasing in this portion of the spill during the interval included naturally-occurring sedges and grasses and the seeded northern alkaligrass. The green cast on the soil surface in the 2001 image is moss, which was encouraged by fertilizer applications. Notice deepening of polygon troughs occurred during the 1997-2001 interval.

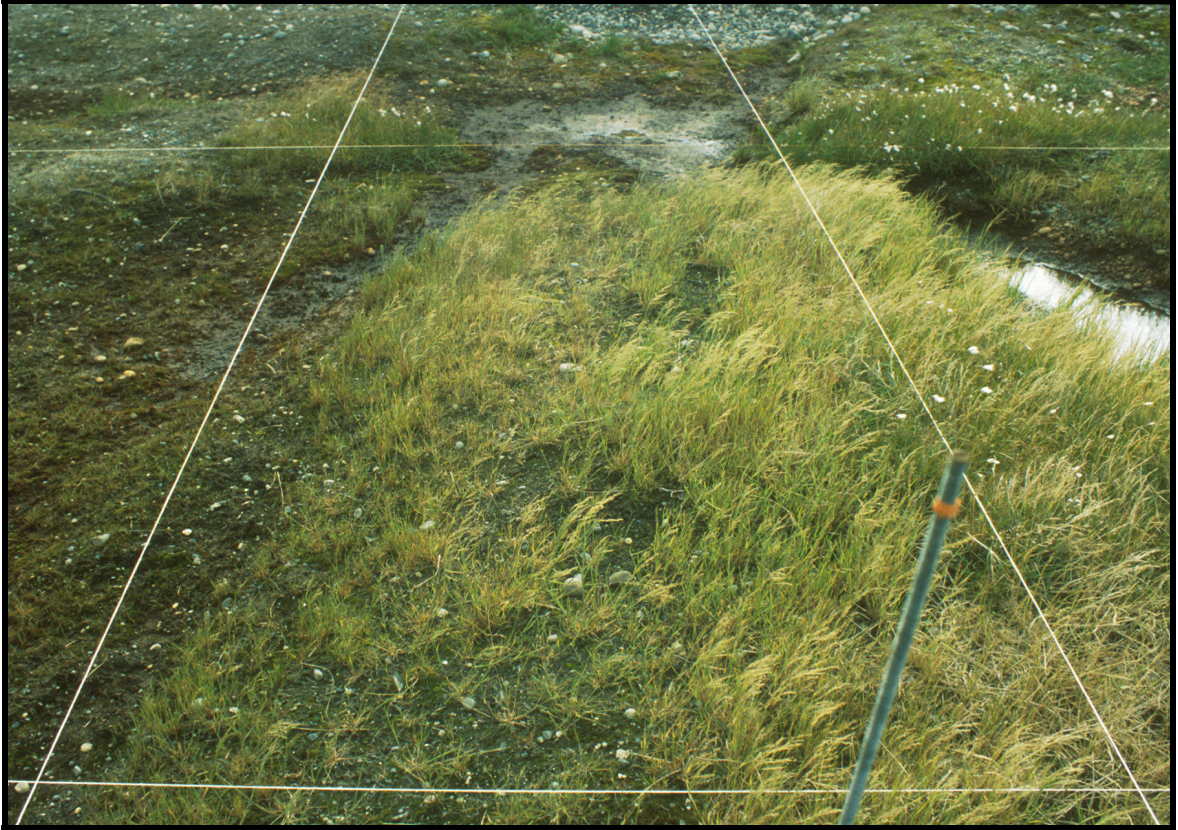
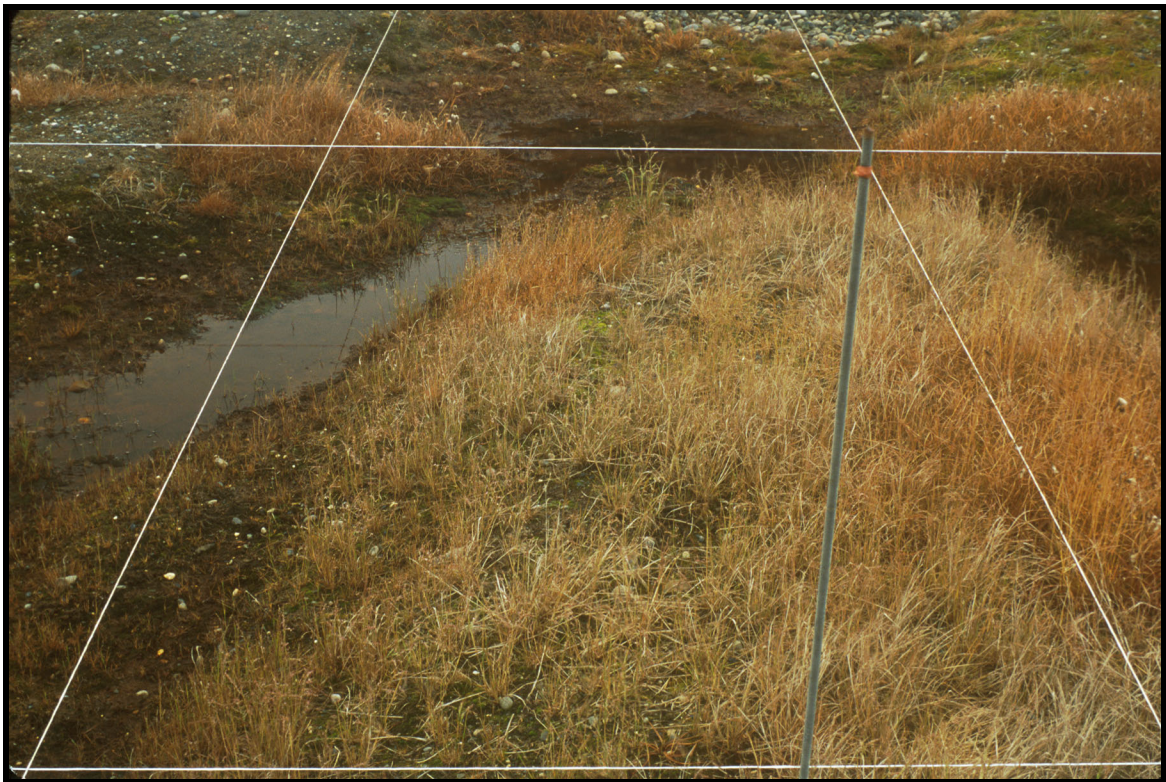
PHOTO SERIES 2

This photo sequence illustrates the establishment and maturation of *Puccinellia borealis* (Umiat ecotype). This particular plot was mostly within a polygon center, which became a raised center when the troughs subsided in response to the disturbances of the spill and cleanup operations. The fertilizer treatment in this plot was 200-0-120 (lbs/a N-P-K, respectively). In 1997, the ground surface was barren of vascular plants because of the spill and cleanup efforts. The *Puccinellia* seed was applied and germinated in 1998. These succulent seedlings were grazed intensively by geese and caribou that season and to a lesser degree the following year. By 1999, the plants were mature enough to produce inflorescences, and the grazing declined with the associated decrease in palatability, which accompanies inflorescence production. In 2000, these plants were grazed very little, and in 2001, there appeared to have been no grazing on the northern alkaligrass plants, even though they were affected by fertilizer applications.

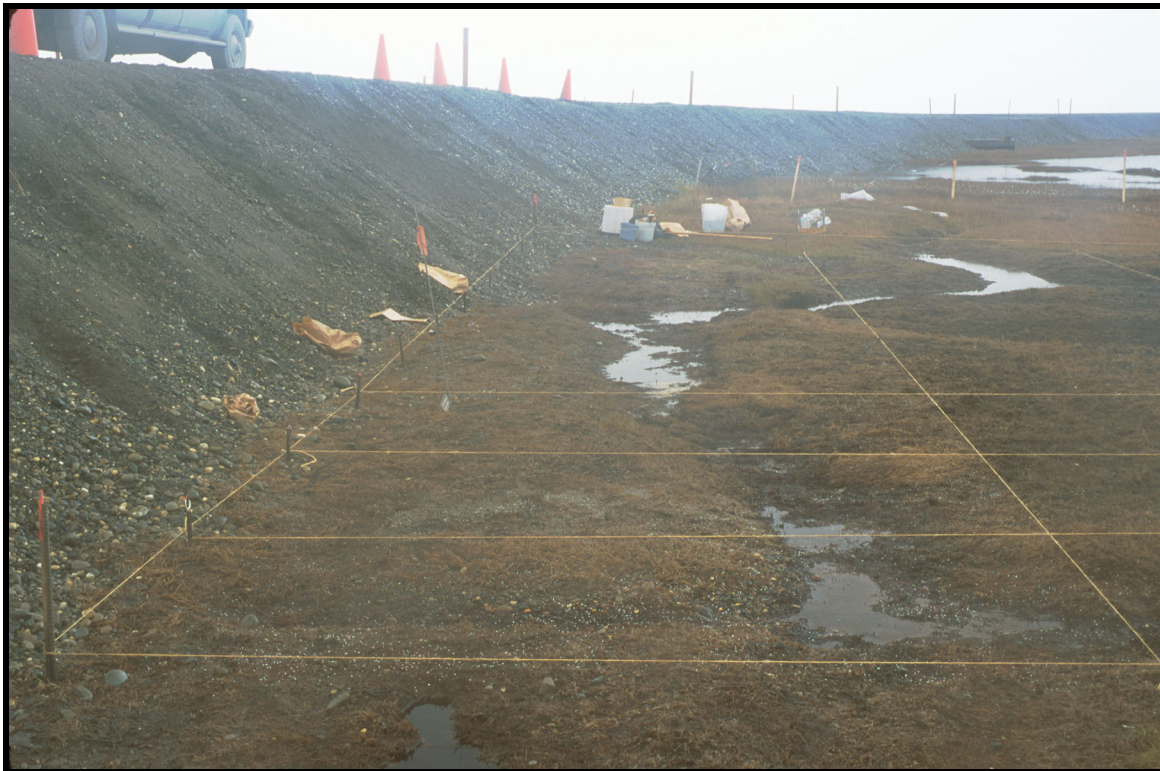
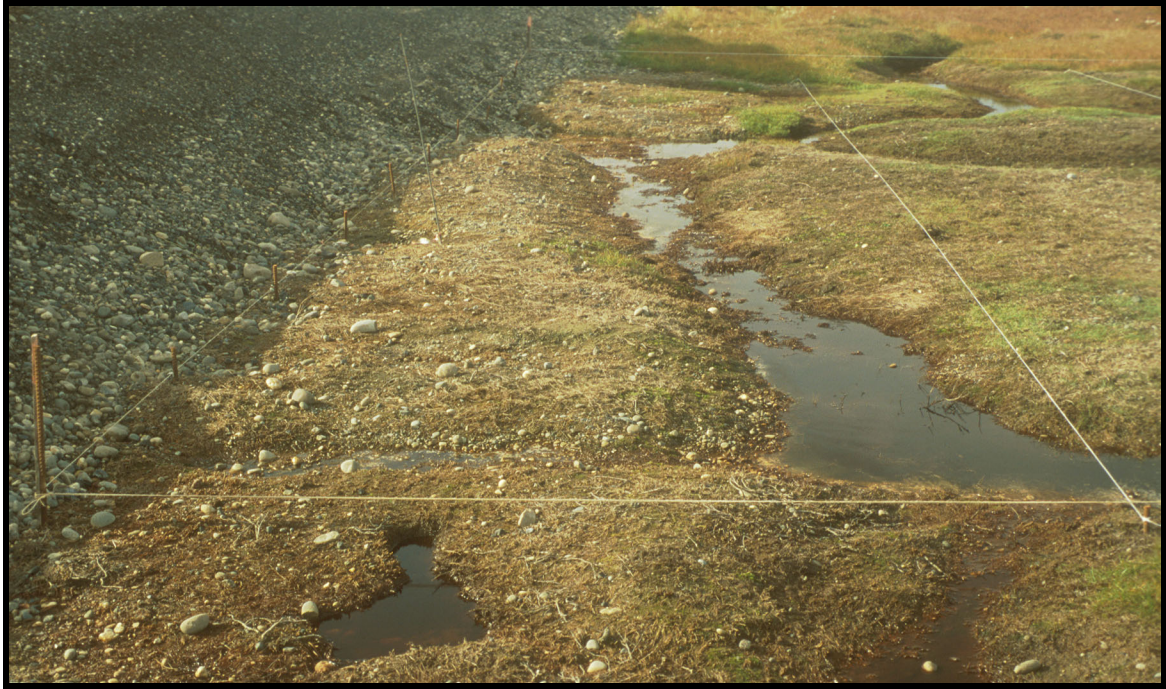
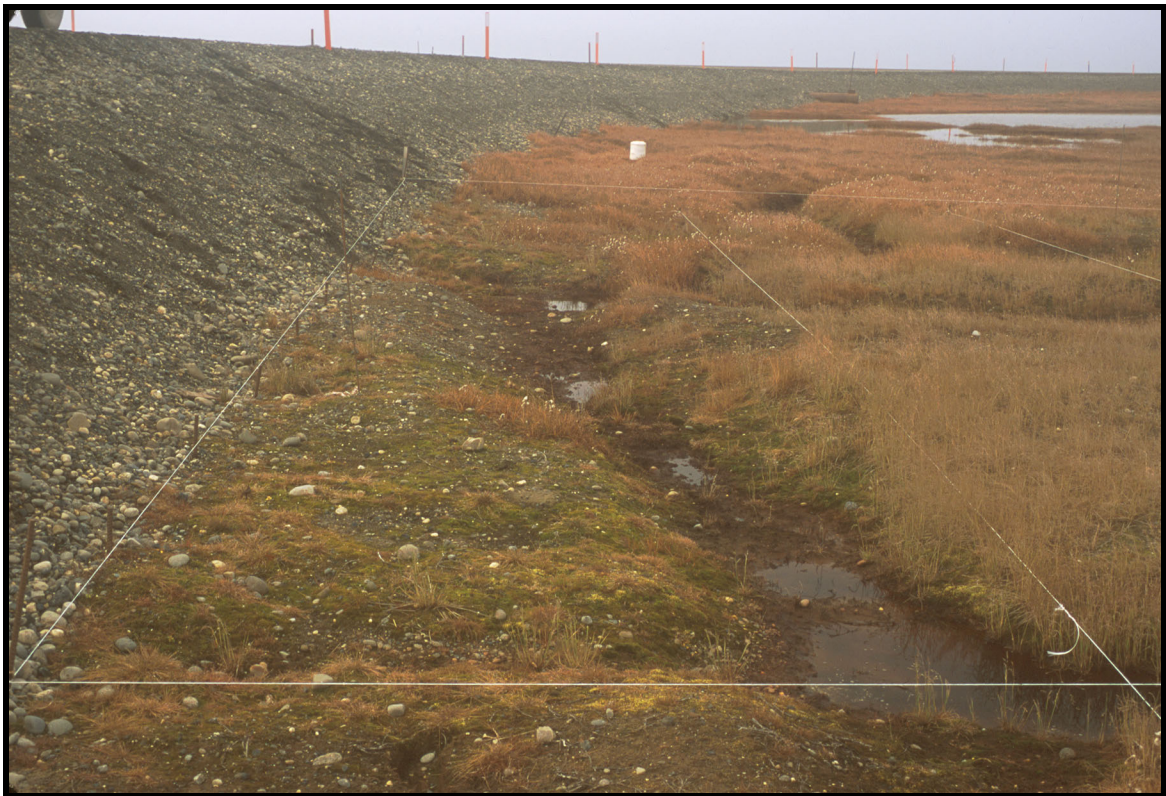
PHOTO SERIES 3

This sequence of photos shows the improvement of vegetation cover during a four-year interval on the unseeded strip of plots. This strip is next to the road, and affected by gravel stones that spill onto it. Snow drifts form over this area in winter, and lie late in the spring, shortening the growing season for plants in these plots. Plots are shaded in the afternoon, which possibly limits plant photosynthesis. This area was also probably more affected by the spill than locations more distant to the release point. Despite those drawbacks, there has been a gradual improvement in plant cover on these plots. *Phippsia algida* has invaded through seedling establishment (small clumps of grass in foreground of 2001 image). Mosses have established in response to fertilizer applications, and a few stray seedlings of *Puccinellia borealis* have established. These northern alkaligrass seedlings resulted mostly from seed inadvertently carried onto the site from the adjacent seeded plot.

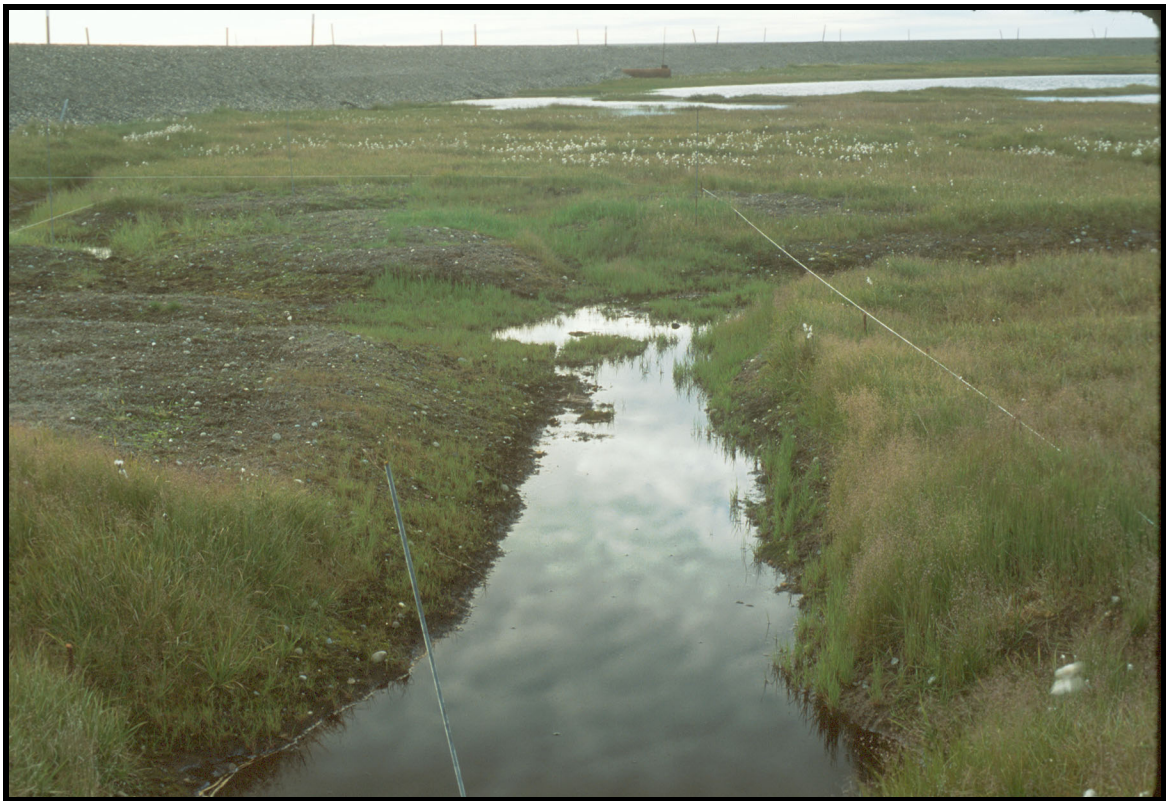
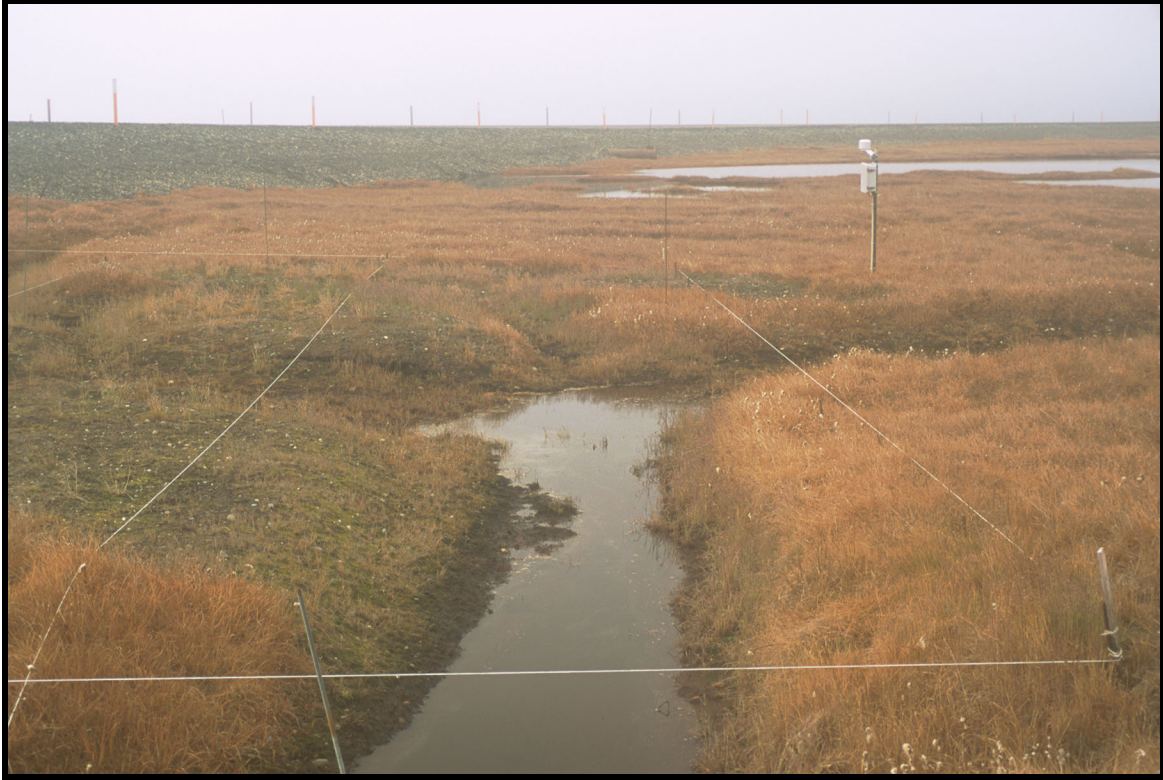
PHOTO SERIES 4

The photo sequences obtained at this location show a positive recovery by both natural and seeded plant species during the 1997-2001 time frame. Fertilizer effects could be seen within seeded plots and were also evident in the natural vegetation that sometimes occurred within fertilized plots. The fertilizer increased growth, delayed senescence, and encouraged grazing (Photo Series 1, 2, and 4). The northern alkaligrass ecotype from Umiat was the most vigorous of the two ecotypes seeded at this location (Photo Series 2 and 6). The ecotype from the Deadhorse ERA Helicopters location was seeded to a portion of the site that was largely flooded polygon trough (Photo Series

4). That limited the ERA ecotype's chances to establish and develop at this location. Based on seedling establishment in these seasonally flooded microhabitats, it appears that this ecotype may be better suited to wet soils than the Umiat ecotype. In an unseeded strip, *Phippsia algida* established where fertilizer was applied (Photo Series 3). This grass is indigenous to the vicinity and was a volunteer colonizer within the spill area. Native *Puccinellia augustata* did not perform well at this location (Photo Series 5). Its poor germination was attributed to the seed coating treatment, which may have reduced germination for the seedlot, which originated from hand collections in the Prudhoe Bay Western Operating Area.

This sequence of images shows the development of *Puccinellia borealis* (ERA Helicopter ecotype). Seed was applied on 12 September 1997. It germinated during the 1998 growing season. This ecotype typically establishes slowly in comparison with the ecotype from Umiat. That is evident in this sequence. The plants are shorter than those from the Umiat source. The best development of this ecotype in this plot occurred in the partially flooded polygon trough near the far end of the plot. In contrast, the Umiat ecotype developed best on the drier ground of polygon centers. The ERA Helicopter ecotype was still a better performer than *Puccinellia augustata* at this location. Notice the effect of fertilizer on the natural tundra plants at the right edge of the 30 August 1998 image. The fertilized tundra plants are still bright green, and the unfertilized cohorts outside the plot have senesced and turned brown.

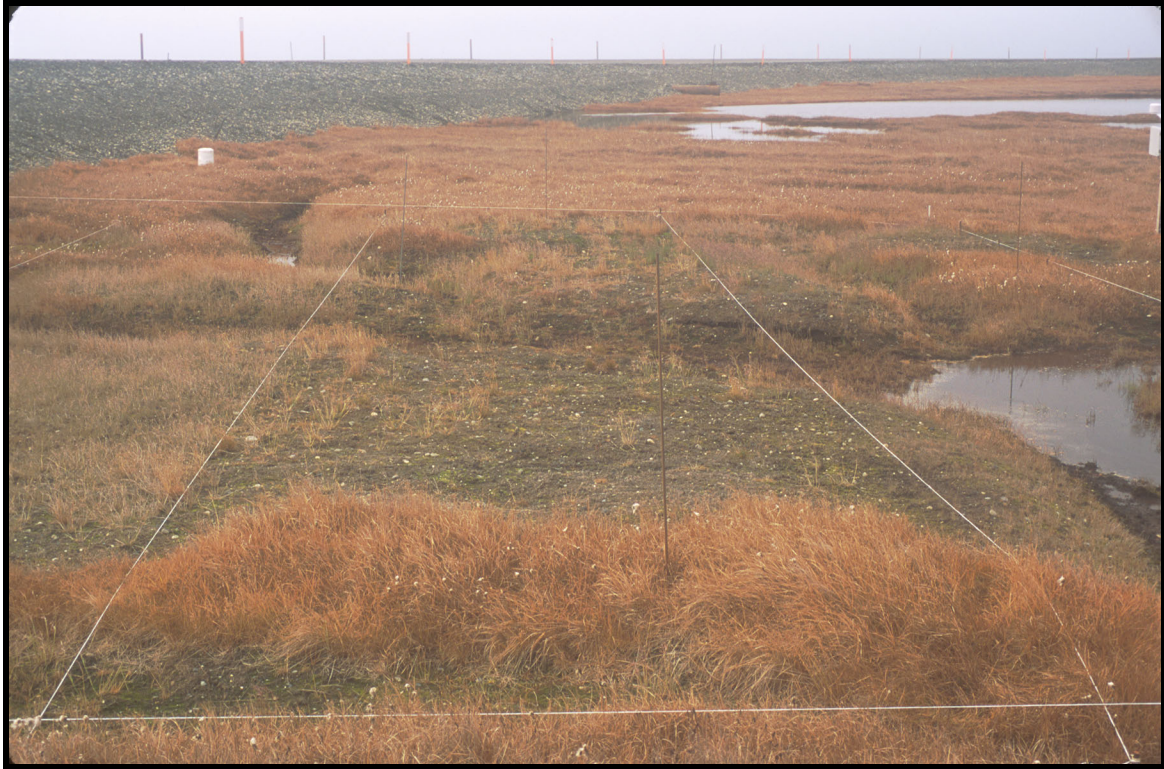
This sequence of images illustrates the poor development of *Puccinellia augustata* in the seeding at the diesel spill site. Seed was applied on 12 September 1997, and it germinated during the 1998 growing season. Plants matured during the 1999 growing season. By the end of the 2001 growing season, there were only a few scattered individuals established. The poor development was believed to have been caused by limited germination. This species' seed normally has a relatively high germination percentage (in the 90% range). However, this seed lot was given a coating to ease handling and applying the seed. Apparently the coating process substantially reduced the germination percentage. This was not the only location where poor development occurred with this seed lot. Therefore, we do not believe the performance accurately reflected the effects either of the spill or the cleanup procedures on this grass plants' establishment. Plants that did establish appeared normal, grew well and were robust.

Most of the vegetation in this image is natural species that survived the spill, and scattered individuals of northern alkaligrass that were accidentally seeded.

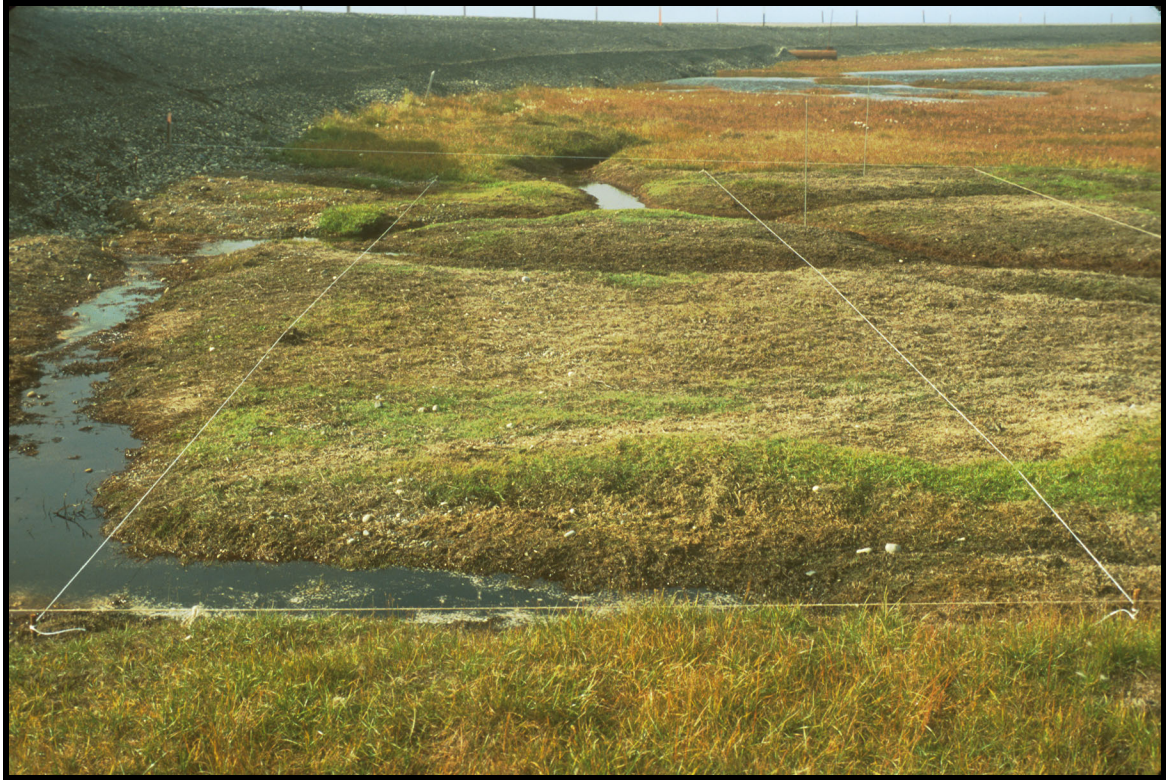
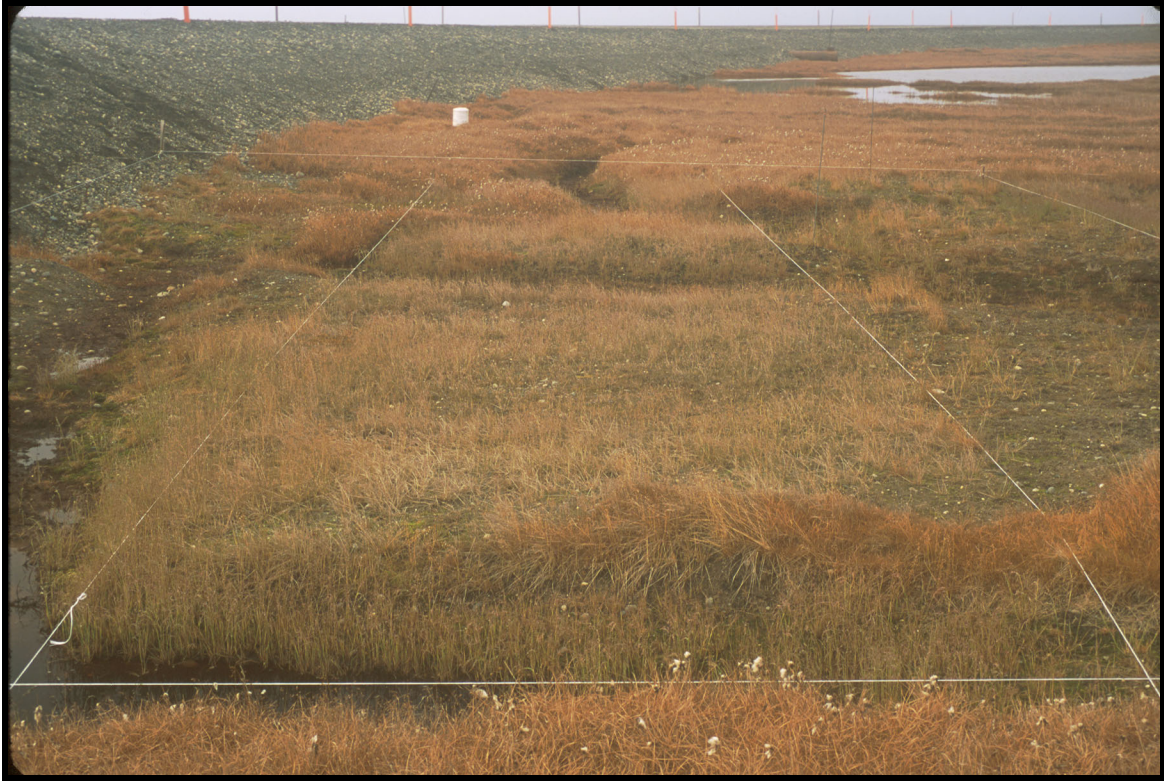
PHOTO SERIES 6

This sequence of photos shows the robust development of *Puccinellia borealis* (Umiat ecotype). Seed was applied on 12 September 1997, and germinated during the 1998 growing season. Seedlings were intensely grazed by caribou and geese. This grazing was enticed by the plants' succulence, their phenological age and effects from fertilizer. As the plants aged and began developing inflorescences, their attractiveness to grazers diminished. By 1999, the grazing intensity was markedly lower. By 2001, there appeared to have been little grazing on these plants, even though other graminoids in the vicinity had been grazed. This ecotype developed well on the raised micro-topography within the spill area, and responded positively to fertilizer applications. It appears to be a desirable grass species for revegetation in this region.
