Source Water Assessment -
Anchorage Bible Fellowship
Anchorage, Alaska

Hydrogeologic Susceptibility and Vulnerability Analysis

DRINKING WATER PROTECTION PROGRAM REPORT 18

August 2001

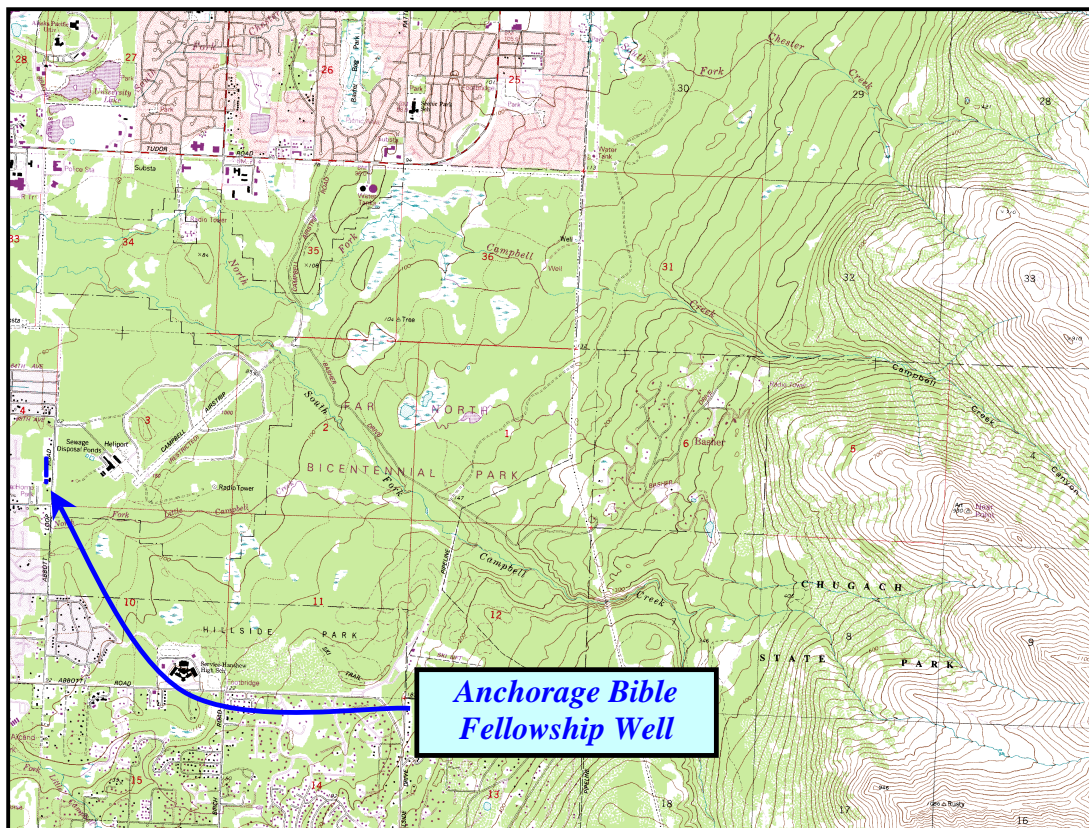
Figure 3. Map showing the location of the drinking water source for Anchorage Bible Fellowship [Base: USGS Anchorage A8 NE].

base of the Chugach Mountains and is at an elevation of 200 feet above sea level. The well is located near the middle of the north property line at the intersection of Abbott Loop Road and East 72nd Avenue (see Figure 3). According to an engineering report (5/31/96), the well for Anchorage Bible Fellowship penetrates intermittent layers of gravel, sand, silt and clay to a total depth of 74 feet below land surface where it encounters bedrock and does not appear to be properly grouted. Whether the well is screened or has an open hole is unknown. According to the engineering report the static water level was found to be 20.3 feet below land surface.

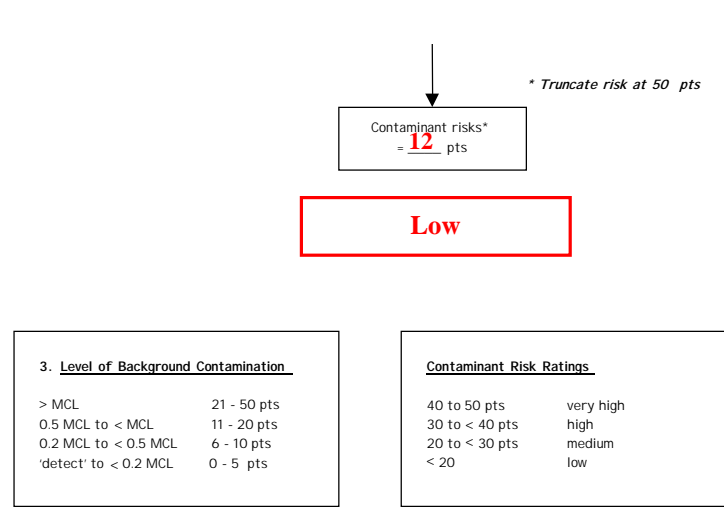
Chart 7. Contaminant risks for Anchorage Bible Fellowship – Volatile Organic Compounds

Campbell Airstrip intersects the Zone C protection area along with recreation trails within Far North Bicentennial Park. An accidental release of fuel could enter the aquifer through the land surface and flow toward the well. Due to the potential of an accidental release occurring the airstrip was initially ranked as posing medium potential contaminant risk for volatile organic chemicals. However, this airstrip is only actively used during the summer months (June through September) for emergency purposes only. Therefore, the risk for this potential source of contamination has been reduced and ranks as a low for volatile organic chemicals.

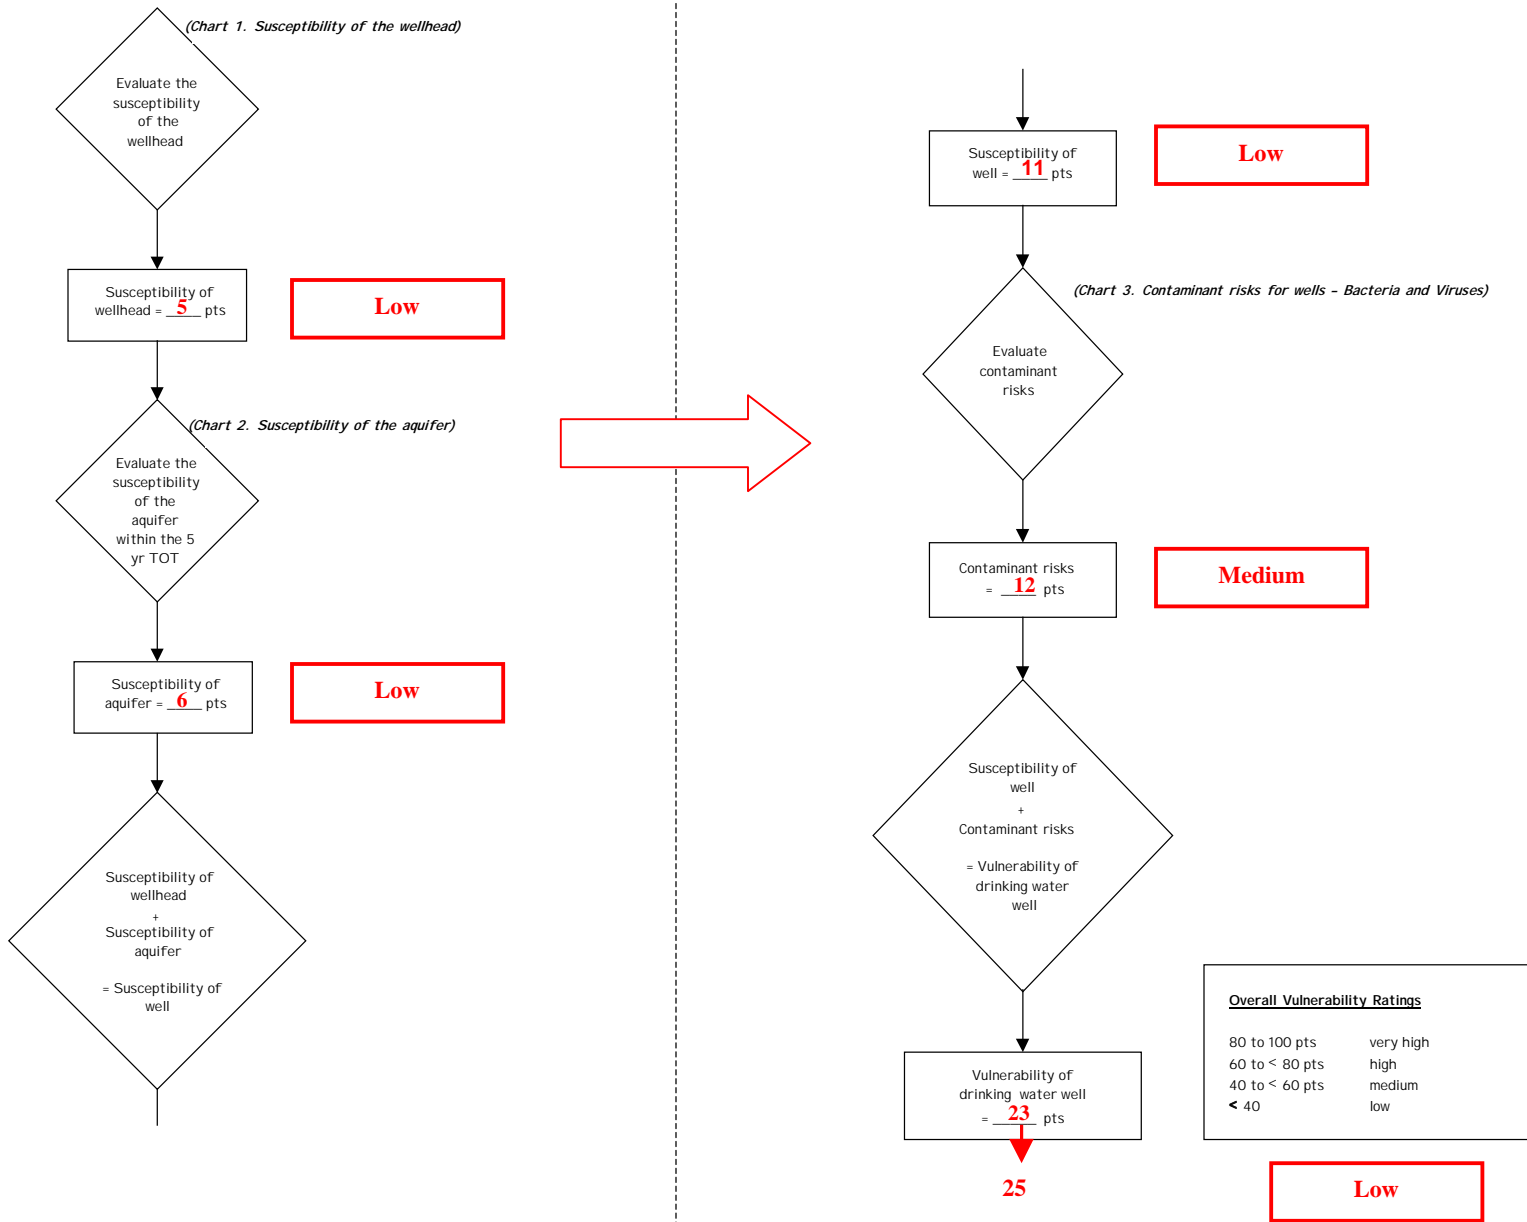
Chart 8. Vulnerability analysis for Anchorage Bible Fellowship – Volatile Organic Chemicals
