# *Source Water Assessment* for New Grace Lutheran Church Anchorage, Alaska

A Hydrogeologic Susceptibility and Vulnerability Analysis

DRINKING WATER PROTECTION PROGRAM REPORT 166 PWSID 215867.001

December 2001

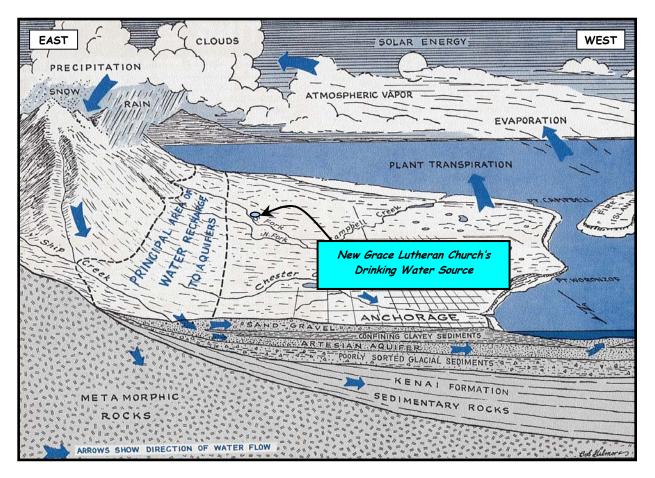
Figure 2. Generalized hydrologic cycle in the Anchorage area [Barnwell, George, Dearborn, Weeks, and Zenone, 1972].

In the Anchorage area, two principal groundwater flow systems or aquifers exist (see Figure 2). The upper unconfined aquifer or water-table aquifer is separated from a lower confined aquifer system by layers of silty, clayey glacially derived sediments (confining layer) [*Ulery and Updike*, 1983]. The lower confined aquifer system consists of a series of hydrologically interconnected layers and lenses of gravel, sand and silt that, collectively, form the confined aquifer. The confining layer ranges from 0 to 270 feet thick throughout the Anchorage area and generally thins with increasing distance from Cook Inlet, thus pinching out at the mountain front [*Patrick, Brabets, and Glass*, 1989].

Conceptually, groundwater enters the aquifer systems along the front range of the Chugach Mountains (Figure 2) and flows toward Cook Inlet. An analytical calculation was used to determine the size and shape of the area that contributes water to the well. The input parameters describing the attributes of the aquifer in this calculation were adopted from the U.S. Geological Survey [Patrick, Brabets, and Glass, 1989]. This analytical calculation was used as a guide as the first step in establishing the protection area for each public drinking water source in Anchorage. Additional methods were further employed to take into account any uncertainties in groundwater flow and aquifer characteristics to arrive at meaningful and conservative protection areas with respect to public health (Please refer to the Guidance Manual for Class B Public Water Systems for additional information).

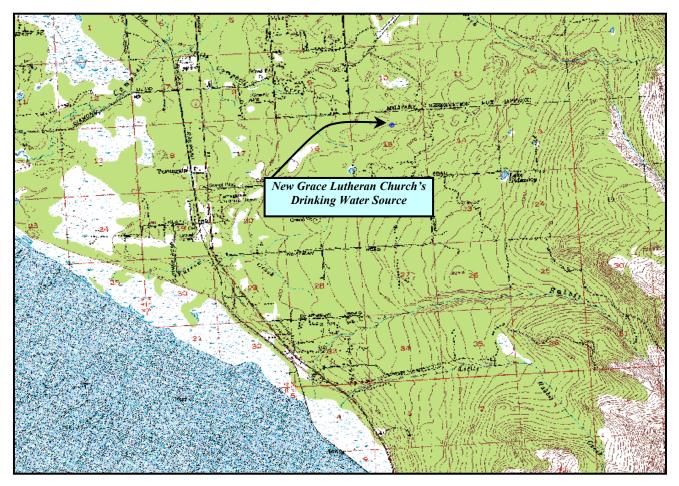
**Figure 3. Map showing the location of the drinking water source for New Grace Lutheran Church** [Base: USGS Anchorage A8].

The public water system serving New Grace Lutheran Church is a Class B (transient/non-community) water system, which is owned and operated by New Grace Lutheran Church. The system consists of one well, which is located off of O'Malley Road at an elevation of approximately 500 feet above sea level (see Figure 3).

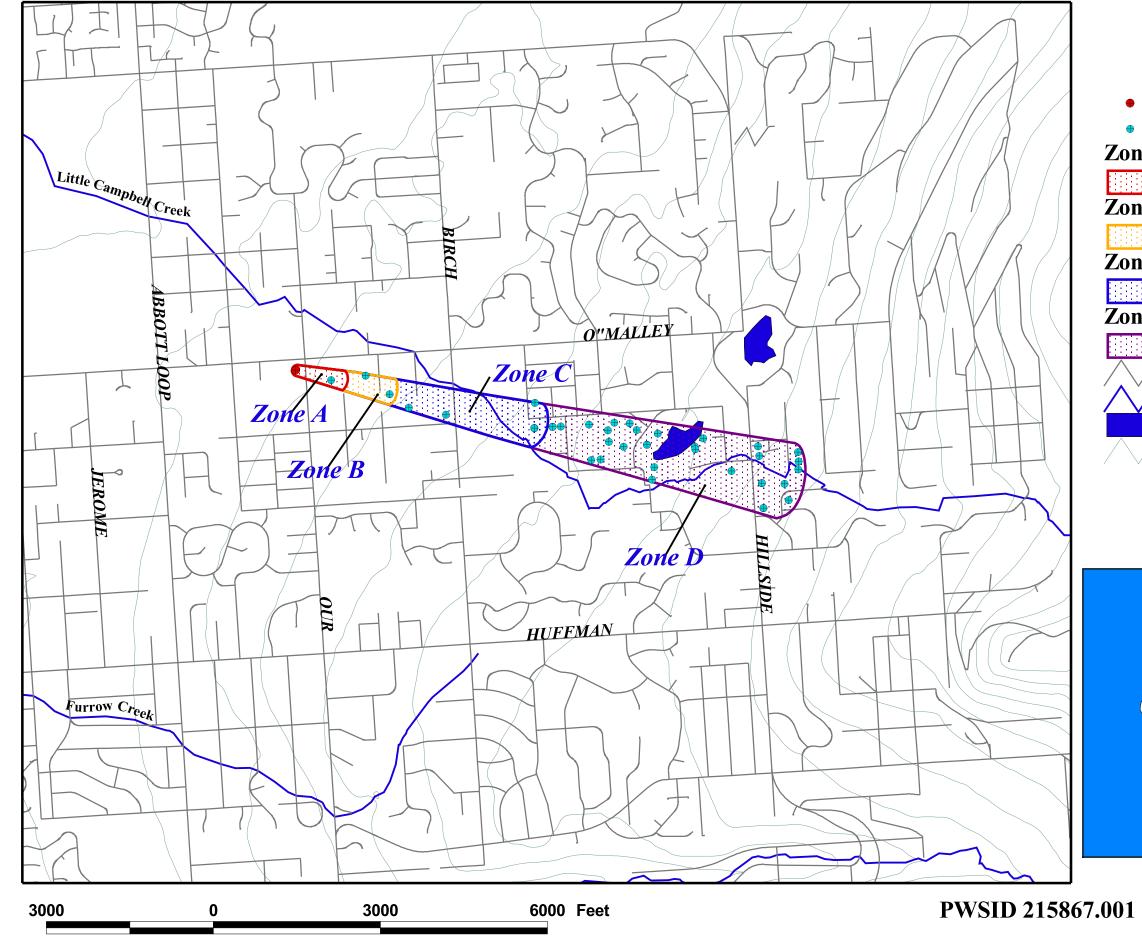
New Grace Lutheran Church's Drinking Water Protection Area

Unity Church Of Anchorage DW Well
Private and Public DW Wells
Zone A Protection Area
Several Months Travel Time
Zone B Protection Area
Less Than 2 Years Travel Time
Zone C Protection Area
Less Than 5 Years Travel Time
Zone D Protection Area
Less Than 10 Years Travel Time
Roads
Anchorage Streams
Anchorage Lakes
Elevation Contours

The Drinking Water Protection Areas established for wells by the Alaska Department of Environmental Conservation are separated into zones. These zones correspond to a time-of-travel. Time-of-travel is the time required for water to move in the saturated zone of the ground from a specific point to the well. The Drinking Water Protection Area for New Grace Lutheran Church contains four zones, Zone A through Zone D (See Map 1 in Appendix A). Zone A corresponds to the area between the well and the distance equal to  $\frac{1}{4}$  of the distance of the 2-year time-of-travel. Depending on where a contaminant source is located within Zone A, travel time for a contaminant to the well may be on the order of several days to several hours. Zone A also extends downgradient from the well to take into account the area of the aquifer that is influenced by pumping of the well. Zone B corresponds to a time-of-travel of less than two years. Zones C and D correspond to those areas between 5 years and 10 years time-of-travel, respectively.

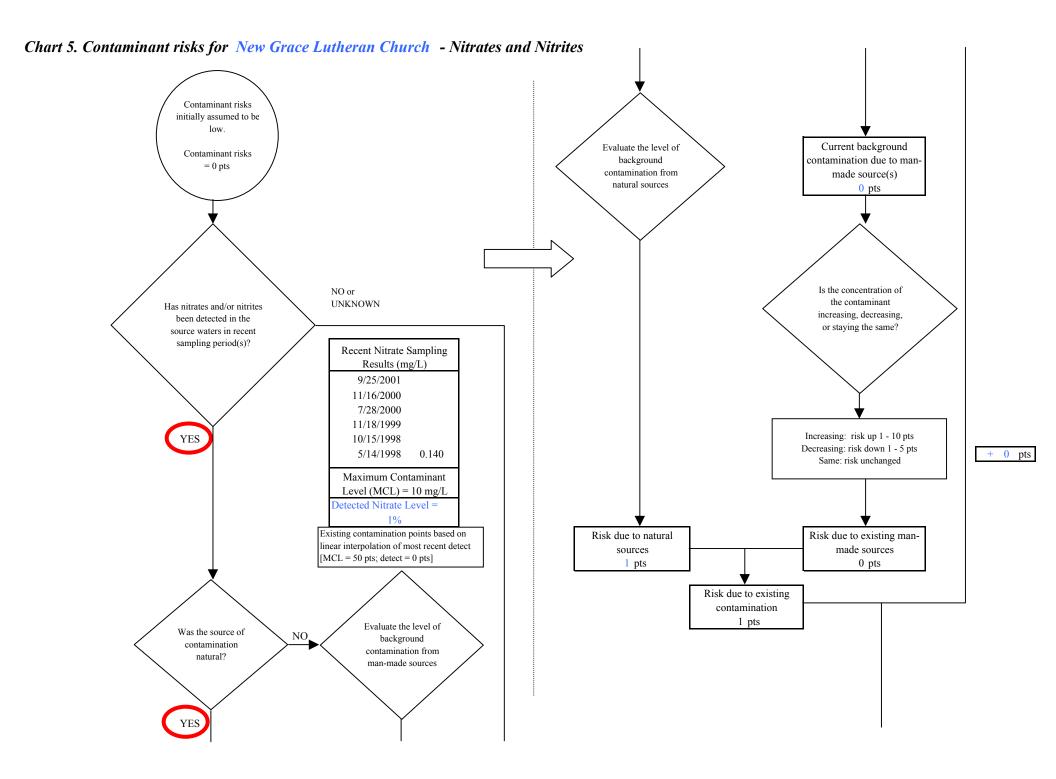
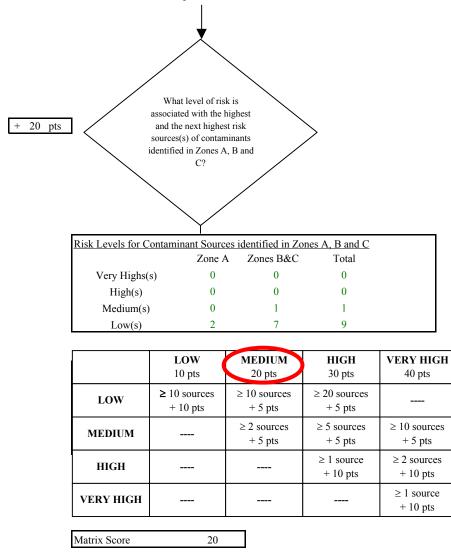
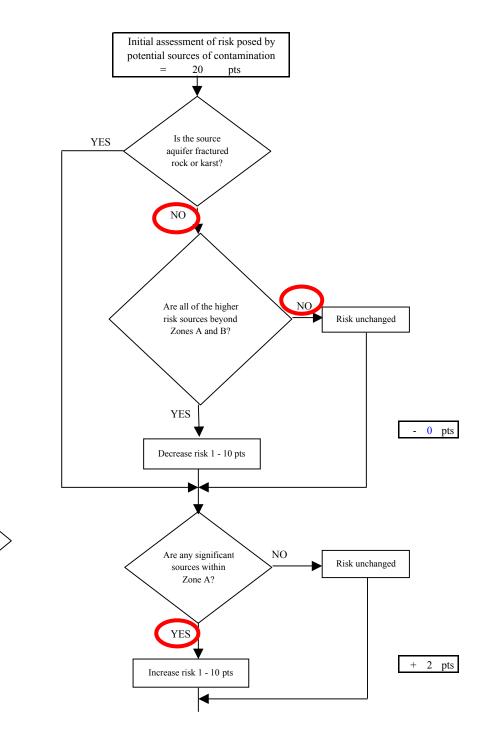
Chart 5. Contaminant risks for New Grace Lutheran Church - Nitrates and Nitrites

Note: Septic systems, sewerlines, and roads are each assigned a risk ranking for each individual contaminant source in the CSI. The VA, however, counts these contaminant sources as a group and assigns a calculated number of either "lows" or "mediums" based on the density.

Overall, contaminant risk for nitrates and/or nitrites is medium with Municipal or City Parks driving the increase of contaminant risks. Combining this potential nitrates and/or nitrites contamination risk with the natural susceptibility of the well leads to an overall vulnerability to contamination of medium.

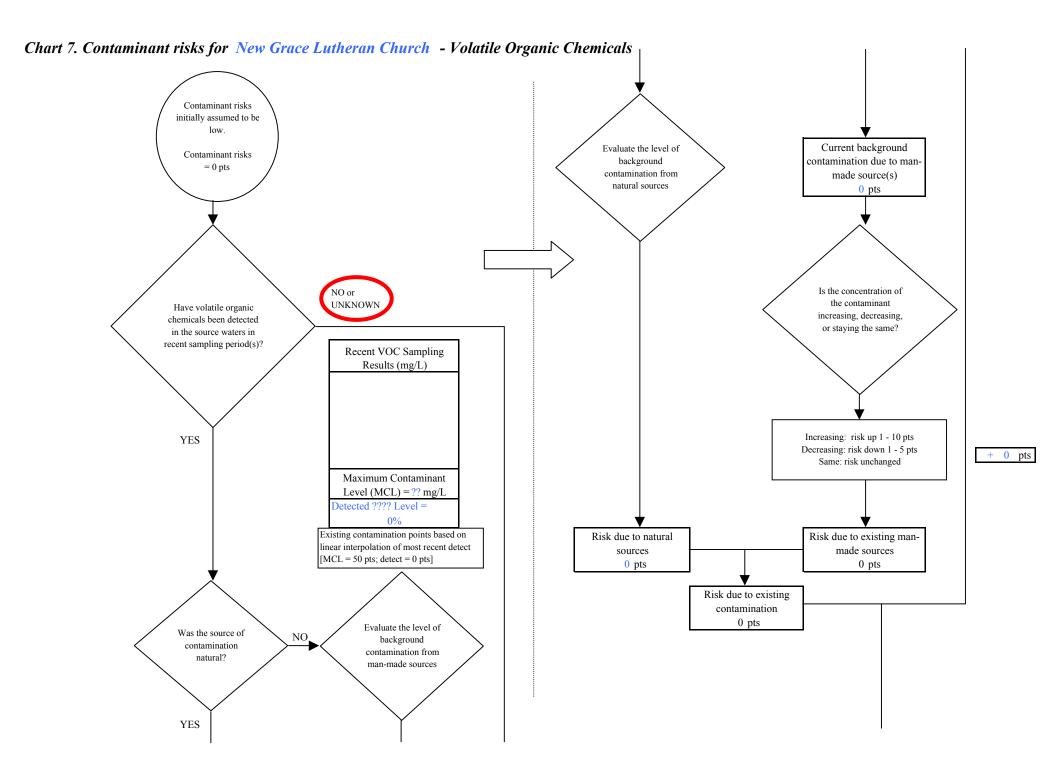
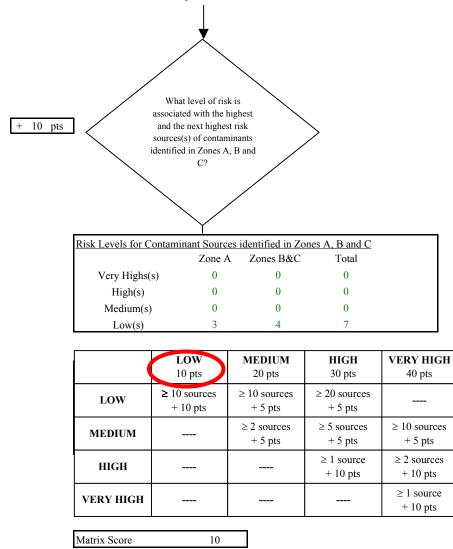
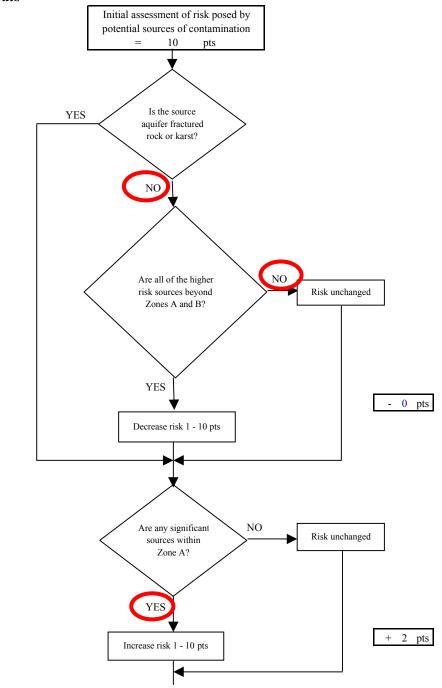
Chart 7. Contaminant risks for New Grace Lutheran Church - Volatile Organic Chemicals

Note: Septic systems, sewerlines, and roads are each assigned a risk ranking for each individual contaminant source in the CSI. The VA, however, counts these contaminant sources as a group and assigns a calculated number of either "lows" or "mediums" based on the density.

Overall, contaminant risk for volatile organic chemicals is low with paved roads and residential septic systems driving the increase of contaminant risks. Combining this potential volatile organic chemical contamination risk with the natural susceptibility of the well leads to an overall vulnerability to contamination of low.
