Source Water Assessment

Puffin Inn,
Anchorage, Alaska
PWSID#210540.001

DRINKING WATER PROTECTION PROGRAM REPORT 698

Alaska Department of Environmental Conservation
September 2002

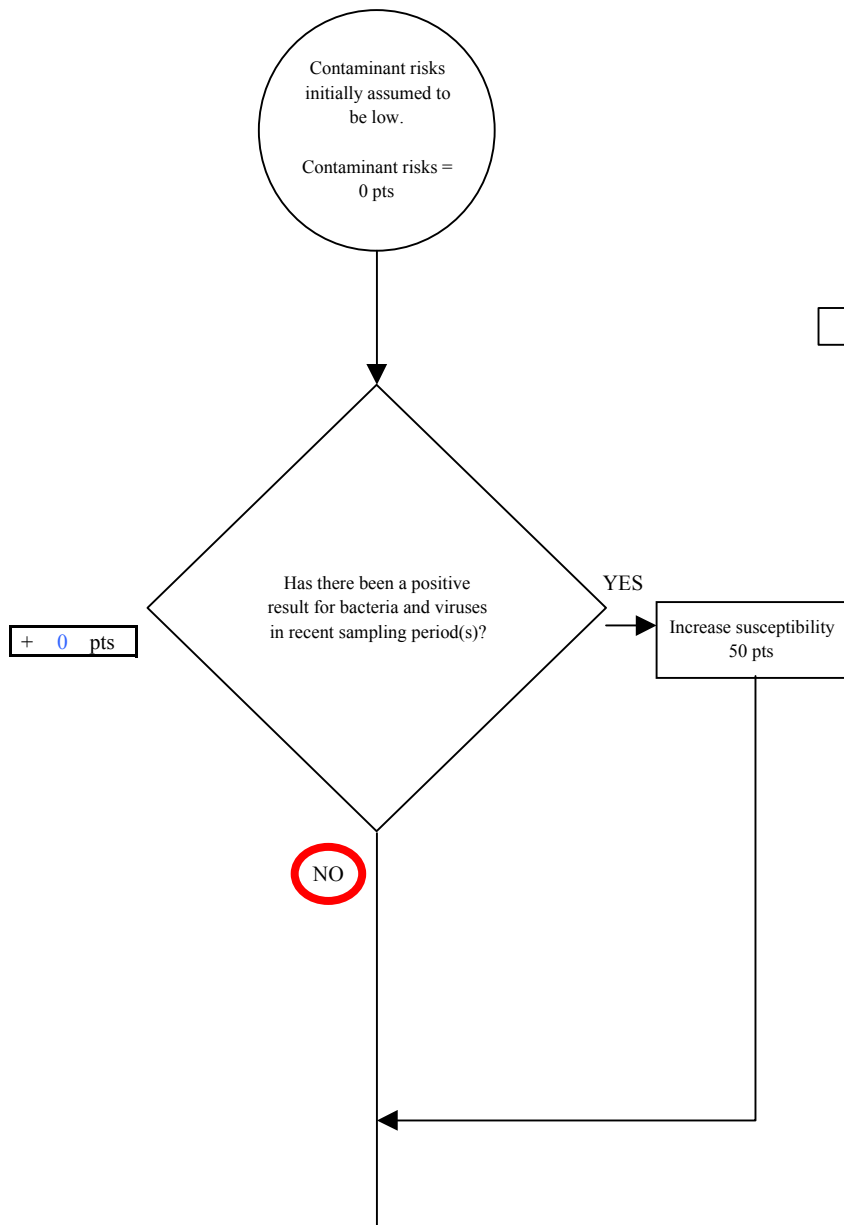
Chart 3. Contaminant risks for Puffin Inn- Bacteria & Viruses

Risk Rankings for Contaminant Sources Identified in Zones A and B

Matrix Score 10

The contaminant risk for bacteria and viruses is medium with sewer lines and parks presenting the most significant risk to the drinking water well (See Chart 3 – Contaminant Risks for Bacteria and Viruses in Appendix D).

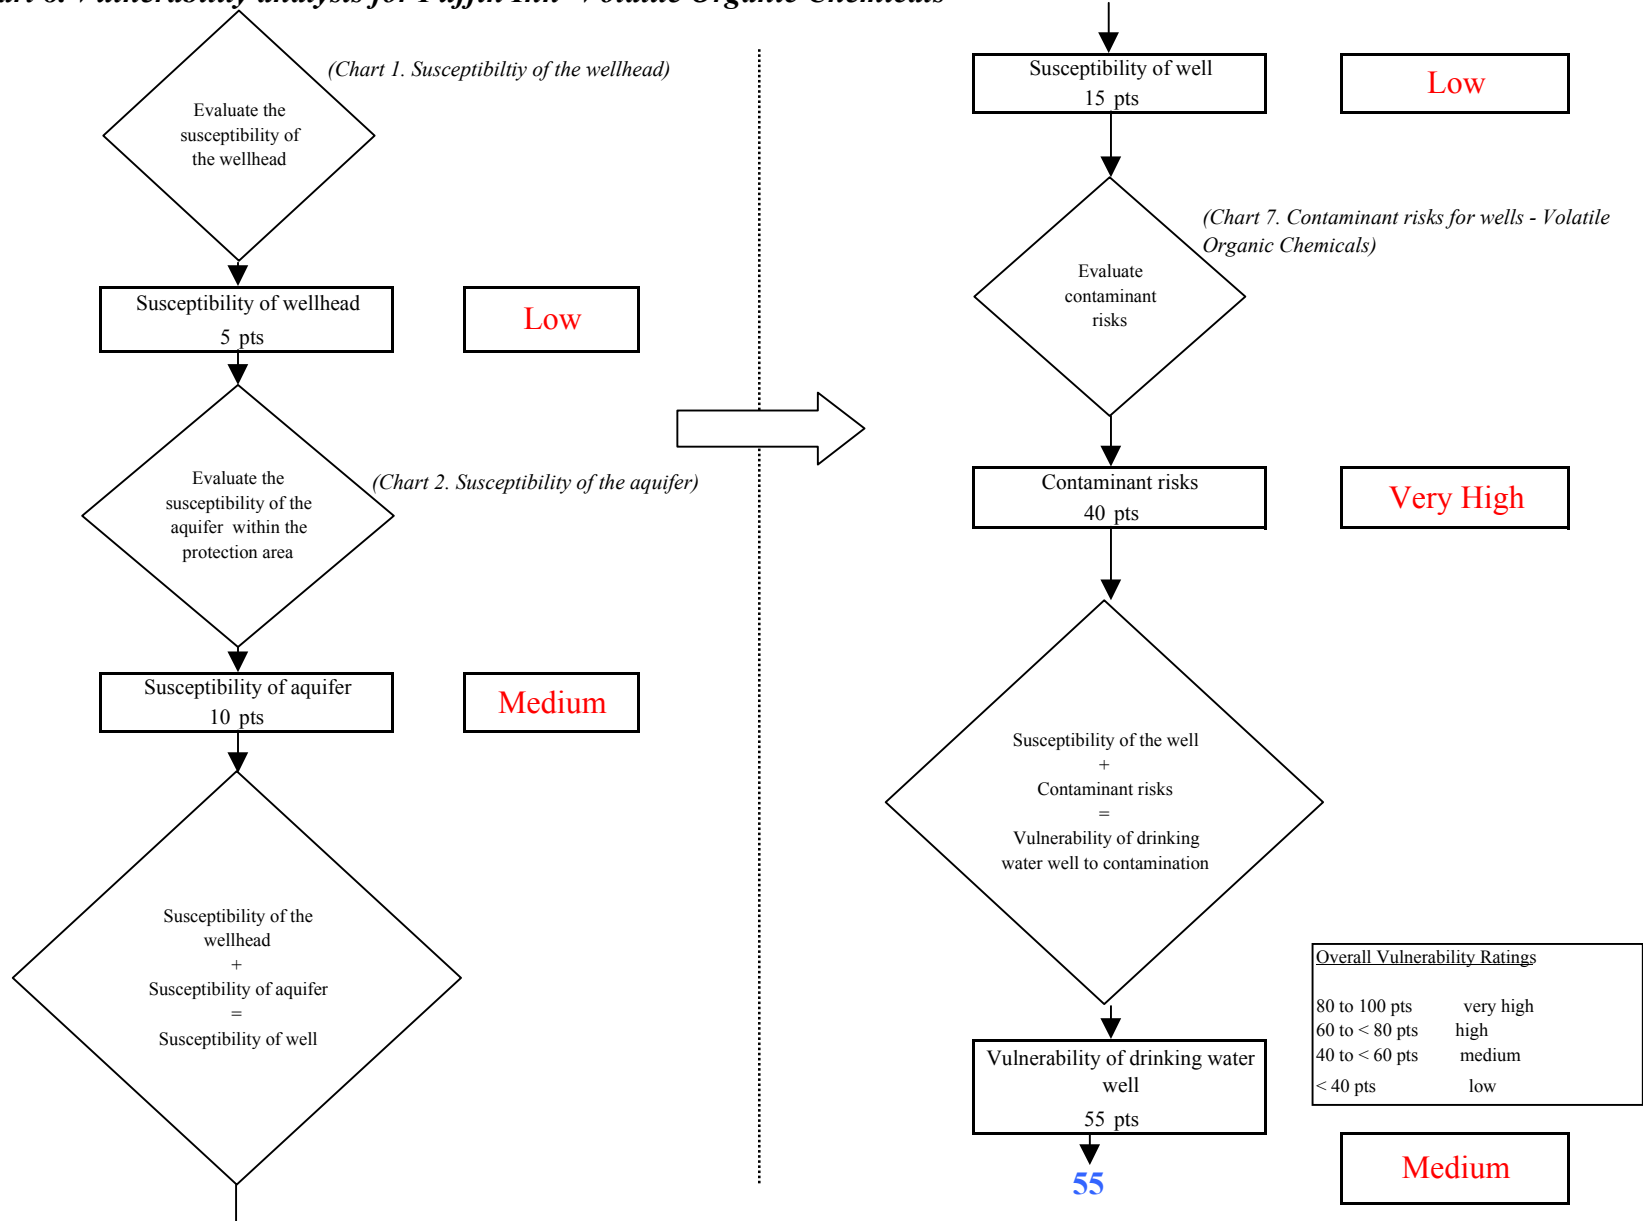
Chart 8. Vulnerability analysis for Puffin Inn- Volatile Organic Chemicals

After combining the contaminant risk for volatile organic chemicals with the natural susceptibility of the wells, the overall vulnerability of the wells to contamination is medium.
