Source Water Assessment

A Hydrogeologic Susceptibility and
Vulnerability Assessment for
Lakeview Apartments Water System
Drinking Water System,
Bethel, Alaska

PWSID # 271172.001

April 2004

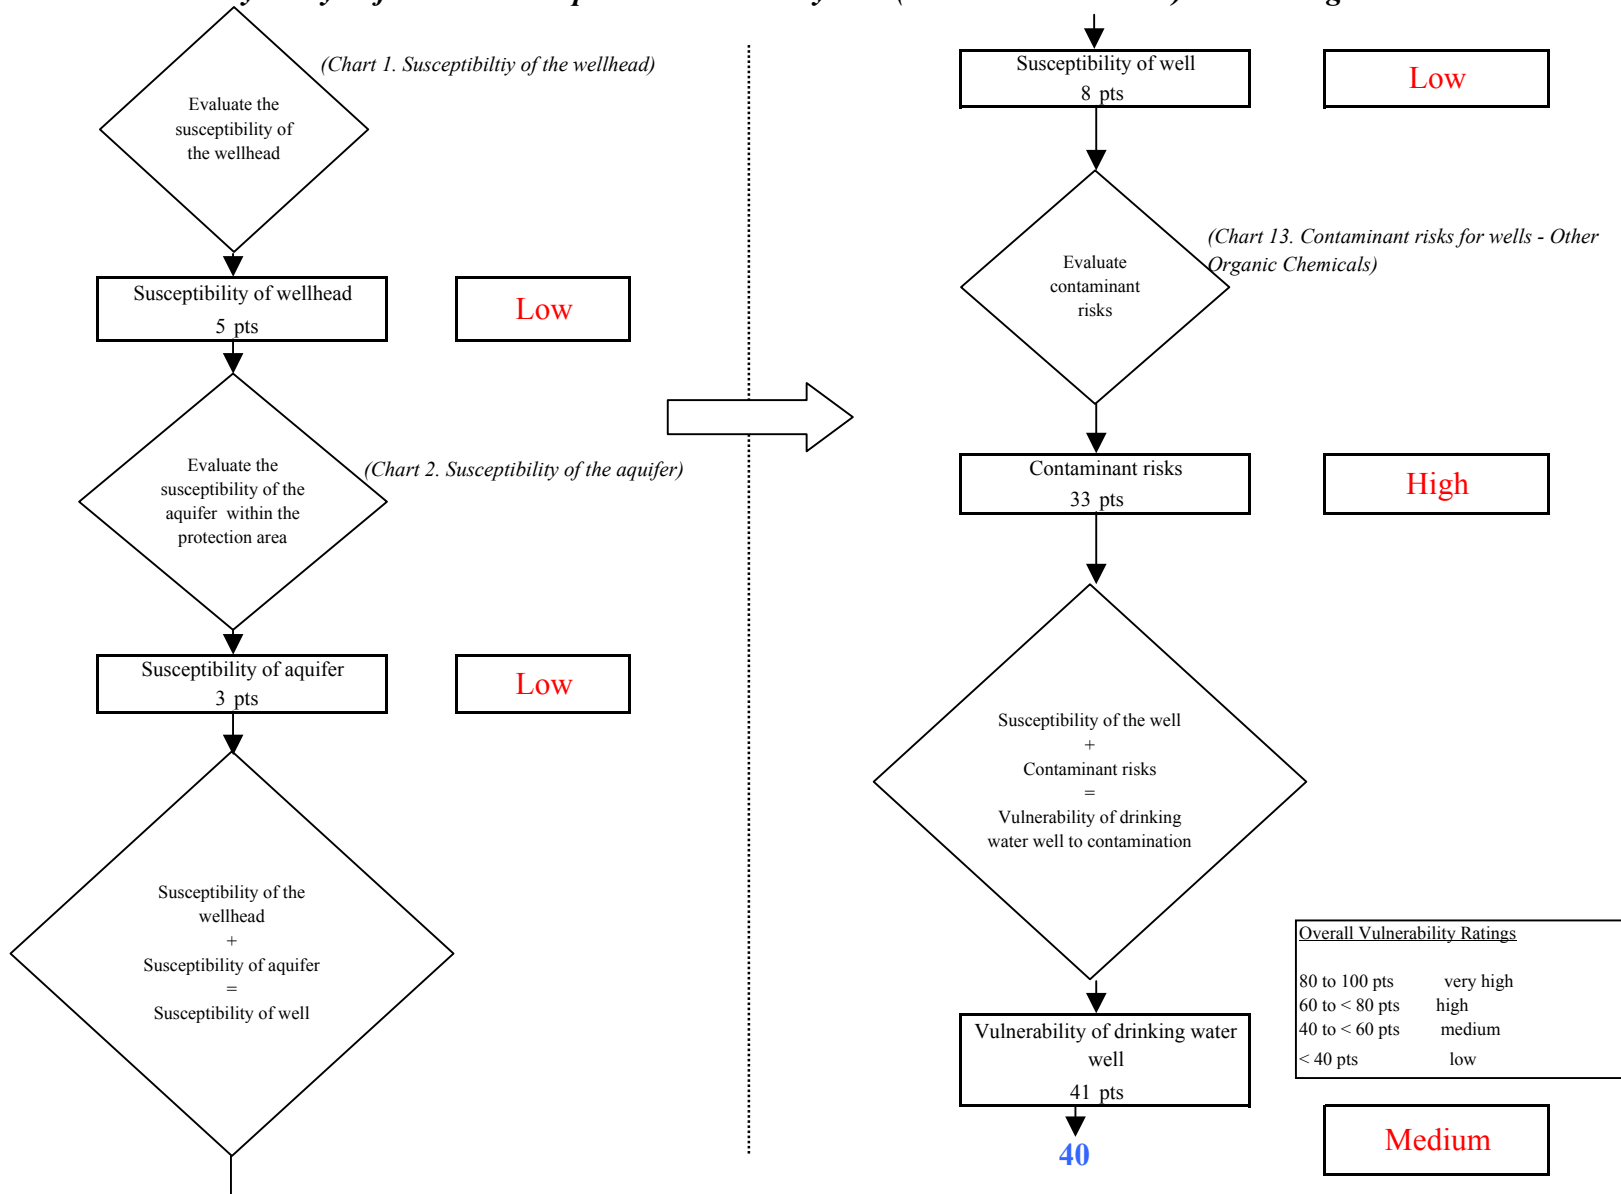
Chart 14. Vulnerability analysis for Lakeview Apartments Water System (PWS No.271172.001) - Other Organic Chemicals
