Source Water Assessment for
Pt. McKenzie Rehabilitation Center
Big Lake Area, Alaska

A Hydrogeologic Susceptibility and Vulnerability Assessment

DRINKING WATER PROTECTION PROGRAM REPORT 185
PWSID 225281

February 2002

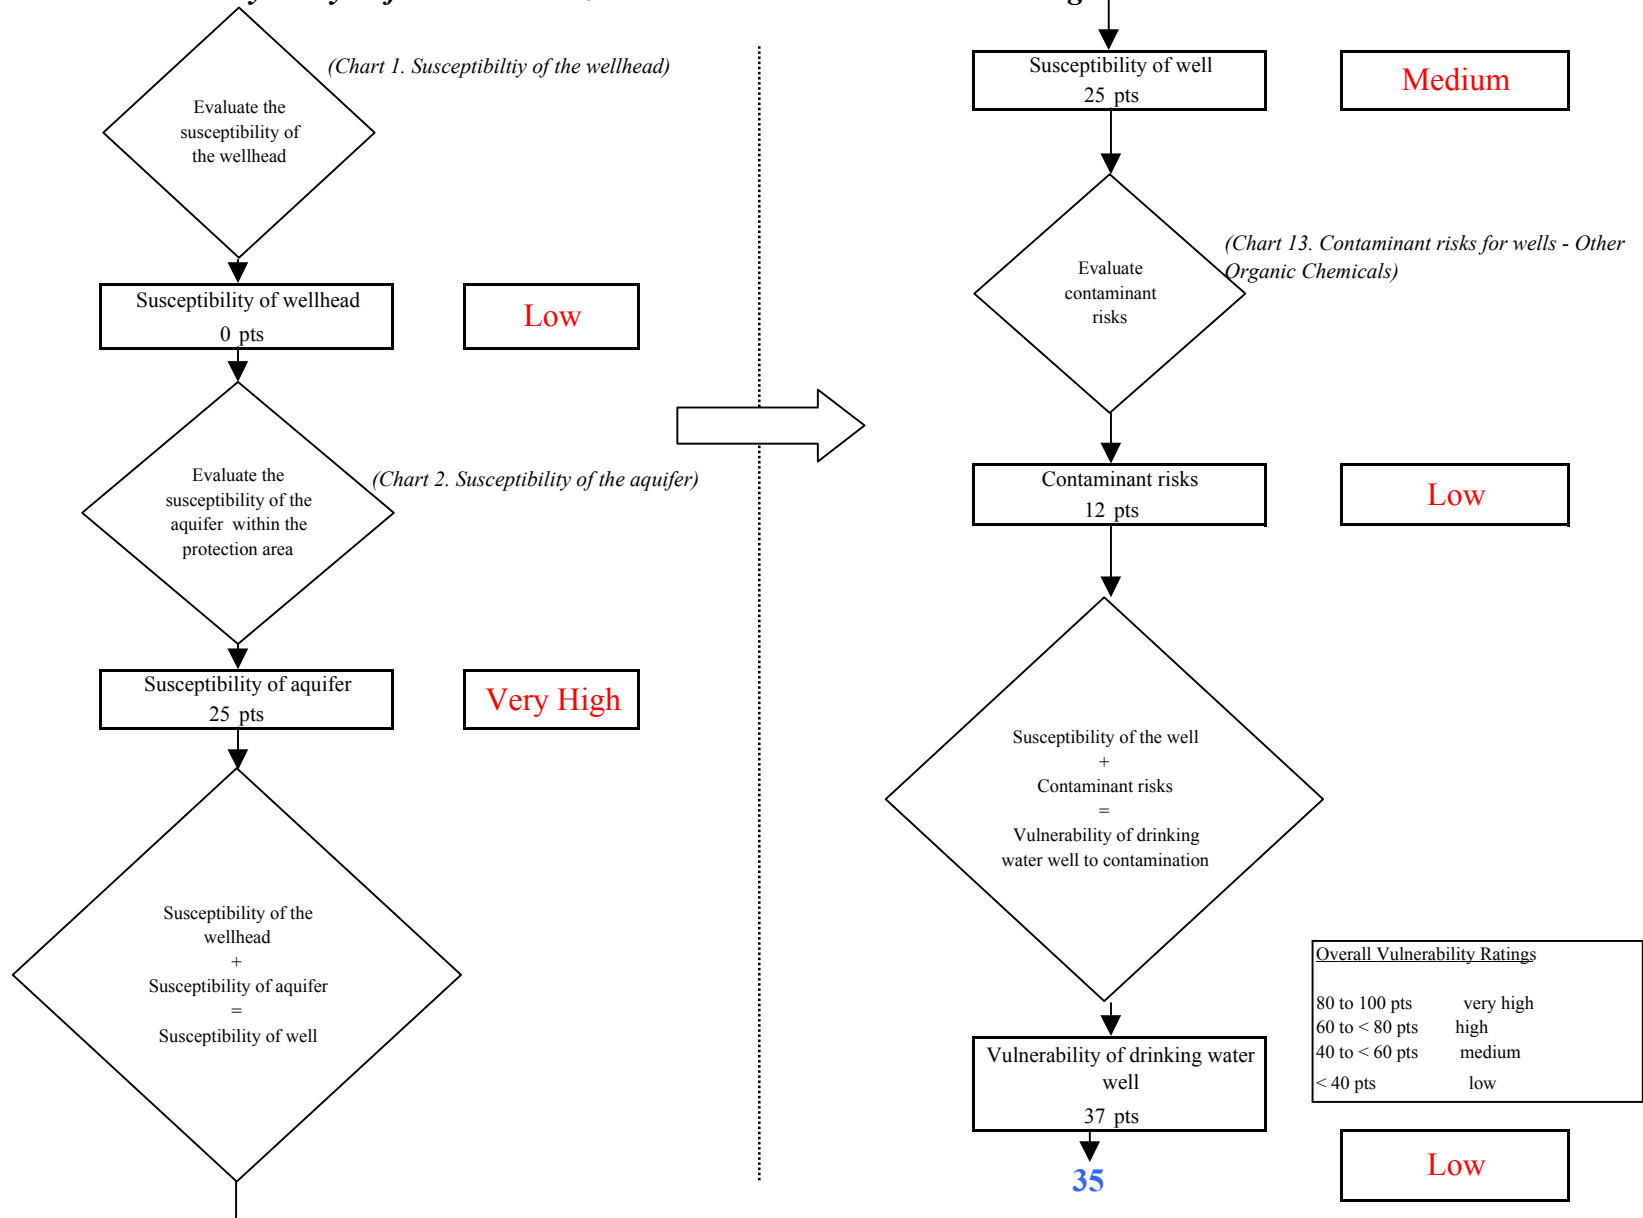
Chart 14. Vulnerability analysis for Pt. McKenzie Rehabilitation Center - Other Organic Chemicals
