Hydrogeologic Susceptibility and Vulnerability Assessment for Rocky  
Lake Campground Drinking Water Well, Big Lake, Alaska

DRINKING WATER PROTECTION PROGRAM REPORT 62

October 2001

By Shannon & Wilson, Inc.

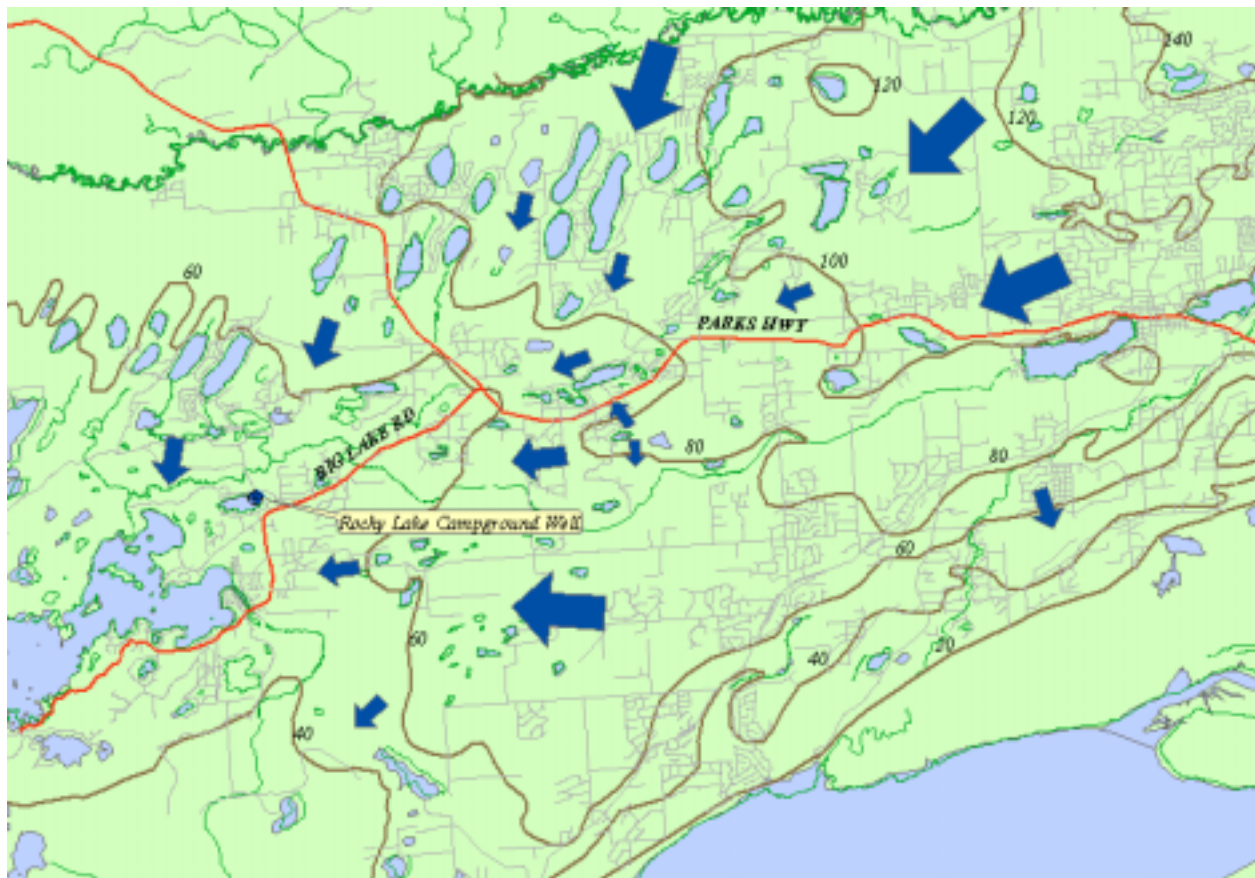
Figure 2. Map showing regional ground-water flow in Matanuska-Susitna Valley. (Jokela, Munter and Evans, 1991)

Groundwater flow in the confined aquifer is generally, north to south in the central region of the valley, toward the Matanuska River in the eastern region and the slope is predominantly northeast to northwest in the western region. The direction of groundwater flow in the upper unconfined aquifer's are more variable due to the influence from surficial topography as well as its close connection with surface water bodies. (*Jokela, Munter and Evans, 1991*) (Figure 2).
