Source Water Assessment

A Hydrogeologic Susceptibility and
Vulnerability Assessment for
Bird Ridge Cafe and Bakery
Drinking Water System,
Bird Creek, Alaska
PWSID # 218574.001

DRINKING WATER PROTECTION PROGRAM REPORT # 341
Alaska Department of Environmental Conservation

By URS Corporation

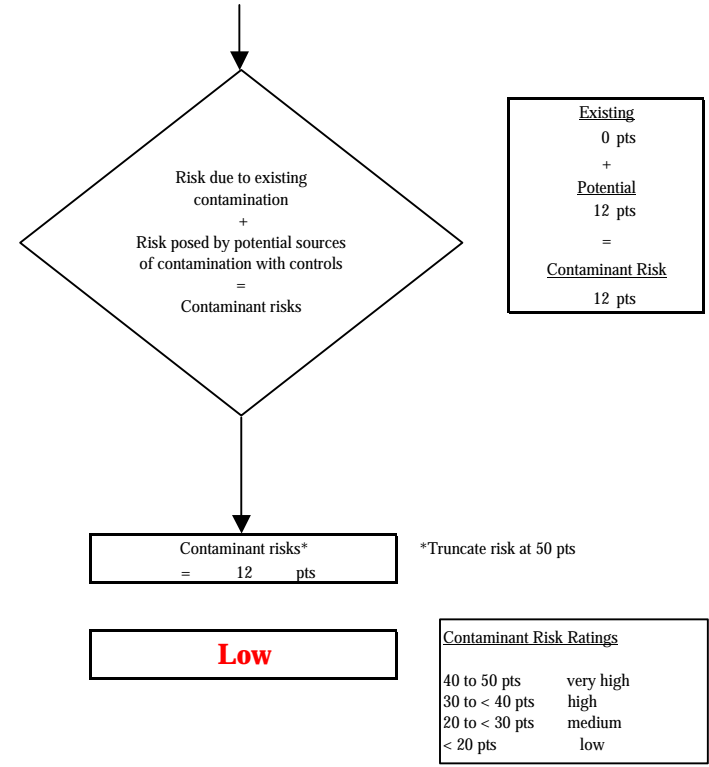
Chart 7. Contaminant risks for Bird Ridge Café and Bakery (218574.001) - Volatile Organic Chemicals

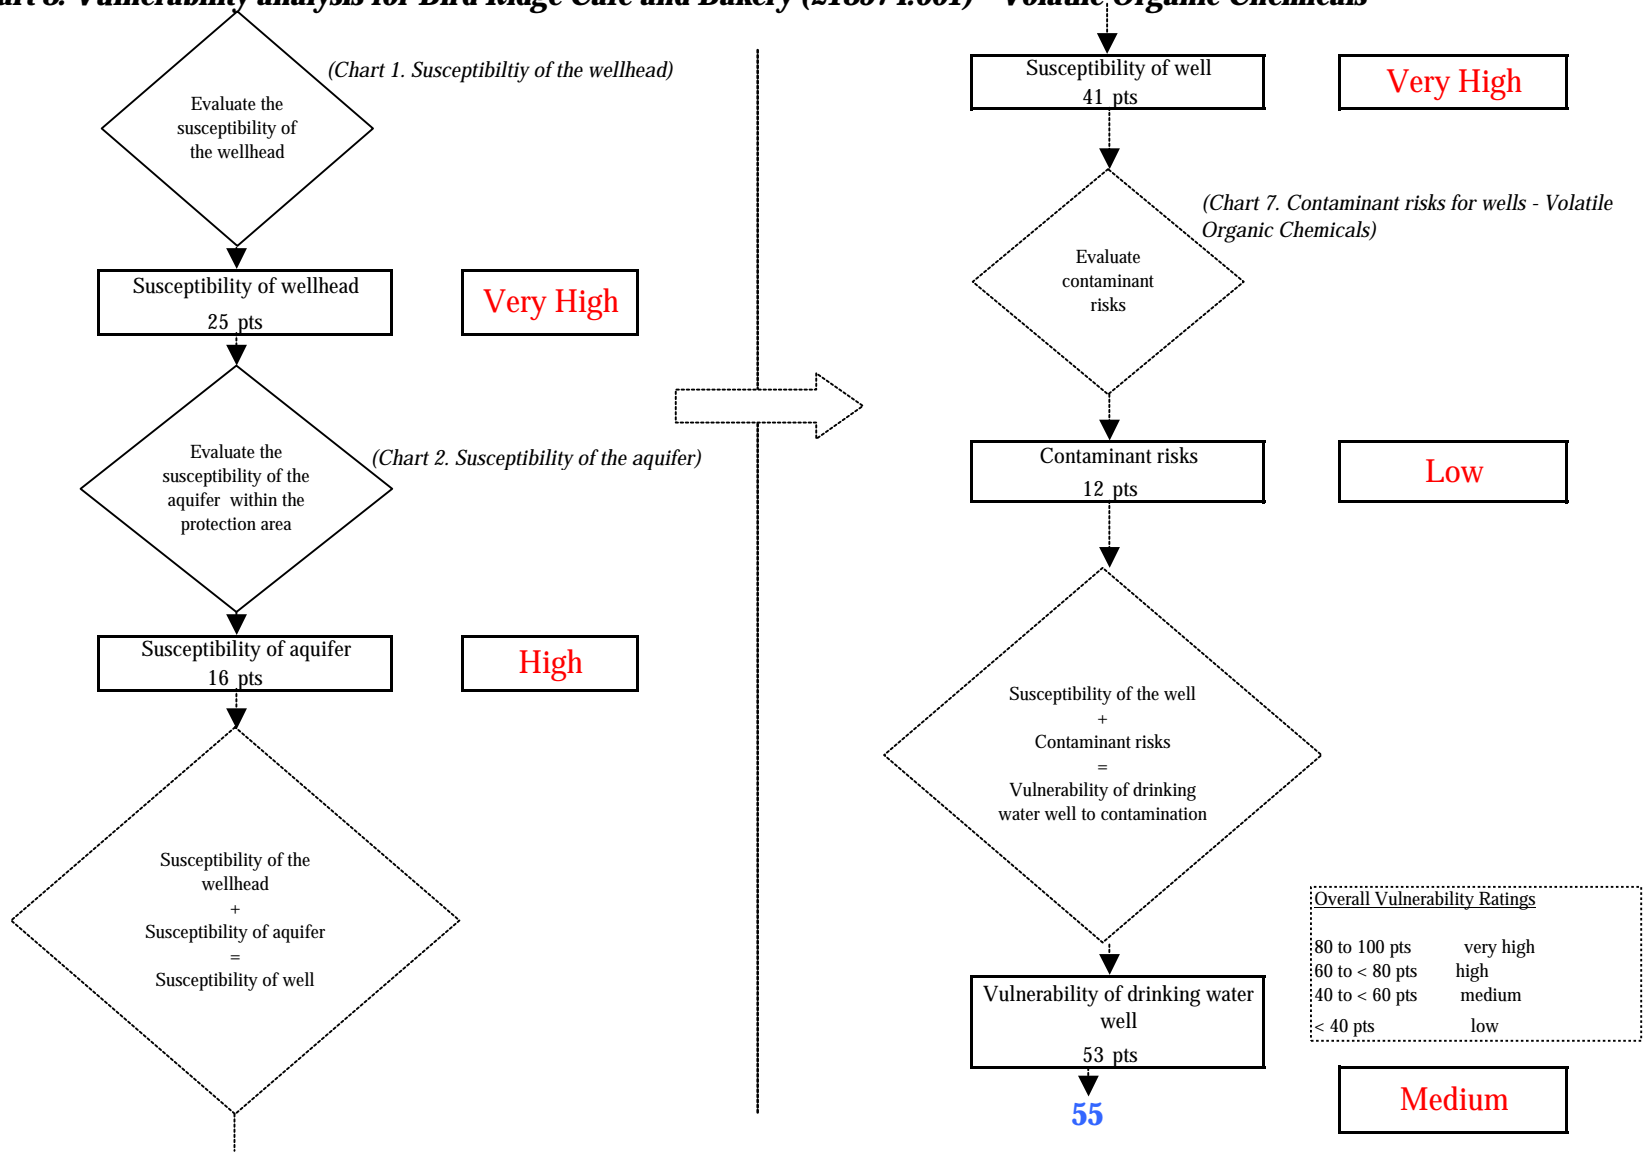
Chart 8. Vulnerability analysis for Bird Ridge Café and Bakery (218574.001) - Volatile Organic Chemicals
