Source Water Assessment

A Hydrogeologic Susceptibility and Vulnerability Assessment for Grace Brethren Church E/R Drinking Water System, Chugiak, Alaska Grace Brethren Church E/R #218538

DRINKING WATER PROTECTION PROGRAM REPORT # 222 Alaska Department of Environmental Conservation

AUGUST 2002

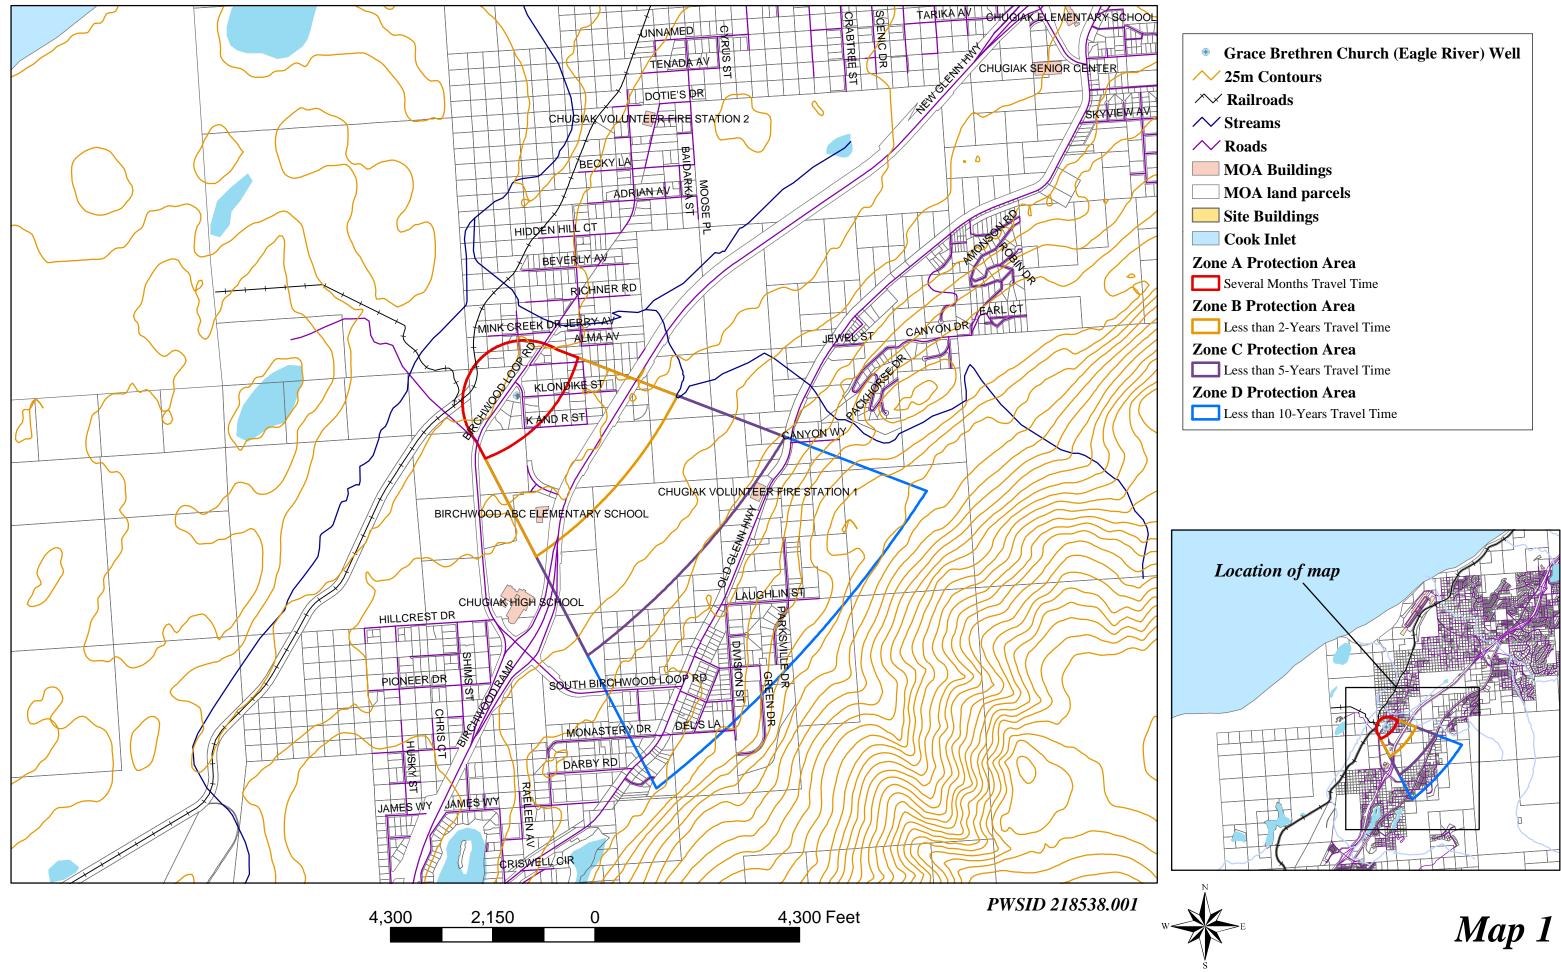
Grace Brethren Church E/R Drinking Water Protection Area (Map 1)

Drinking Water Protection Areas for Grace Brethren Church (Eagle River)

Grace Brethren Church (Eagle River) Well
✓ 25m Contours
/ Railroads
∕∕✓ Streams
∕─ Roads
MOA Buildings
MOA land parcels
Site Buildings
Cook Inlet
Zone A Protection Area
Several Months Travel Time
Zone B Protection Area
Less than 2-Years Travel Time
Zone C Protection Area
Less than 5-Years Travel Time
Zone D Protection Area
Less than 10-Years Travel Time

The most probable area for contamination to reach the drinking water well is the area that contributes water to the well, the groundwater recharge area. This area is designated as the Drinking Water Protection Area (DWPA). Because a release of contaminants within the DWPA are most likely to impact the drinking water well, this area will serve as the focus for voluntary protection efforts.

An analytical calculation was used to determine the size and shape of the DWPA. The input parameters describing the attributes of the aquifer in this calculation were adopted from the U.S. Geological Survey (*Patrick, Brabets, and Glass, 1989*), and State of Alaska Department of Water Resources. Additional methods were also used to take into account any uncertainties in groundwater flow and aquifer characteristics to arrive at a meaningful DWPA (Please refer to the Guidance Manual for Class B Public Water Systems for additional information).

The DWPAs established for wells by the ADEC are separated into four zones. These zones correspond to differences in the time-of-travel (TOT) of the water moving through the aquifer to the well. The TOT for contaminants within the water varies and is dependent on the physical and chemical characteristics of each contaminant. The following is a summary of the four DWPA zones and the calculated TOT for each:

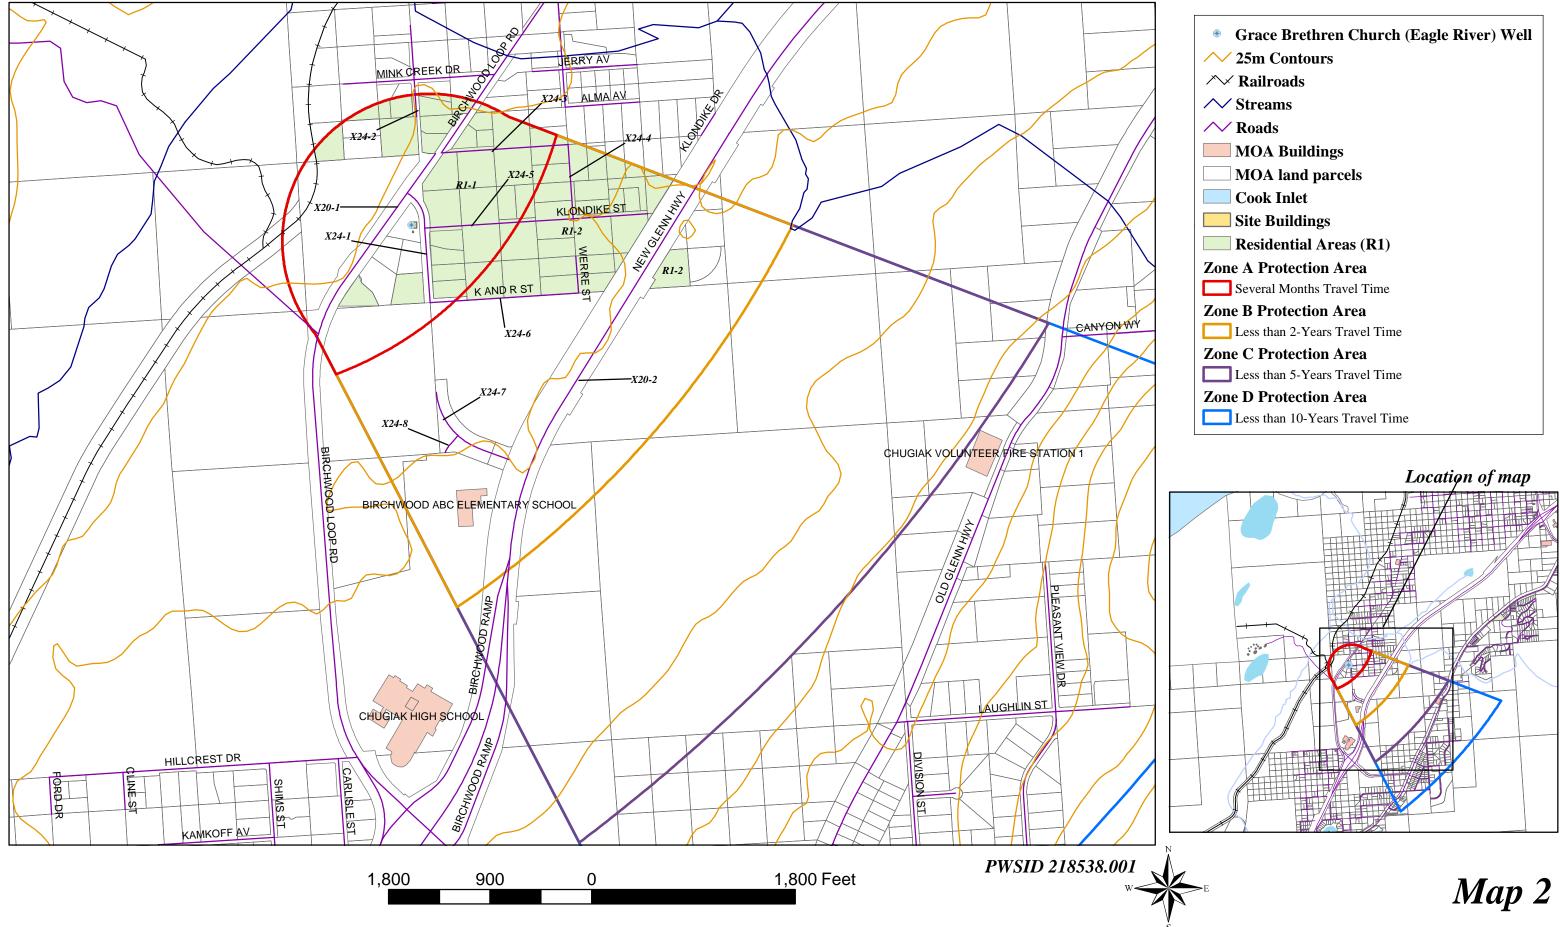
Grace Brethren Church E/R Drinking Water Protection Area and Potential and Existing Contaminant Sources (Maps 2-3)

Drinking Water Protection Areas for Grace Brethren Church (Eagle River) and **Potential and Existing Sources of Contamination**

Grace Brethren Church (Eagle River) Well					
✓ 25m Contours					
N Railroads					
/ Streams					
∕─ Roads					
MOA Buildings					
MOA land parcels					
Cook Inlet					
Site Buildings					
Residential Areas (R1)					
Zone A Protection Area					
Several Months Travel Time					
Zone B Protection Area					
Less than 2-Years Travel Time					
Zone C Protection Area					
Less than 5-Years Travel Time					
Zone D Protection Area					
Less than 10-Years Travel Time

Inventoried potential sources of contamination within Zones A through Zone D were associated with residential and light industrial type activities. The sources are summarized in the tables in Appendix B.

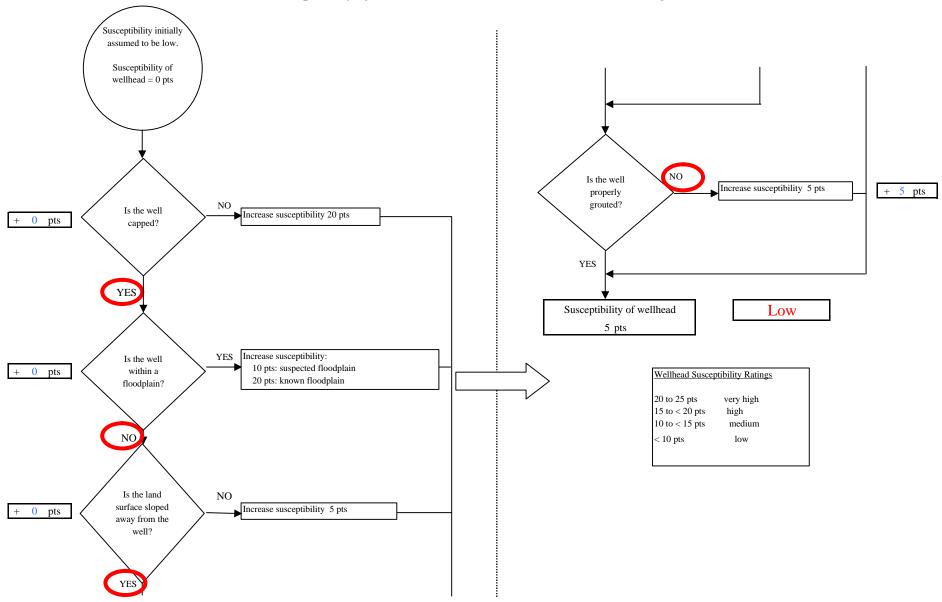
Chart 1. Susceptibility of the wellhead - Grace Brethren Church (Eagle River)

Appendix D contains eight charts, which together form the 'Vulnerability Analysis' for a source water assessment for a public drinking water source. Chart 1 analyzes the 'Susceptibility of the Wellhead' to contamination by looking at the construction of the well Chart 2 analyzes the and its surrounding area. 'Susceptibility of the Aquifer' to contamination by looking at the naturally-occurring attributes of the water source and influences on the groundwater system that might lead to contamination. Chart 3 analyzes 'Contaminant Risks' for the drinking water source with respect to bacteria and viruses. The 'Contaminant Risks' portion of the analysis considers potential sources of contaminants as well as a review of contamination that has or may have occurred, but has not arrived or been detected at the well. Lastly, Chart 4 contains the 'Vulnerability Analysis for Bacteria and Viruses.' Charts 5 through 8 contain the Contaminant

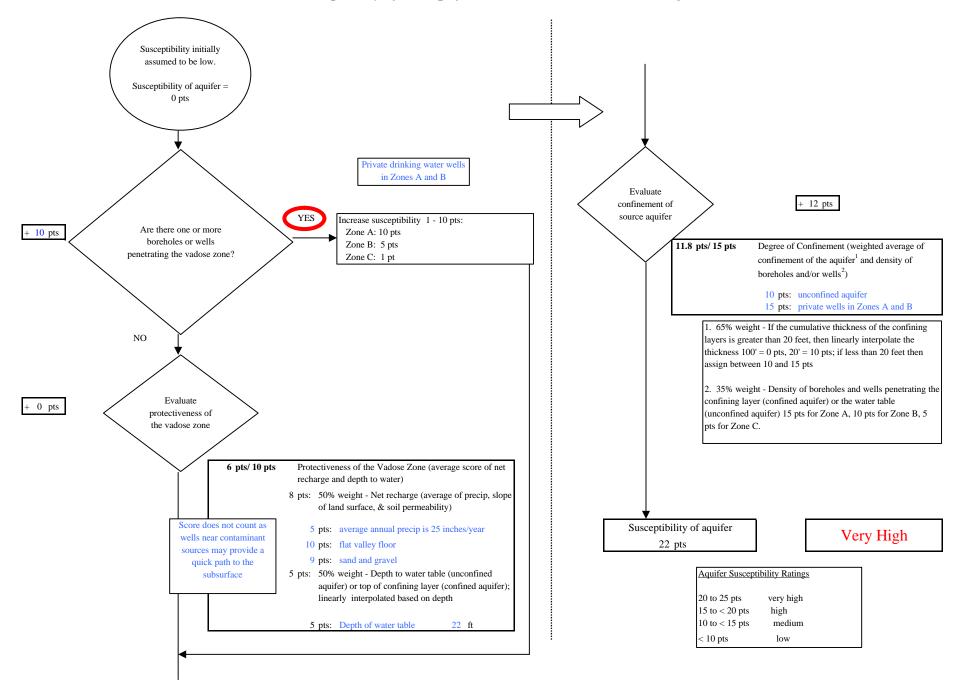
Chart 2. Susceptibility of the aquifer - Grace Brethren Church (Eagle River)

The well for Grace Brethren Church E/R is completed in an unconfined aquifer setting. Because an unconfined aquifer is recharged by surface water and precipitation that migrates downward from the surface, contaminants at the surface have the potential to adversely impact this aquifer. Table 2 shows the Overall Susceptibility score and rating for Grace Brethren Church E/R.

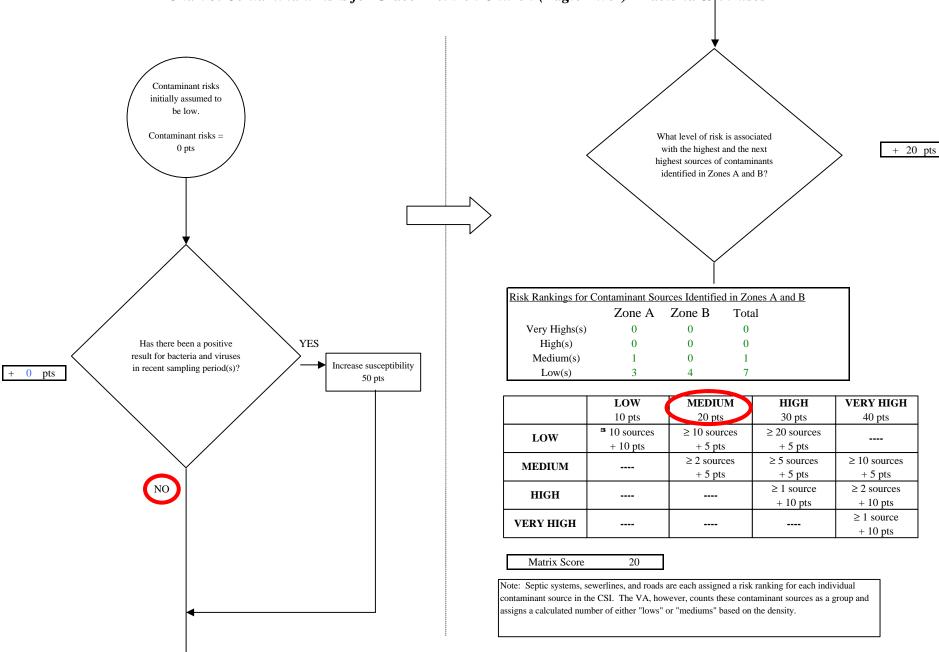
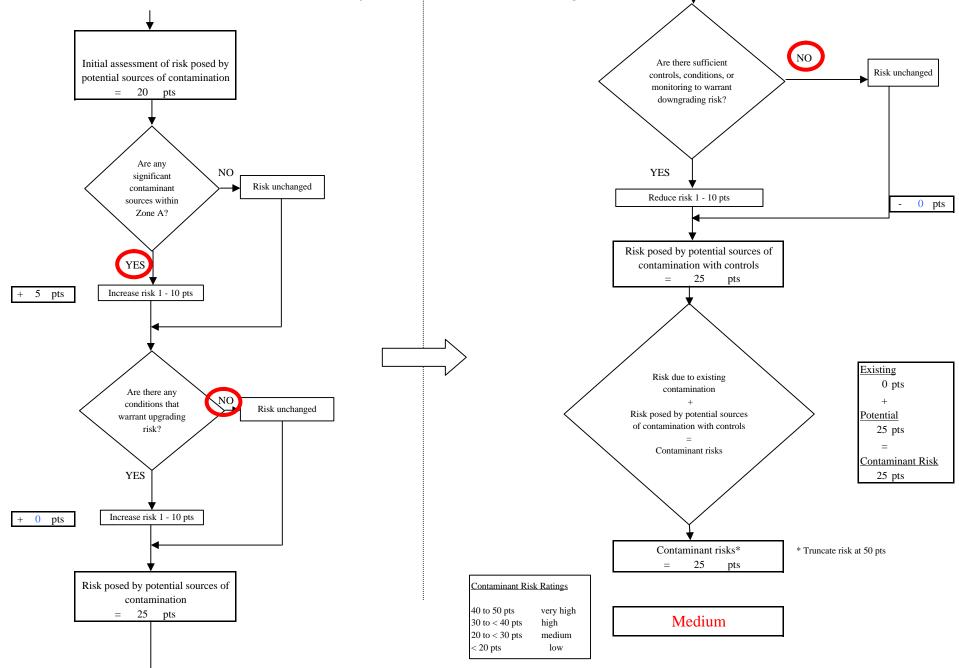
Chart 3. Contaminant risks for Grace Brethren Church (Eagle River) - Bacteria & Viruses

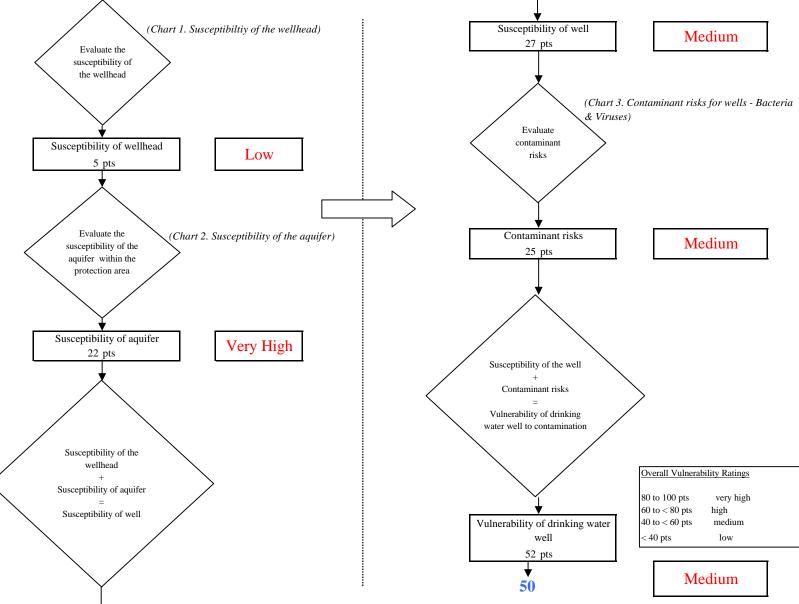
Chart 4. Vulnerability analysis for Grace Brethren Church (Eagle River) - Bacteria & Viruses

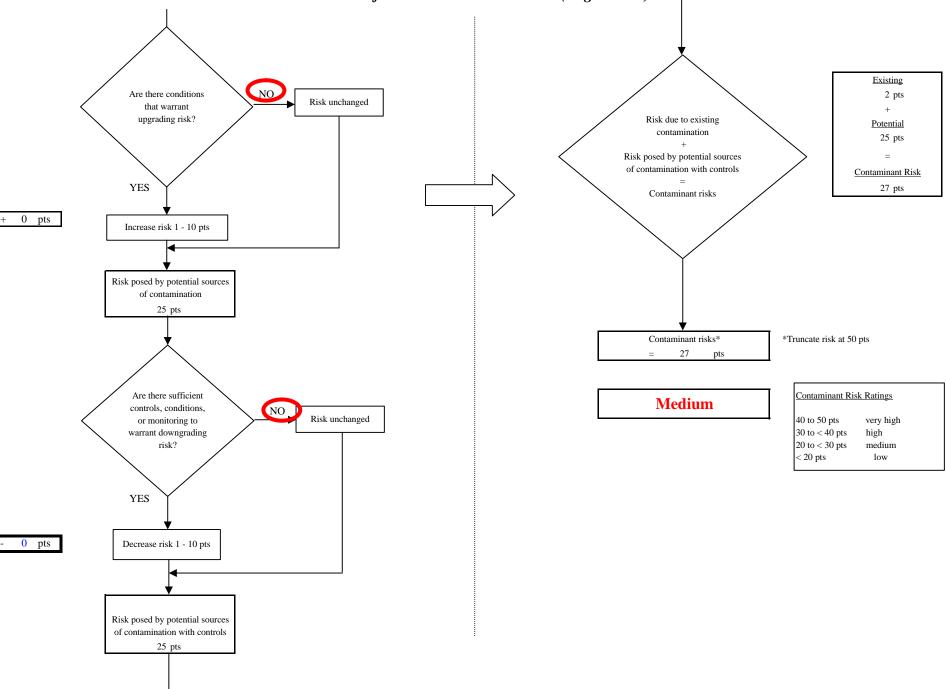
Chart 5. Contaminant risks for Grace Brethren Church (Eagle River) - Nitrates and Nitrites

Sampling history for Grace Brethren Church E/R well indicates that low concentrations of nitrates have been detected (see Chart 5 - Contaminant Risks for Nitrates and/or Nitrites in Appendix D). The maximum reported existing nitrate concentration is approximately 0.440 mg/L or 4% of the Maximum Contaminant Level (MCL) of 10 mg/L. The MCL is the maximum level of contaminant that is allowed to exist in drinking water and still be consumed by humans without harmful health effects. Due to the high solubility and weak retention by soil, nitrates are very mobile, moving at approximately the same rate as water. Though existing nitrate contamination was detected at the site, concentrations remain at safe levels with respect to human health.

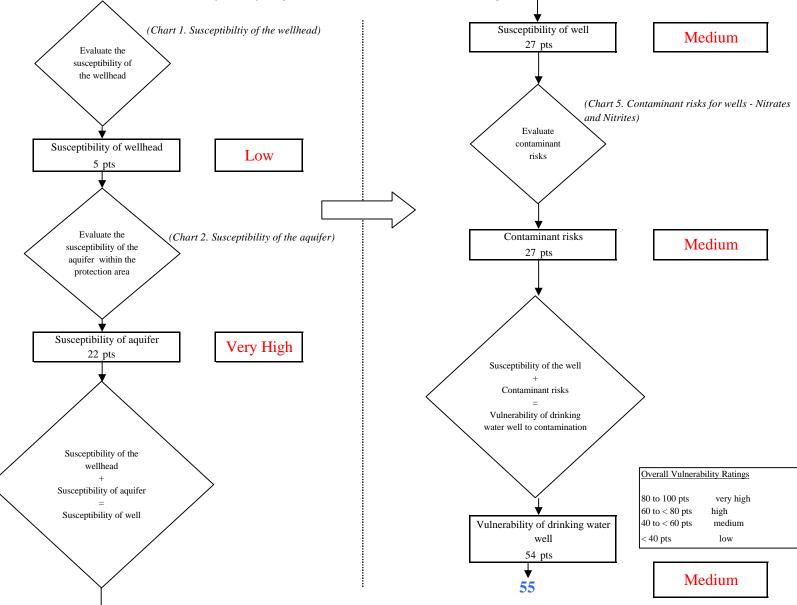
Chart 6. Vulnerability analysis for Grace Brethren Church (Eagle River) - Nitrates and Nitrites

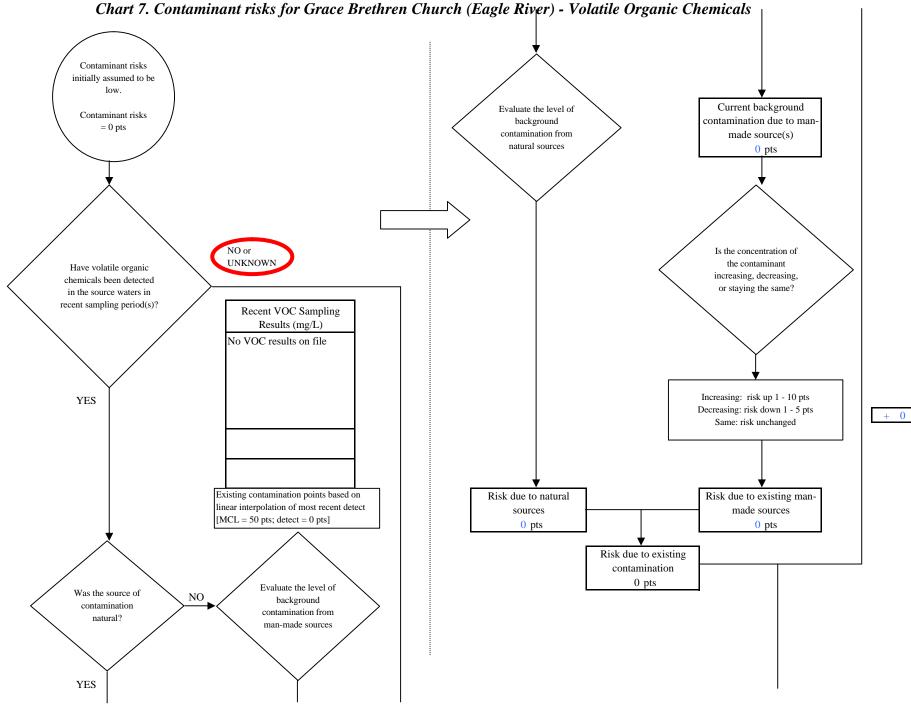
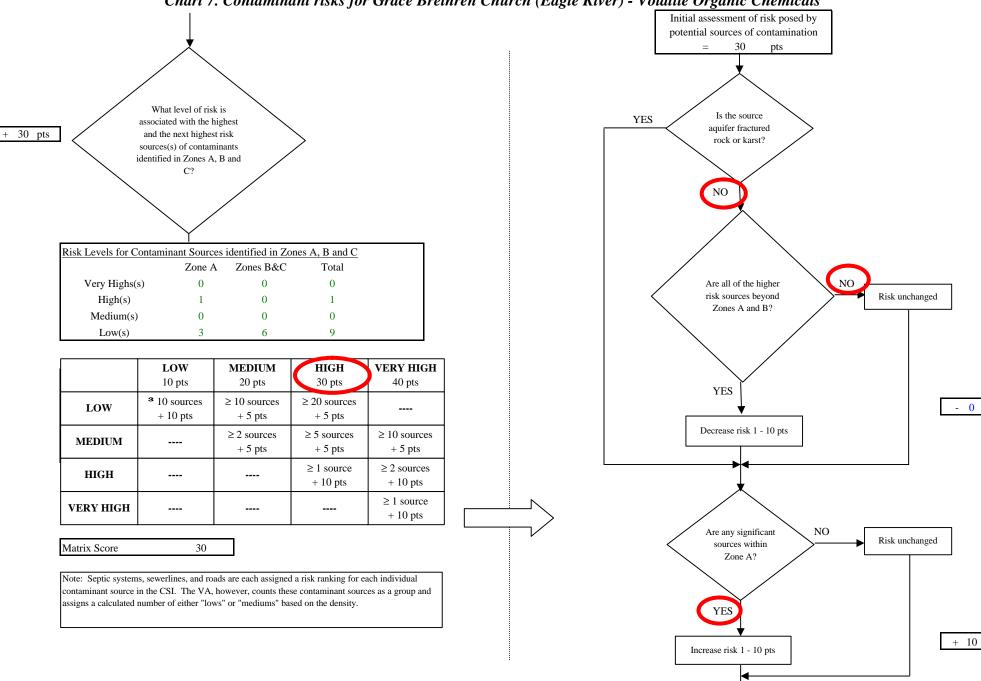
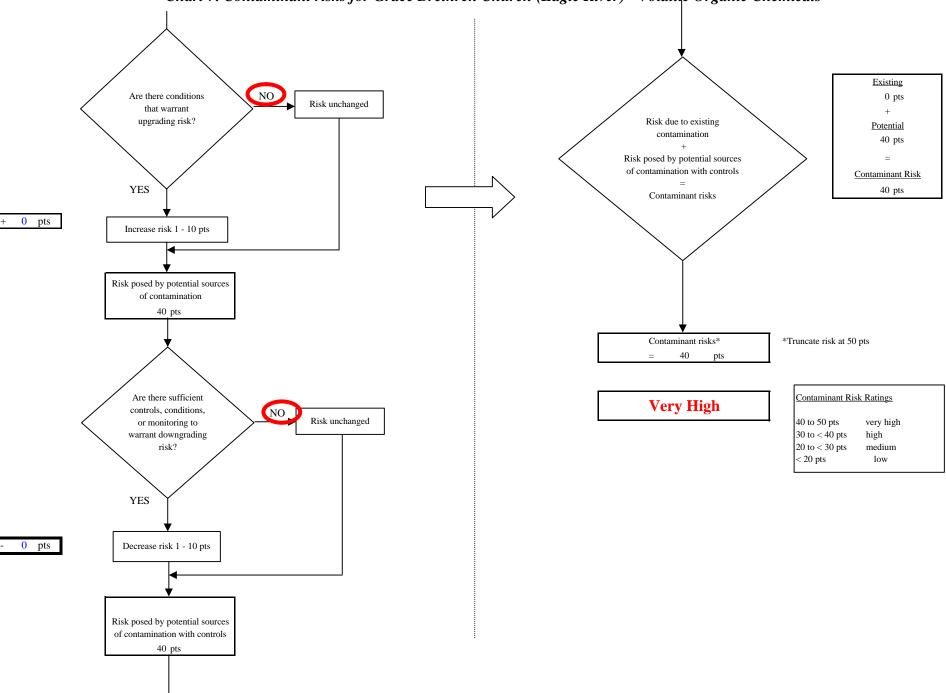
Chart 7. Contaminant risks for Grace Brethren Church (Eagle River) - Volatile Organic Chemicals

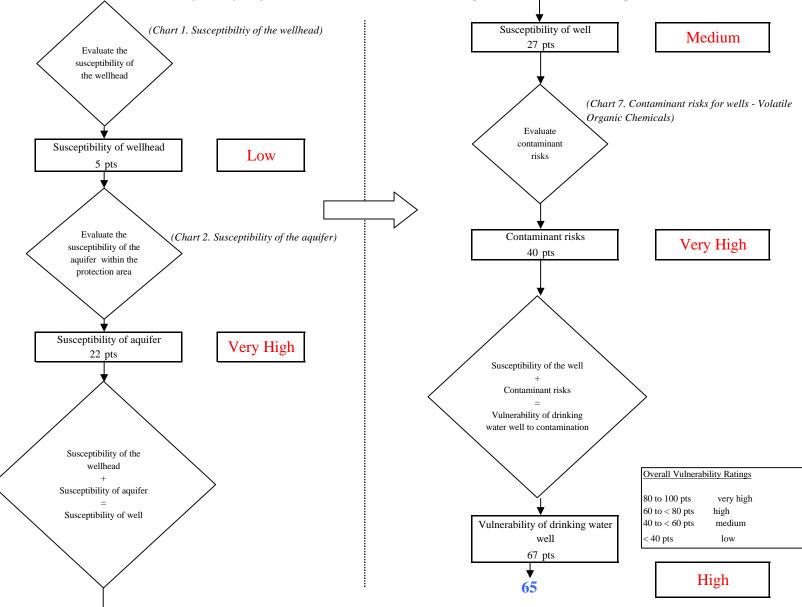
Chart 8. Vulnerability analysis for Grace Brethren Church (Eagle River) - Volatile Organic Chemicals
