A Hydrogeologic Susceptibility and
Vulnerability Assessment for
USFS Crescent Creek Campground
Drinking Water System,
Cooper Landing, Alaska
PWSID # 240228.001

DRINKING WATER PROTECTION PROGRAM REPORT # 345
Alaska Department of Environmental Conservation

By URS Corporation

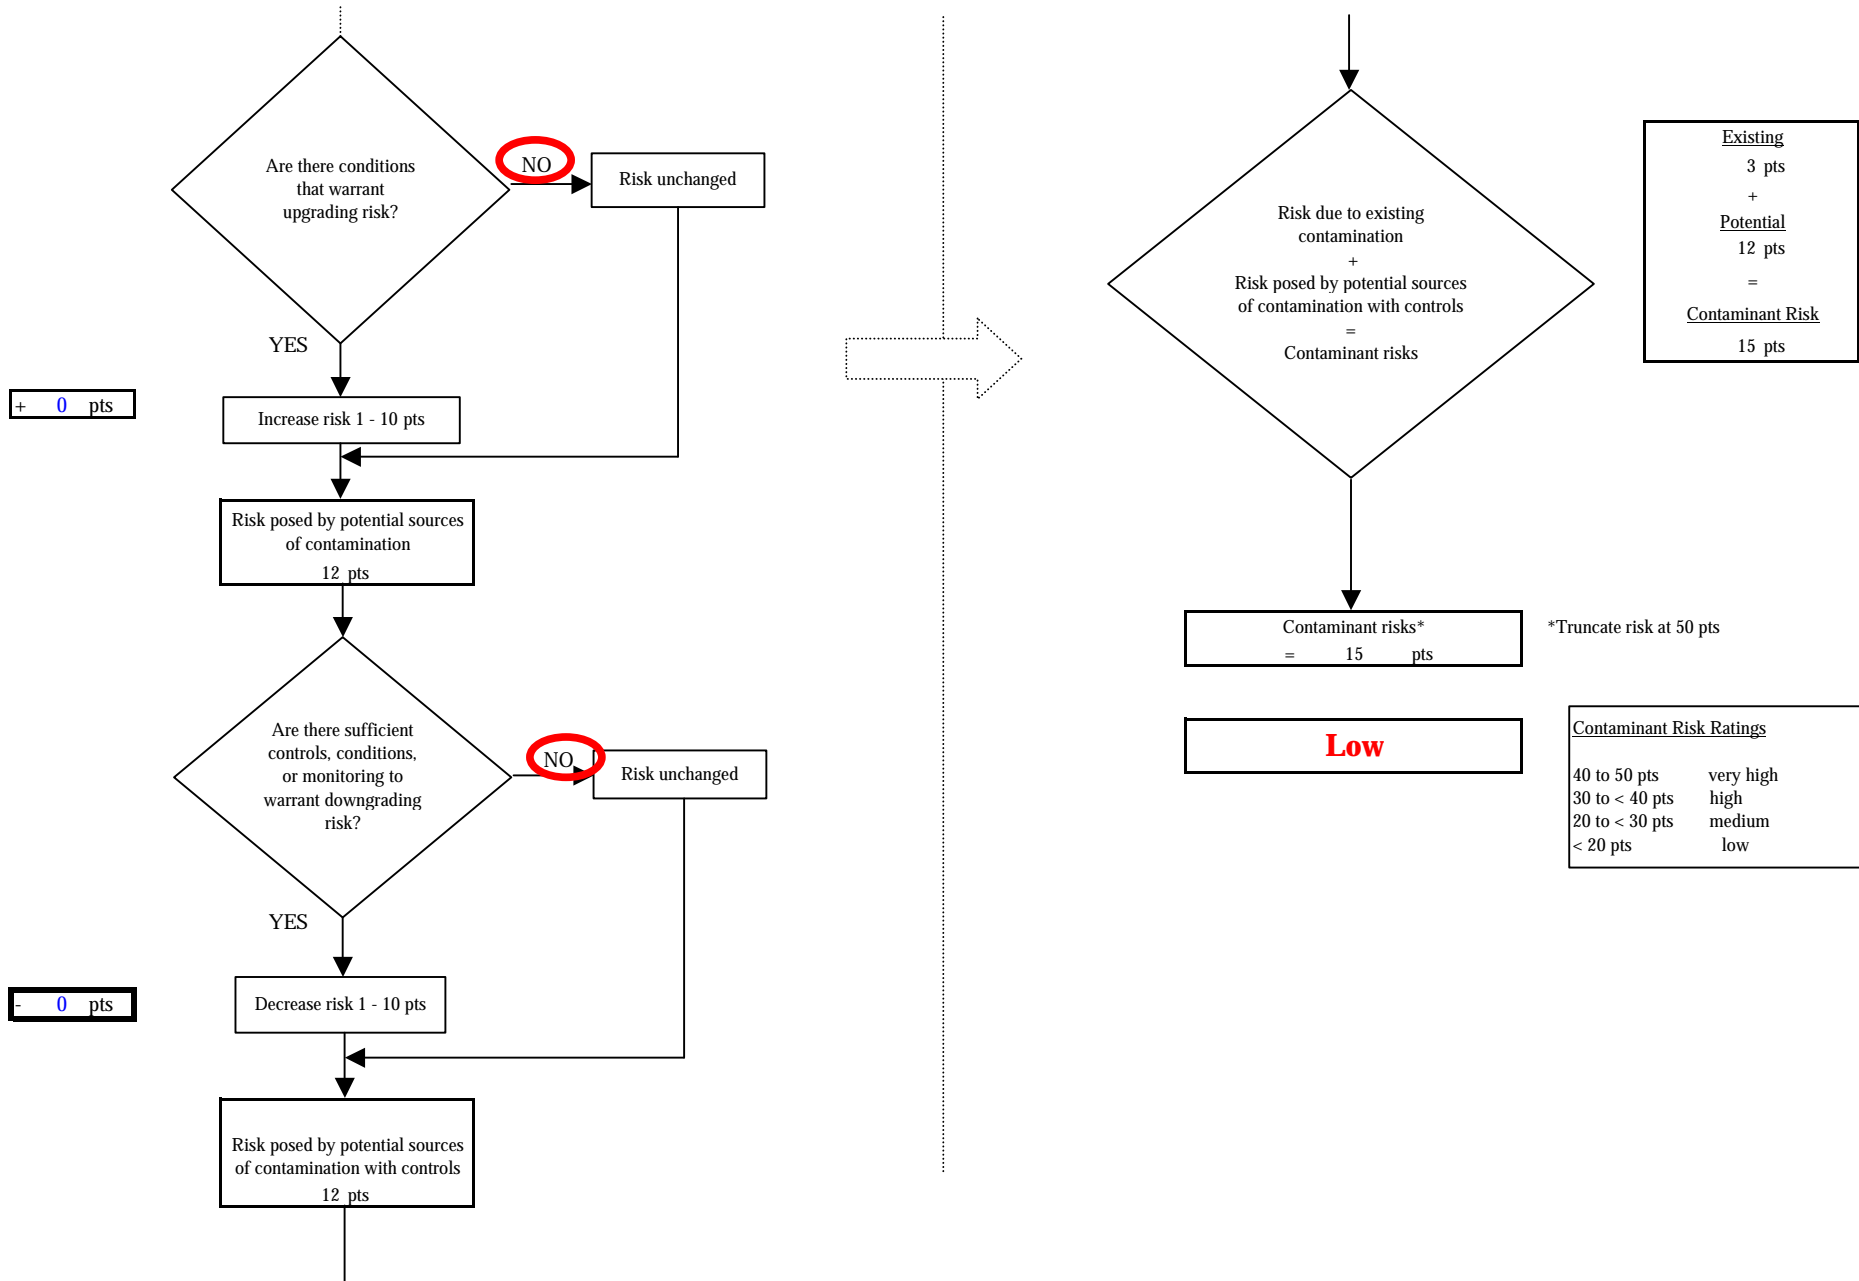
Chart 5. Contaminant risks for USFS Crescent Creek Campground (240228.001) - Nitrates and Nitrites

Sampling history for USFS Crescent Creek Campground well indicates that low concentrations of nitrate have been detected (See Chart 5 - Contaminant Risks for Nitrates and/or Nitrites in Appendix D). Existing nitrate concentration is approximately 0.6 mg/L or 6 % of the Maximum Contaminant Level (MCL) of 10mg/L. The MCL is the maximum level of contaminant that is allowed to exist in drinking water and still be consumed by humans without harmful health effects. Due to the high solubility and weak retention by soil, nitrates are very mobile, moving at approximately the same rate as water. Though existing nitrate contamination was detected at the site, concentrations remain at very safe levels with respect to human health.

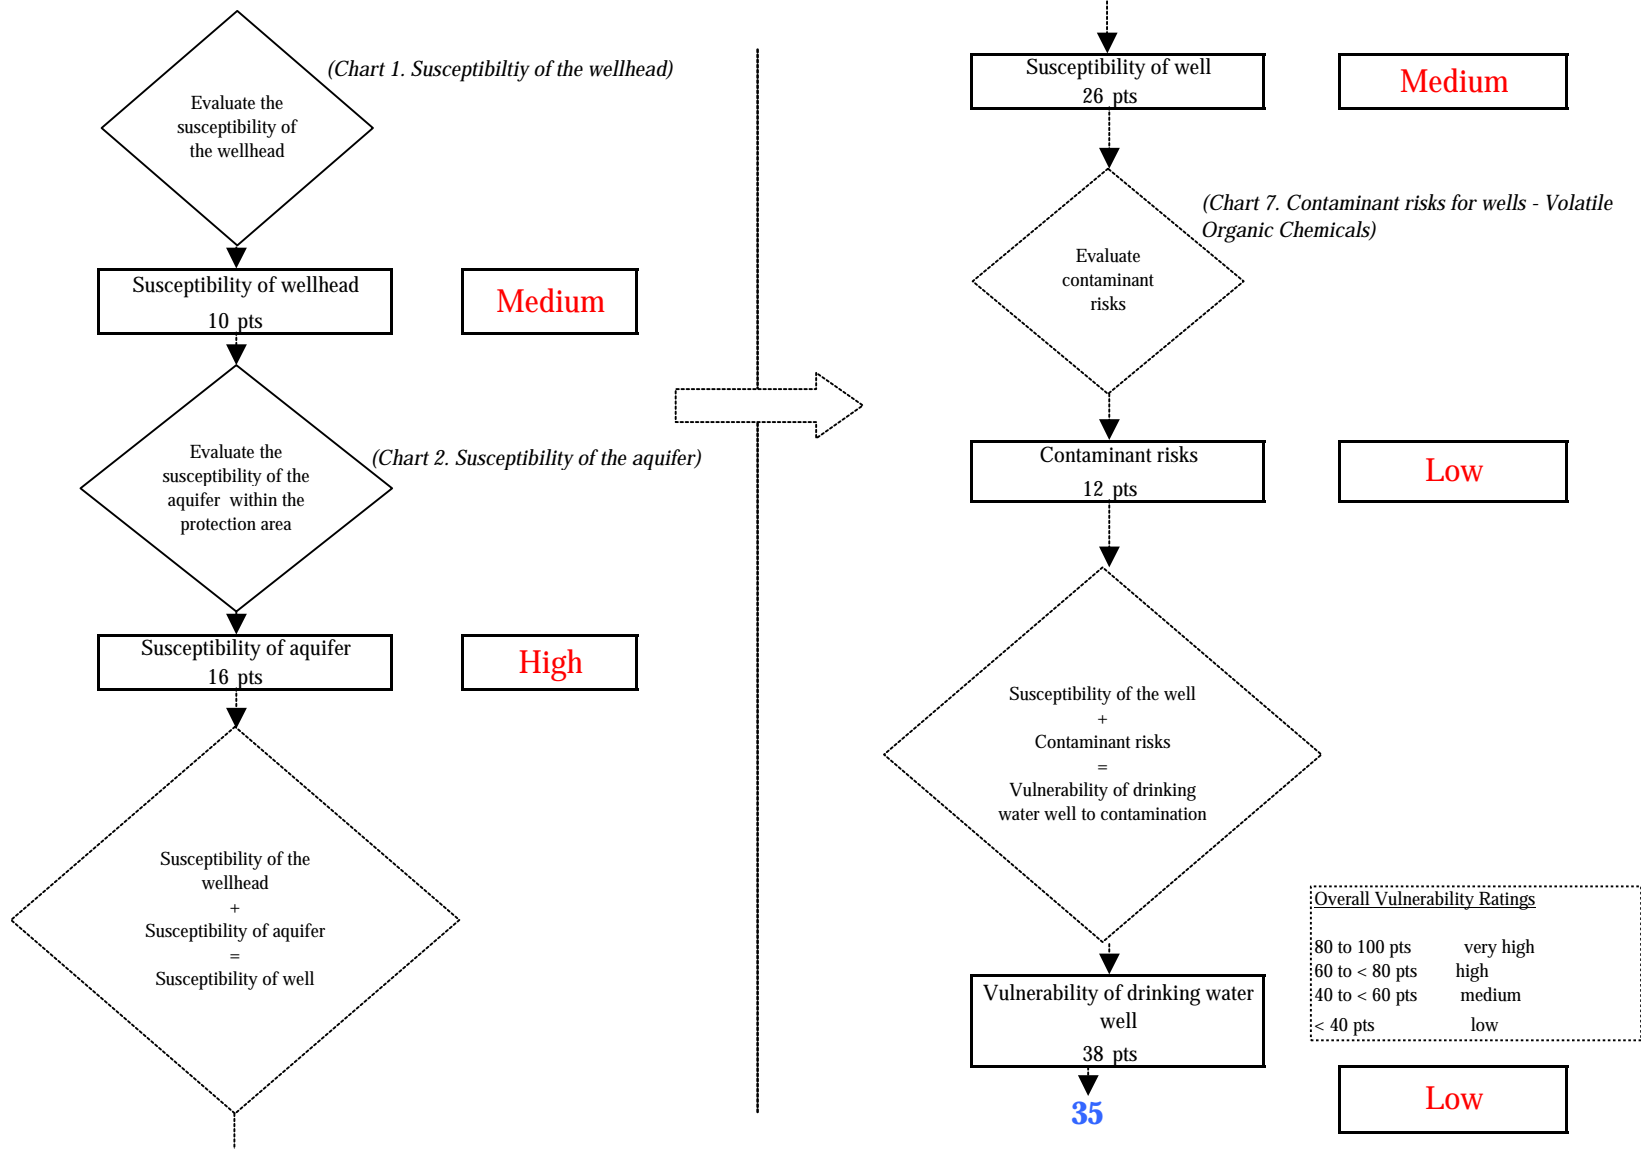
Chart 8. Vulnerability analysis for USFS Crescent Creek Campground (240228.001) - Volatile Organic Chemicals
