Source Water Assessment

A Hydrogeologic Susceptibility and
Vulnerability Assessment for
Ranch House Lodge
Drinking Water System,
Glennallen, Alaska
Ranch House Lodge # 291245

DRINKING WATER PROTECTION PROGRAM REPORT 258
Alaska Department of Environmental Conservation

AUGUST 2002

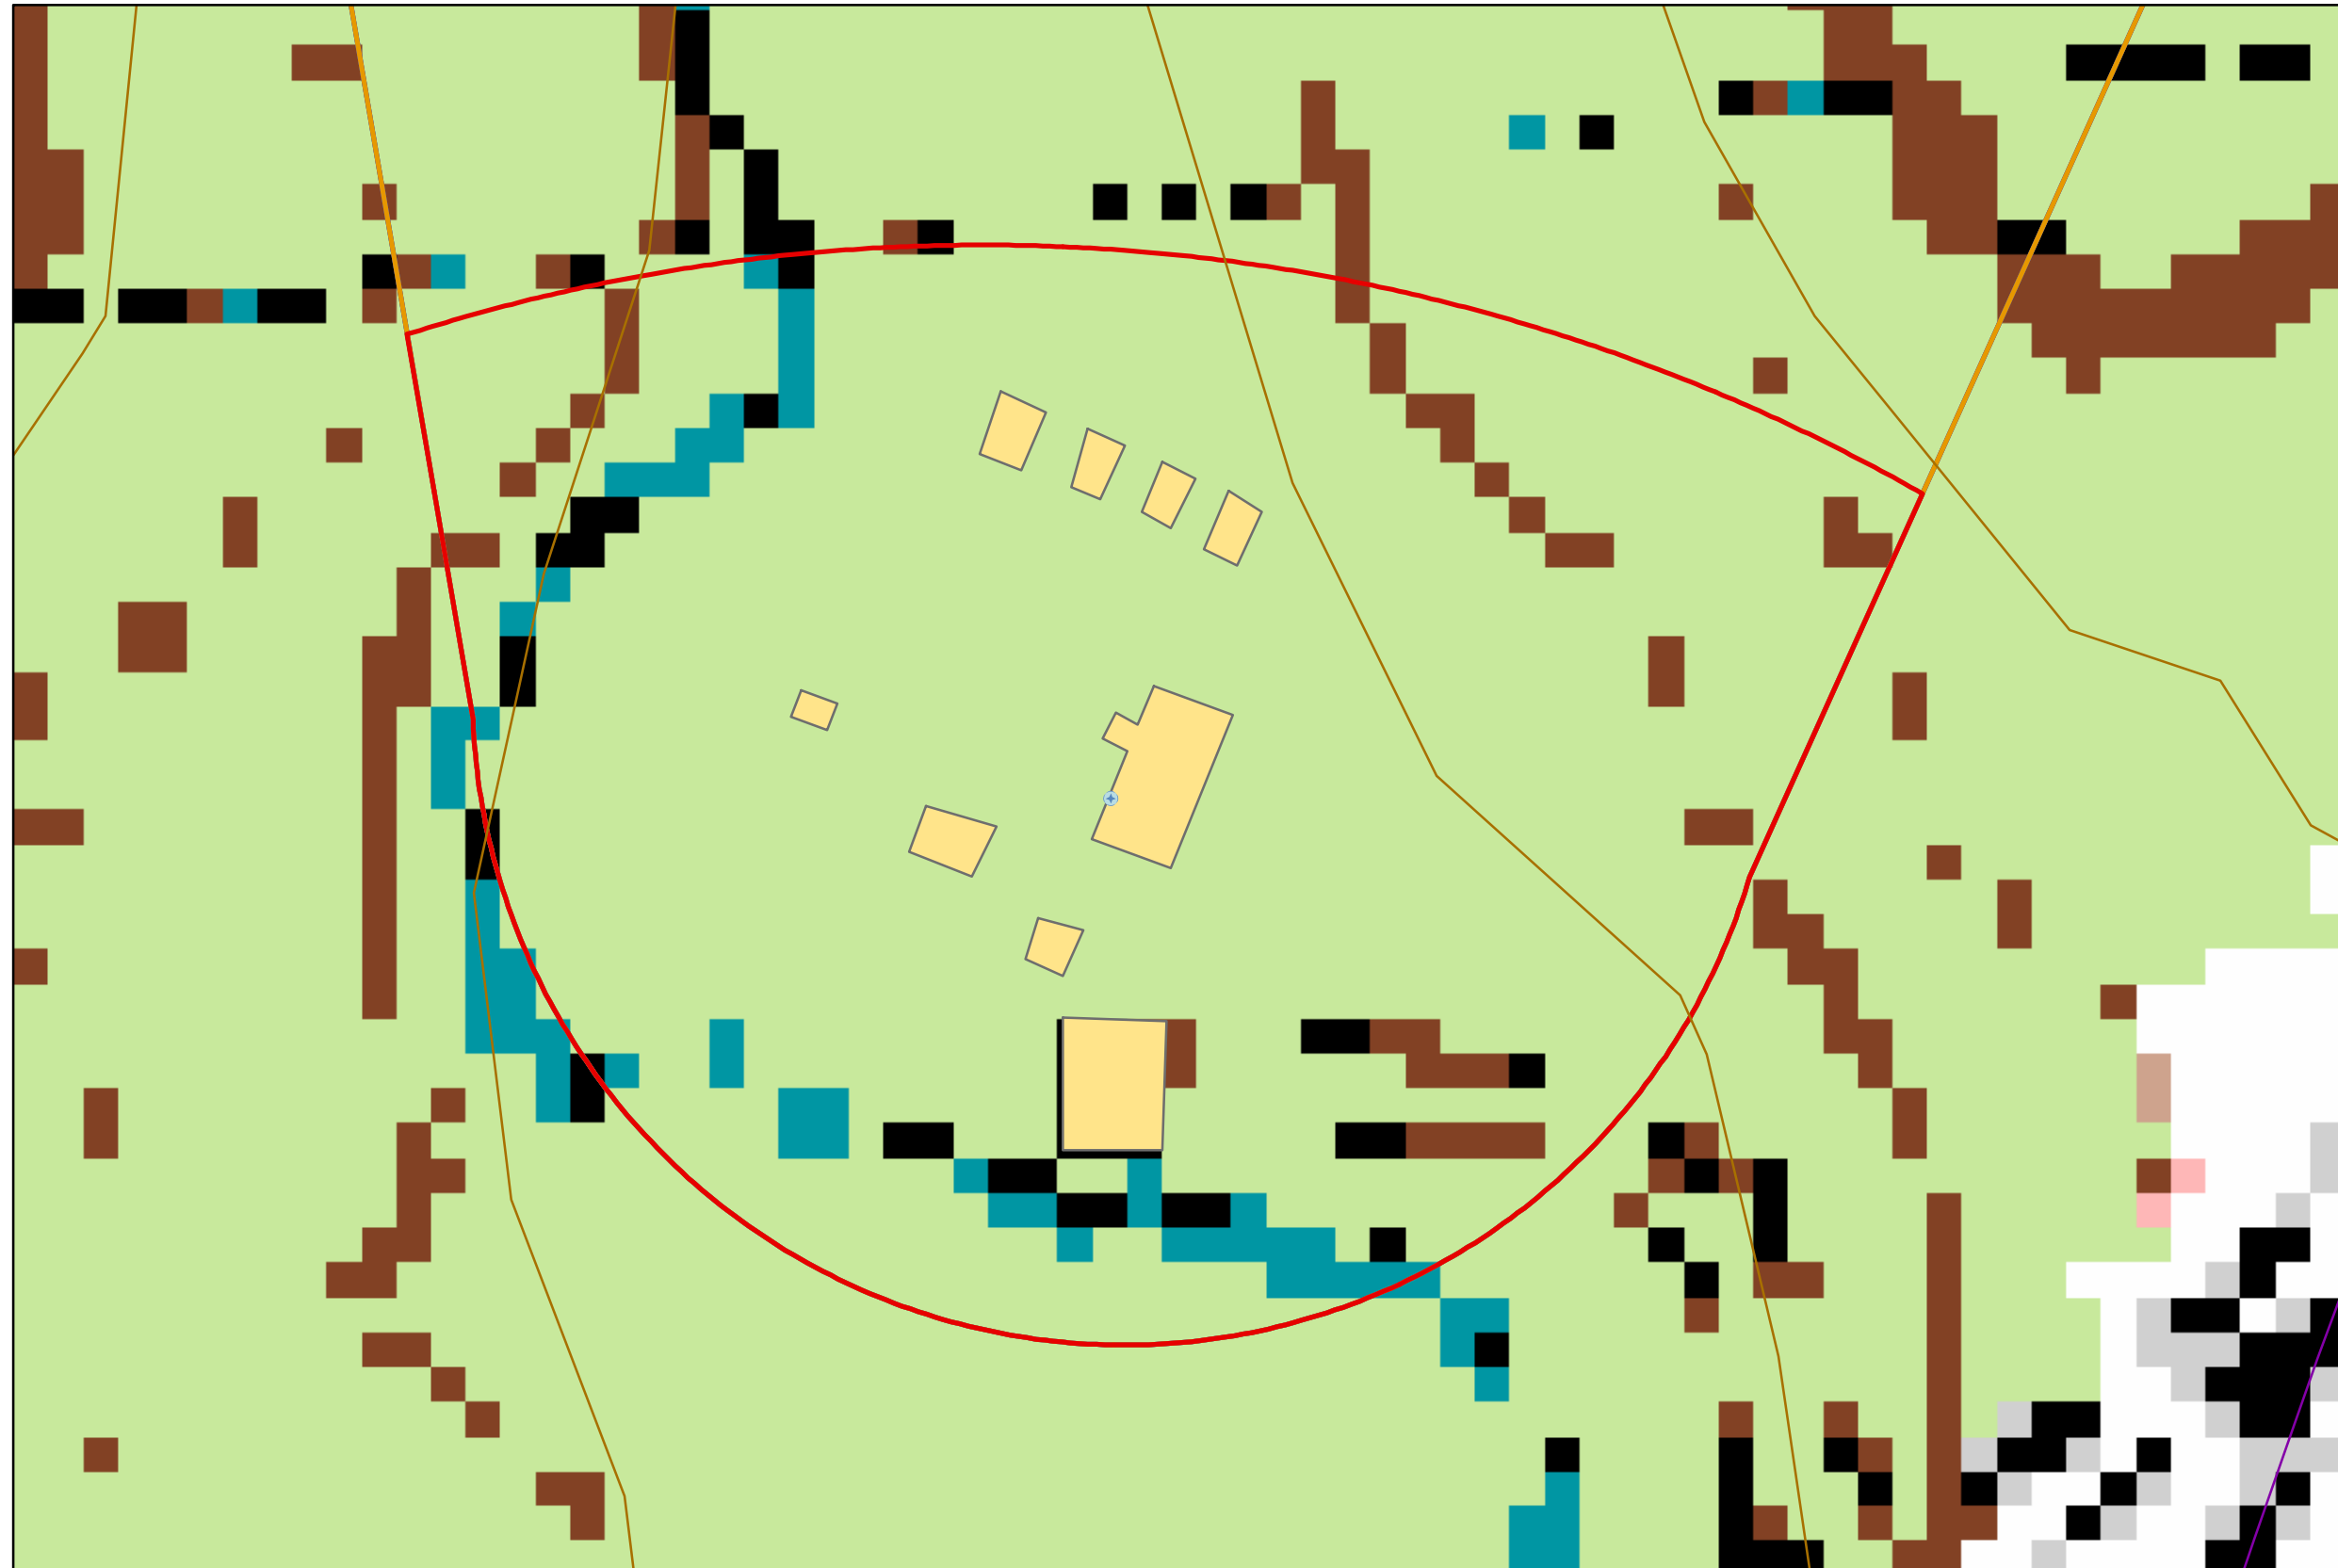
Map 2

Drinking Water Protection Areas for Ranch House Lodge and Potential and Existing Sources of Contamination

- Ranch House Lodge Well
- MSB Roads
- Site Buildings
- Zone A Protection Area**
 - Several Months Travel Time
- Zone B Protection Area**
 - Less than 2-Years Travel Time
- Zone C Protection Area**
 - Less than 5-Years Travel Time
- Zone D Protection Area**
 - Less than 10-Years Travel Time

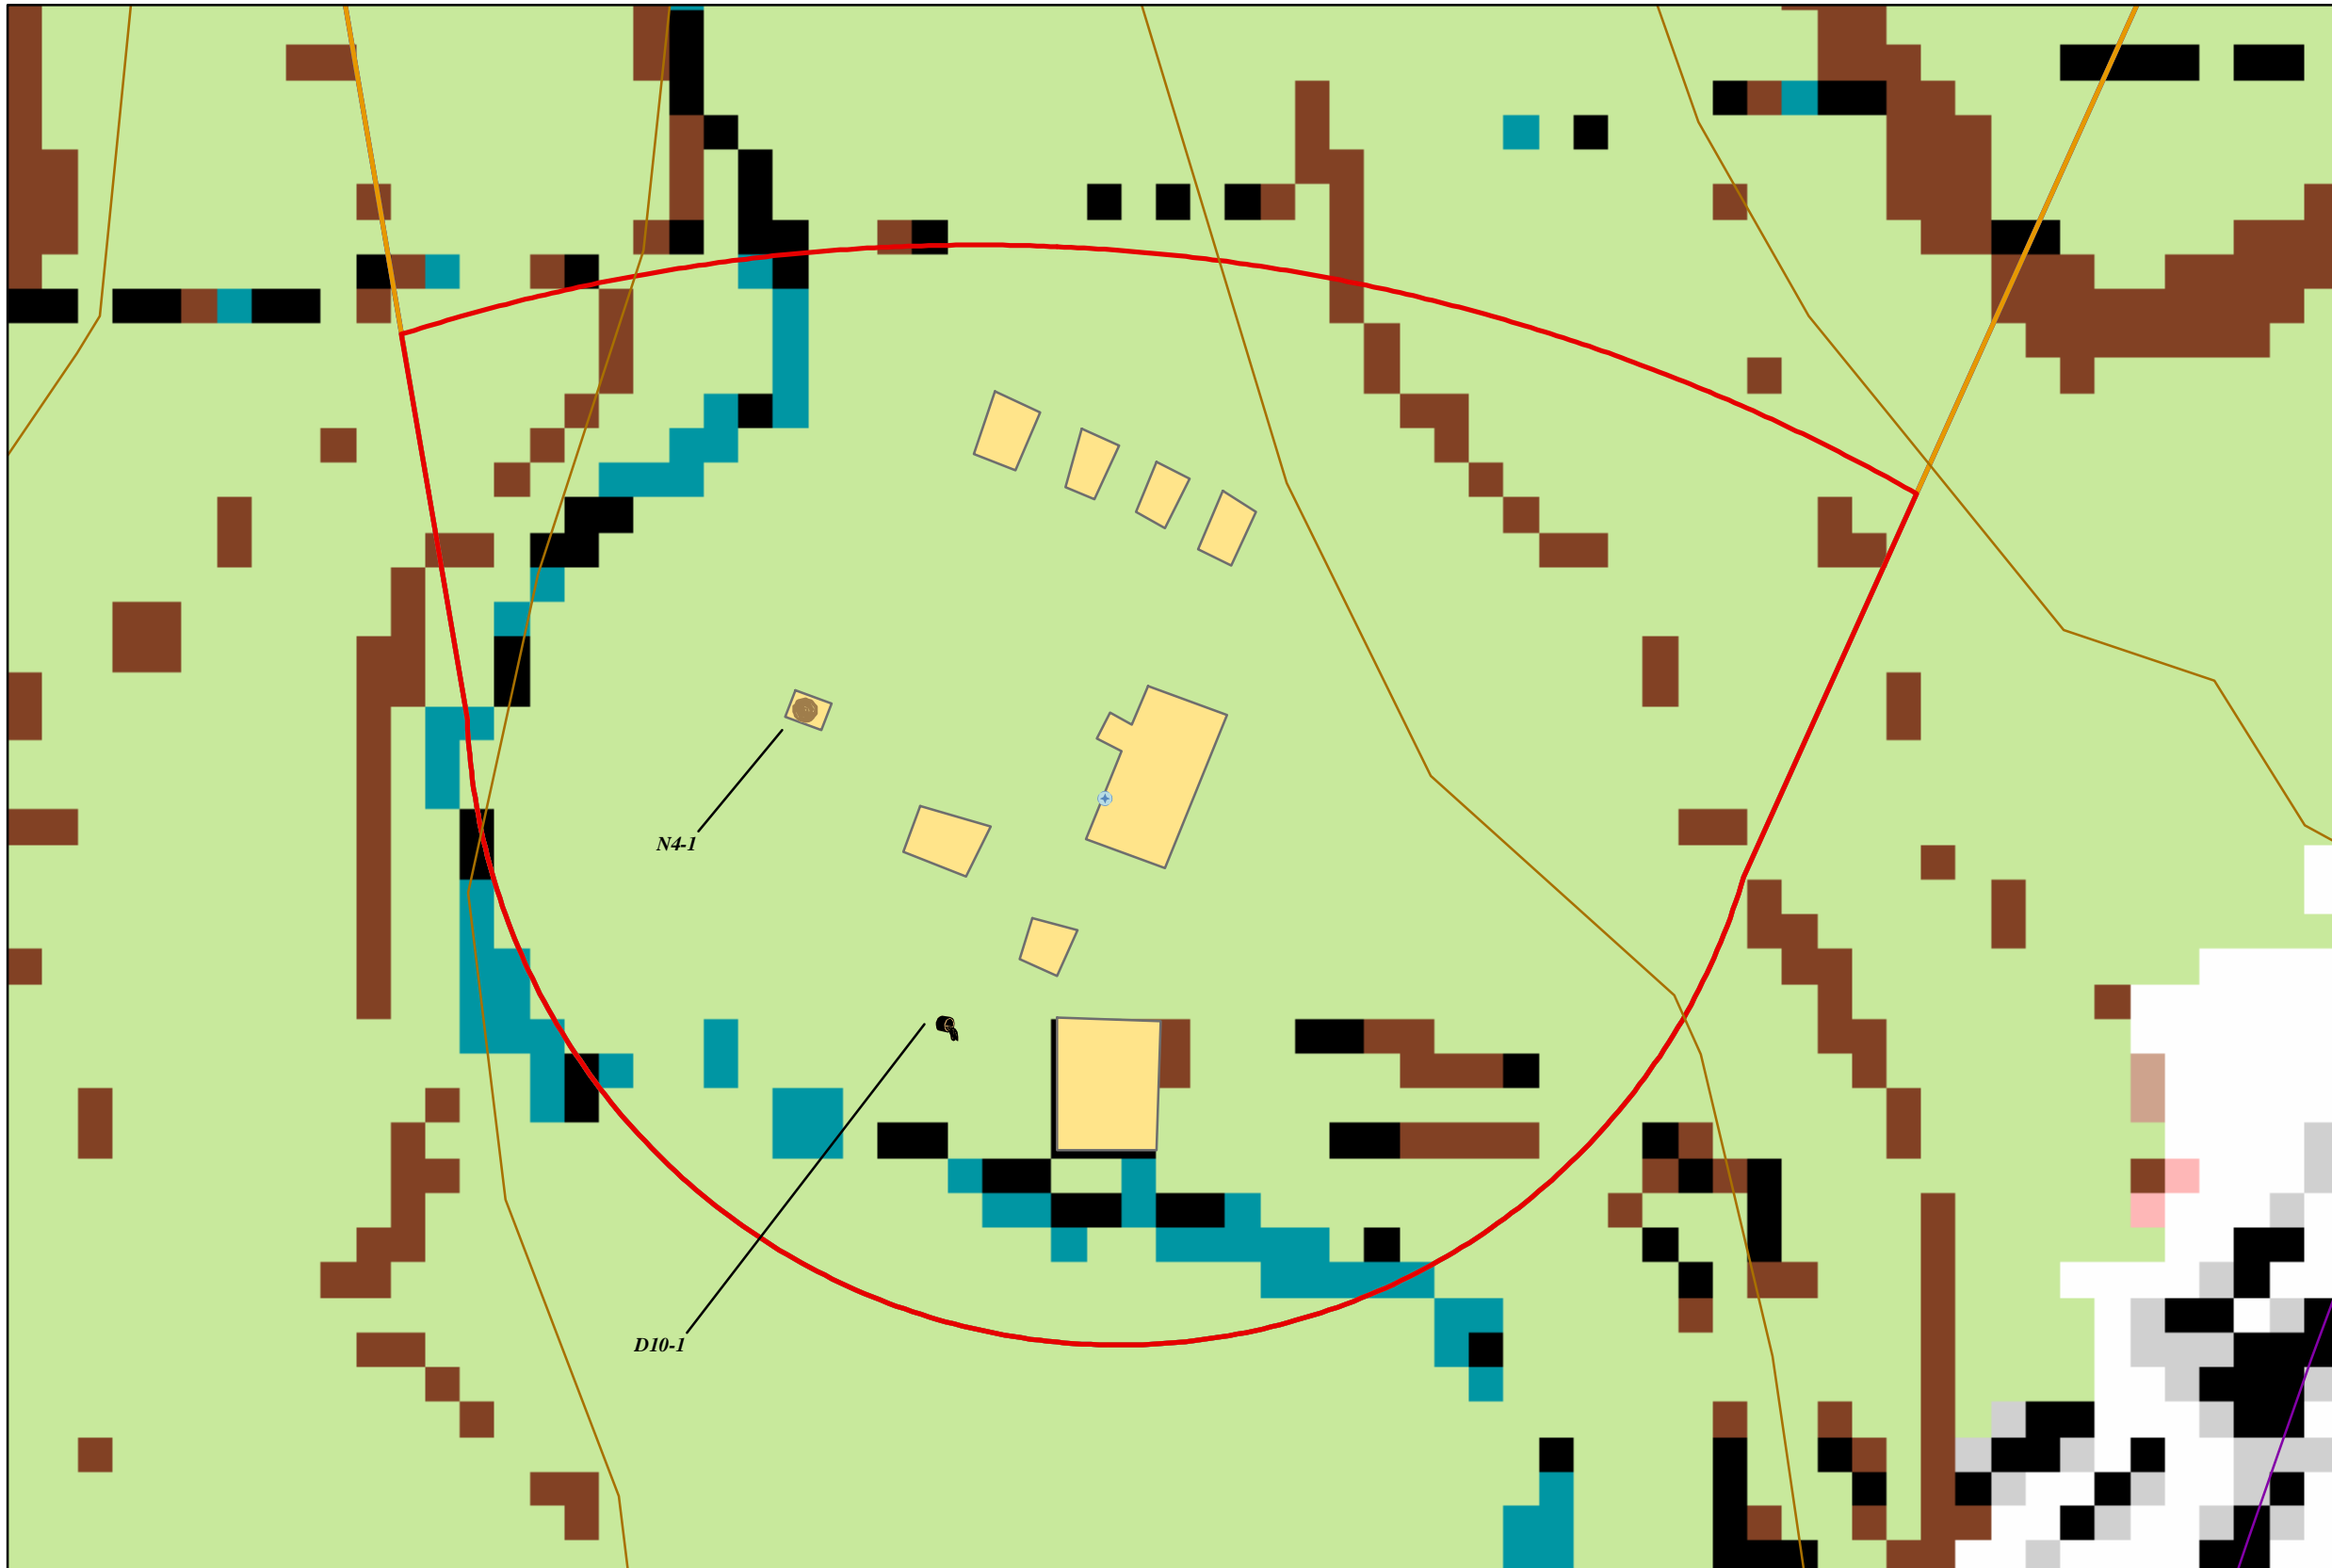
Map 3

Drinking Water Protection Areas for Ranch House Lodge and Potential and Existing Sources of Contamination

- Ranch House Lodge Well
- MSB Roads
- Lumber Processing (N4)
- Large Capacity Septic Systems (D10)
- Site Buildings
- Zone A Protection Area**
- Several Months Travel Time
- Zone B Protection Area**
- Less than 2-Years Travel Time
- Zone C Protection Area**
- Less than 5-Years Travel Time
- Zone D Protection Area**
- Less than 10-Years Travel Time

Contaminant Source Type	Contaminant Source ID	CS ID tag	Zone	Location	Map Number	Comments
Injection wells (Class V) Large-Capacity Septic System (Drainfield Disposal Method)	D10	D10-1	A	SW of Ranch House Lodge	3	
Lumber processing and preservation	N04	N4-1	A	NW of Ranch House Lodge	3

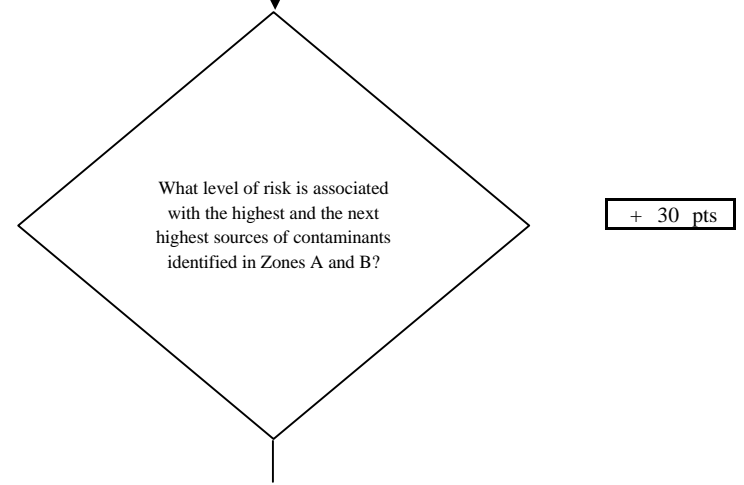
Chart 3. Contaminant Risks for Ranch House Lodge - Bacteria & Viruses

Zone A	Zone B	Total
Very High(s)	0	0	0
High(s)	1	0	1
Medium(s)	0	0	0
Low(s)	0	0	0

Matrix Score 30

Note: Septic systems, sewerlines, and roads are each assigned a risk ranking for each individual contaminant source in the CSI. The VA, however, counts these contaminant sources as a group and assigns a calculated number of either "lows" or "mediums" based on the density.
