Source Water Assessment for
Motherlode Lodge
Hatcher Pass Area, Alaska

A Hydrogeologic Susceptibility and Vulnerability Assessment

DRINKING WATER PROTECTION PROGRAM REPORT 194
PWSID 226541

March 2002

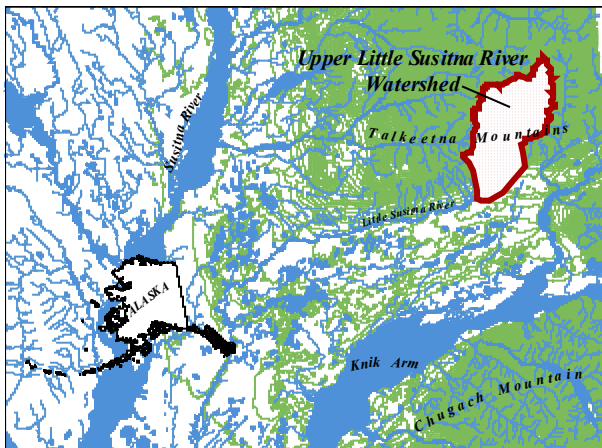
Figure 1. Index map showing Matanuska-Susitna Valley and the Upper Little Susitna River Watershed.

The Upper Little Susitna River watershed is located within the Matanuska-Susitna Borough in southcentral Alaska. The Borough encompasses a total of 24,694 square miles supporting a population of approximately 60,000. It is contained within the watersheds of the Matanuska and Susitna Rivers which flow from the glacier melt waters in the Alaska Range, Talkeetna Mountains, and the Chugach Mountains to tidewater in the Knik Arm of Upper Cook Inlet (*Jokela, Munter and Evans, 1991*). This area between the Matanuska and Susitna Valleys is commonly referred to as the Mat-Su Valley. The Little Susitna River originates in the Talkeetna Mountains north of Palmer and Wasilla and flows into Cook Inlet between Knik Arm and the outlet for Susitna River (see Figure 1). The Upper Little Susitna River watershed extends from the headwaters of the Little Susitna River down through the foothills of the Talkeetna Mountains.

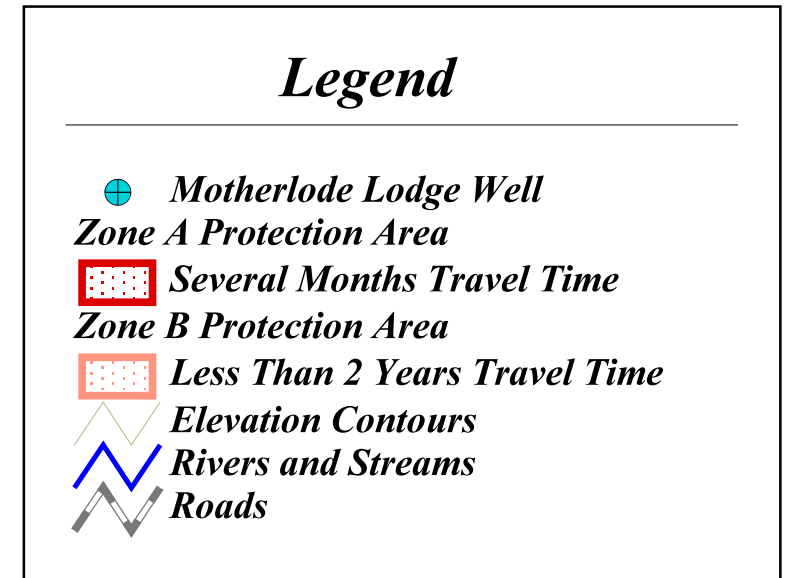
Motherlode Lodge Drinking Water Protection Area

The Drinking Water Protection and Assessment Area that has been established for Motherlode Lodge source of drinking water is the area that is most sensitive to contamination. This area has served as a basis for assessing the risk of the drinking water source to contamination. The zones around the drinking water source outline the most critical area for the preservation of the quality of the drinking water for this system. For simplicity, this area will be known as your Drinking Water Protection Area and will serve as the focus for voluntary protection efforts.

The Drinking Water Protection Areas established for wells by the Alaska Department of Environmental Conservation are separated into zones. These zones correspond to a time-of-travel. Time-of-travel is the time required for water to move in the saturated zone of the ground from a specific point to the well. The Drinking Water Protection Area for Motherlode Lodge contains two zones, Zone A and Zone B (See Map 1 in Appendix A). Zone A corresponds to the area between the well and the distance equal to $\frac{1}{4}$ of the distance of the 2-year time-of-travel. Depending on where a contaminant source is located within Zone A, travel time for a contaminant to the wells may several hours to several days. Zone A also extends downgradient from the well to take into account the area of the aquifer that is influenced by pumping of the wells.

Zone B encompasses the entire immediate watershed and corresponds to a time-of-travel of less than two years.

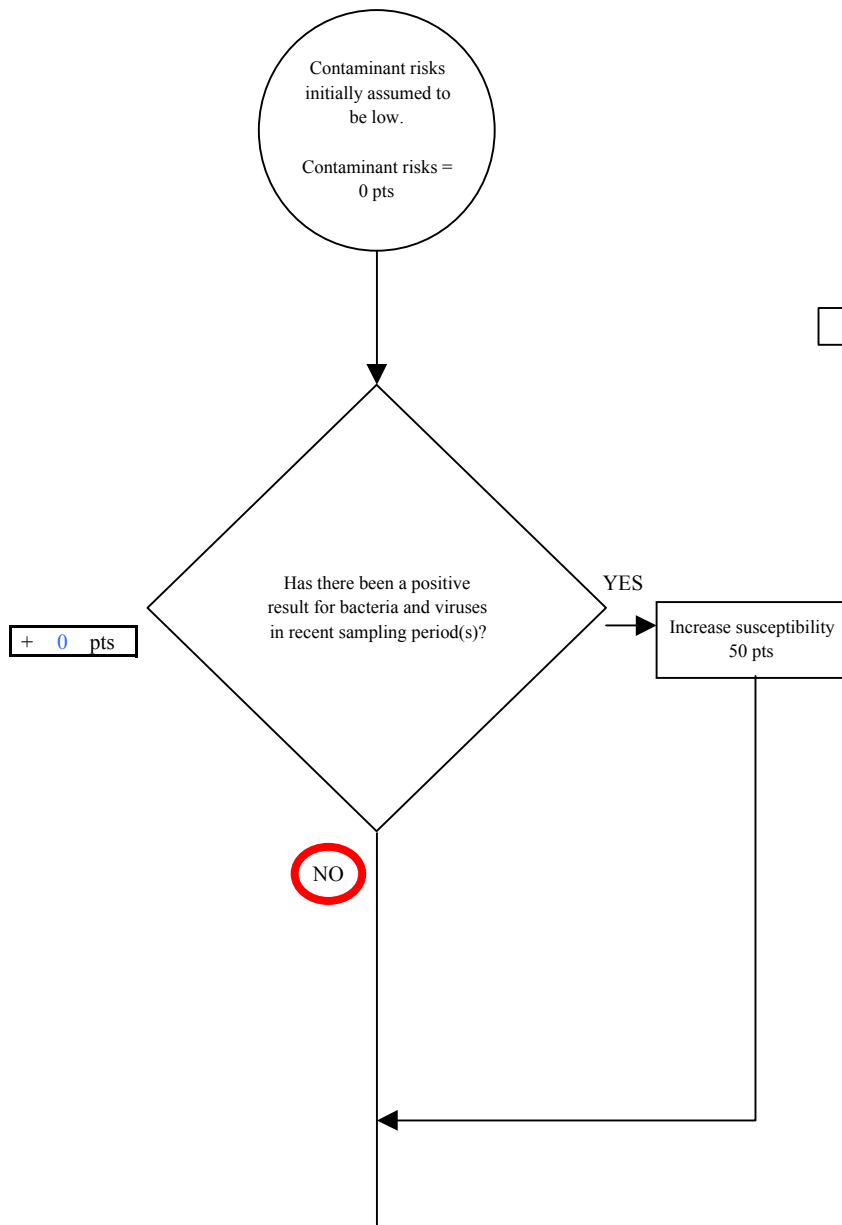
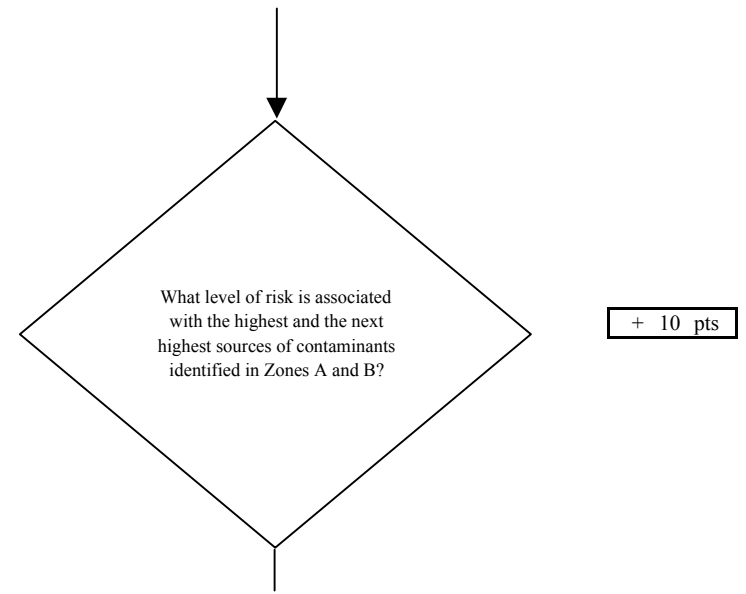
Chart 3. Contaminant risks for *Motherlode Lodge - Bacteria & Viruses*

Risk Rankings for Contaminant Sources Identified in Zones A and B			
	Zone A	Zone B	Total
Very High(s)	0	0	0
High(s)	0	0	0
Medium(s)	0	0	0
Low(s)	2	0	2

Note: Septic systems, sewerlines, and roads are each assigned a risk ranking for each individual contaminant source in the CSI. The VA, however, counts these contaminant sources as a group and assigns a calculated number of either "lows" or "mediums" based on the density.

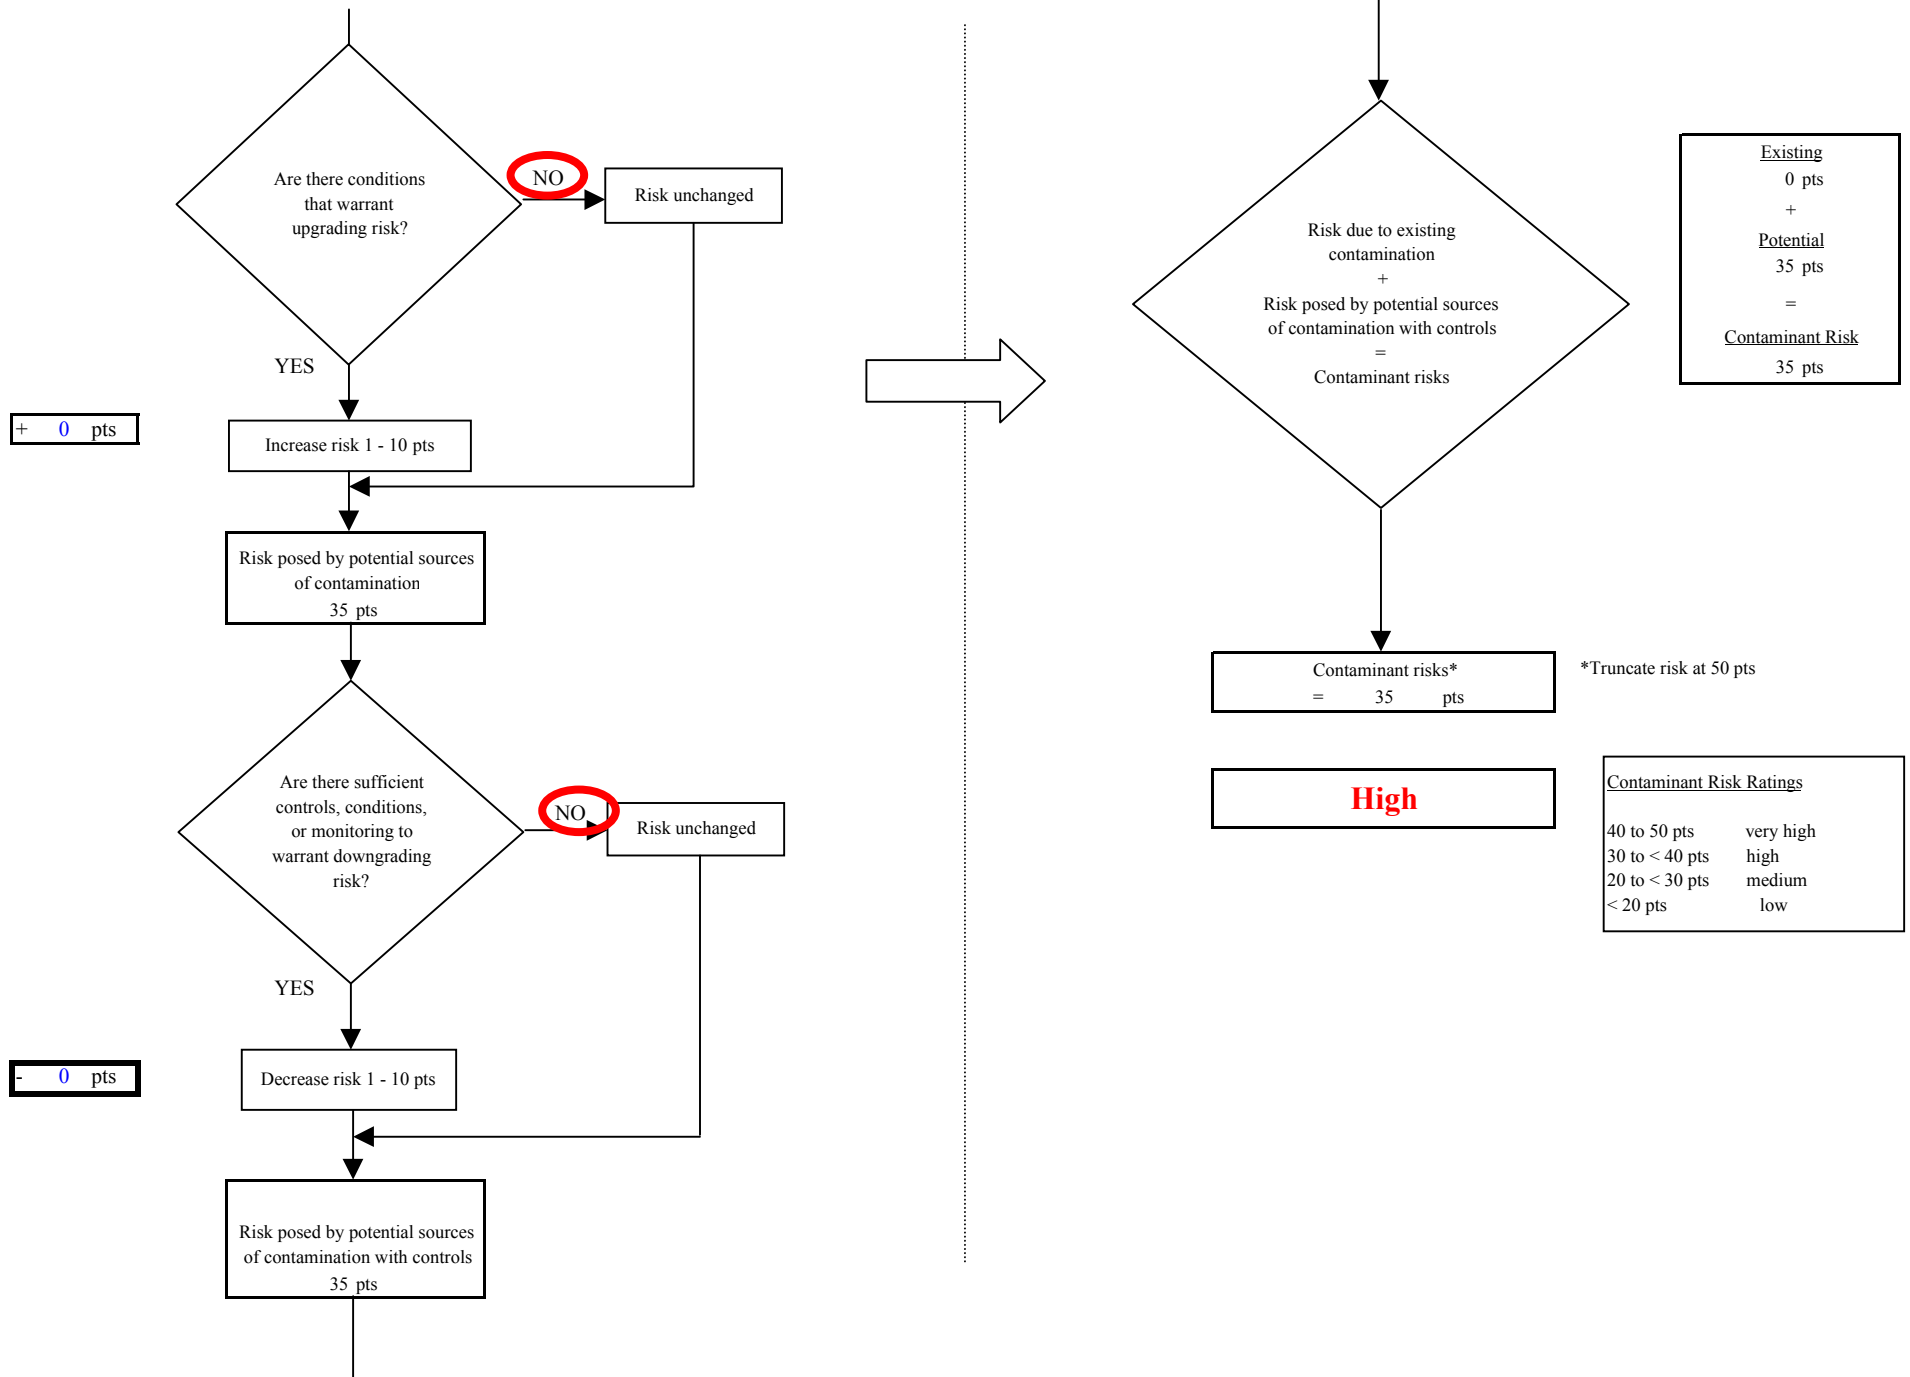
Chart 7. Contaminant risks for *Motherlode Lodge* - Volatile Organic Chemicals

The twelve hardrock underground mines located in Zone B form the greatest risk for volatile organic chemicals. Underground mines also pose a large risk to the water source for heavy metals contamination. Water flowing over and through the metal-rich rock exposed by mining activities can contaminate the surface and ground waters. This occurrence is called acid mine drainage, and is often generated from waste rock piles or other mining wastes. Acid mine drainage can occur at an active or inactive mine and continue long after mining ends.

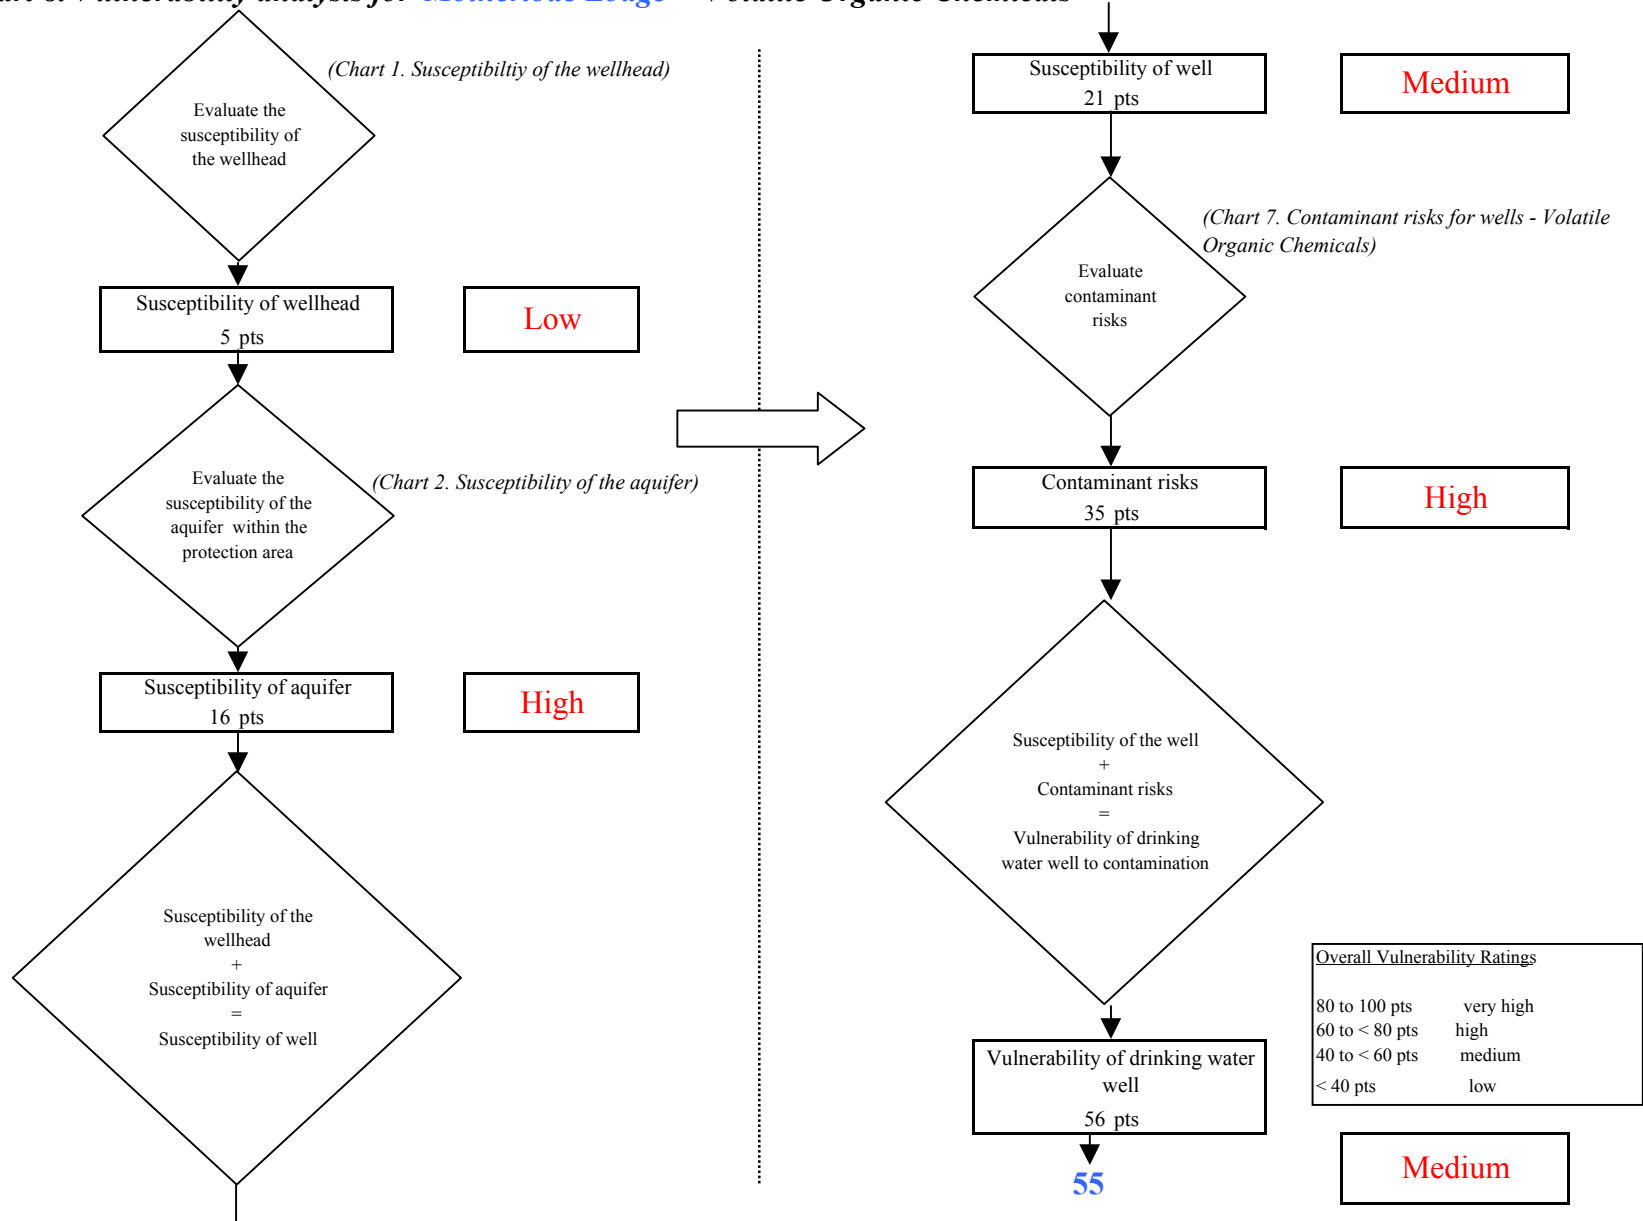
Chart 8. Vulnerability analysis for *Motherlode Lodge* - Volatile Organic Chemicals
