# Source Water Assessment

A Hydrogeologic Susceptibility and  
Vulnerability Assessment for  
USFS Granite Creek Campground No. 1  
Drinking Water System,  
Turnagain, Alaska  
PWSID # 240236.001

DRINKING WATER PROTECTION PROGRAM REPORT # 346  
Alaska Department of Environmental Conservation

By URS Corporation

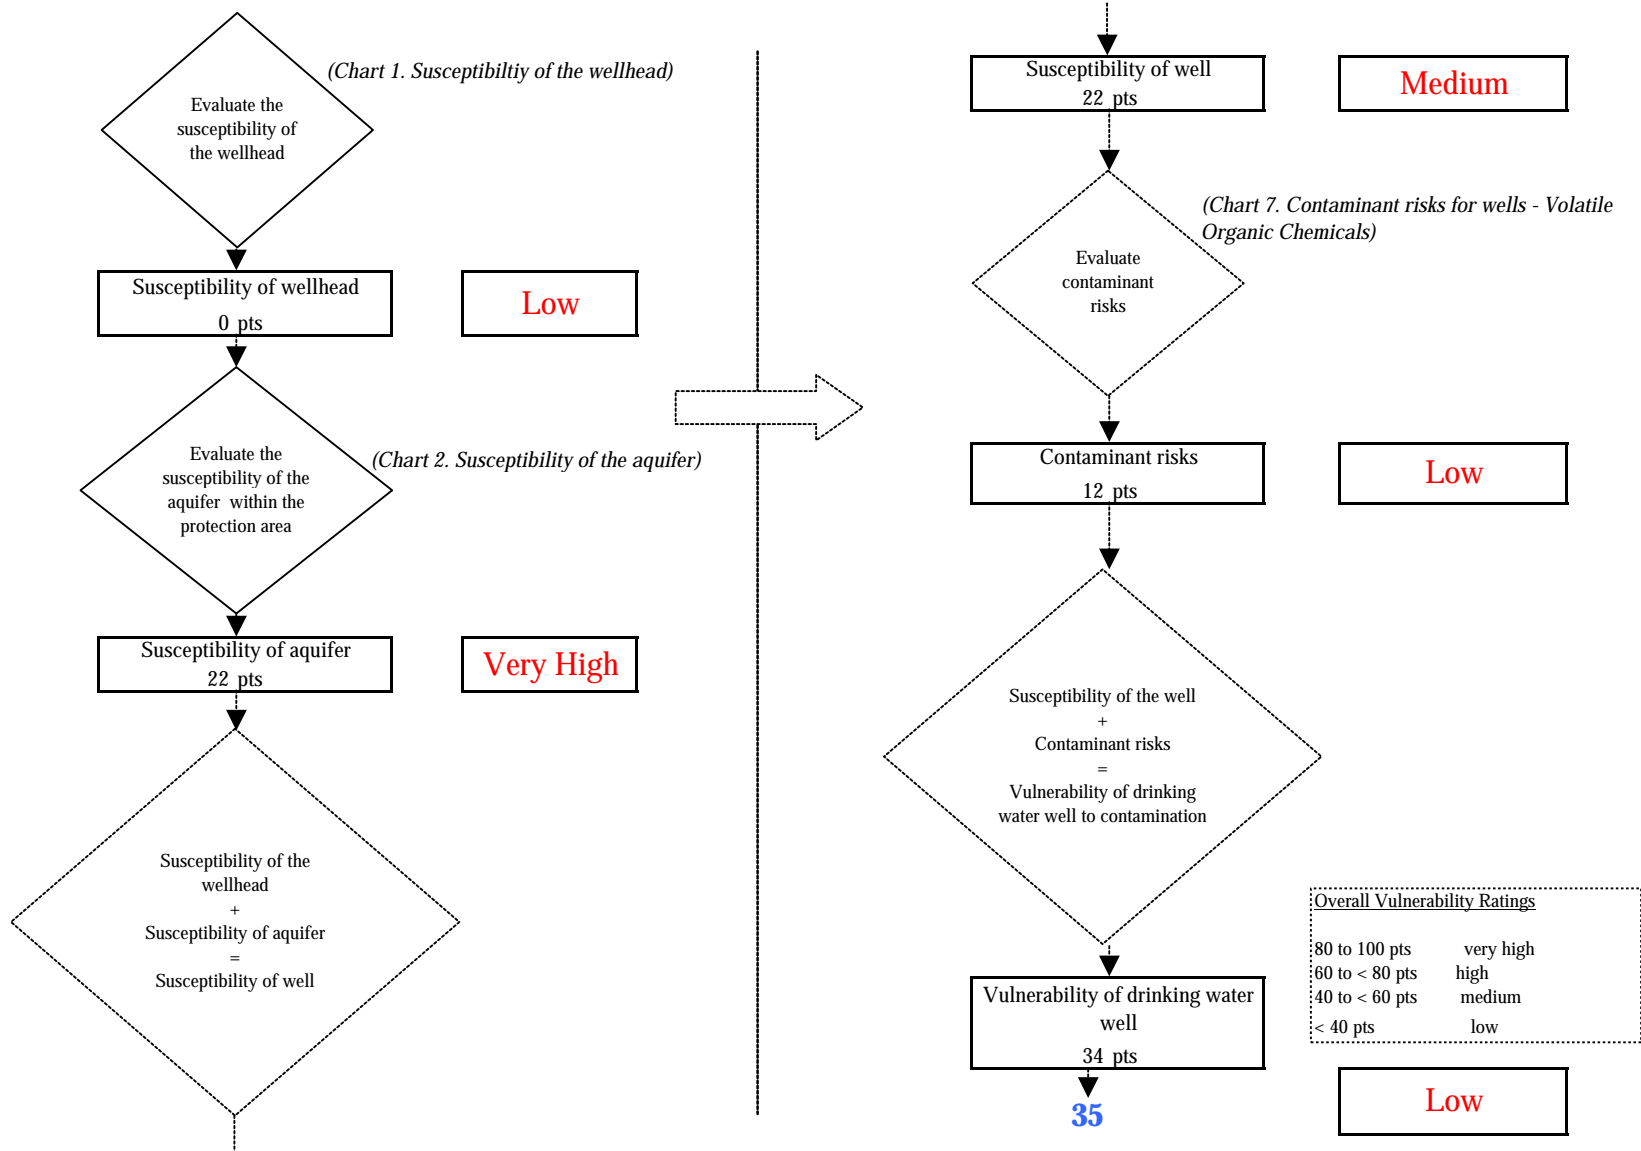
**Chart 8. Vulnerability analysis for USFS Granite Creek Campground #1 (240236.001) - Volatile Organic Chemicals**
