A Hydrogeologic Susceptibility and
Vulnerability Assessment for
USFS Granite Creek Campground No. 2
Drinking Water System,
Turnagain, Alaska
PWSID # 242246.001

By URS Corporation

DRINKING WATER PROTECTION PROGRAM REPORT # 367

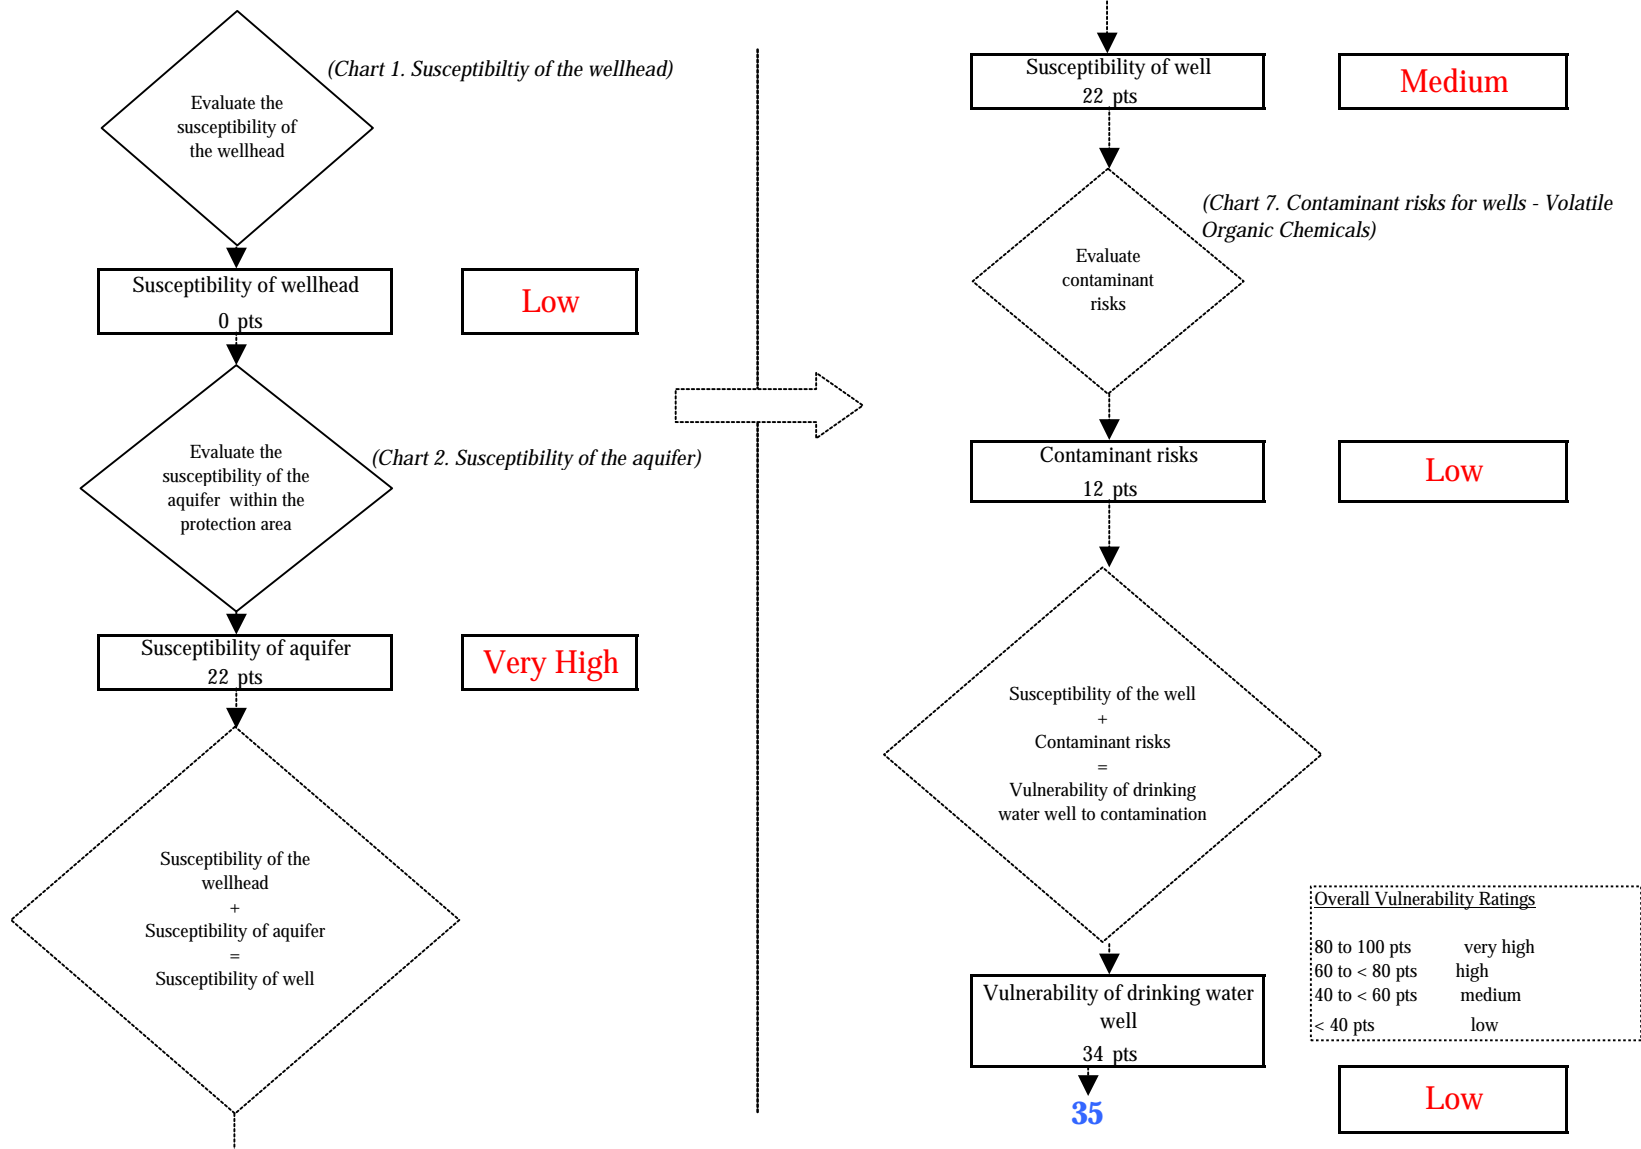
Chart 8. Vulnerability analysis for USFS Granite Creek Campground #2 (242246.001) - Volatile Organic Chemicals
