# Source Water Assessment

A Hydrogeologic Susceptibility and  
Vulnerability Assessment for  
USFS Bertha Creek Campground  
Drinking Water System,  
Turnagain Pass, Alaska  
PWSID # 240171.001

DRINKING WATER PROTECTION PROGRAM REPORT # 342  
Alaska Department of Environmental Conservation

By URS Corporation

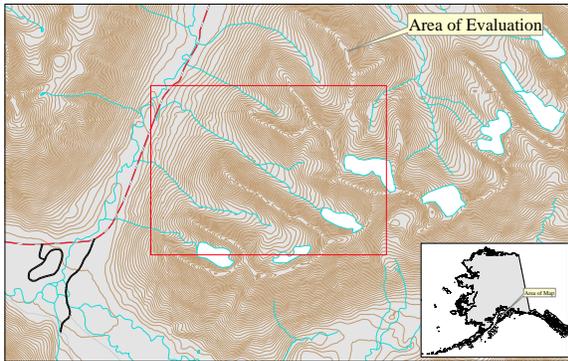
Figure 1

The Kenai Peninsula is broken into two distinct geographic areas; the Kenai Mountains and the Kenai Lowland. The Kenai Mountains are located in the southern and eastern part of the peninsula, comprising about 6,500 square miles. Towns located within the Kenai Mountains include Moose Pass, Cooper Landing, Crown Point, Trail Lake, and Seward. The Kenai Lowlands are located in the west and comprise about 2,900 square miles and include the towns of Sterling, Soldotna, Kenai, Clam Gulch, Ninilchik and Homer. Two main highways divide the peninsula; the Seward Highway begins in Anchorage and ends in Seward, connecting the Turnagain Arm to the peninsula. The Sterling Highway splits off from Seward Highway at Tern Lake Junction and runs east and west to Kenai, where it then turns south and ends in Homer. The peninsula is bordered by the Prince William Sound in the east, Gulf of Alaska in the south and the Cook Inlet in the west. The Kenai River, located in the Kenai Mountains, is the largest stream within the peninsula, beginning at Kenai Lake and draining into the Cook Inlet through the Kenai Lowlands (USGS, 1915).

FIGURE	1. Index map showing the location of the Kenai Mountains Watershed	1
--------	--	---

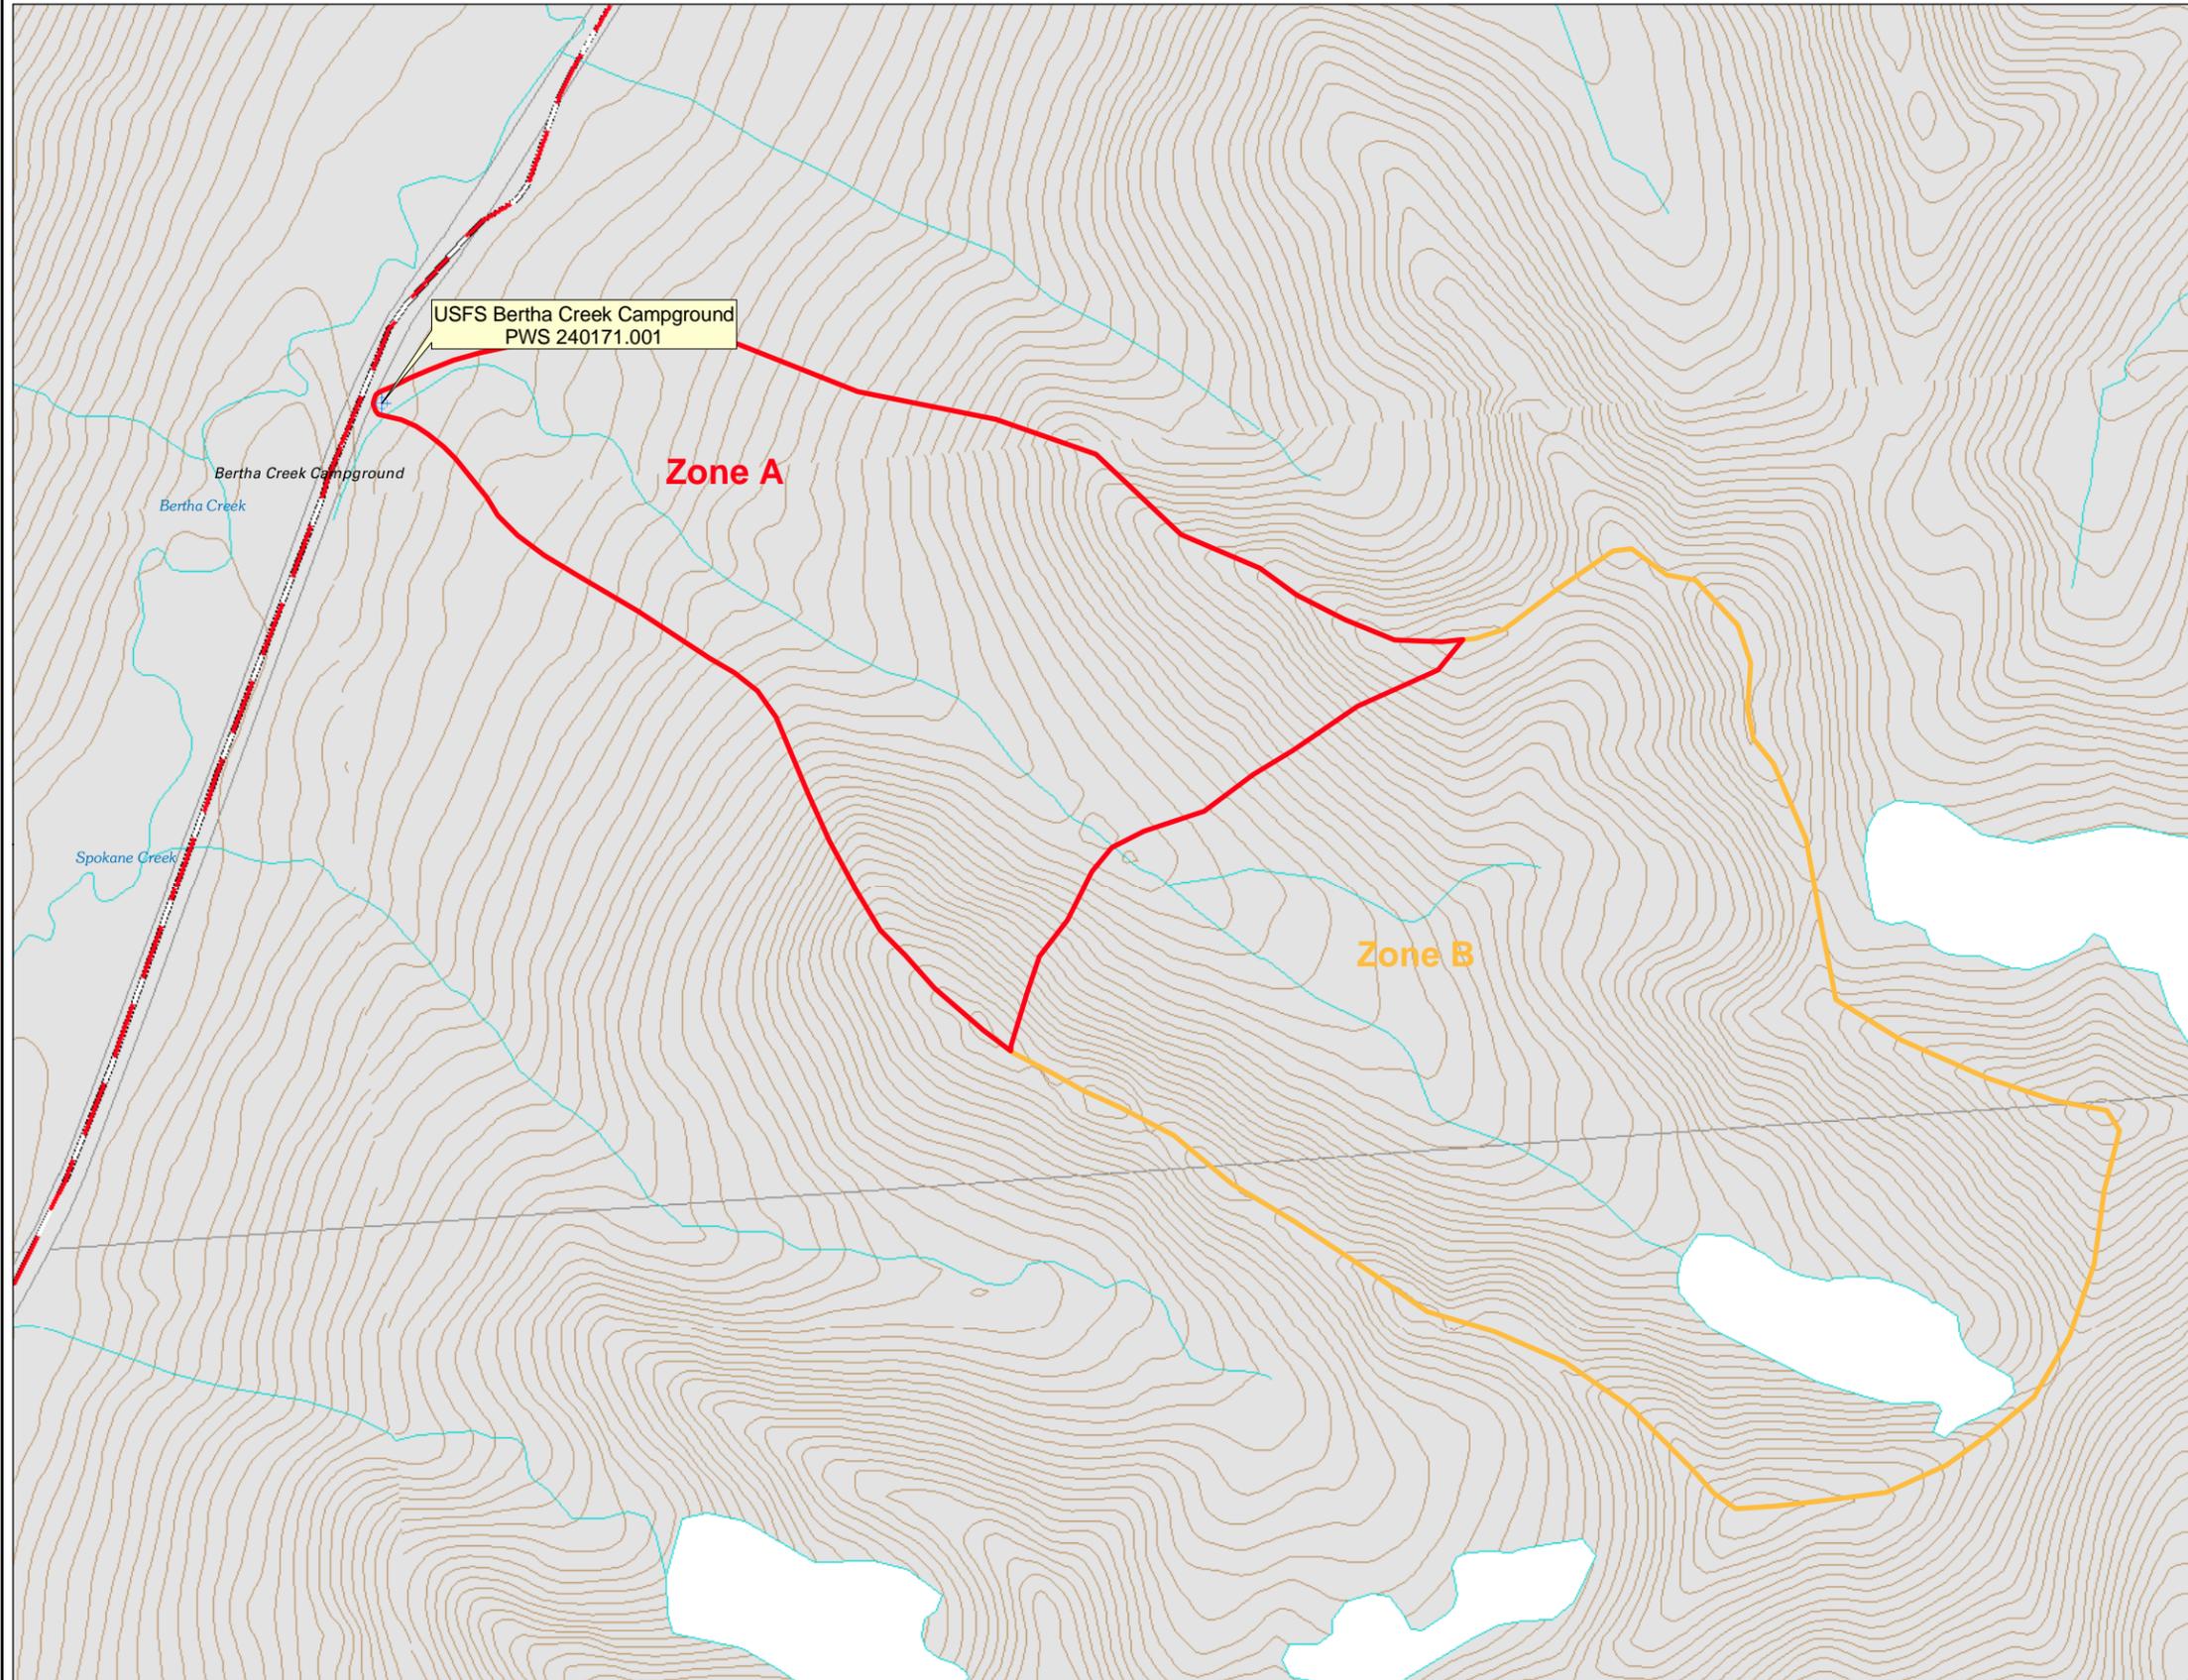
### **USFS Bertha Creek Campground Drinking Water Protection Area (Map 1)**

# Drinking Water Protection Areas for the Public Water Well System for PWS # 240171.001 USFS Bertha Creek Campground

- Zone A – Several Months Travel Time
- Zone B – Less Than 2 Years Travel Time

The most probable area for contamination to reach the drinking water well is the area that contributes water to the well, the groundwater recharge area. This area is designated as the Drinking Water Protection Area (DWPA). Because a release of contaminants within the DWPA are most likely to impact the drinking water well, this area will serve as the focus for voluntary protection efforts.

The DWPAs established for wells by the ADEC are usually separated into four zones, limited by the watershed. These zones correspond to differences in the time-of-travel (TOT) of the water moving through the aquifer to the well. An analytical calculation was used to determine the size and shape of the DWPA. The input parameters describing the attributes of the aquifer in this calculation were adopted from the U.S. Geological Survey (*Patrick, Brabets, and Glass, 1989*), and State of Alaska Department of Water Resources (*Jokela et. al., 1991*).

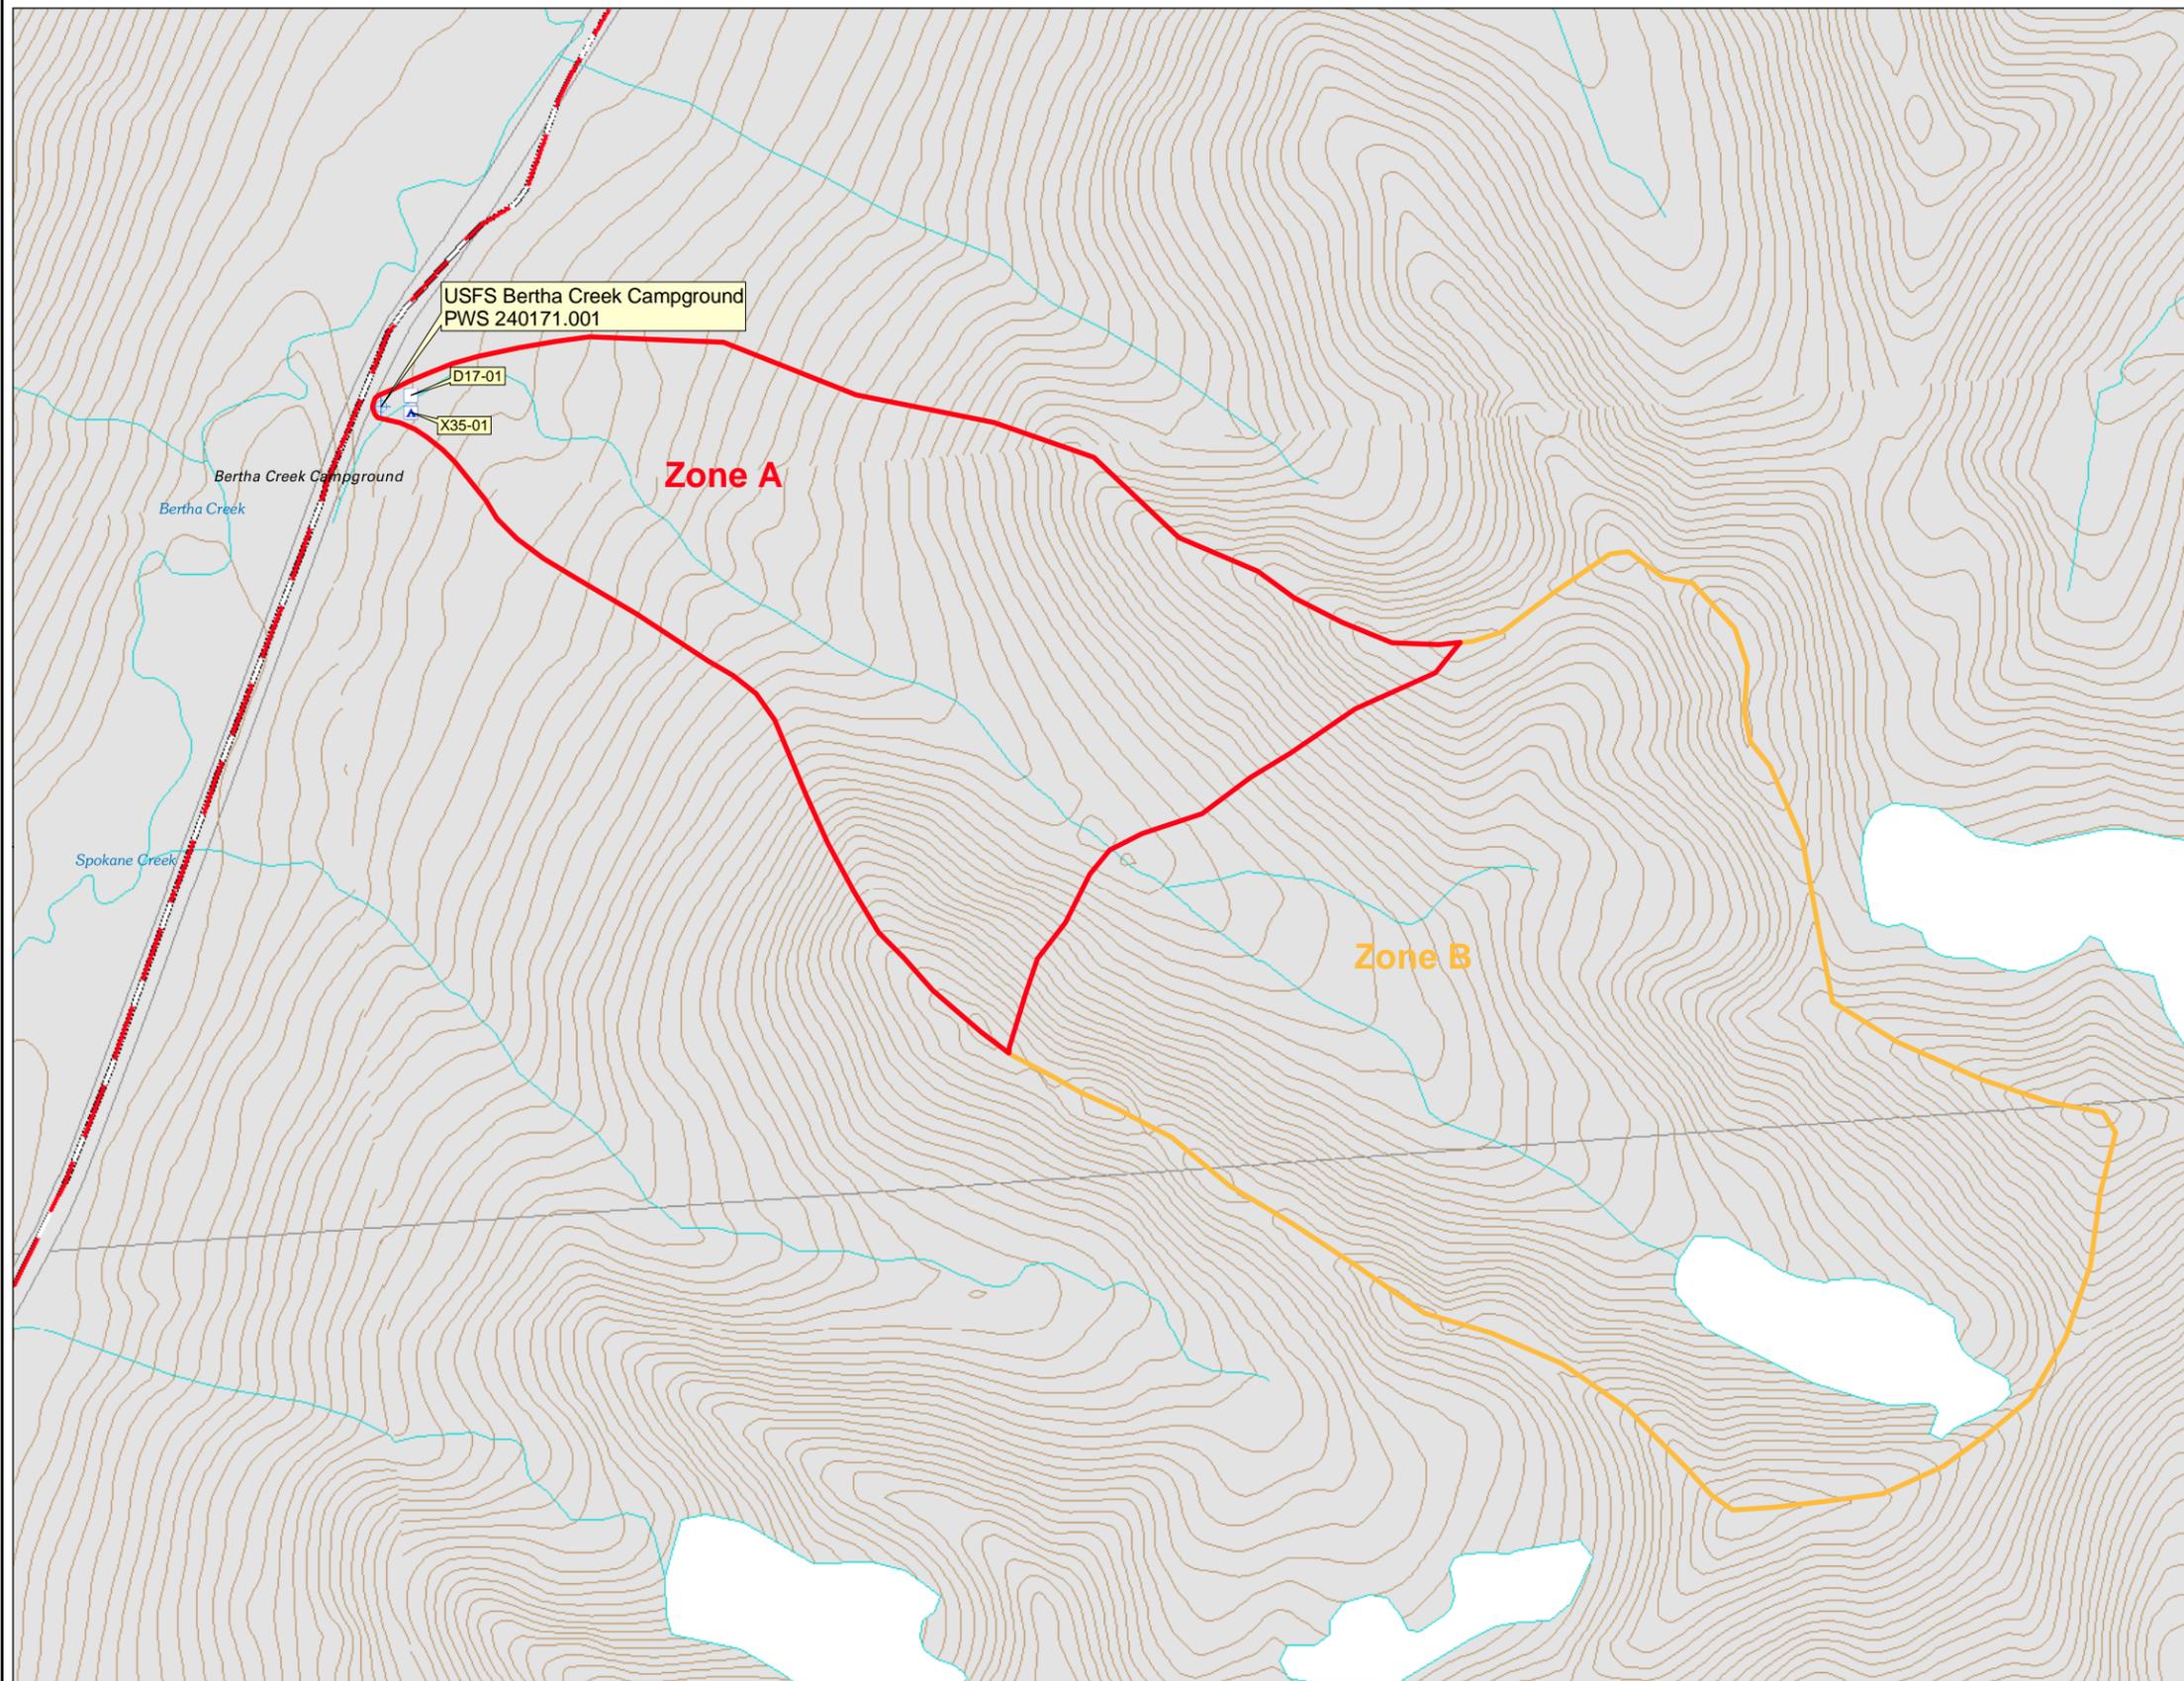
### **USFS Bertha Creek Campground Drinking Water Protection Area and Potential and Existing Contaminant Sources (Map 2)**

# Drinking Water Protection Areas for the Public Water Well System for PWS # 240171.001 USFS Bertha Creek Campground

## Showing Potential and Existing Sources of Contamination

Campgrounds and RV Parks (X35)
-

Pit Toilets (vaulted) nonresidential (one or more) (D17)

Inventoried potential sources of contamination within Zones A and B are associated with residential and light industrial type activities. The sources are summarized in the tables in Appendix B.

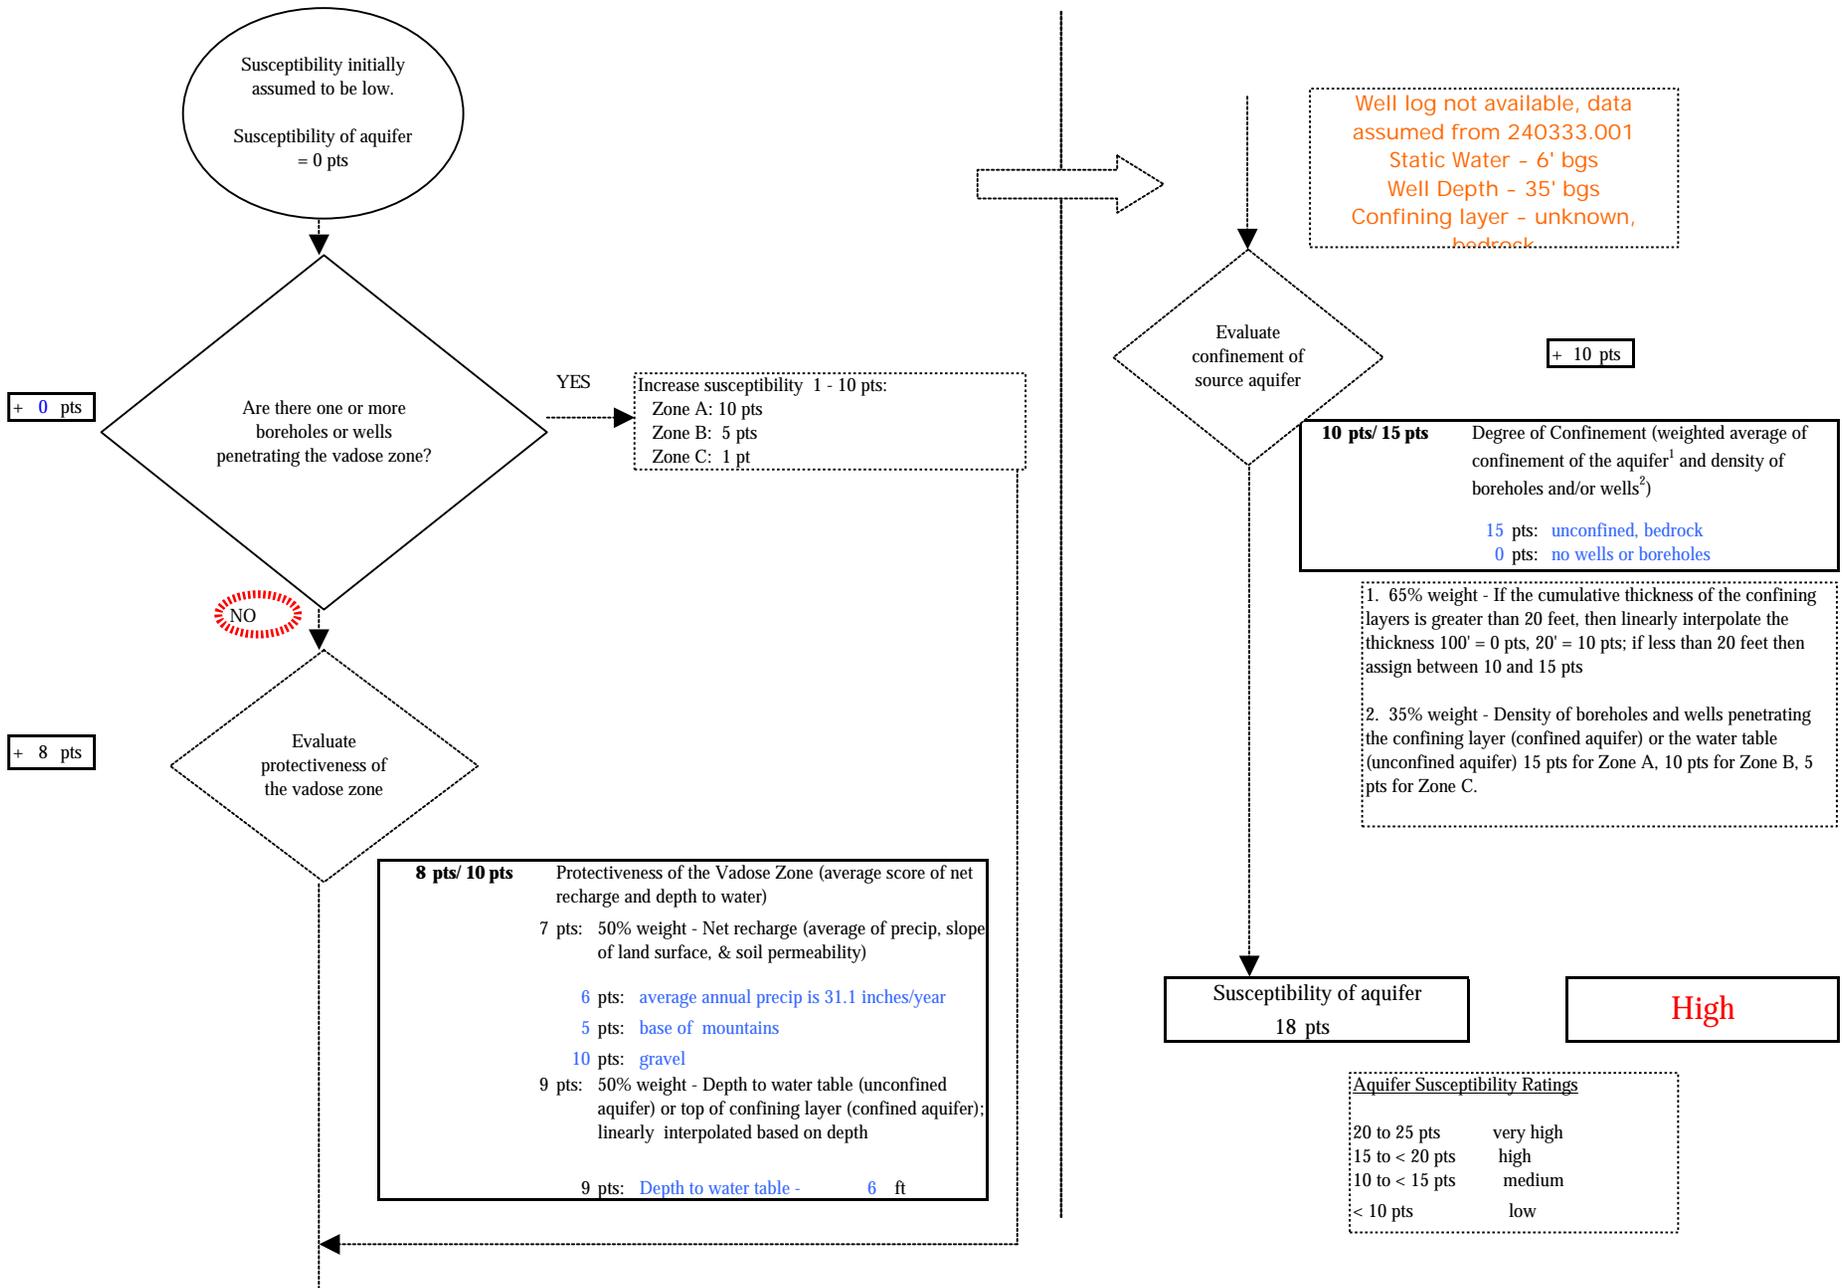
**Chart 2. Susceptibility of the aquifer - USFS Bertha Creek Campground (240171.001)**

The well for USFS Bertha Creek Campground is completed in an unconfined aquifer setting. Because an unconfined aquifer is recharged by surface water and precipitation that migrates downward from the surface, contaminants at the surface have the potential to adversely impact this aquifer. Table 2 shows the Overall Susceptibility score and rating for USFS Bertha Creek Campground.

Appendix D contains eight charts, which together form the ‘Vulnerability Analysis’ for a source water assessment for a public drinking water source. Chart 1 analyzes the ‘Susceptibility of the Wellhead’ to contamination by looking at the construction of the well and its surrounding area. Chart 2 analyzes the ‘Susceptibility of the Aquifer’ to contamination by looking at the naturally occurring attributes of the water source and influences on the groundwater system that might lead to contamination. Chart 3 analyzes ‘Contaminant Risks’ for the drinking water source with

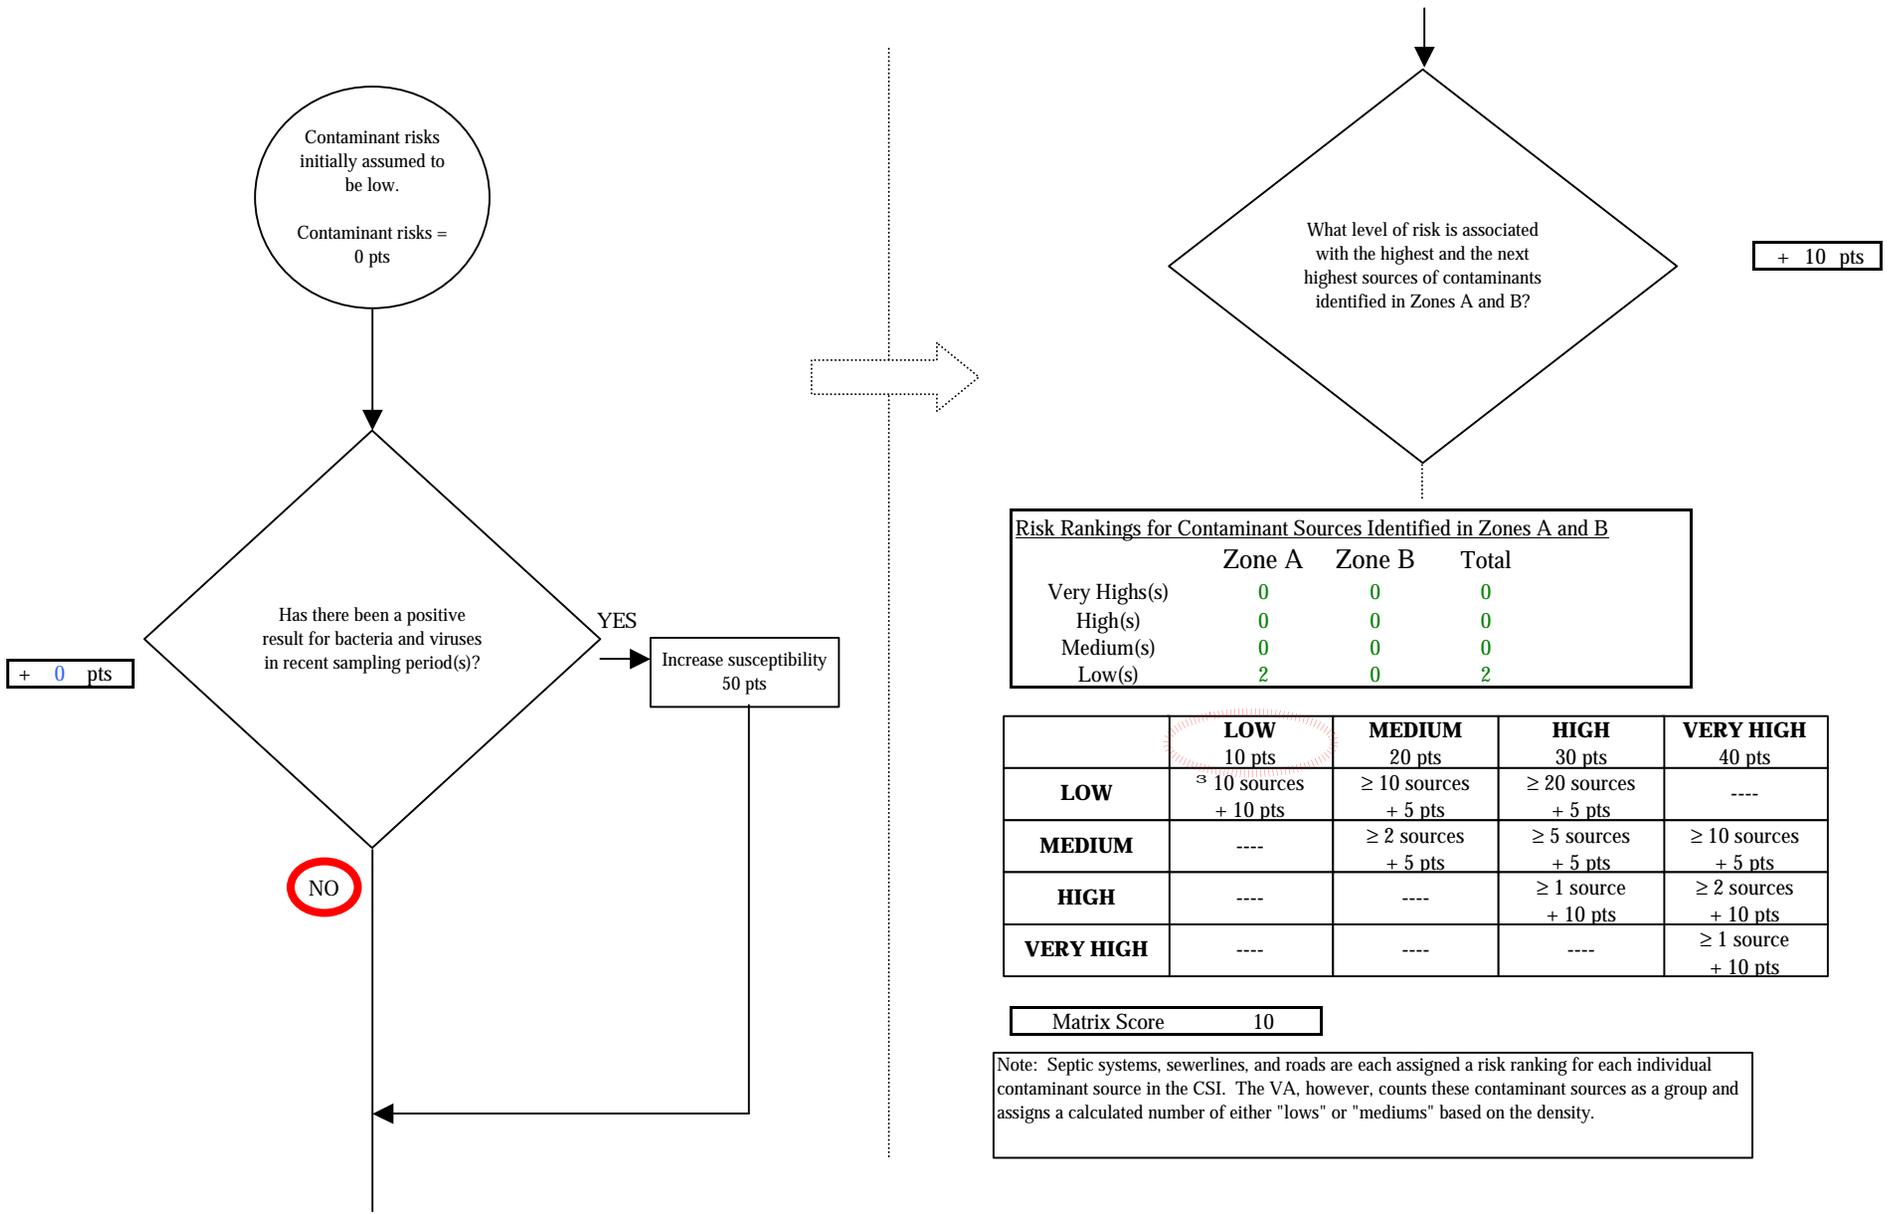
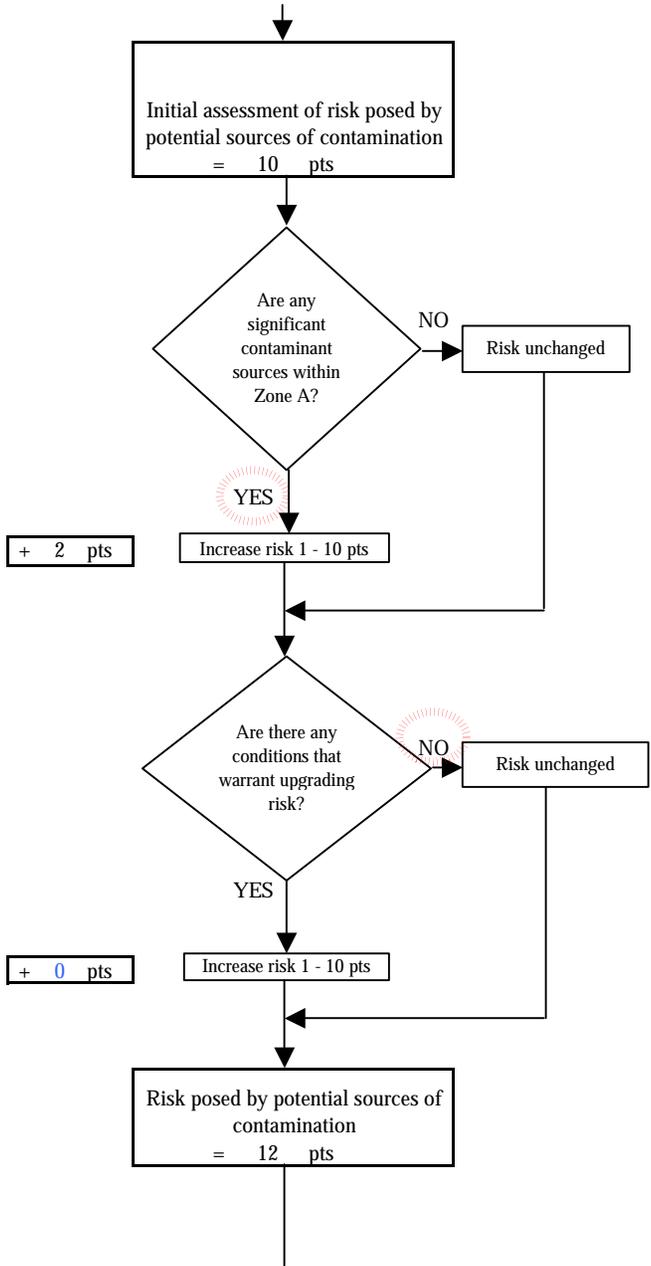
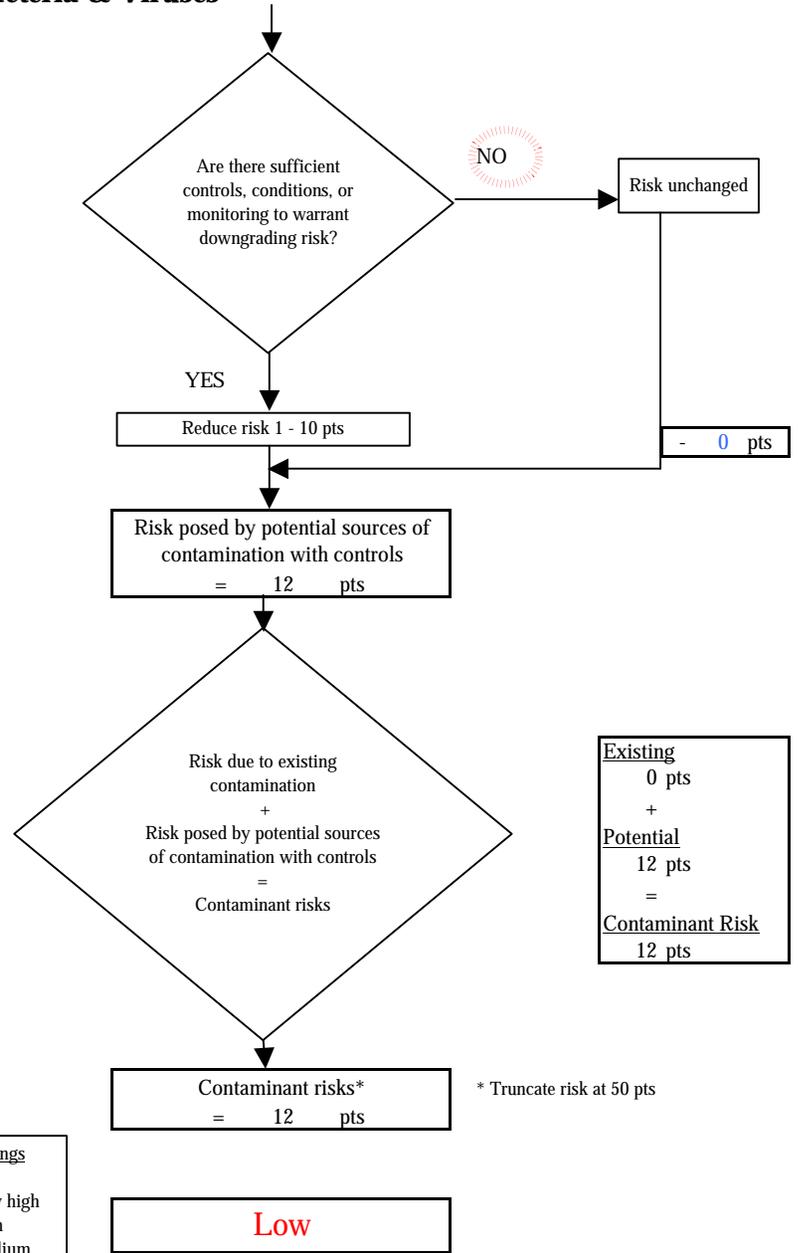
**Chart 3. Contaminant risks for USFS Bertha Creek Campground (240171.001) - Bacteria & Viruses**

Existing	0 pts
+	
Potential	12 pts
=	
Contaminant Risk	12 pts

Contaminant Risk Ratings	
40 to 50 pts	very high
30 to < 40 pts	high
20 to < 30 pts	medium
< 20 pts	low

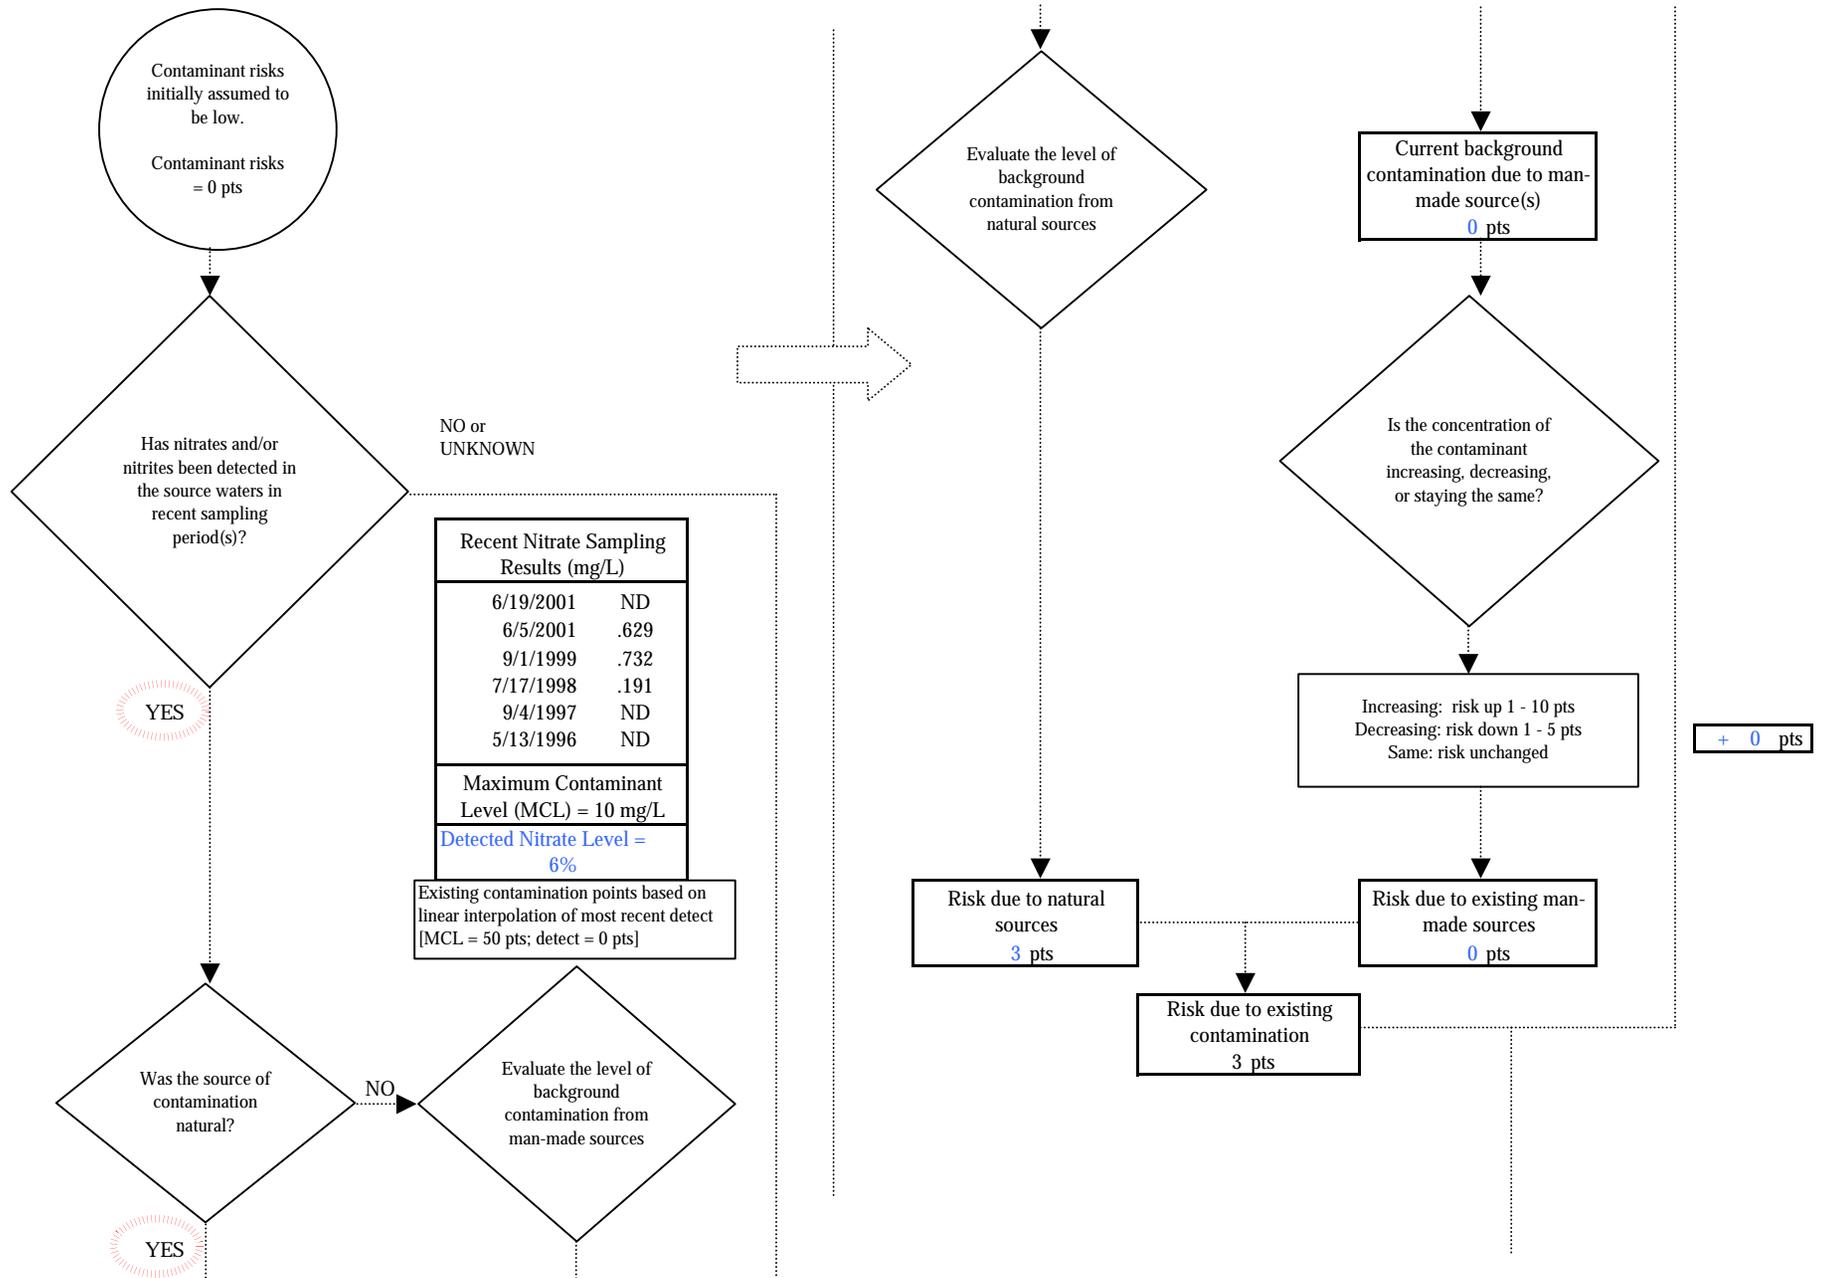
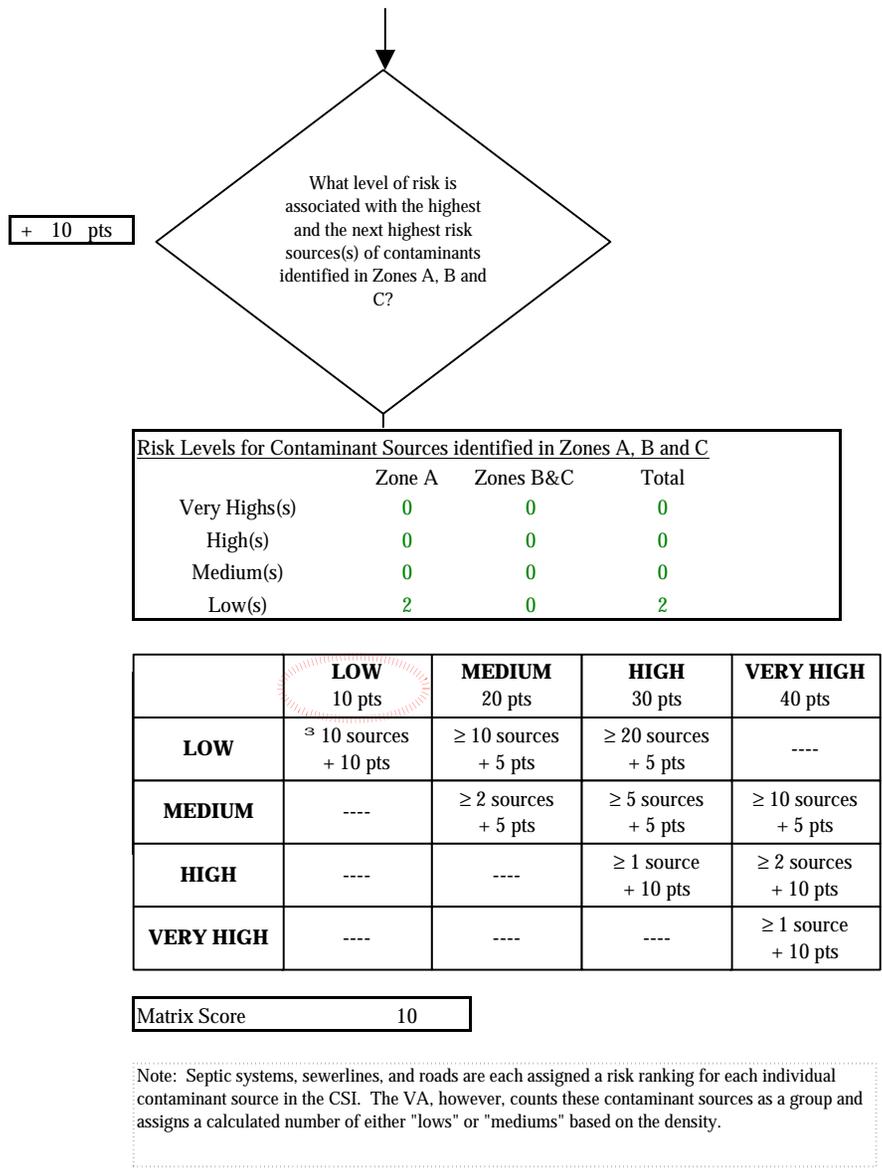
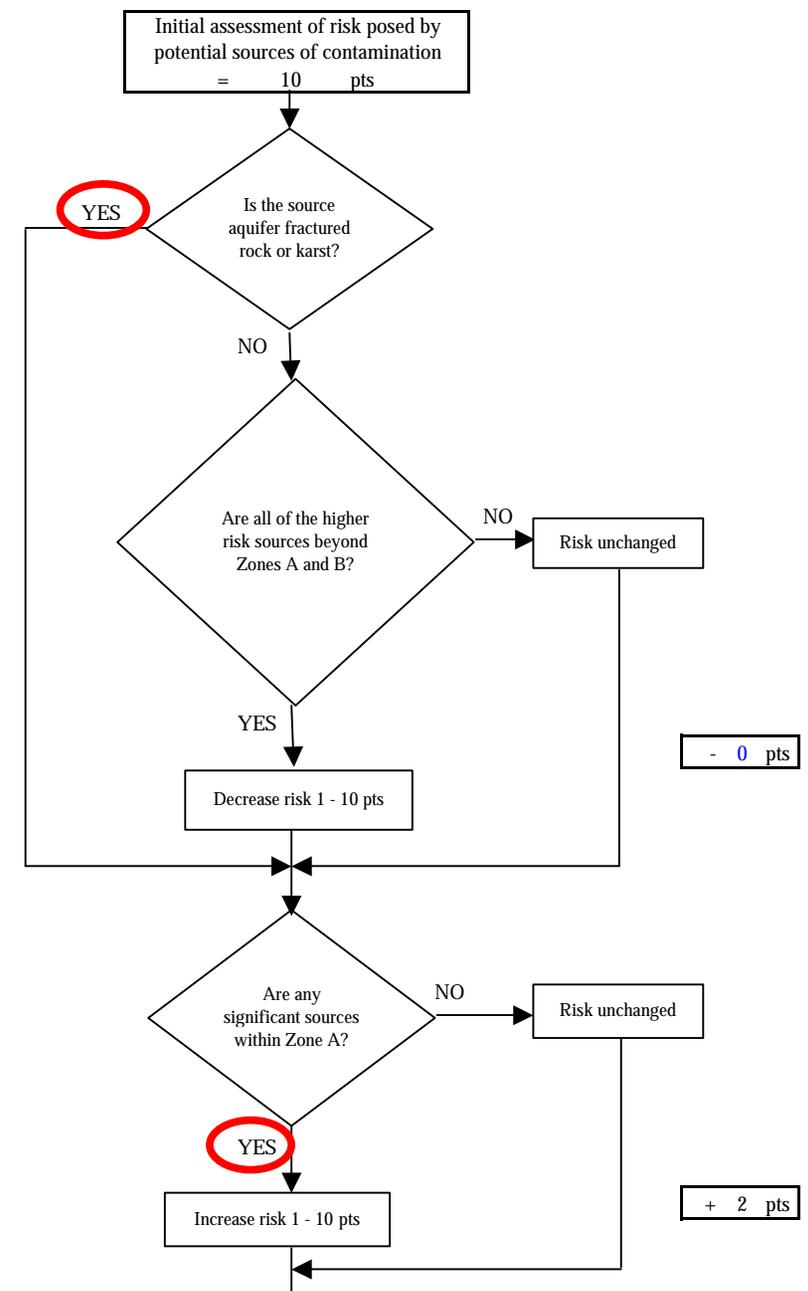
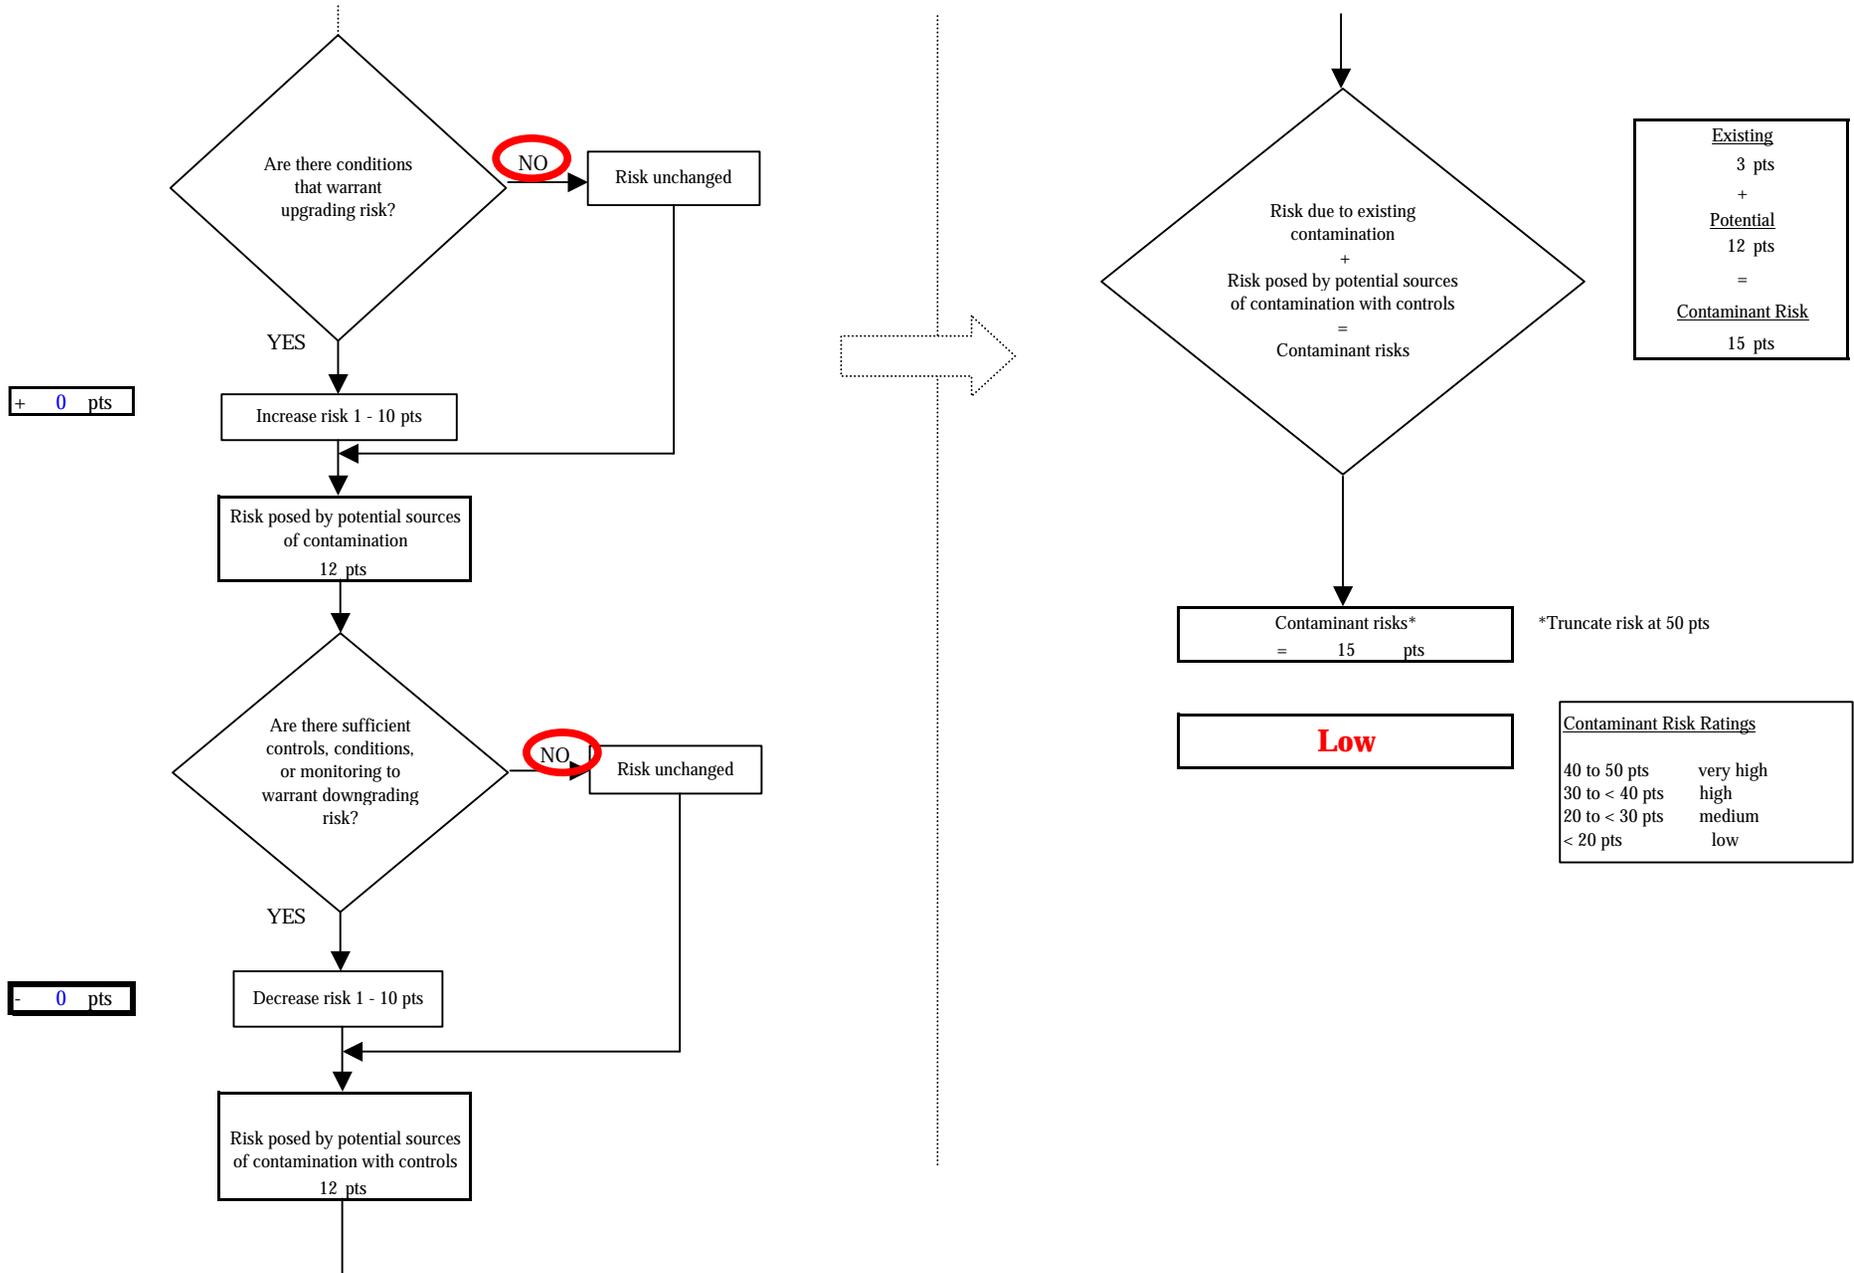
**Chart 5. Contaminant risks for USFS Bertha Creek Campground (240171.001) - Nitrates and Nitrites**

Are any significant sources within Zone A?

Increase risk 1 - 10 pts

Sampling history for USFS Bertha Creek Campground well indicates that low concentrations of nitrate have been detected (See Chart 5 - Contaminant Risks for Nitrates and/or Nitrites in Appendix D). Existing nitrate concentration is approximately 0.6 mg/L or 6 % of the Maximum Contaminant Level (MCL) of 10mg/L. The MCL is the maximum level of contaminant that is allowed to exist in drinking water and still be consumed by humans without harmful health effects. Due to the
