Source Water Assessment

A Hydrogeologic Susceptibility and Vulnerability
Assessment for
Grouse Ridge Sportmans Club Drinking Water
System,
Wasilla, Alaska
Grouse Ridge Sportmans Club PWSID #
225419.001

DRINKING WATER PROTECTION PROGRAM REPORT 766

October 2002

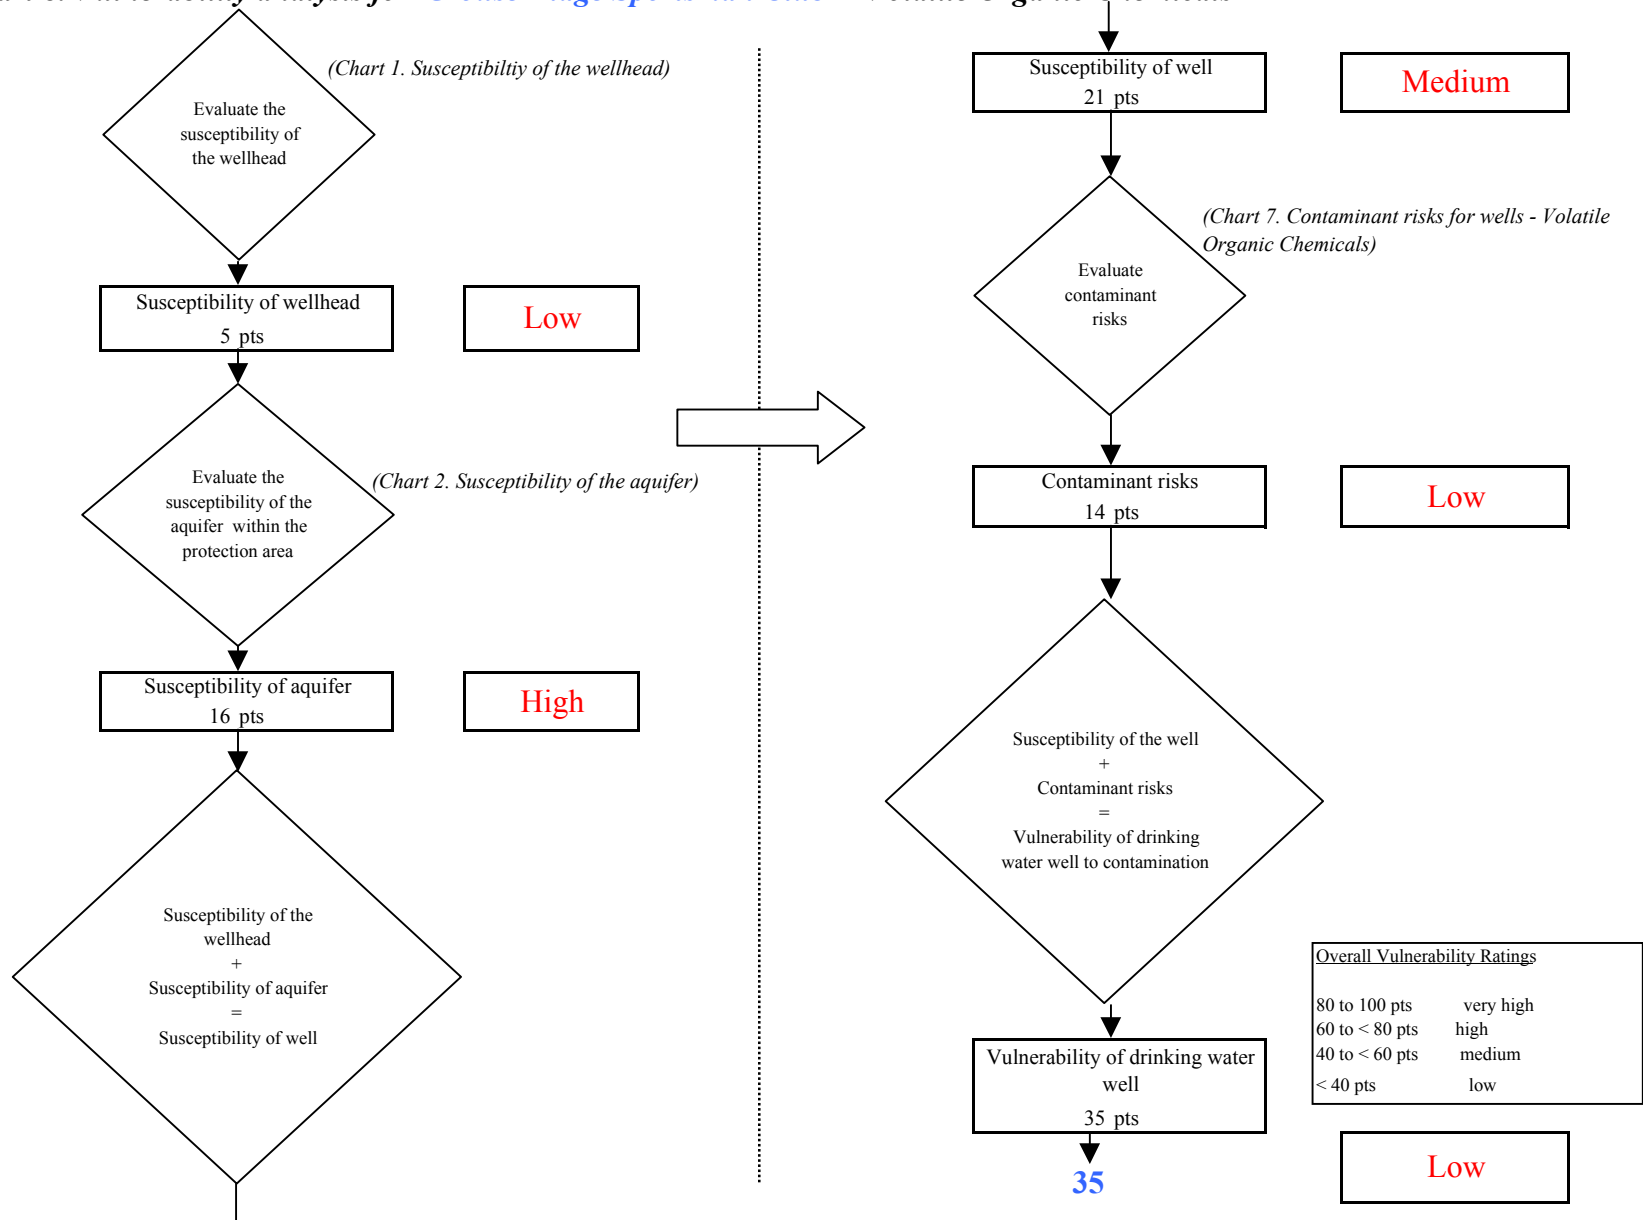
Chart 8. Vulnerability analysis for Grouse Ridge Sportsman Club - Volatile Organic Chemicals

After combining the contaminant risk for volatile organic chemicals with the natural susceptibility of the well, the overall vulnerability of the well to contamination is low.
