Hydrologic Investigations of Prairie Potholes in North Dakota, 1959-68

GEOLOGICAL SURVEY PROFESSIONAL PAPER 585-A

By W. S. EISENLOHR, JR., *and others*

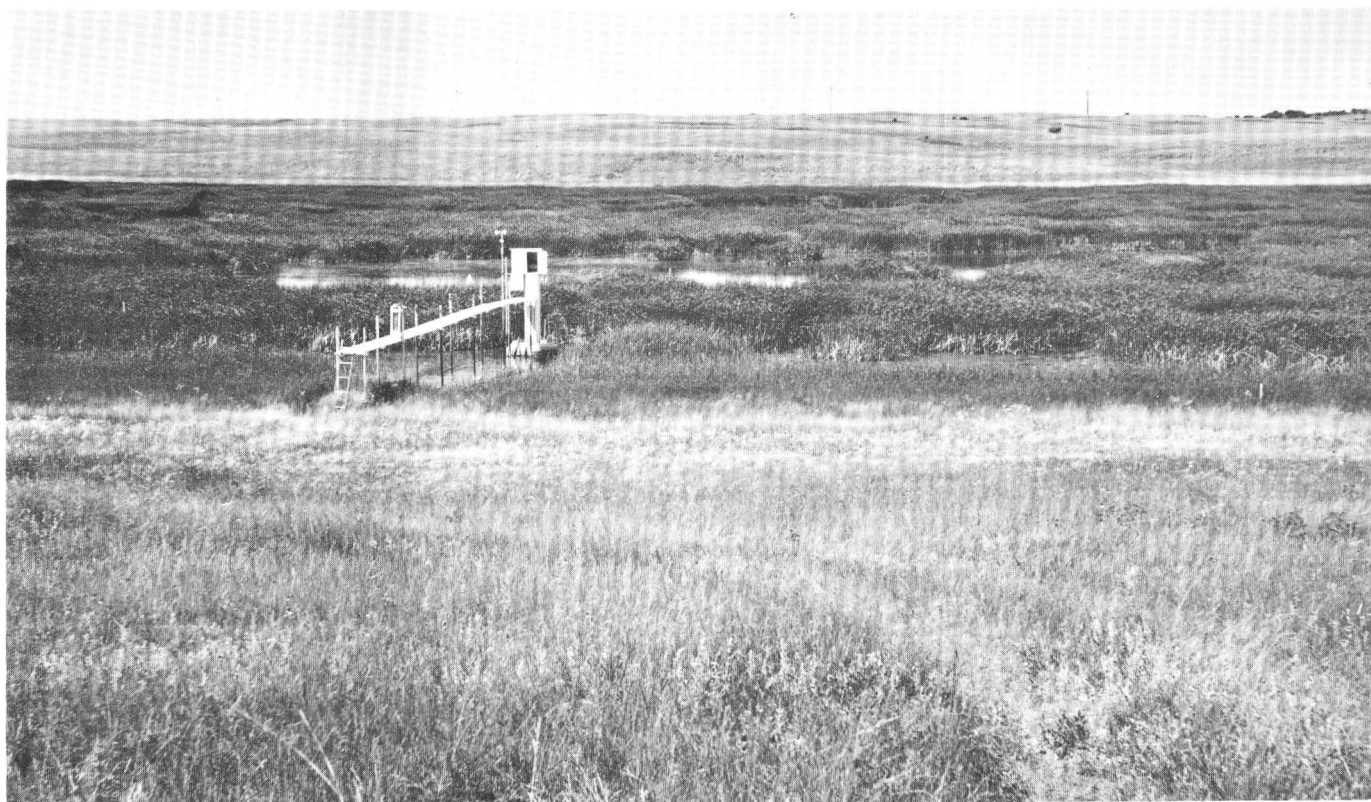
FIGURE 2.—Prairie pothole filled with emergent aquatic vegetation, Ward County, N. Dak. Instruments in foreground are for determining evapotranspiration.

The stilling wells for the water-stage recorders in Ward County were erected in the potholes with access by an elevated walkway (fig. 2). The stilling wells in Dickey County were set in the bank and connected to the pothole by an intake pipe (fig. 4). Neither type was superior to the other. The Ward County installations were subject to large frost heave and did not settle back to a stable position until the end of May, about the same time that the

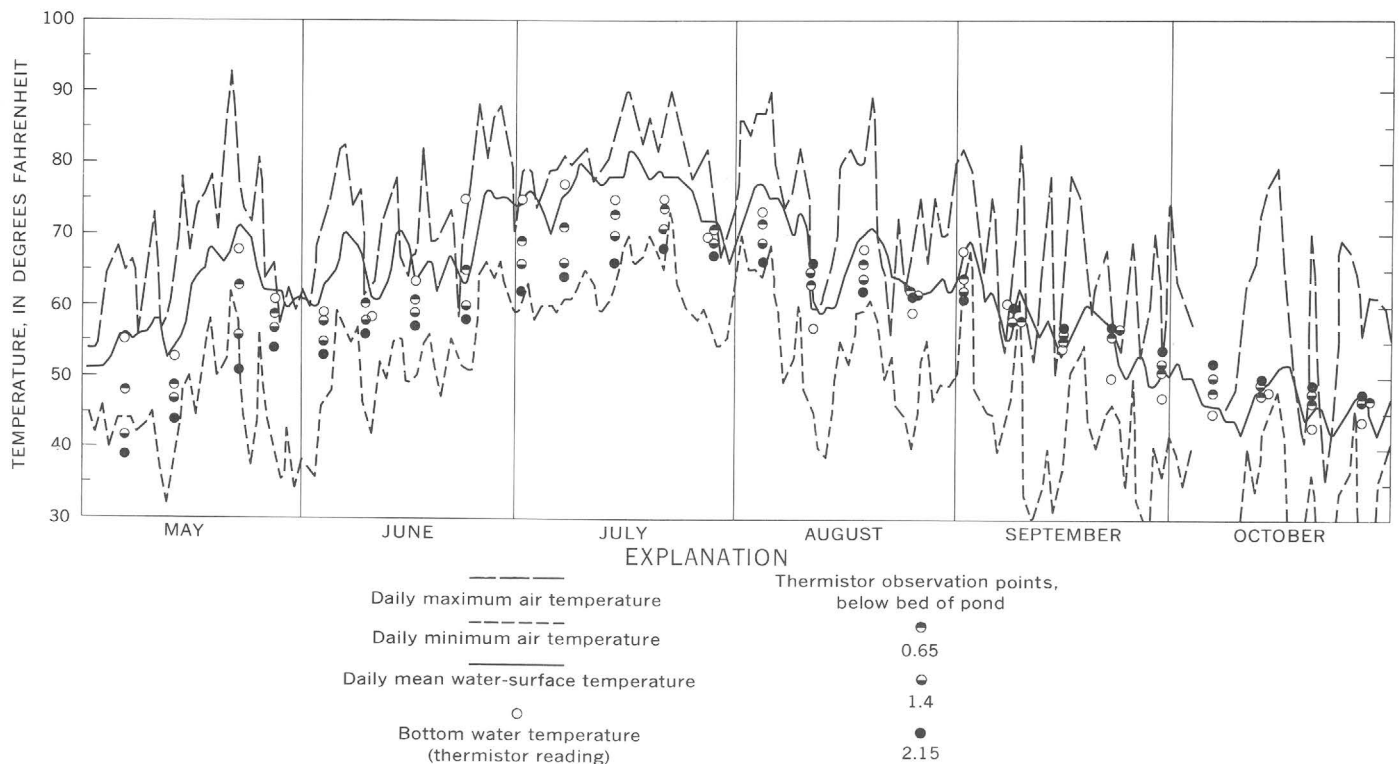
FIGURE 7.—Temperatures at pothole 5, 1964, Dickey County.

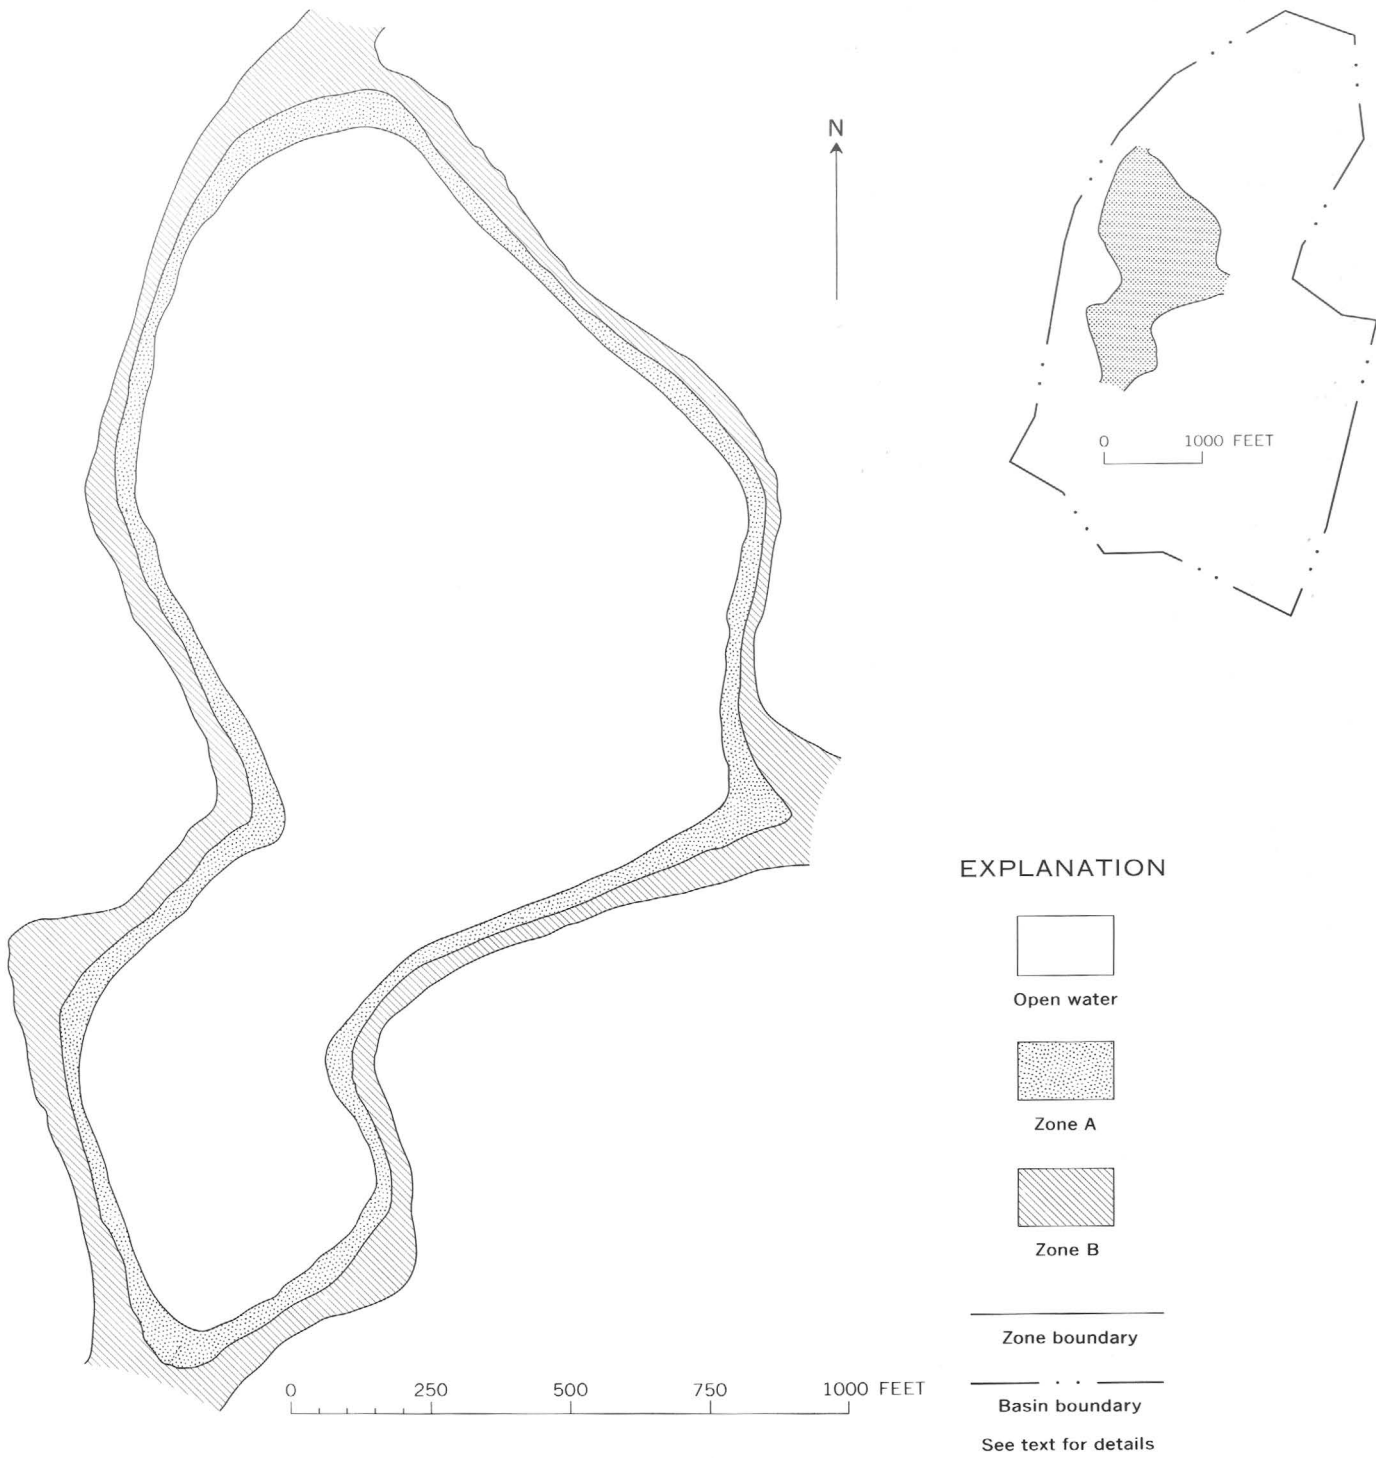
FIGURE 24.—Drainage basin of pothole 3, showing pothole vegetation zones, 1961. Vegetation was mapped by R. E. Stewart. See table 2 for plant names.

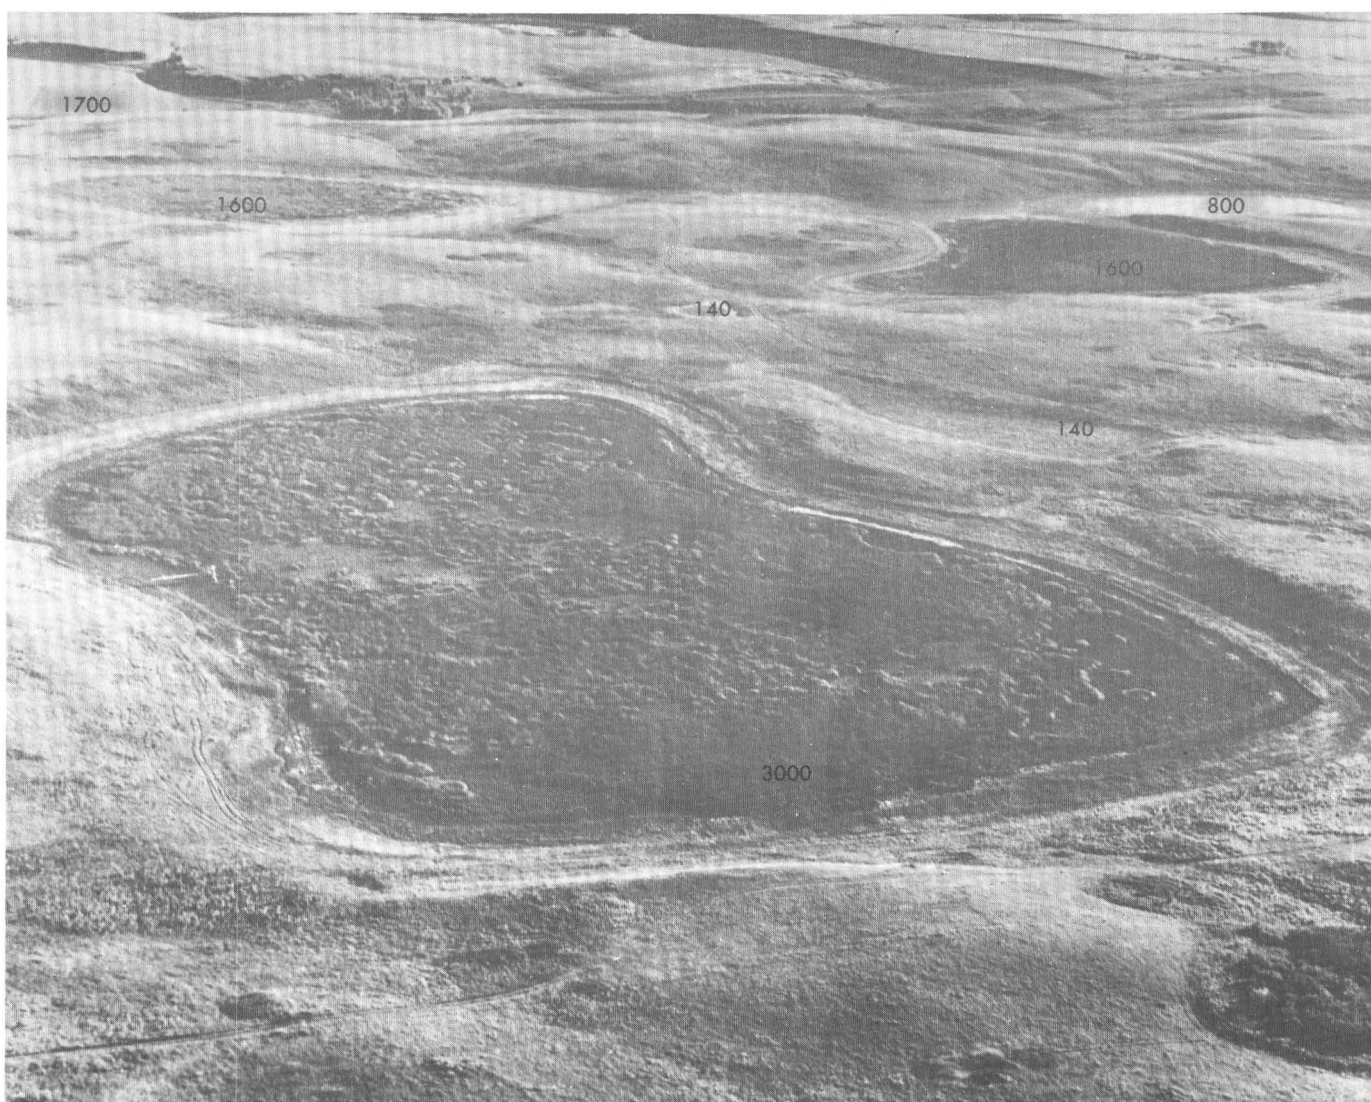
FIGURE 26.—Aerial view of pothole 4, viewed toward the south-southwest. Numbers on potholes indicate specific conductances, in micromhos per centimeter, measured June 11, 1963. Photograph by W. P. Sebens, September 1961.

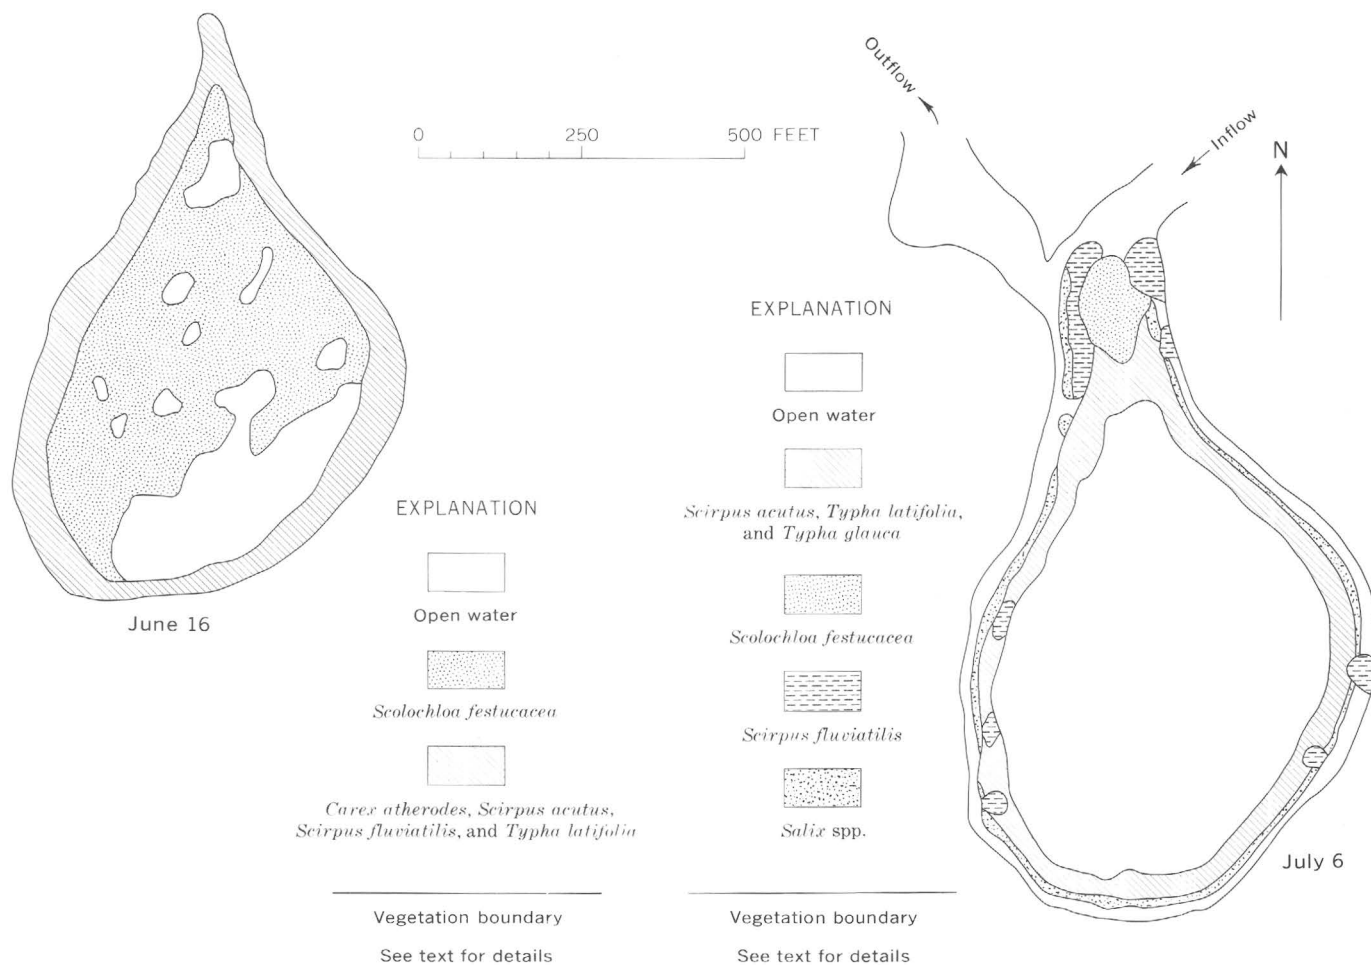
FIGURE 44.—Changes in vegetation from June 16 to July 6, 1964, in pothole 6. Vegetation was mapped by L. F. Lautenschlager.

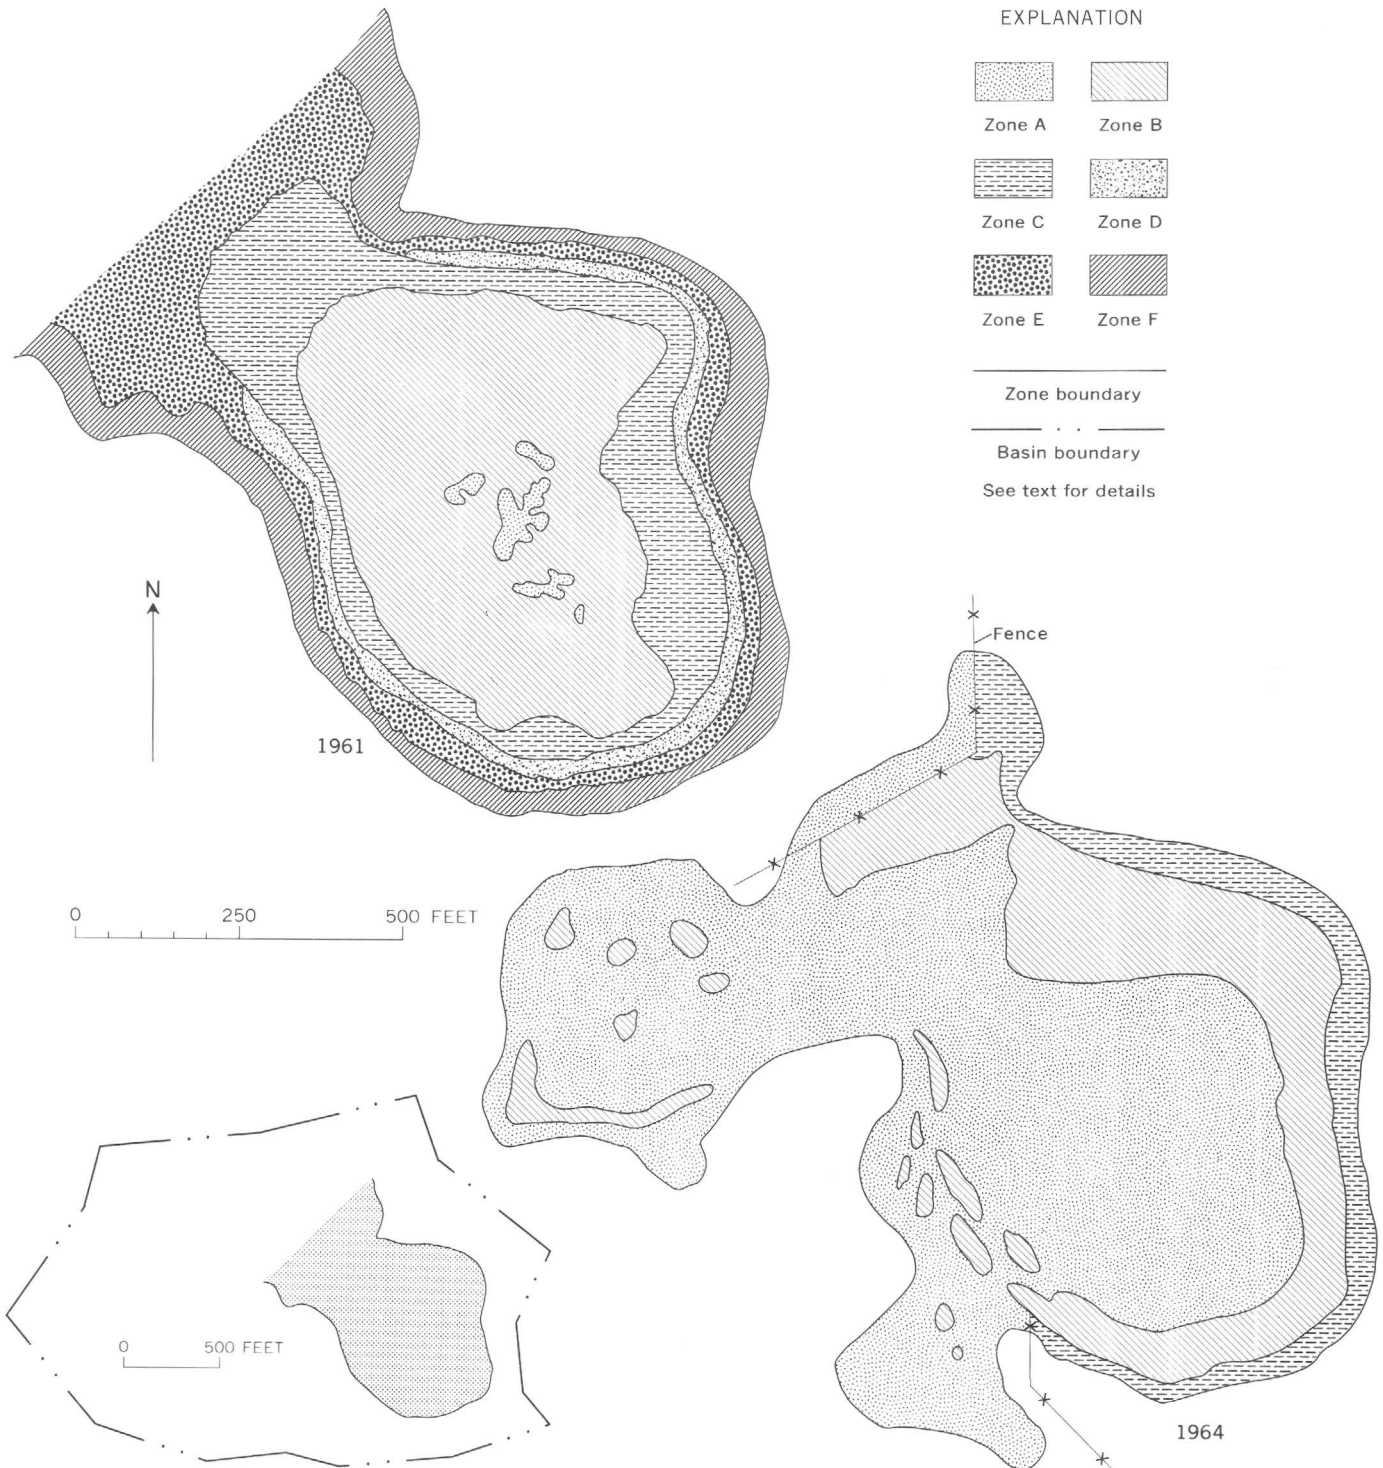
FIGURE 49.—Drainage basin of pothole 7, showing vegetation zones in 1961 and 1964. Vegetation was mapped by R. E. Stewart.

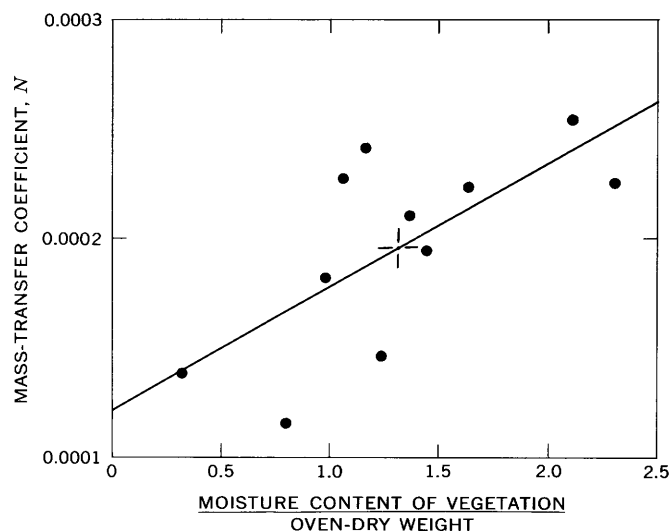
FIGURE 69.—Relation between moisture-content ratio and mass-transfer coefficient for pothole 1, August 3 to October 17, 1966.

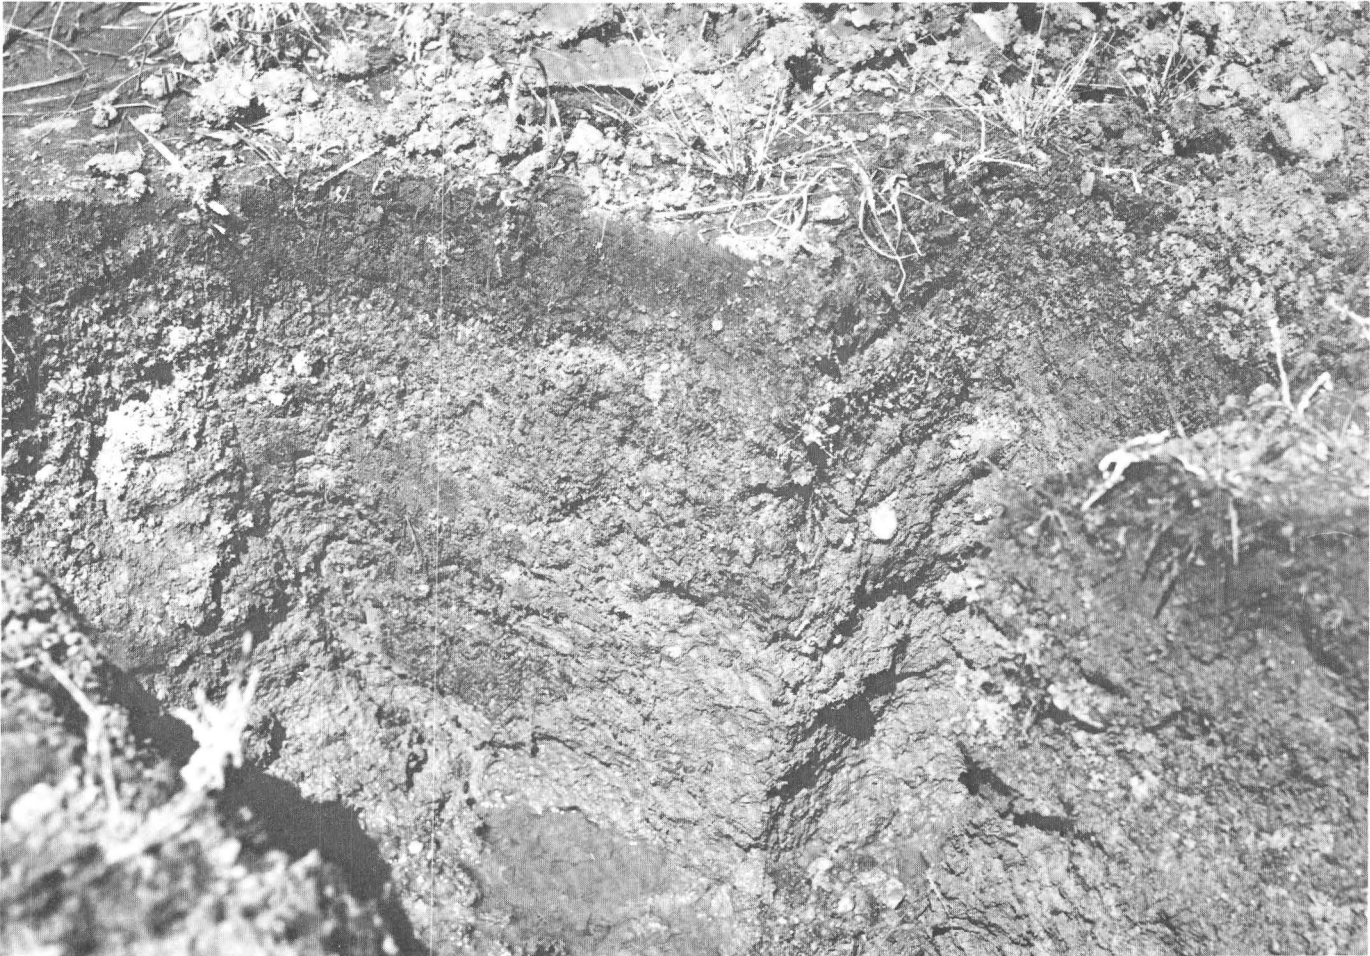
FIGURE 88.—Sample pit at pothole 4, showing gravel layer just below ground surface and white encrustations at ground surface.

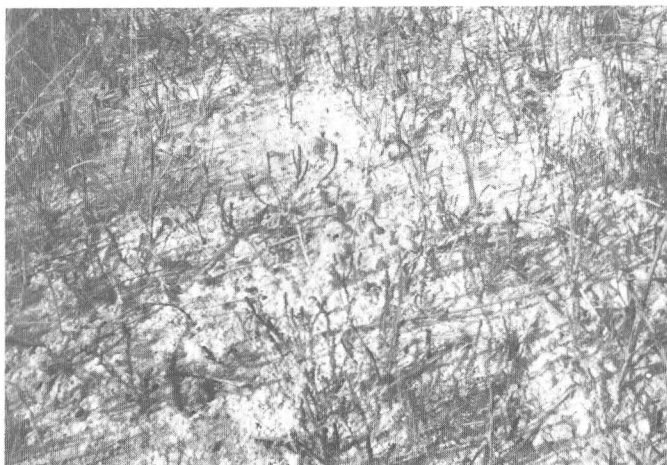
FIGURE 89.—White deposit on shore of pothole 4, left by evaporation of shallow ground water.
