# Evapotranspiration and the Water Budget of Prairie Potholes in North Dakota

GEOLOGICAL SURVEY PROFESSIONAL PAPER 585-B

By JELMER B. SHJEFLO

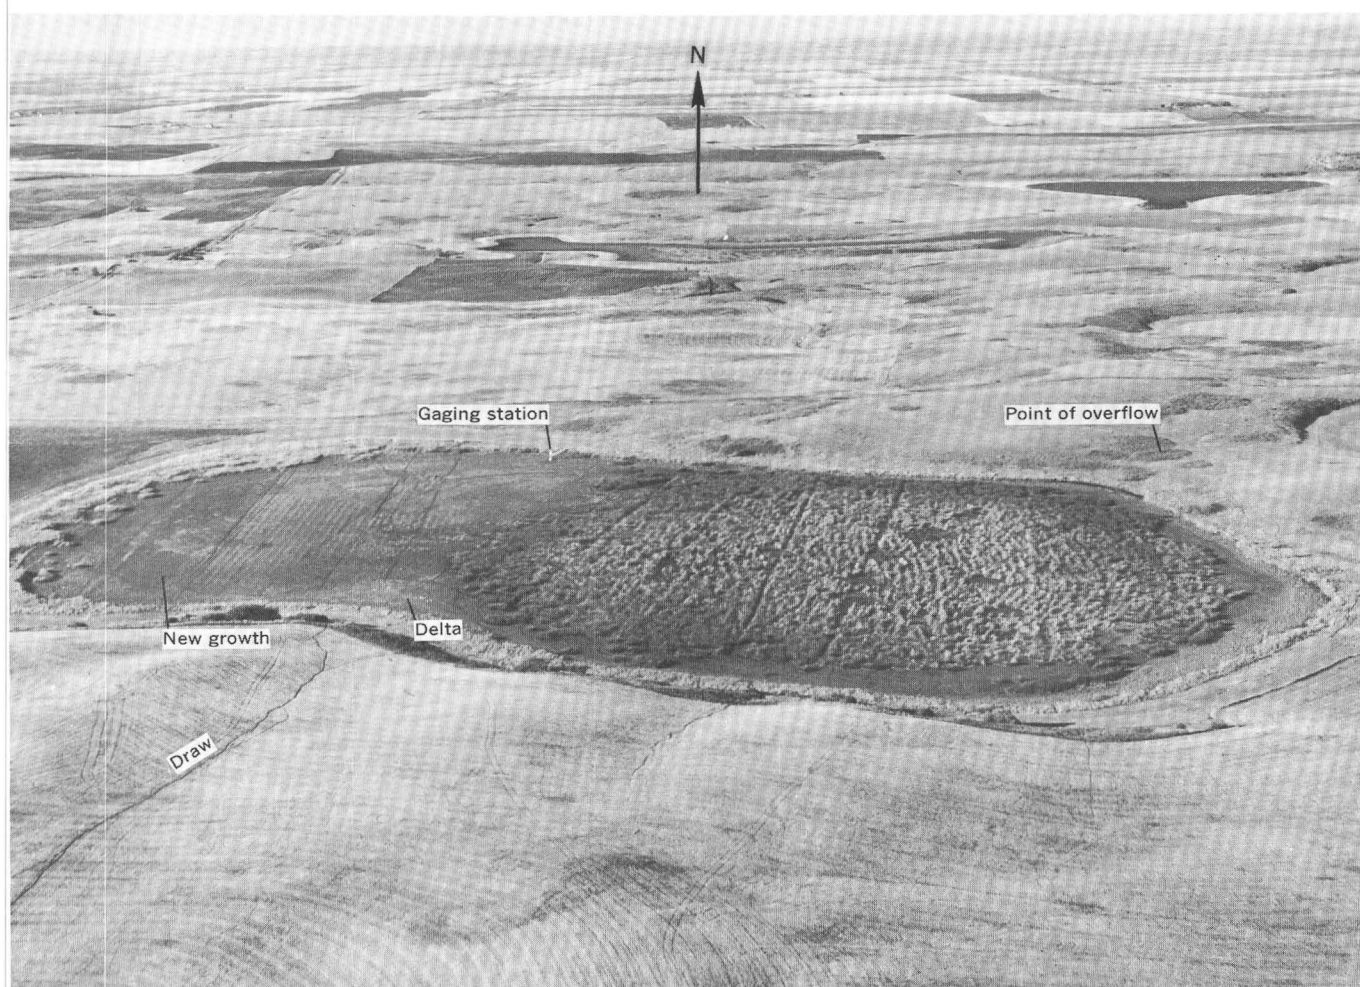
FIGURE 3.—Pothole 2 near Max, N. Dak., September 16, 1961, after it had been dry about 1 month. At low stages, the pothole covered about 30 acres, 18 of which were covered with hardstem bulrush. There was also a ring of cattail and whitetop around the edge. The remaining 12 acres, at the left, stayed clear of vegetation until the fall rains caused cattail seeds to germinate. New growth filled the clear area with plants several inches high before killing frosts occurred. Farming operations during the drought of 1929-39 are clearly indicated by the lines marking the ditches and furrows. There is little evidence of sedimentation, except for the delta on the near side, at the foot of the draw containing a cow trail. The gaging equipment is on the far side of the pothole, and the point of overflow (if any) is in the northeast corner. Photograph by W.P. Sebens, Executive Secretary, North Dakota State Soil Conservation Committee.

with plants several inches high. Pothole 2, shown in figure 3, underwent similar changes.

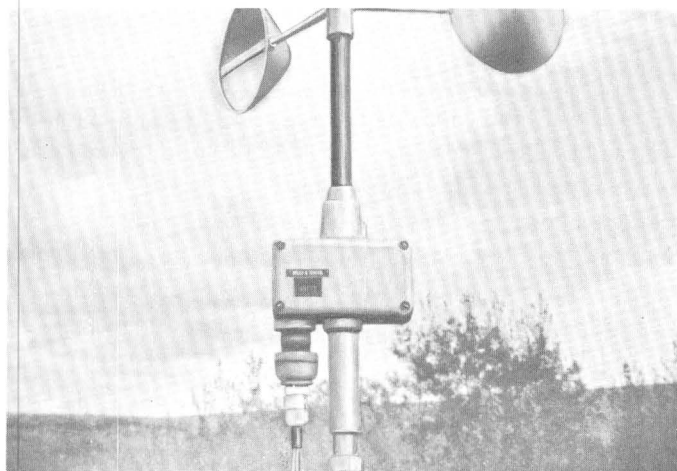
FIGURE 9.—Totalizing anemometer. Photograph by Roger Pewé, September 13, 1965.

Wind movement was measured by a totalizing anemometer, as shown in figure 9. The instrument has three cups, a mechanical counter, and a dial reading to the nearest one-tenth of a mile. The dial showed the total number of miles of wind movement that had passed the gage. At the end of each 10 miles of wind movement, a switch would close and cause a pen on the right margin of the record chart to make a pip. The anemometer was

The anemometers performed very well during the period. Occasionally one of the mechanical counters would become stuck and need replacing. Sometimes the counter could be repaired by replacing the "tenths" wheel. Sometimes the ball bearing at the lower end of the shaft would wear flat on one side and need replacing.

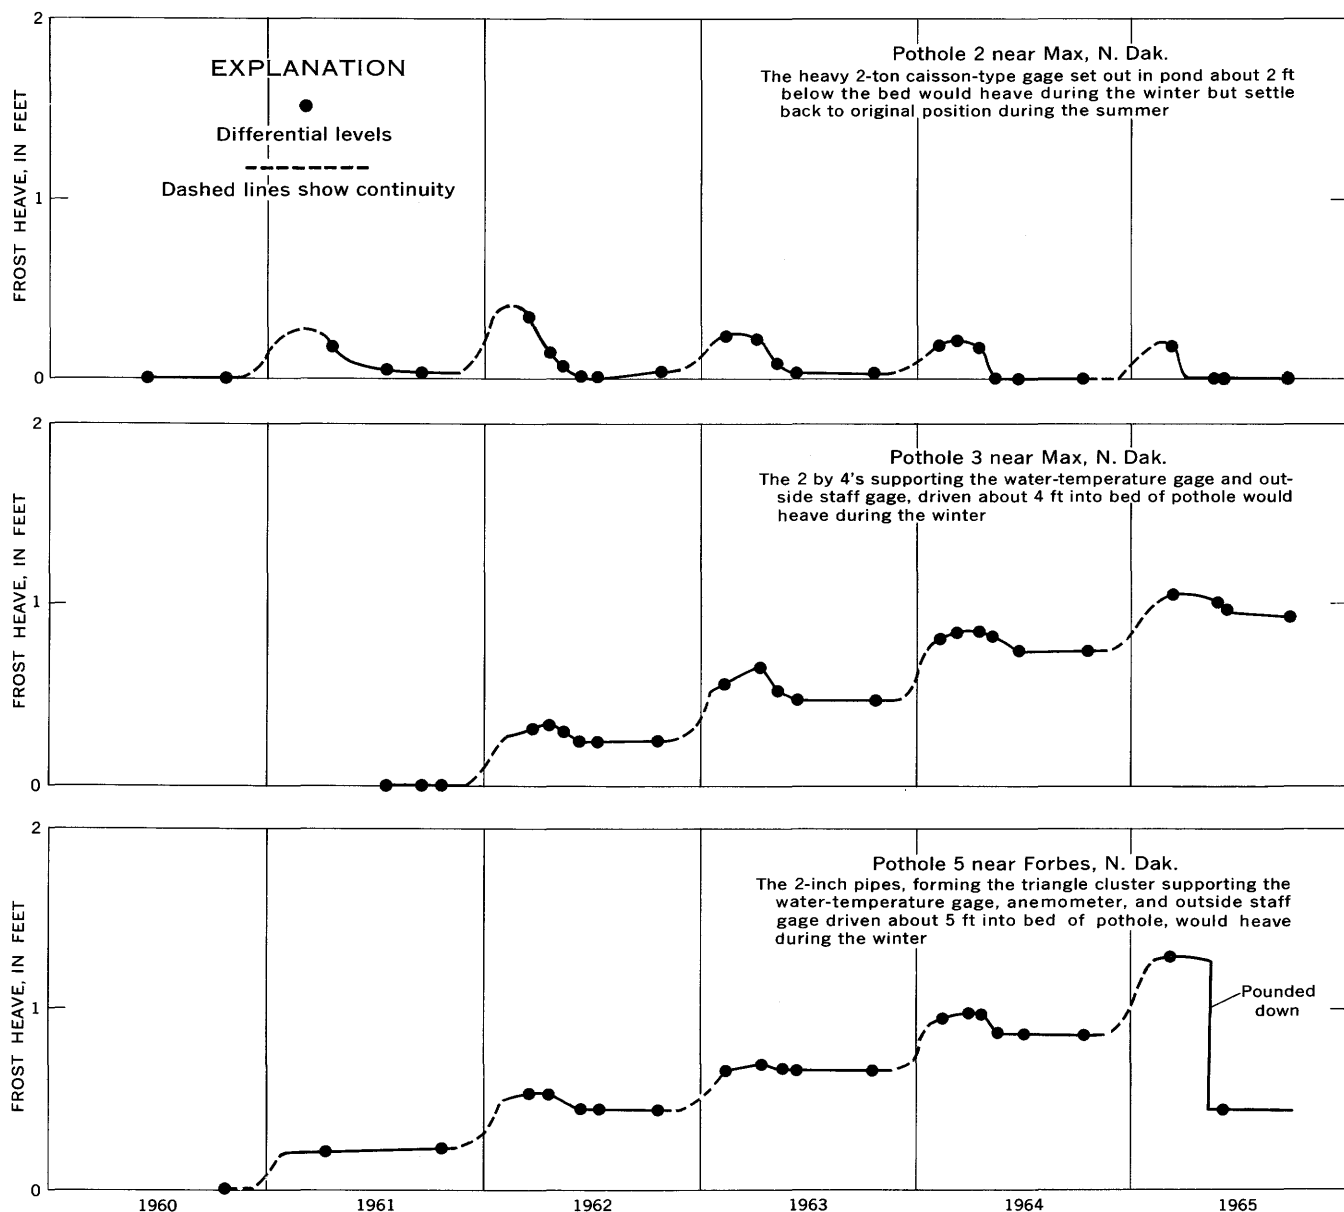
FIGURE 12.—Frost heave for gages of different construction.

Because the heavy gages settled back to their original positions and the deeply set 2-inch pipes beside them did not move appreciably, it became obvious that by placing an index pointer on the nearby pipe and obtaining the difference in elevation between the gage well and the pipe each week, the amount of settling of the gage well could be roughly observed, as shown in figure 13. These weekly measurements are plotted in figure 13 along with the results of the monthly differential leveling, and agreement is very good. These readings helped to define more closely the proper distribution of the datum corrections applicable during this period when rate of change was the greatest.

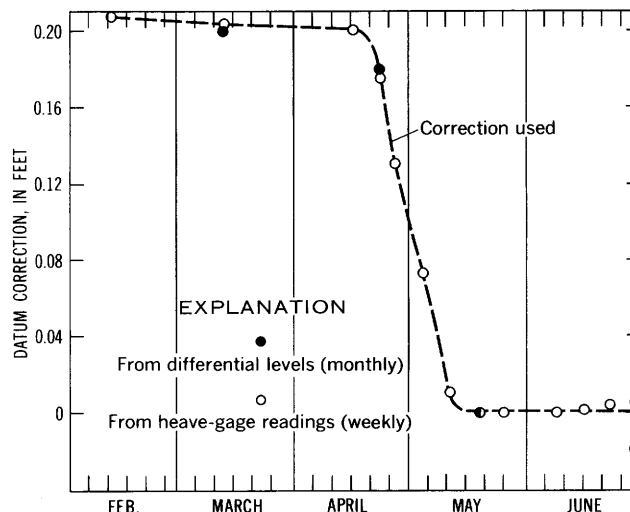
FIGURE 13.—Rate of settlement of the heavy 2-ton gage at pothole 2 during the spring of 1964.

To get more detailed information on the settling rate of these heavy gages, intensive leveling was attempted on May 6 and 7, 1963. An accurate gage-height record was needed to compute an *N* value during May because the settlement of the gage was greater than the water loss during certain periods, and these quantities had to be separated. The plan was to alternate level runs among the four gages in Ward County and measure the amount of settlement continuously for several days. The project was abandoned on the second day when the wind became so strong that the level rod could not be read accurately. A rain (0.16 in.) the first evening at pothole 4 also interfered because it eliminated May 6 and possibly May 7 from being used in the determination of *N*. The datum corrections found to be applicable as a result of this survey are shown in the following table.

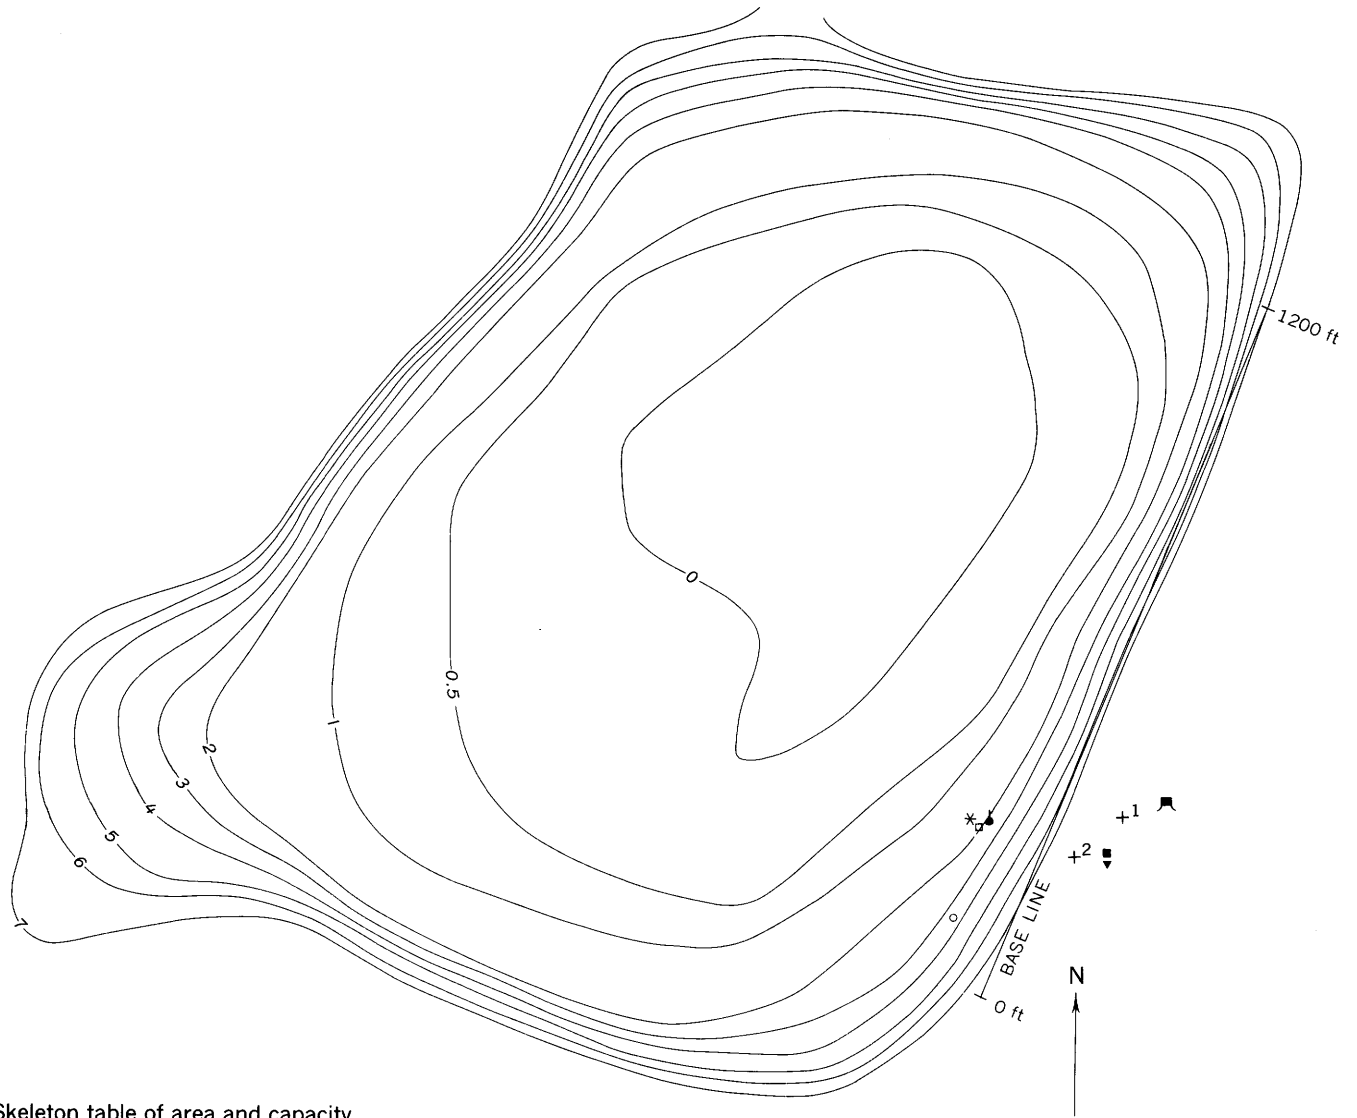
FIGURE 22.—Contour map for pothole C-1 with skeleton table of area and capacity.

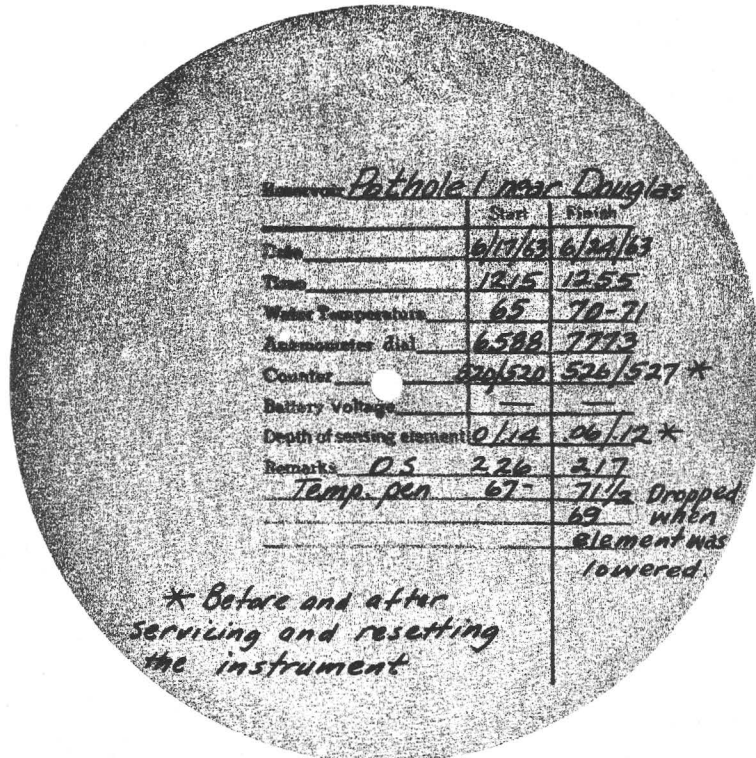
FIGURE 37.—Thermograph chart showing the diurnal fluctuation of water temperature.
