MAPS AND AERIAL PHOTOGRAPHS SHOWING CHANNEL CHANGES  
OF THE GILA RIVER NEAR PIMA, ARIZONA

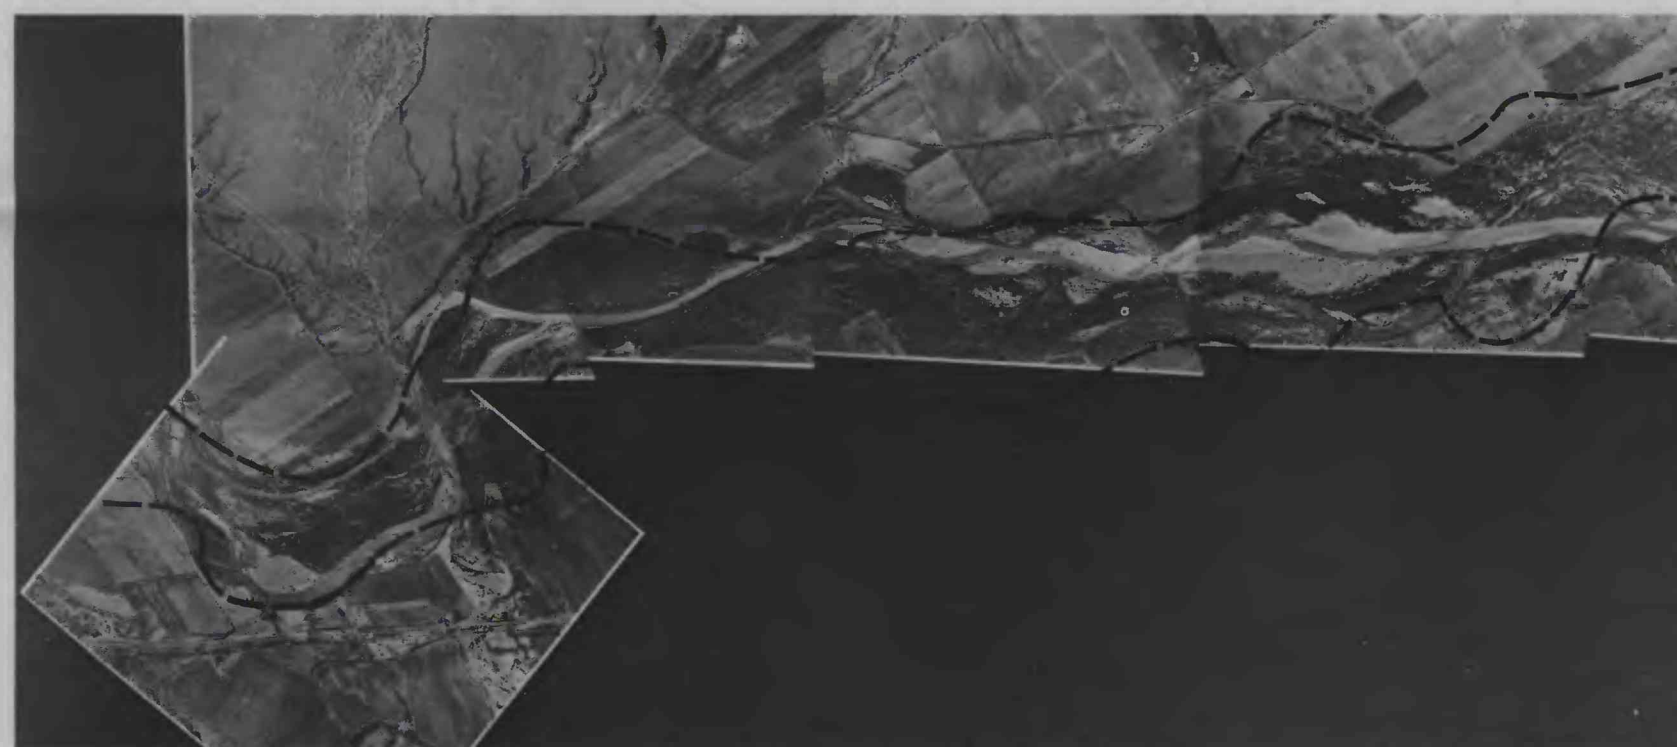
1943

The major widening of the stream channel from 1903 to 1914 was caused mainly by the major winter floods of 1905 and 1906 (p. 3). The widening during 1959-66 was caused mainly by the flood of December 1965; further widening was caused by the flood of August 1967. The maps for 1875 and 1919 are from cadastral surveys and are in the files of the U.S. Bureau of Land Management, Phoenix. The map for 1903 is from a soil survey by Lapham and Neill (1904), and the map for 1915 is from the files of the U.S. Bureau of Indian Affairs, Phoenix. The aerial photographs are from the files of the U.S. Geological Survey, Tucson.
