PHOTOGRAPHS AND GRAPH SHOWING DEVELOPMENT OF THE ALLUVIAL FAN  
AT THE MOUTH OF A TRIBUTARY TO THE GILA RIVER

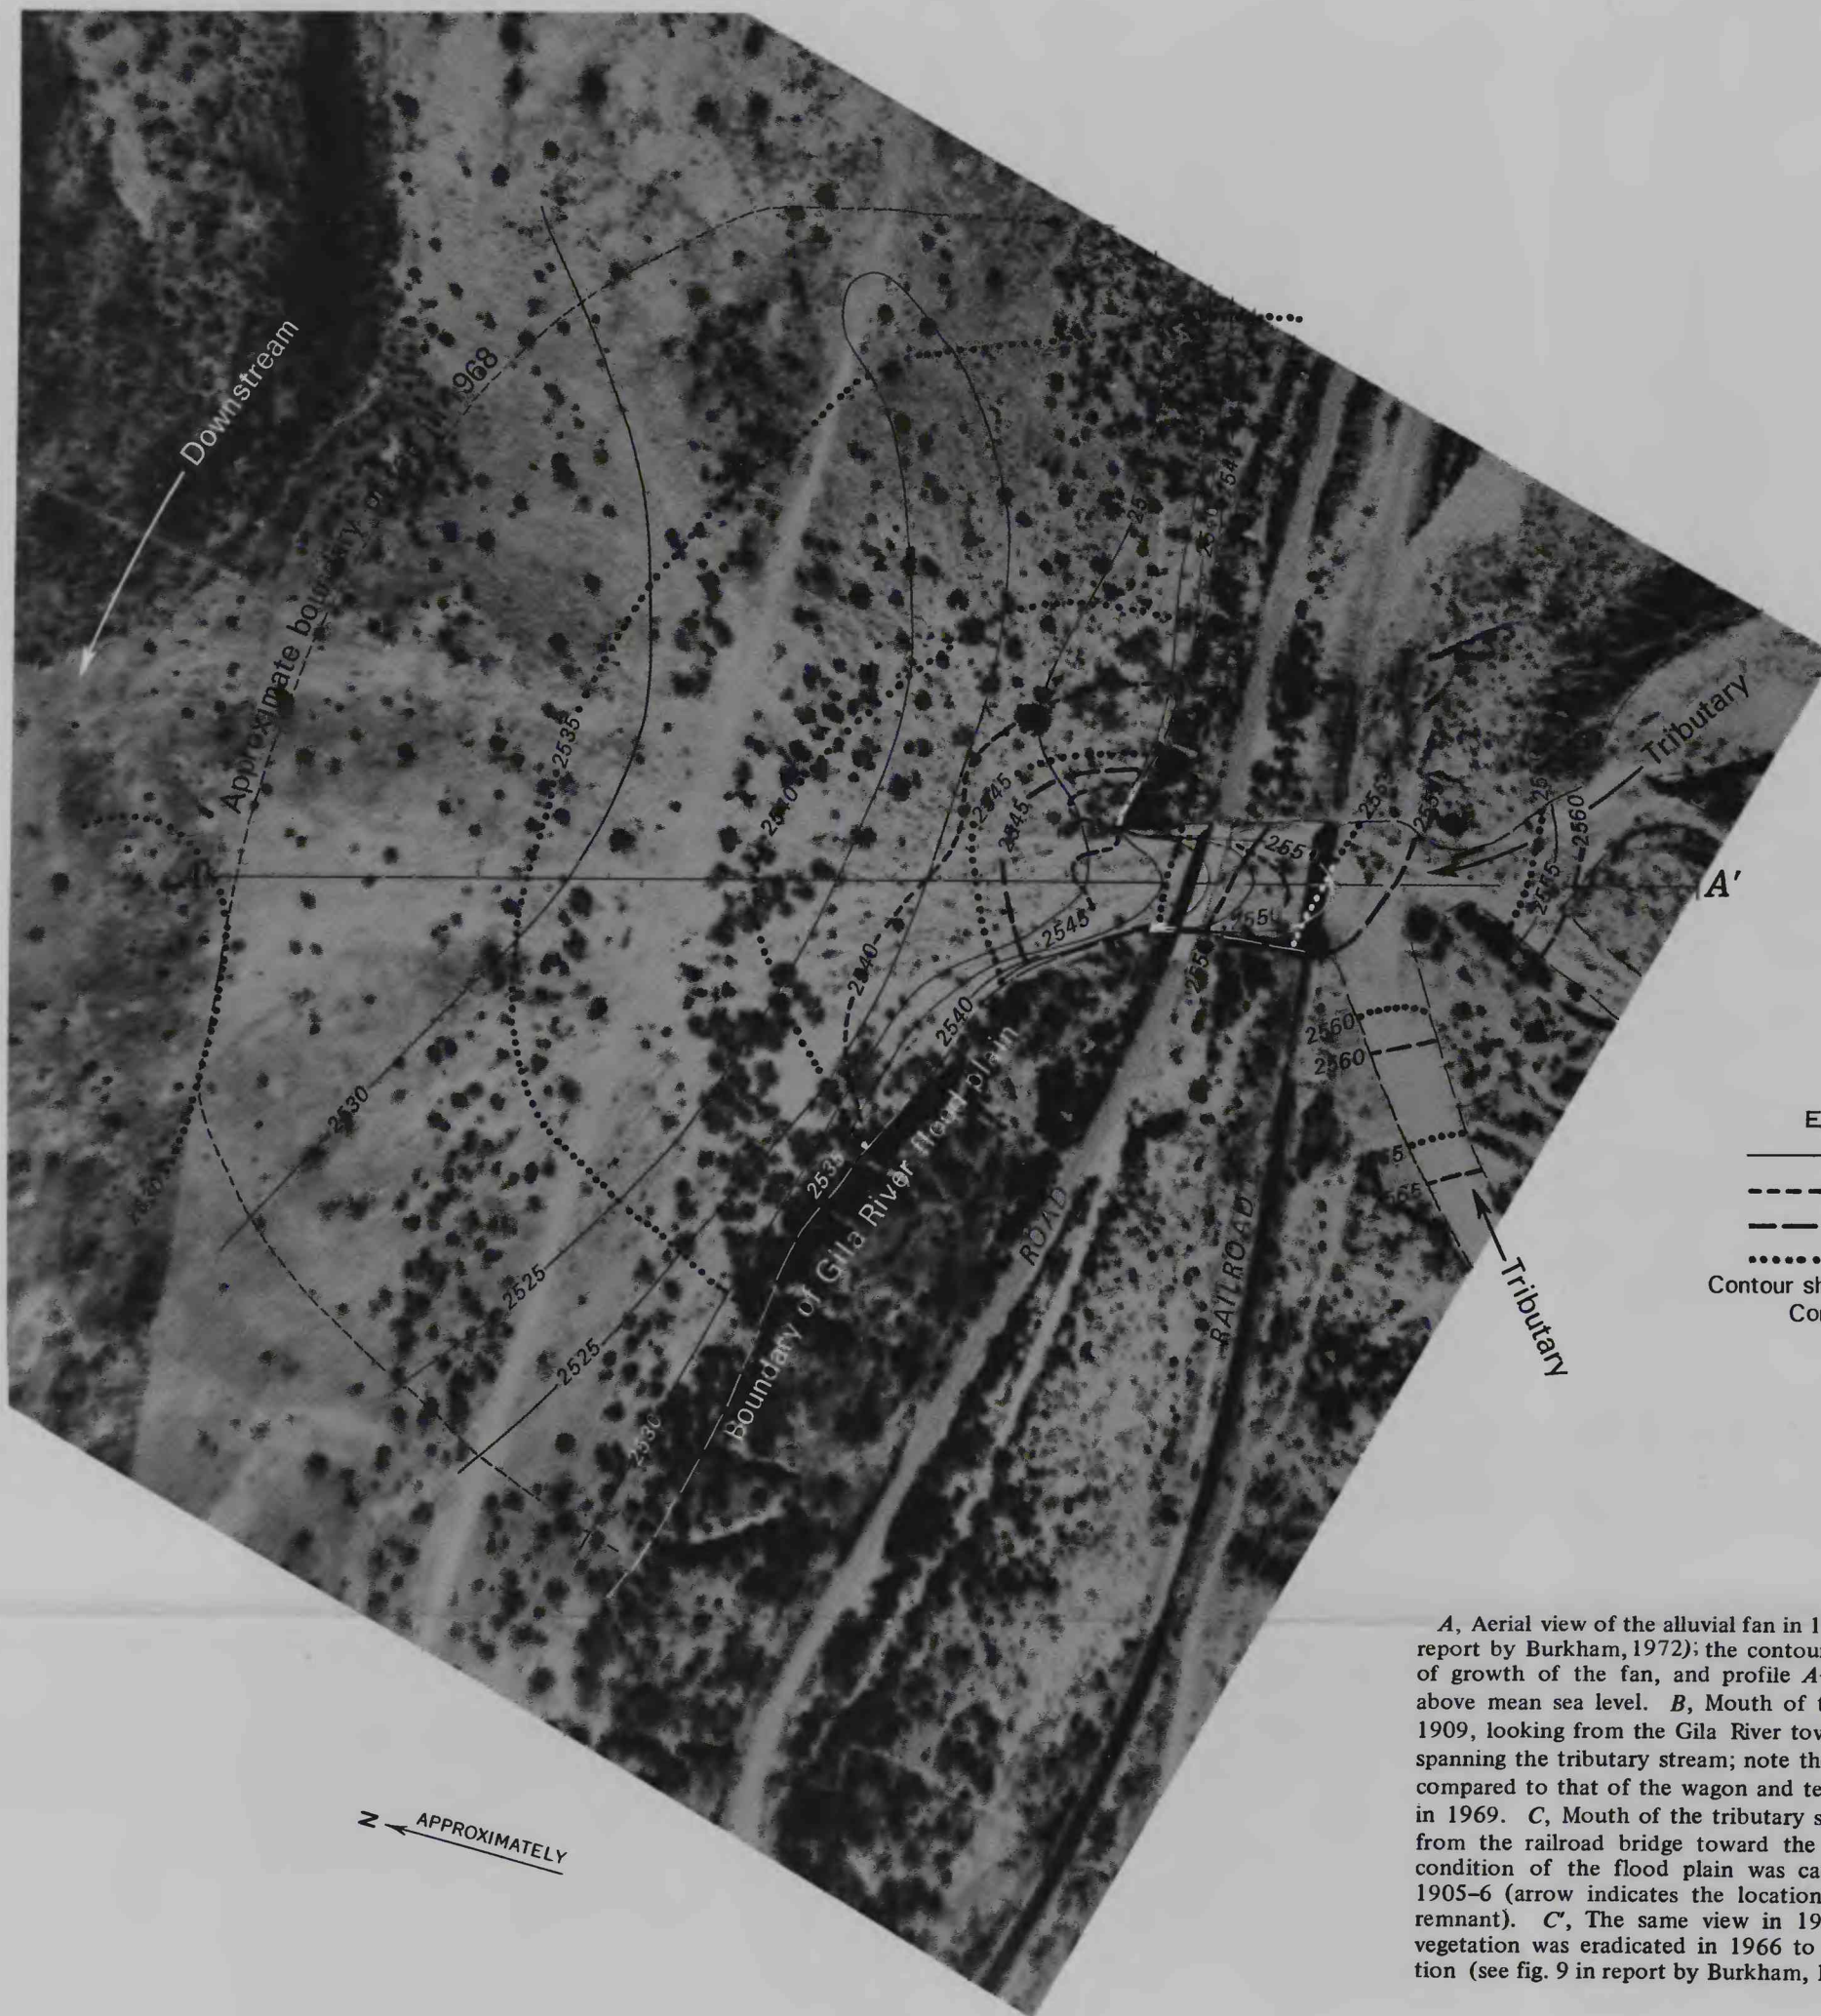
EXPLANATION  
 ——— 1914 ———  
 - - - - 1947 - - - -  
 - - - - 1964 - - - -  
 ..... 1968 .....  
 Contour shows rate of growth of fan  
 Contour interval 5 feet

A. Aerial view of the alluvial fan in 1964 (see figs. 2 and 9 in report by Burkhani, 1972); the contour lines illustrate the rate of growth of the fan, and profile A-A' shows the altitude above mean sea level. B. Mouth of the tributary stream in 1909, looking from the Gila River toward the railroad bridge spanning the tributary stream; note the height of the banks as compared to that of the wagon and team. B', The same view in 1969. C. Mouth of the tributary stream in 1909, looking from the railroad bridge toward the Gila River; the barren condition of the flood plain was caused by the floods of 1905-6 (arrow indicates the location of an old flood-plain remnant). C', The same view in 1969. The bottom-land vegetation was eradicated in 1966 to control evapotranspiration (see fig. 9 in report by Burkhani, 1972).
