1989-AFHS

Site 1-7

Tonsina Bay - NW

ASC NUMBER: 232-10-10342 SEGMENT NUMBER: TB-03 YR CATALOGED:
 LOCATION: TONSINA BAY- HEAD of Bay-NW portion
 STREAM NAME: TONSINA NW Creek LATITUDE: 59 18 37
 KODIAK K-UNIT: LOCAL STREAM #: LONGITUDE: 150 57 06
 USGS QUADRANGLE: Seldovia B-3 LEGAL: S 10S 10W15
 SHORELINE TYPE: BEACH, COVE, tide flats ALL SEGMENTS:
 WAVE EXPOSURE: Low

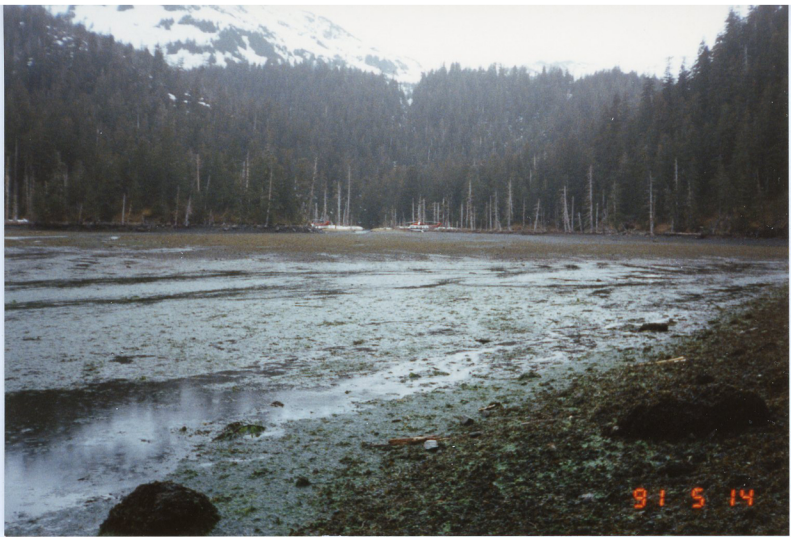
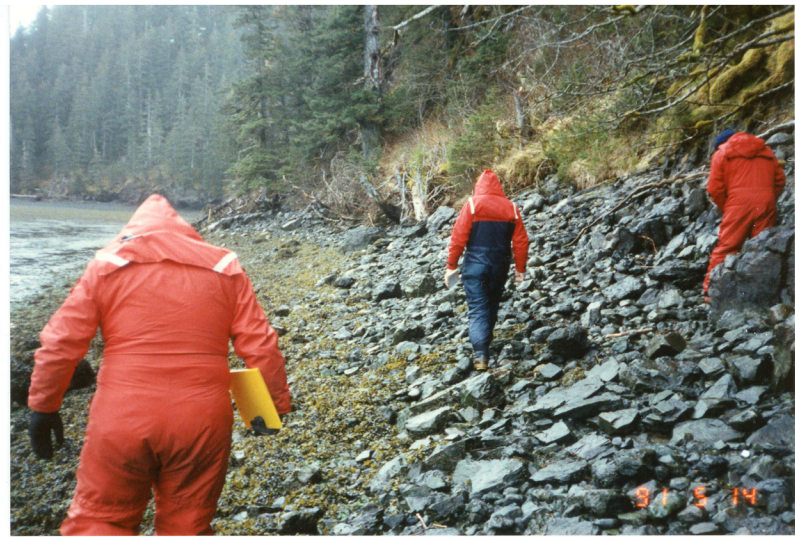
Date: 5/14/91 No. 901
Title: TB003A

Segment No TB-3 Subdivision A
Date 5/14/91 Log Frame No 3
Photographer GARY SHIGENAKA
Location TONSINA BAY
Comments MOUSSE IN COBBLE, EASTERN SHORELINE

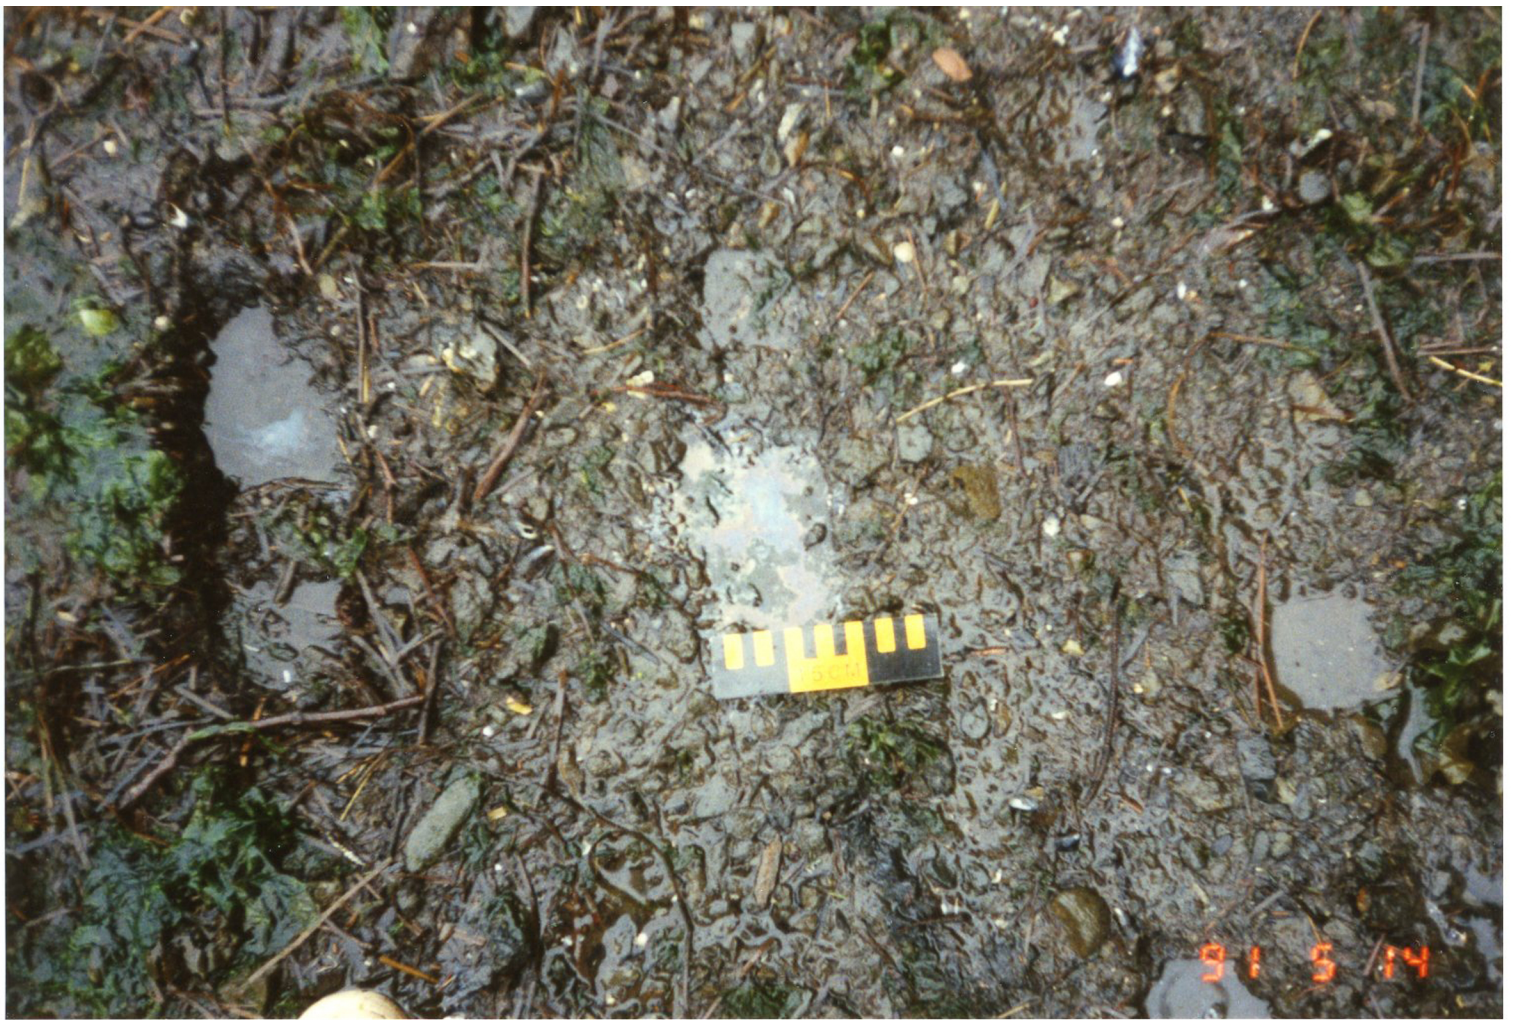
Segment No TB-3 Subdivision A
Date 5/14/91 Log Frame No 4
Photographer GARY SHIGENAKA
Location TONSINA BAY
Comments SHEEN IN BOOTPRINT, IN TIDAL FLAT
AT THE BASE OF RUBBLE SHORELINE, EASTERN
SHORE.

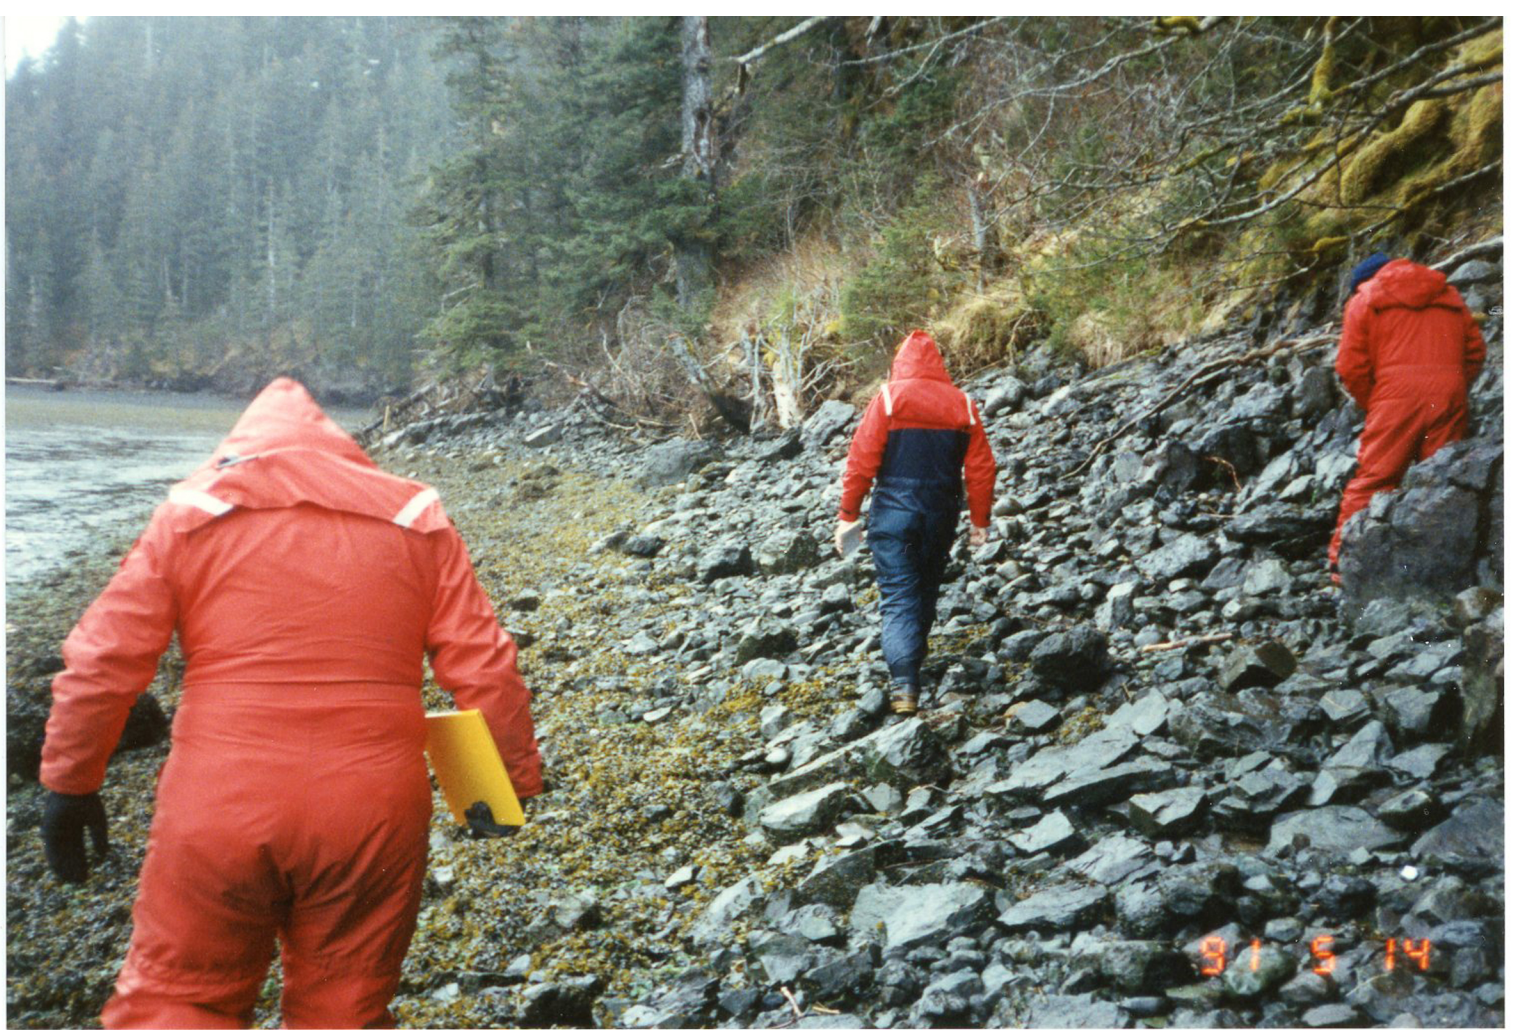
Segment No TB-3 Subdivision A
Date 5/14/91 Log Frame No 2
Photographer GARY SHIGENAKA
Location TONSINA BAY
Comments VIEW FROM SAME LOCATION AS #1, PIVOTED
CLOCKWISE TO A NORTH-NORTHEAST ORIENTATION.

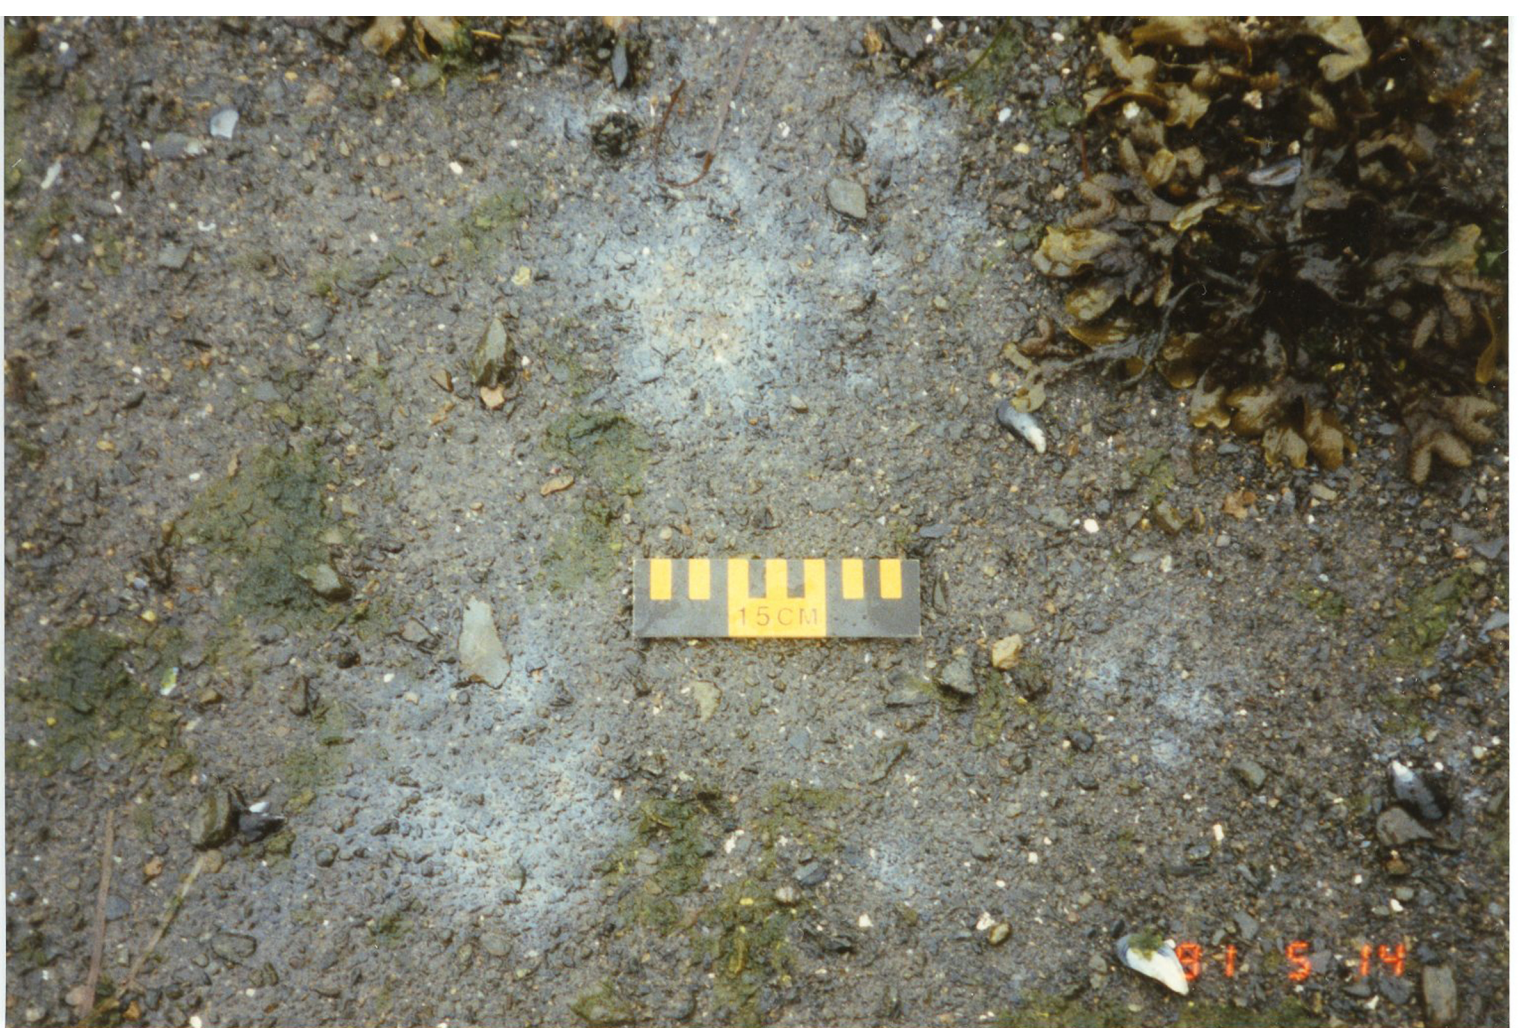
Segment No TB-3 Subdivision A
Date 5/14/91 Log Frame No 8
Photographer GARY SHIGENAKA
Location TONSINA BAY
Comments SHEEN ON THE SURFACE OF THE TIDAL
FLAT
