ADF&G MULTI-ASSESSMENT FORM
1991 GENERAL ENTRY CHECKLIST

LOCATION: NUKA ISLAND, SOUTH END, 1 M NORTH OF NUKA POINT

FISH HABITAT ASSESSMENT FORM

Nuka Island - Southern tip / Nuka Pt. Area

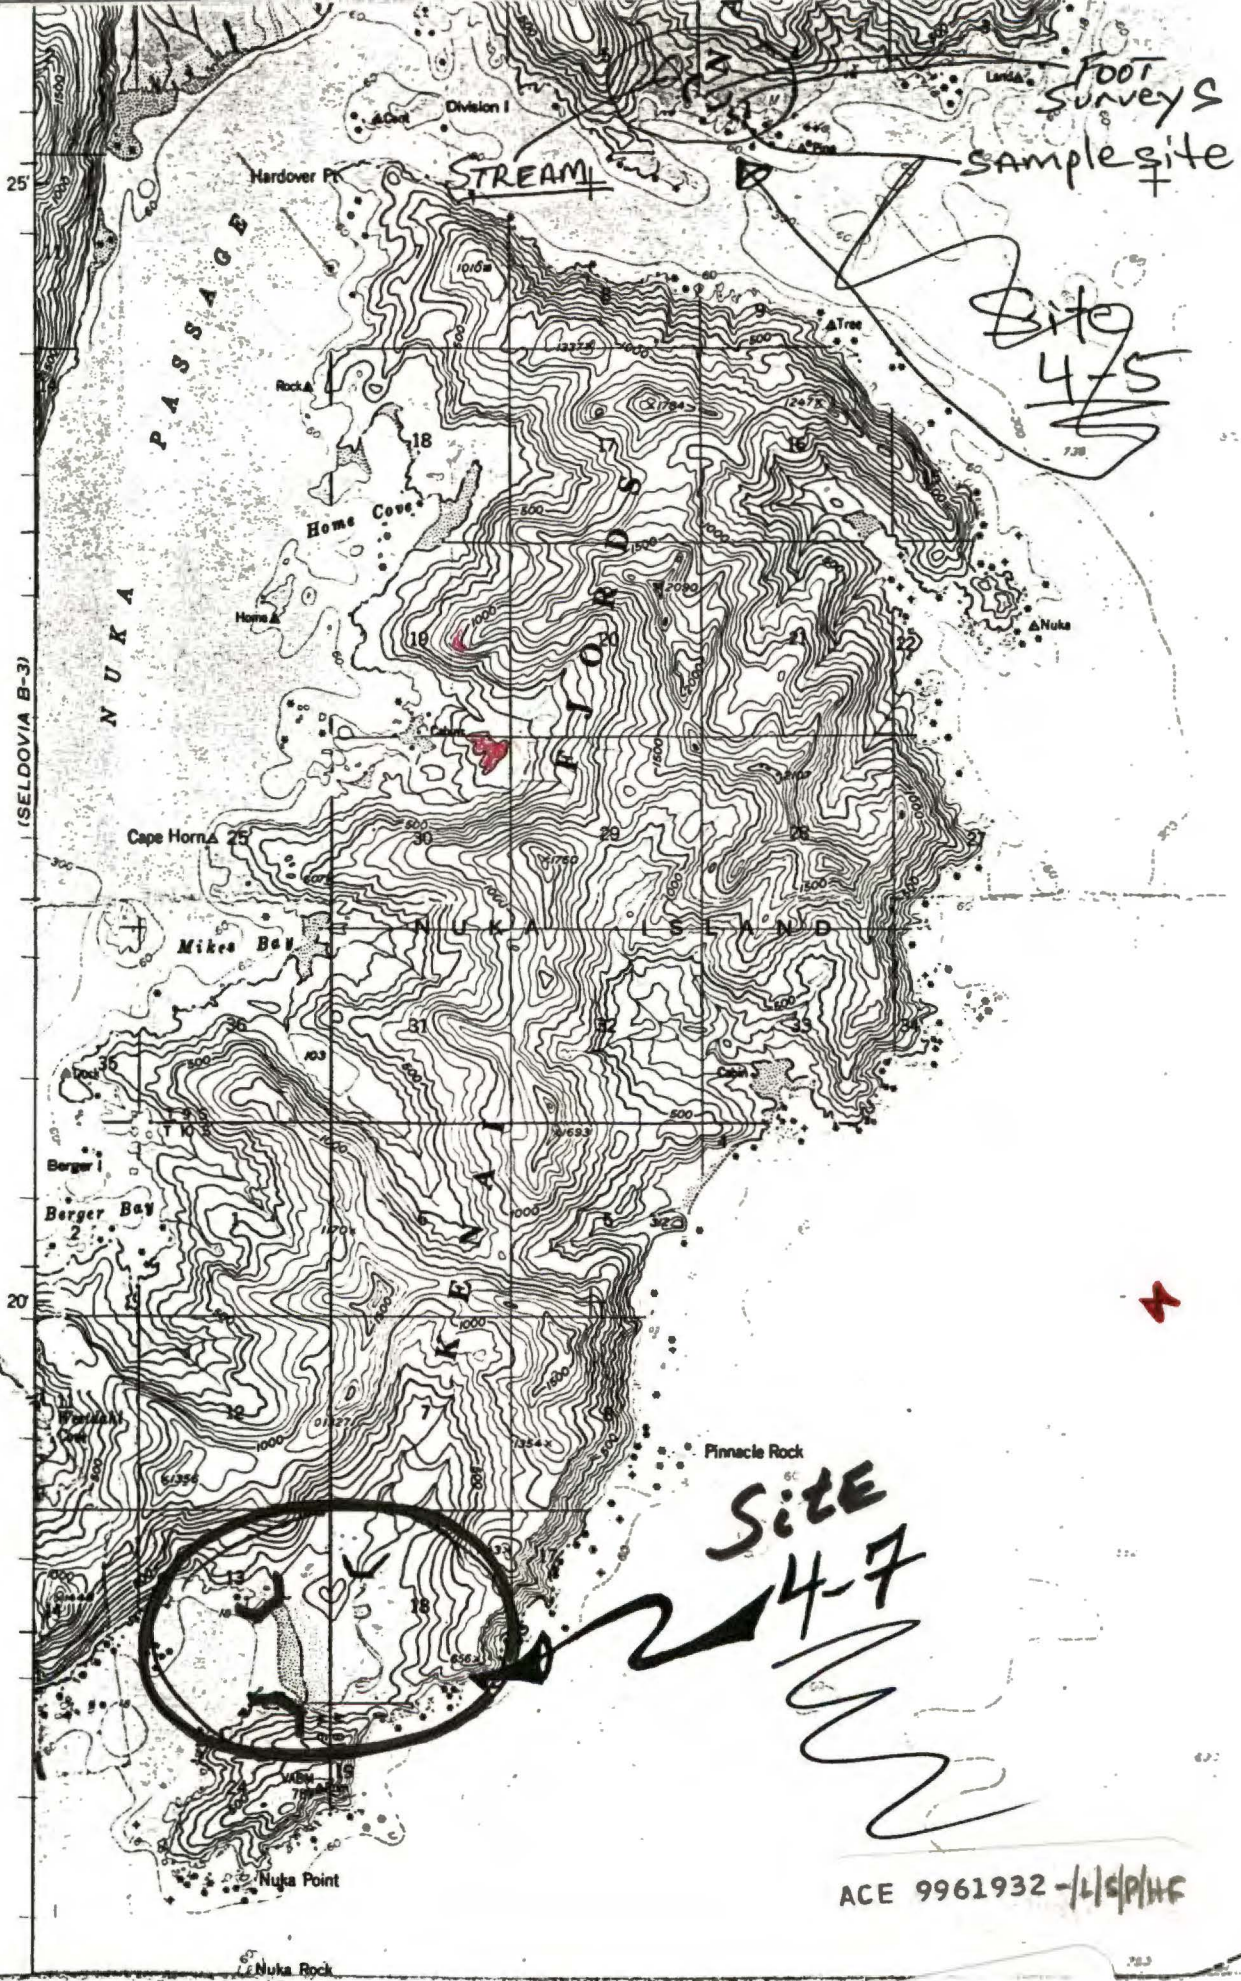
SELDOVIA
B-2

Foot surveys
sample site

Site
4/5

Site
4-7
