FIELD SHORELINE COMMENT SHEET

SEGMENT ST / NK 01 SUBDIVISION: A DATE 4/7/00

ASC NUMBER: 232-21-10230  
 LOCATION: KPOC, Nuka Island, Northeast Cove  
 STREAM NAME: \_\_\_\_\_  
 KODIAK K-UNIT: \_\_\_\_\_ LOCAL STREAM #: \_\_\_\_\_  
 6S QUADRANGLE: Seldovia B-2  
 SHORELINE TYPE: Beach, Cove ALL SEGMENTS: \_\_\_\_\_  
 WAVE EXPOSURE: Moderate

NE NUKA ISLAND COVE

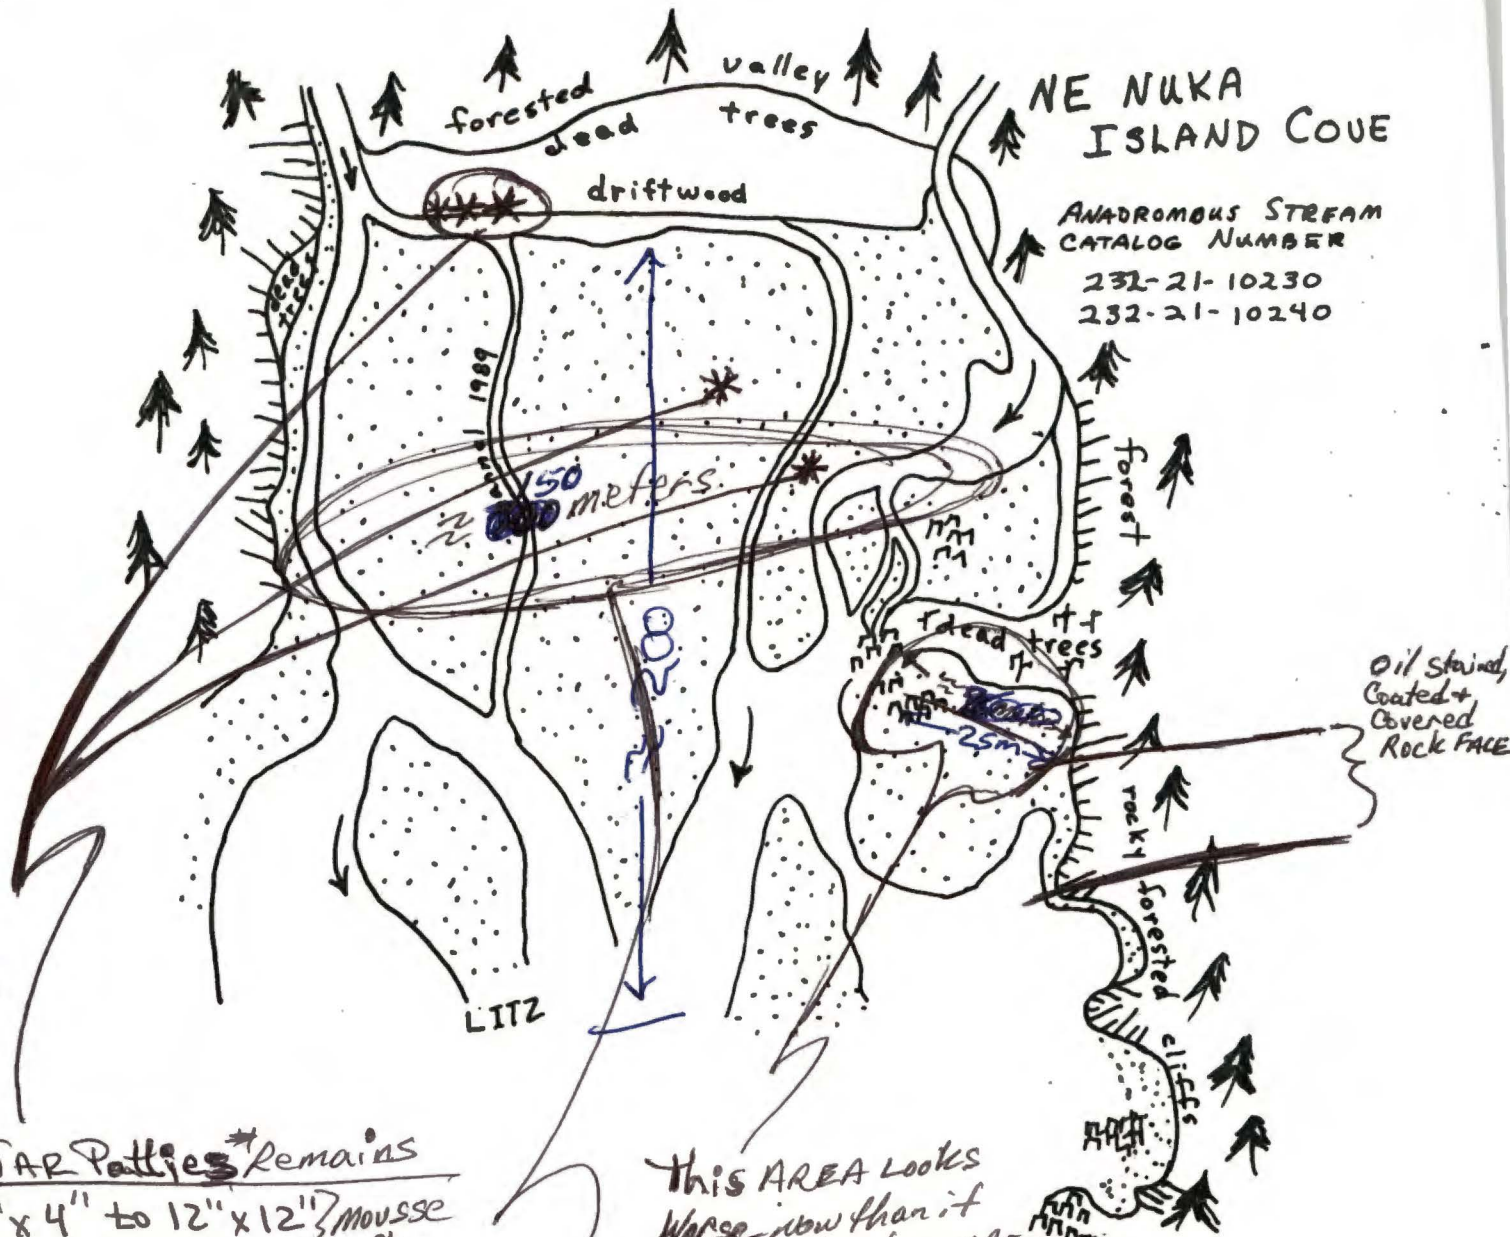
More work obviously needs to be done here. The Kachemak Bay Wilderness Park Ranger's Johnson & McClampbell are disgusted with the quality of the work done here ~~and~~ and feel more needs to be done.

"TAR Patties" Remains  
 24" x 4" to 12" x 12" } Mousse & Sheen  
 4 1/2" ~~at~~ depth

This AREA Looks worse now than it did prior to cleanup - Flowing mousse and sheen present & moving to deeper depth and lower elevations on beach. Heavy sheen on pools & running down beach.

A more hazardous situation for birds & mammals has been created - oil would ~~be~~ easily coat feathers & fur

Either pick the oil up or leave it alone in cases like this.

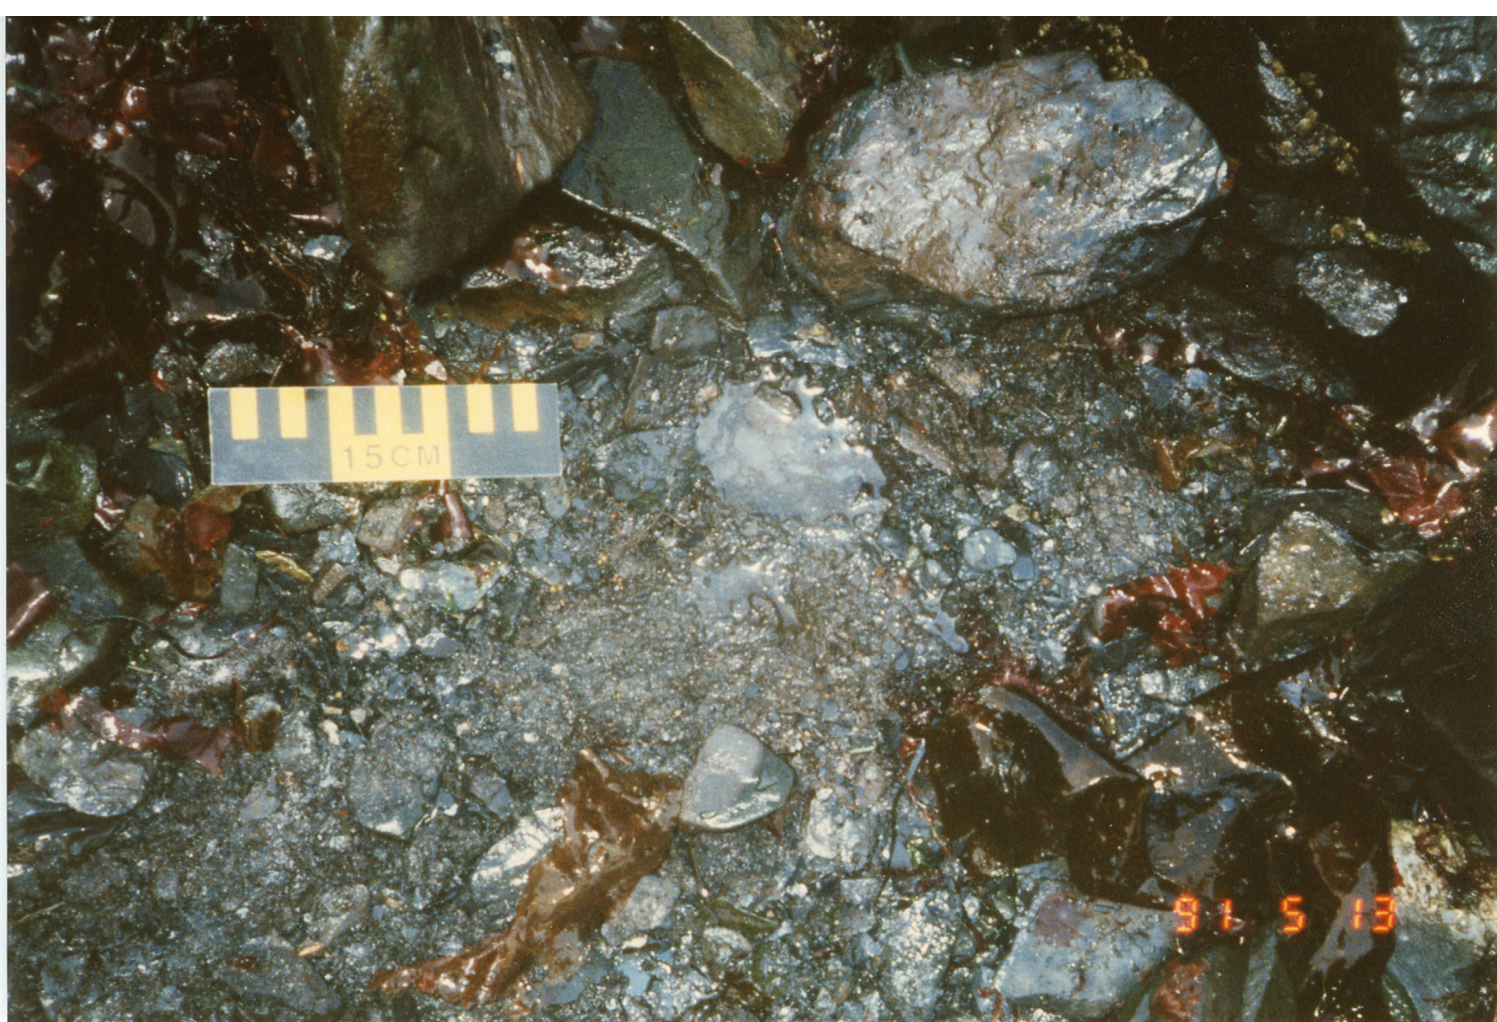
Segment No NK-1 Subdivision A  
Date 5/13/91 Log Frame No 3  
Photographer GARY SHIGENAKA  
Location NUKA ISLAND  
Comments SAME GENERAL AREA AS PHOTOS 1 & 2,  
SHOT OF SHEEN FORMING AFTER COBBLE SUBSTRATE  
OVERTURNED.

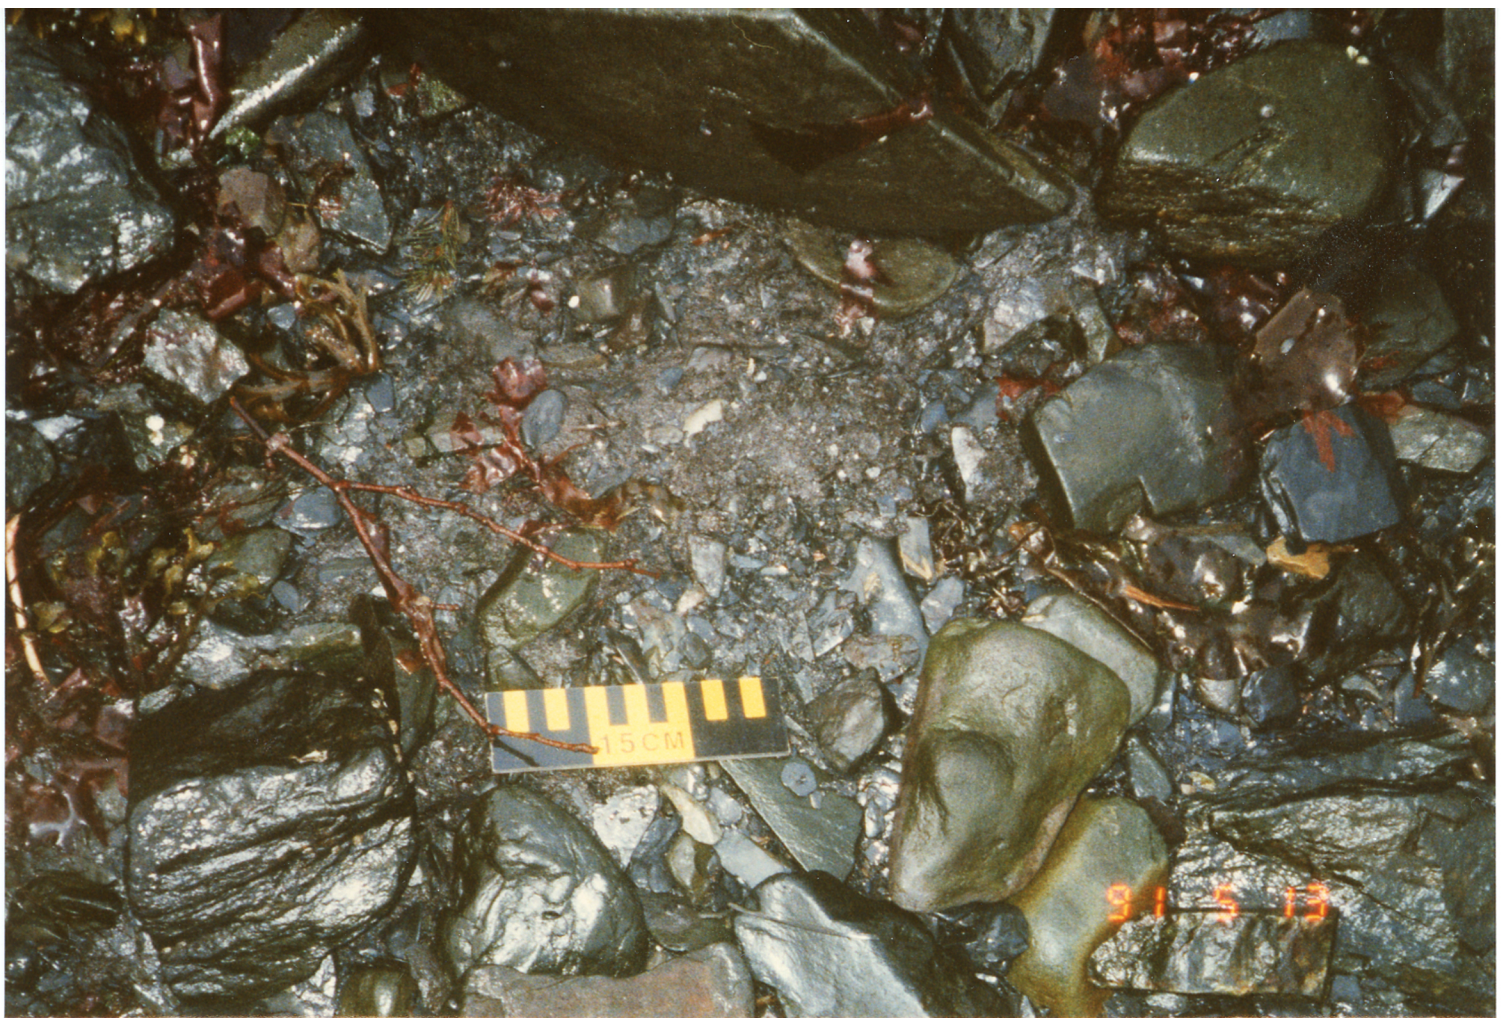
Segment No NK-1 Subdivision A  
Date 5/13/91 Log Frame No 1  
Photographer GARY SHIGENAKA  
Location NUKA ISLAND  
Comments PHOTO OF TAR MAT IN COBBLE SUBSTRATE  
(SUBSEQUENTLY REMOVED) ALONG NORTHEAST SHORE  
OF COVE.

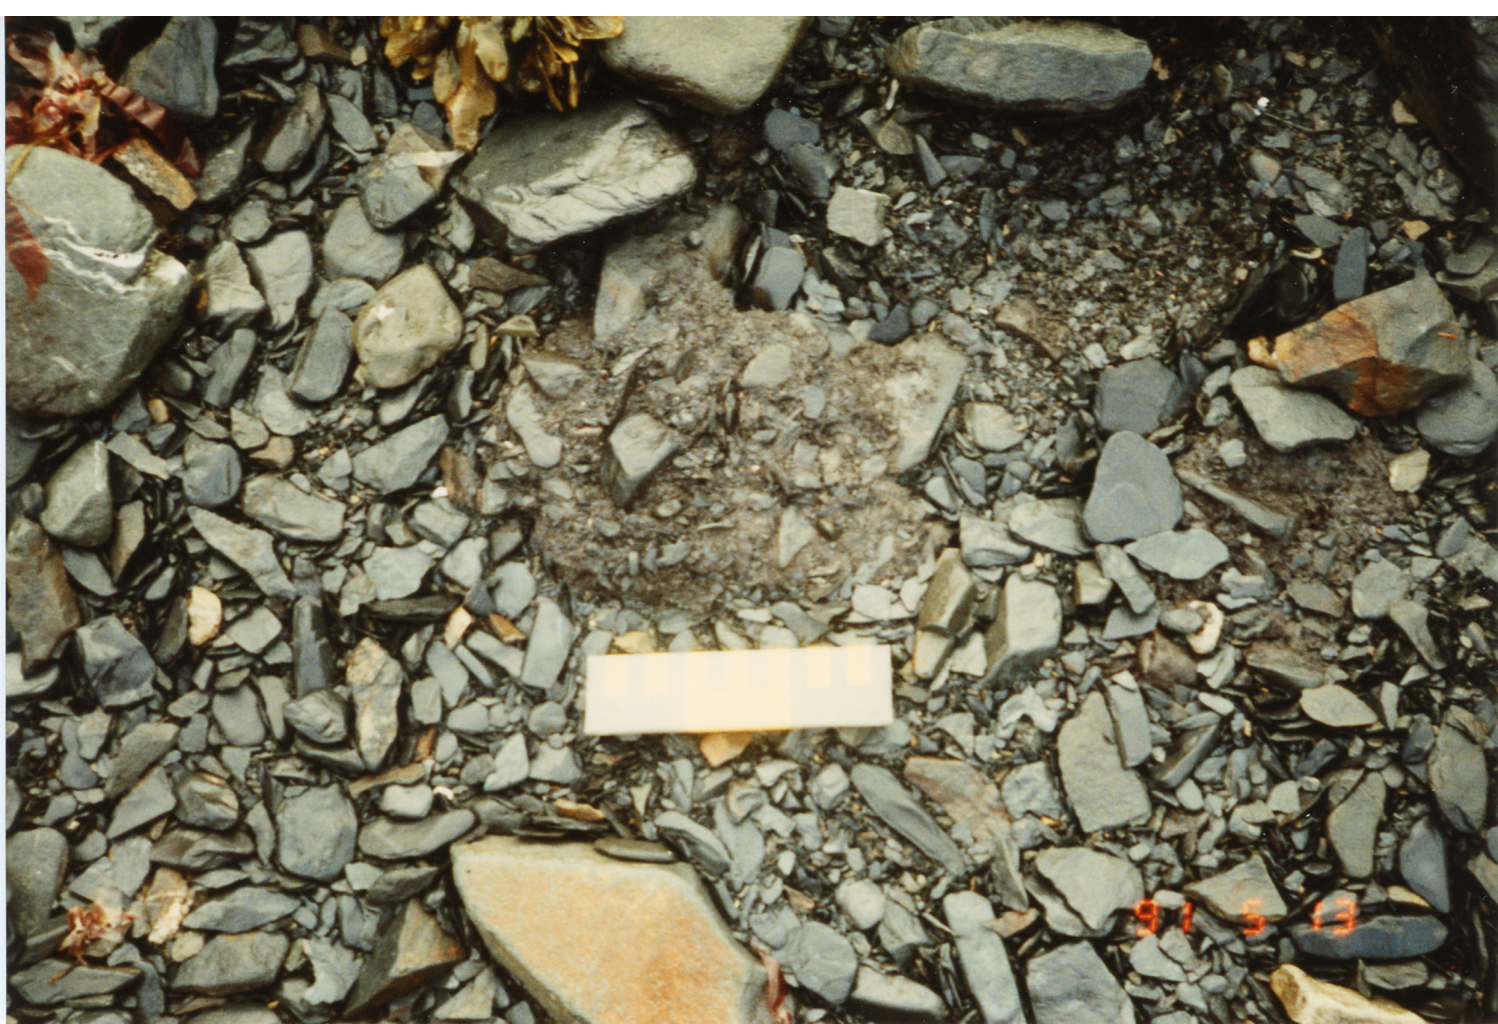
Segment No NK-1 Subdivision A  
Date 5/13/91 Log Frame No 5  
Photographer GARY SHIGENAKA  
Location NUKA ISLAND  
Comments ASPHALT (AP) IN ANGULAR SHALE COBBLE,  
FROM BAND OF MIDDLE INTERTIDAL BEACH WHERE  
OCCURRENCE WAS RELATIVELY MORE COMMON. MATERIAL  
REMOVED AS LOCATED.
