H-Chugach Bay

ADF&G MULTI-ASSESSMENT DATA FORM

MAYSAP - Chugach Bay
ANAO Stream

May Shoreline Assessment Program
1991

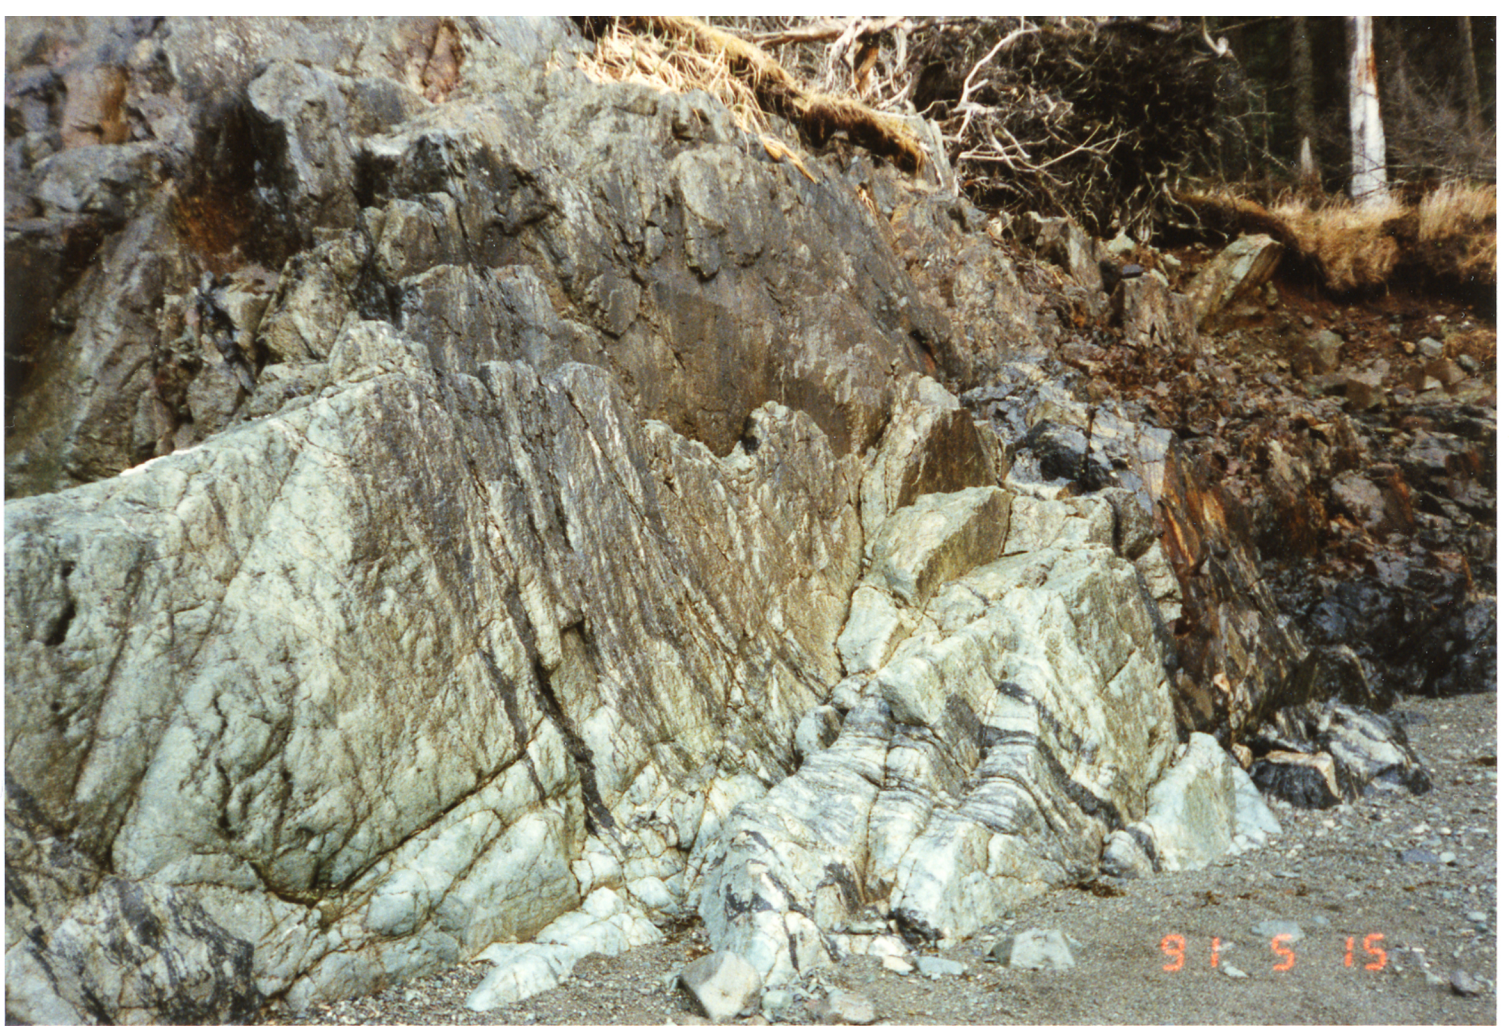
Date 5/15/91 Log Frame No 2

Comments SHOT FROM SAME LOCATION AS #1
BUT PIVOTED 90° CLOCKWISE (SOUTHWESTERN
ORIENTATION) TO SHOW ROCK FACE WHERE COAT
WAS RECORDED IN CRACKS.

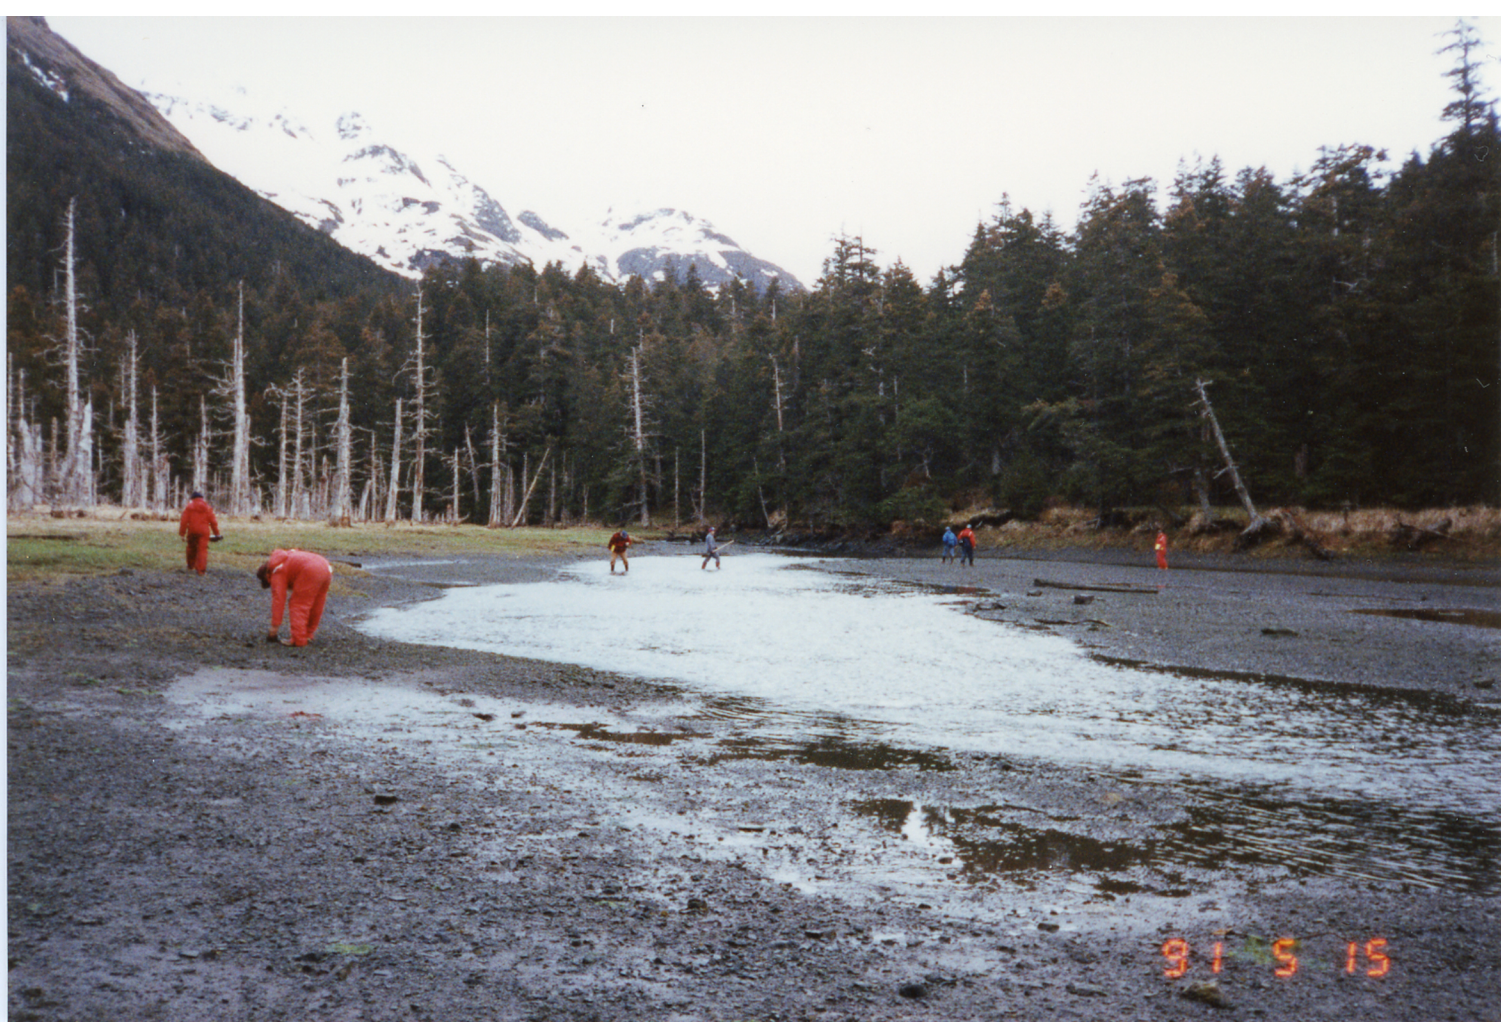
Date 5/15/91 Log Frame No 4

Comments VIEW UPSTREAM TO THE WEST TOWARD
THE PORTION OF THE UPPER STREAMBED WHEN
SOR WAS FOUND.

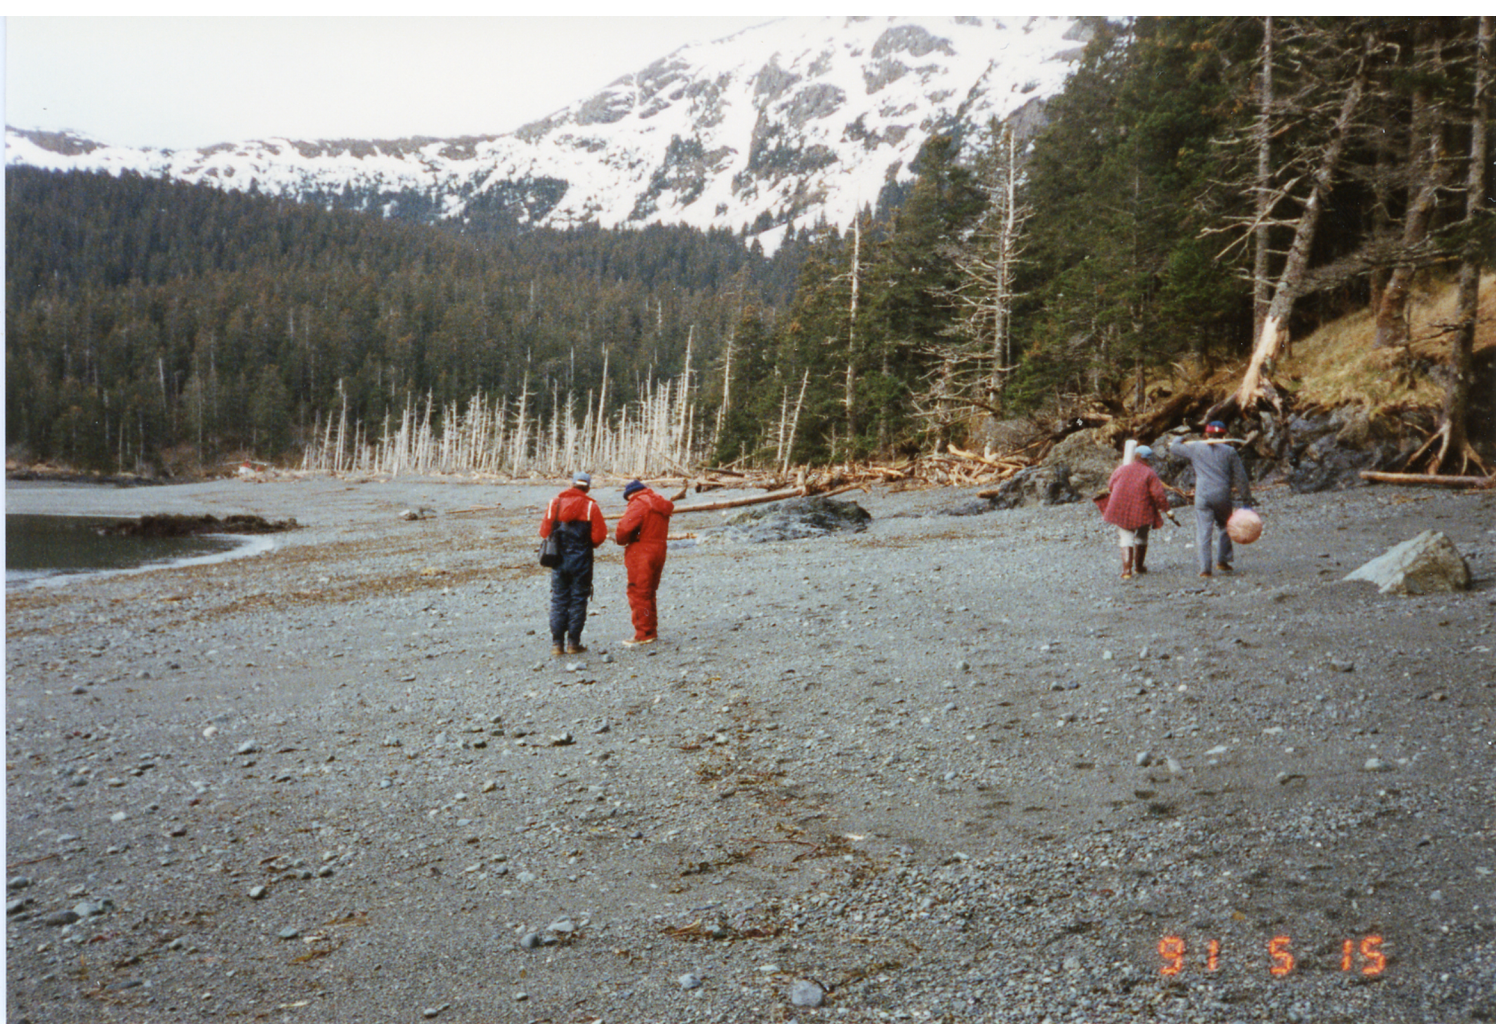
segment No CB-3 Subdivision A
Date 5/15/91 Log Frame No 1
Photographer GARY SHIGENAKA
Location CHUGACH BAY
Comments VIEW DOWN BEACH OF SURVEYED PORTION
OF SEGMENT, FROM NORTHWESTERN TERMINUS FACING
SOUTHEAST.

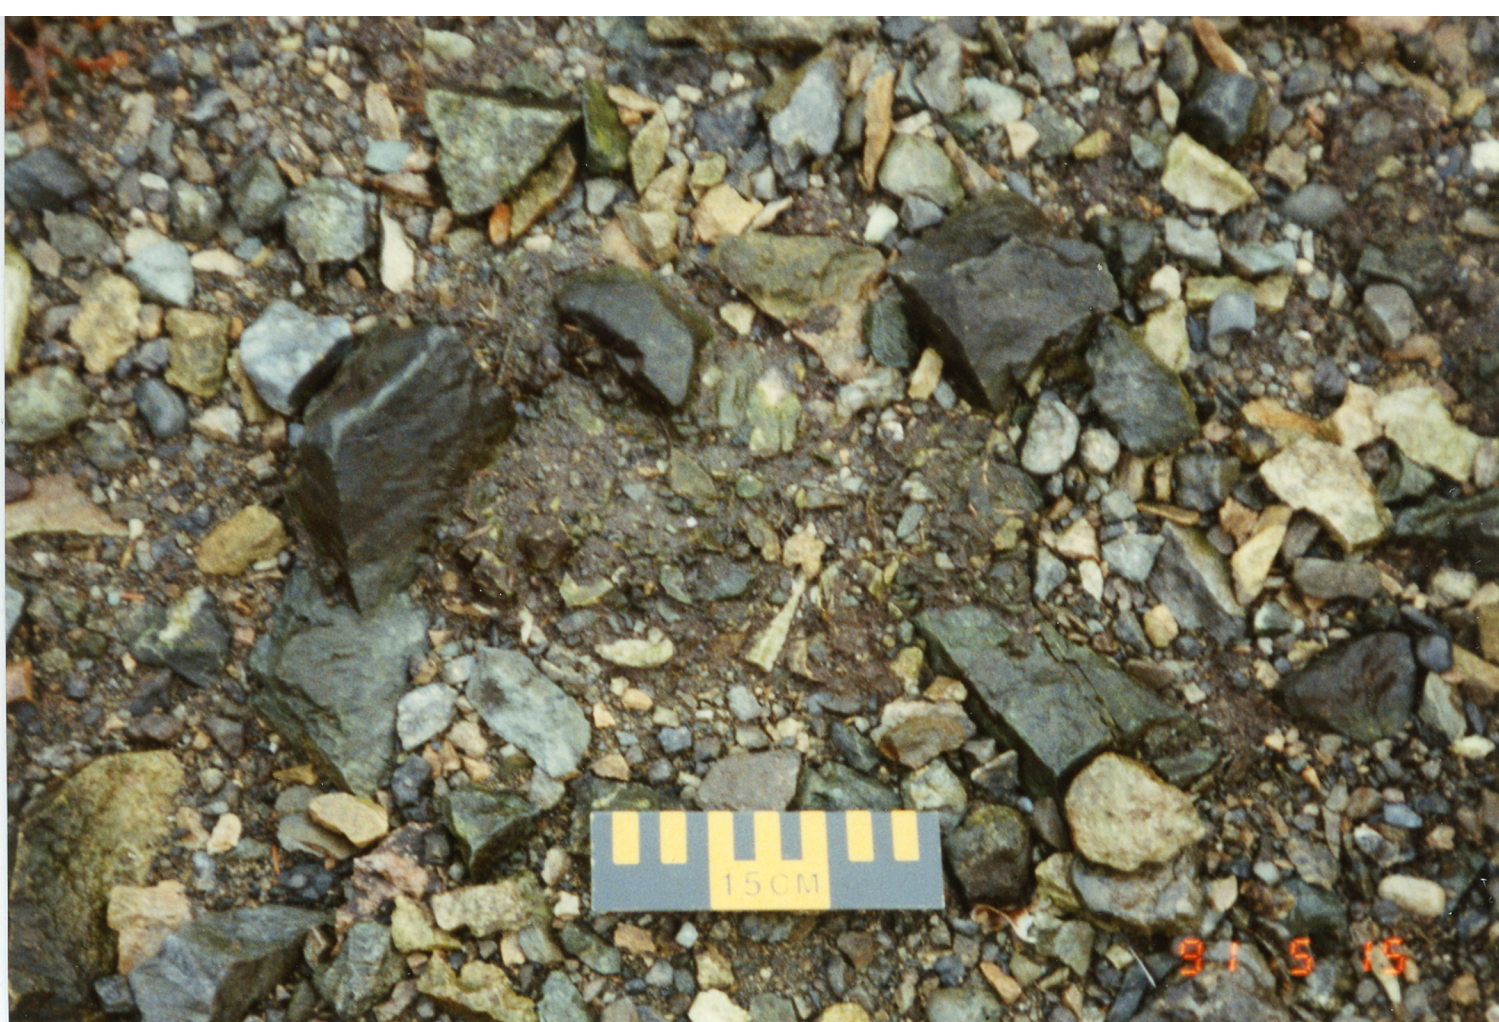
Date 5/15/91 Log Frame No 3

Comments SOR IN BOULDER-COBBLE SUBSTRATE
ALONG SOUTHERN SHORELINE OF BEACH. WAS
SUBSEQUENTLY BROKEN UP / REMOVED.

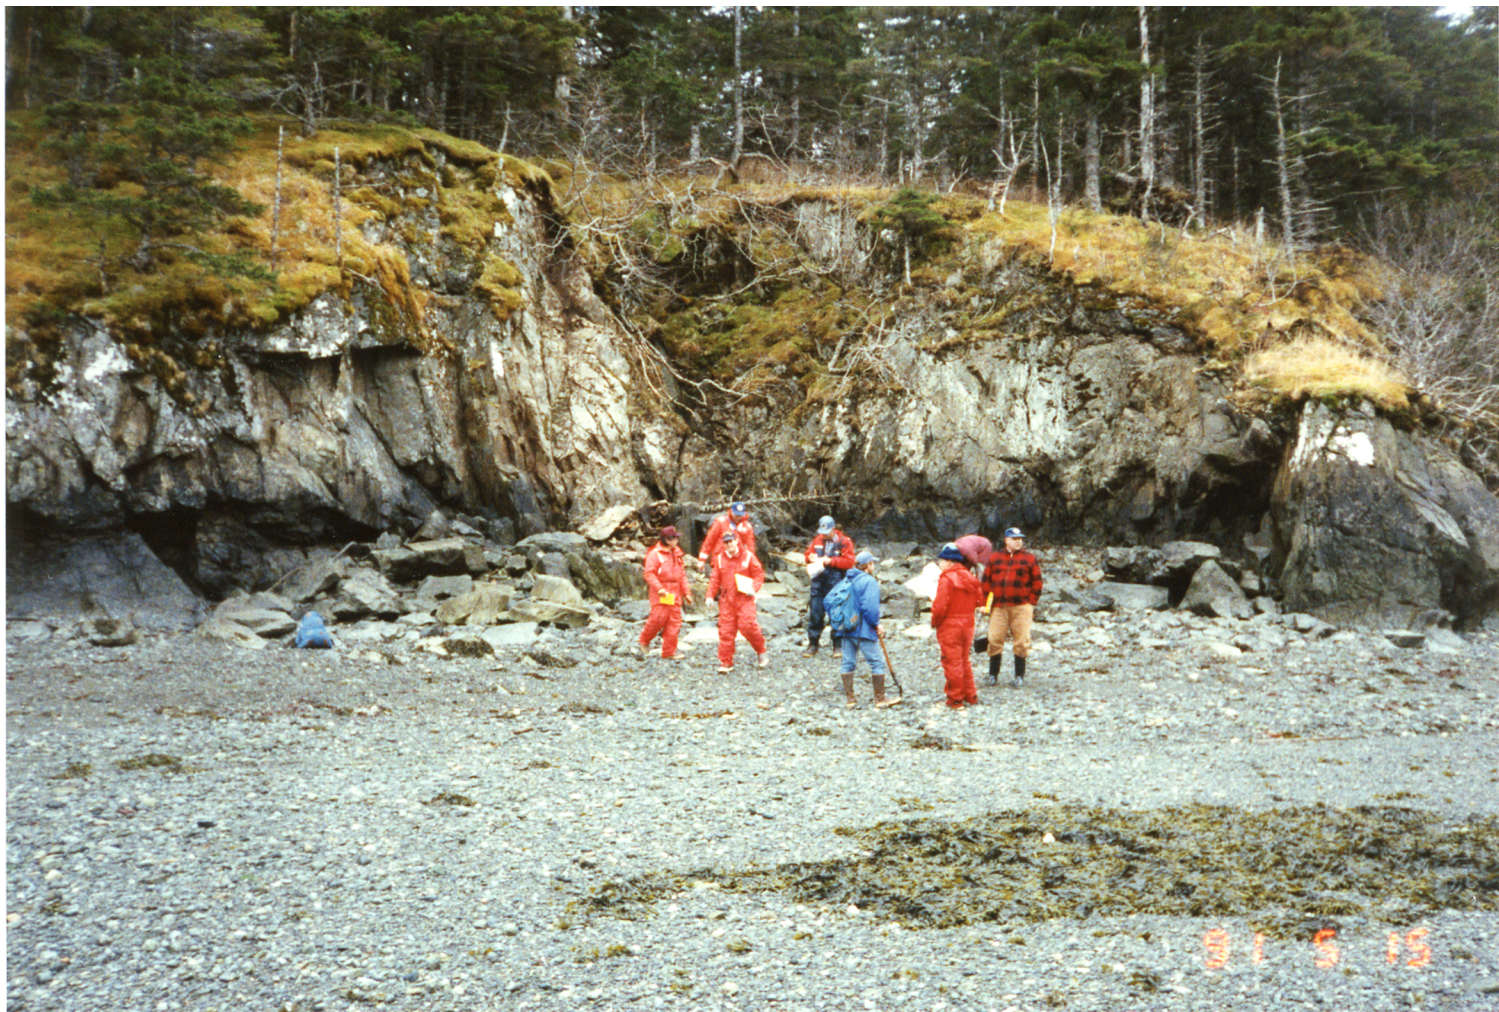
Segment No CB-3 Subdivision A
Date 5/15/91 Log Frame No 6
Photographer GARY SHIGENAKA
Location CHUGACH BAY
Comments VIEW OF BOULDER-COBBLE SUBSTRATE
WHERE MOUSSE IN #5 WAS REMOVED; ORIENTATION
TO THE SOUTHEAST

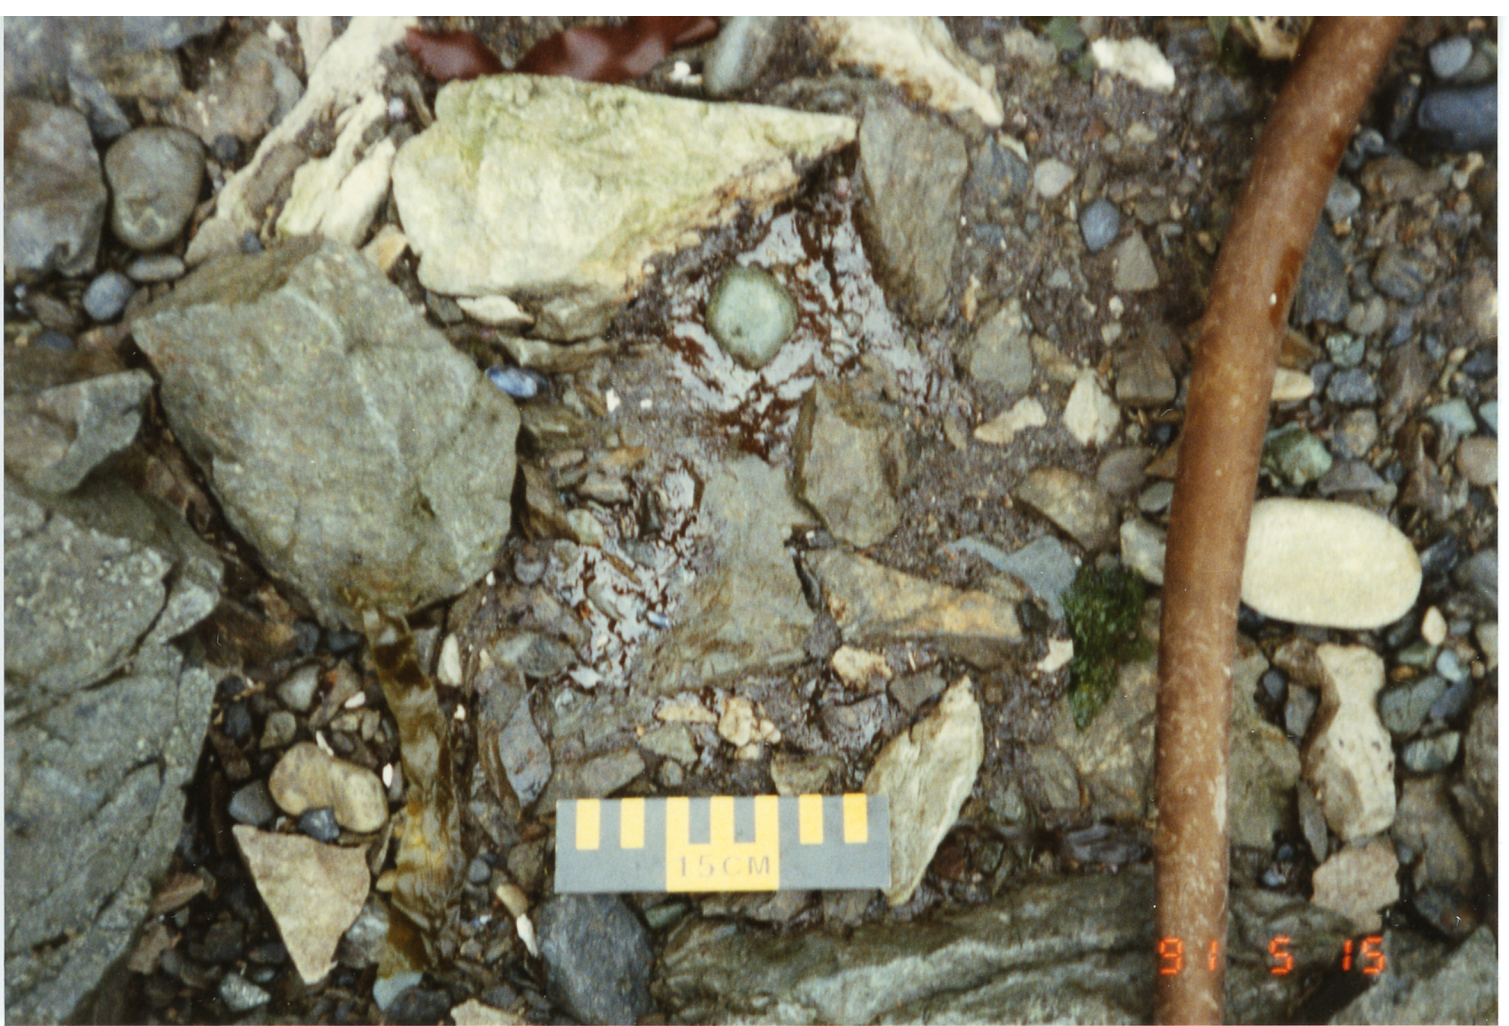
Date 5/15/91 Log Frame No 5

Comments MOUSSE (MS/SOR) IN COBBLE; MATERIAL
WAS OF A SOMEWHAT SOFTER CONSISTENCY, FOUND IN
UPPER INTERTIDAL; REMOVED BY VECO
