ADF&G MULTI-ASSESSMENT FORM
1991 GENERAL ENTRY CHECKLIST

LOCATION: ROCKY BAY, PICNIC HARBOR, FIRST STREAM EAST OF

Rocky Bay, First Stream East of Picnic Harbor

May Shoreline Assessment Program
1991

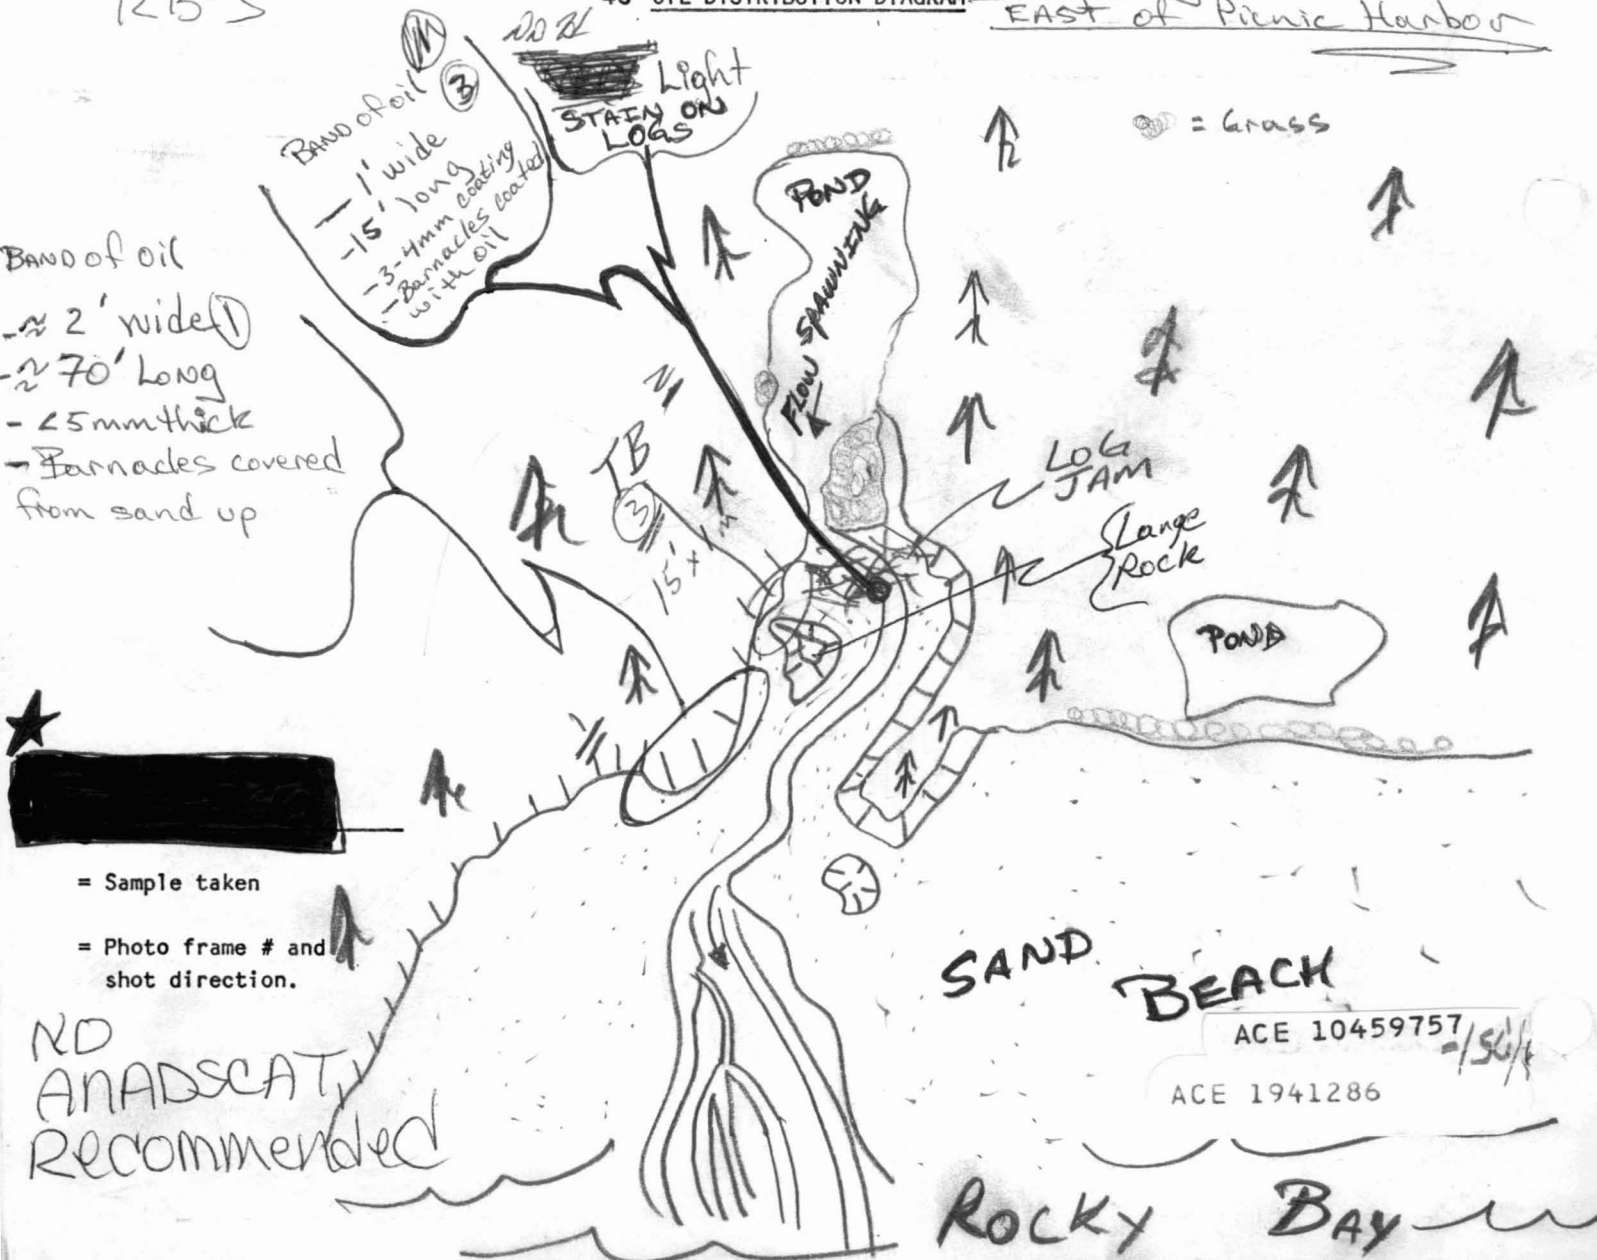
46 OIL DISTRIBUTION DIAGRAM

COMMENTS: no oil was observed in stream bed. Stream was unfrozen. Light stain on logs jammed in stream, stain on bluff on west shore, covering of oil on west shore bluff and on large rock below log jam. Russel Kinobe (ADEG) claims to have observed sheen in pit dug 20' downstream of large rock.

July 25, 90 landed this stream with Dave Kenney, Jane Middleton, Susan McNamee. Arctic salver/bio of me anchored off shore (eating lunch) Met two AUG persons on beach Glen Heyman and Mike Lu. I pointed out the oil buried on bank of the stream near the log jam. Glen said the cleanup crew would pick up what they could. we dug test holes on east end of the beach and observed stream in these holes.

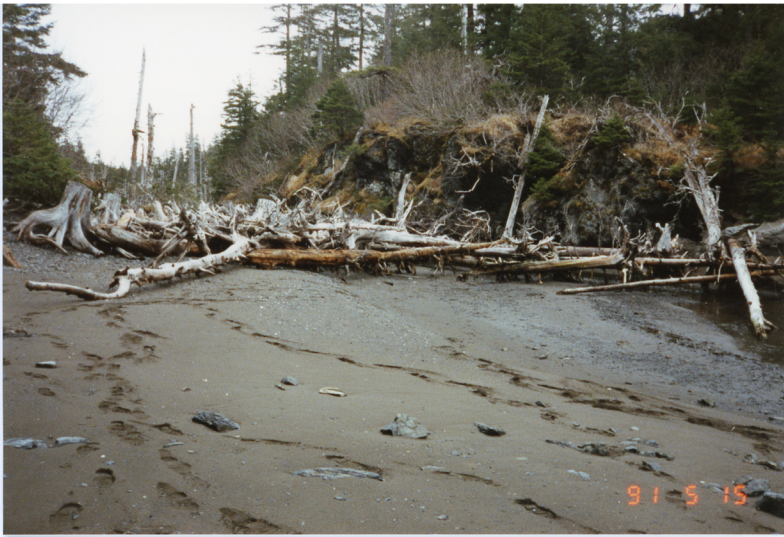
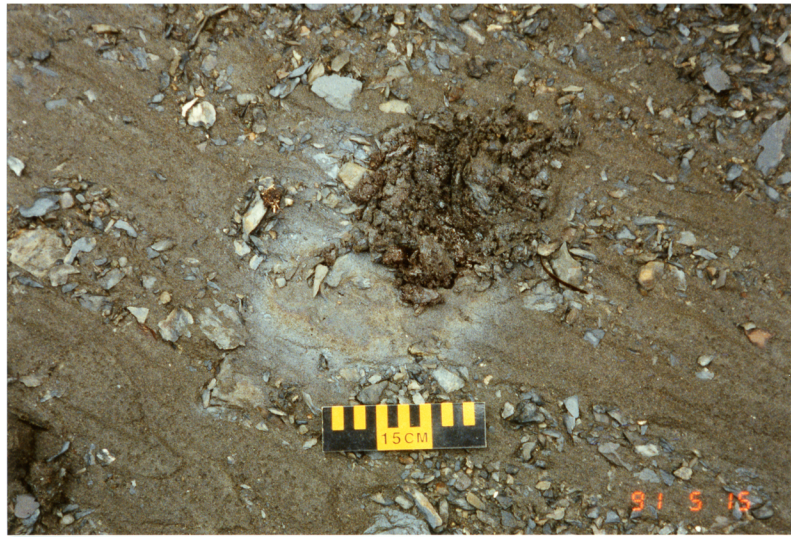
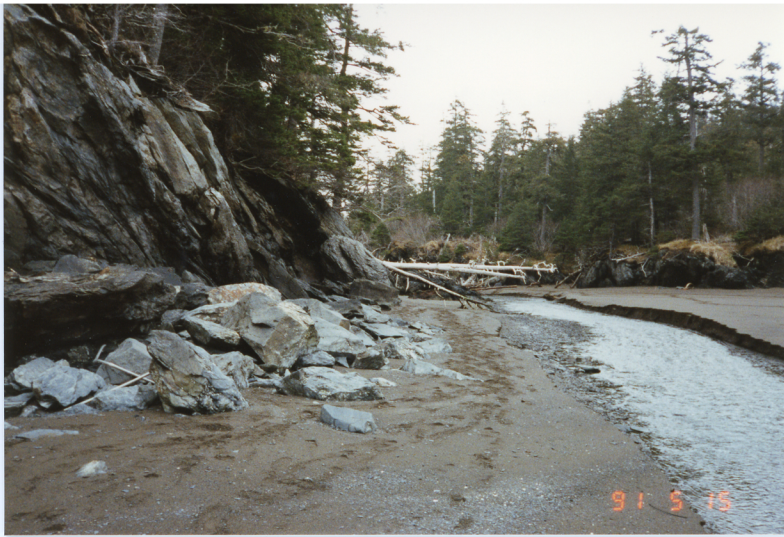
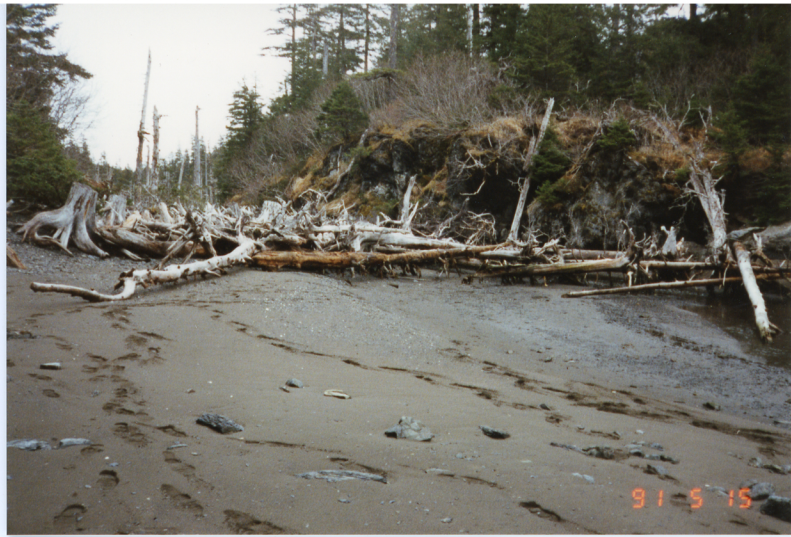
Date: 5/15/91 No. 902

Segment No RB-3 Subdivision A
Date 5/15/91 Log Frame No 21
Photographer GARY SHIGENAKA
Location ROCKY BAY
Comments VIEW FROM SOUTHWEST TERMINUS OF
SURVEYED PORTION OF SEGMENT ACROSS BEACH,
ORIENTATION TO THE NORTH (THIS SHOT MAY OR
MAY NOT HAVE BEEN TAKEN - SEE #22)

Segment No RB-3 Subdivision A
Date 5/15/91 Log Frame No 19
Photographer GARY SHIGENAKA
Location ROCKY BAY
Comments SOR AND SHEEN FOUND NEAR BANK OF
STREAM JUST BELOW JUMBIE OF LOGS ACROSS
BED. SUBSTRATE IS SAND, PENETRATION ABOUT
2 CM.
Roll No MAYSAP-6-15 Neg. No 18
Control No 902 (Office Use Only)

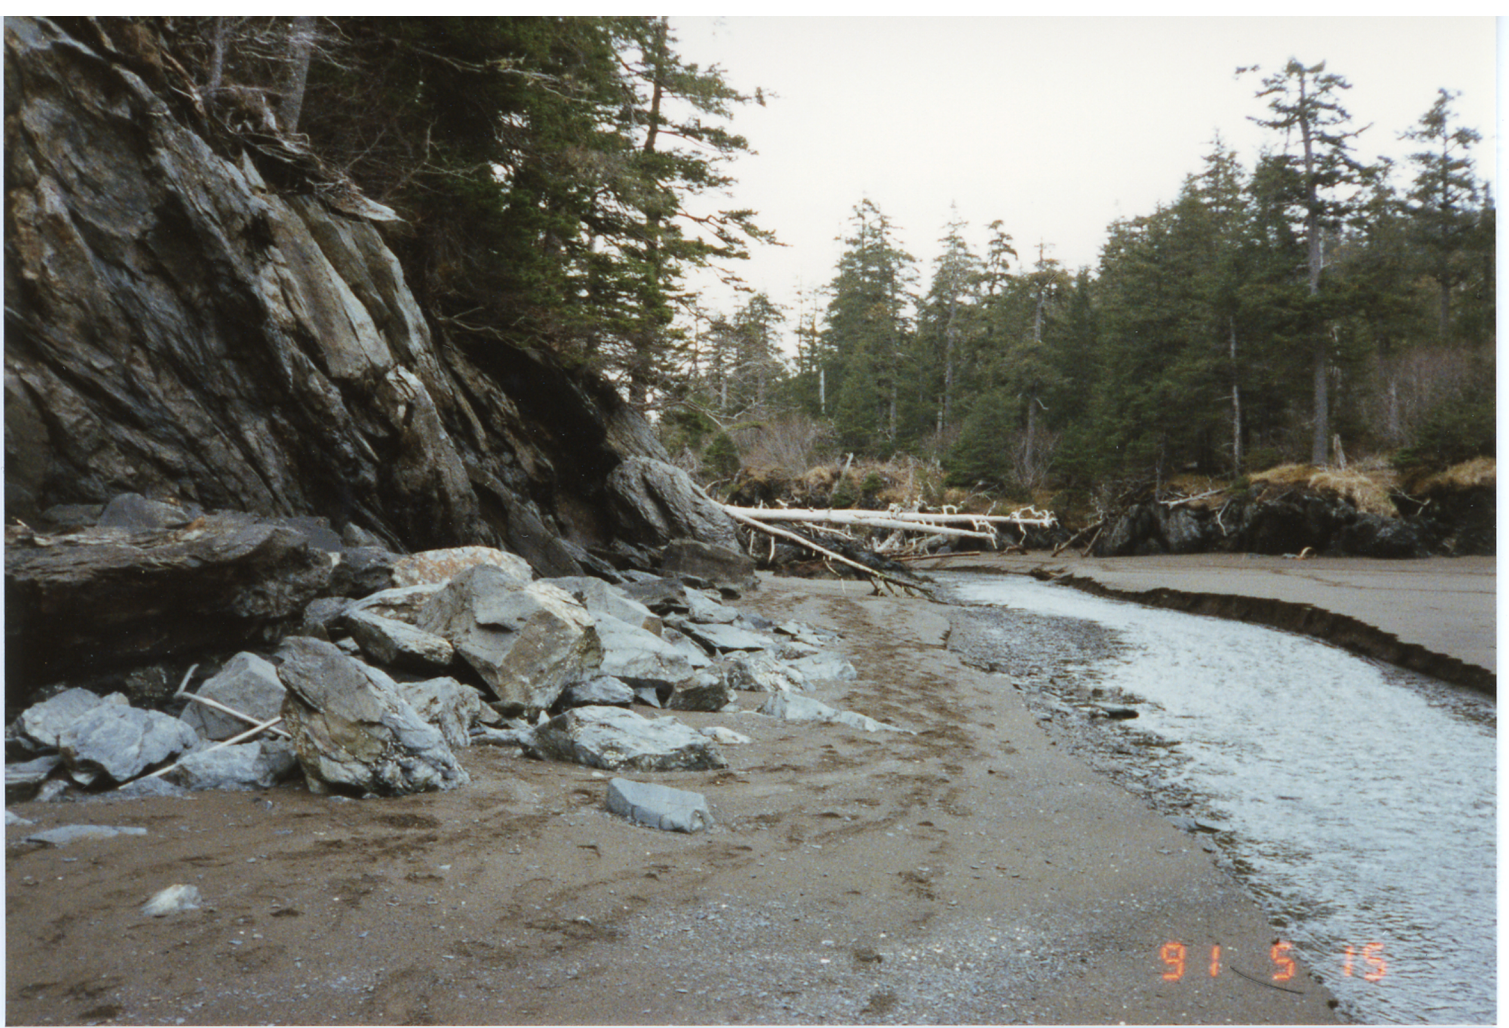
Segment No RB-3 Subdivision A
Date 5/15/91 Log Frame No 22
Photographer GARY SHIGENAKA
Location ROCKY BAY
Comments (PHOTOGRAPHER ISN'T EXACTLY CERTAIN
THAT HE TOOK THIS SHOT BUT IS ASSUMING HE DID...)
VIEW FROM SAME LOCATION AS #21, PIVOTED
TO LOOK UPSTREAM - ORIENTATION NORTHERLY?
Roll No MAYSAP-6-15 Neg. No 21
Control No 902 (Office Use Only)

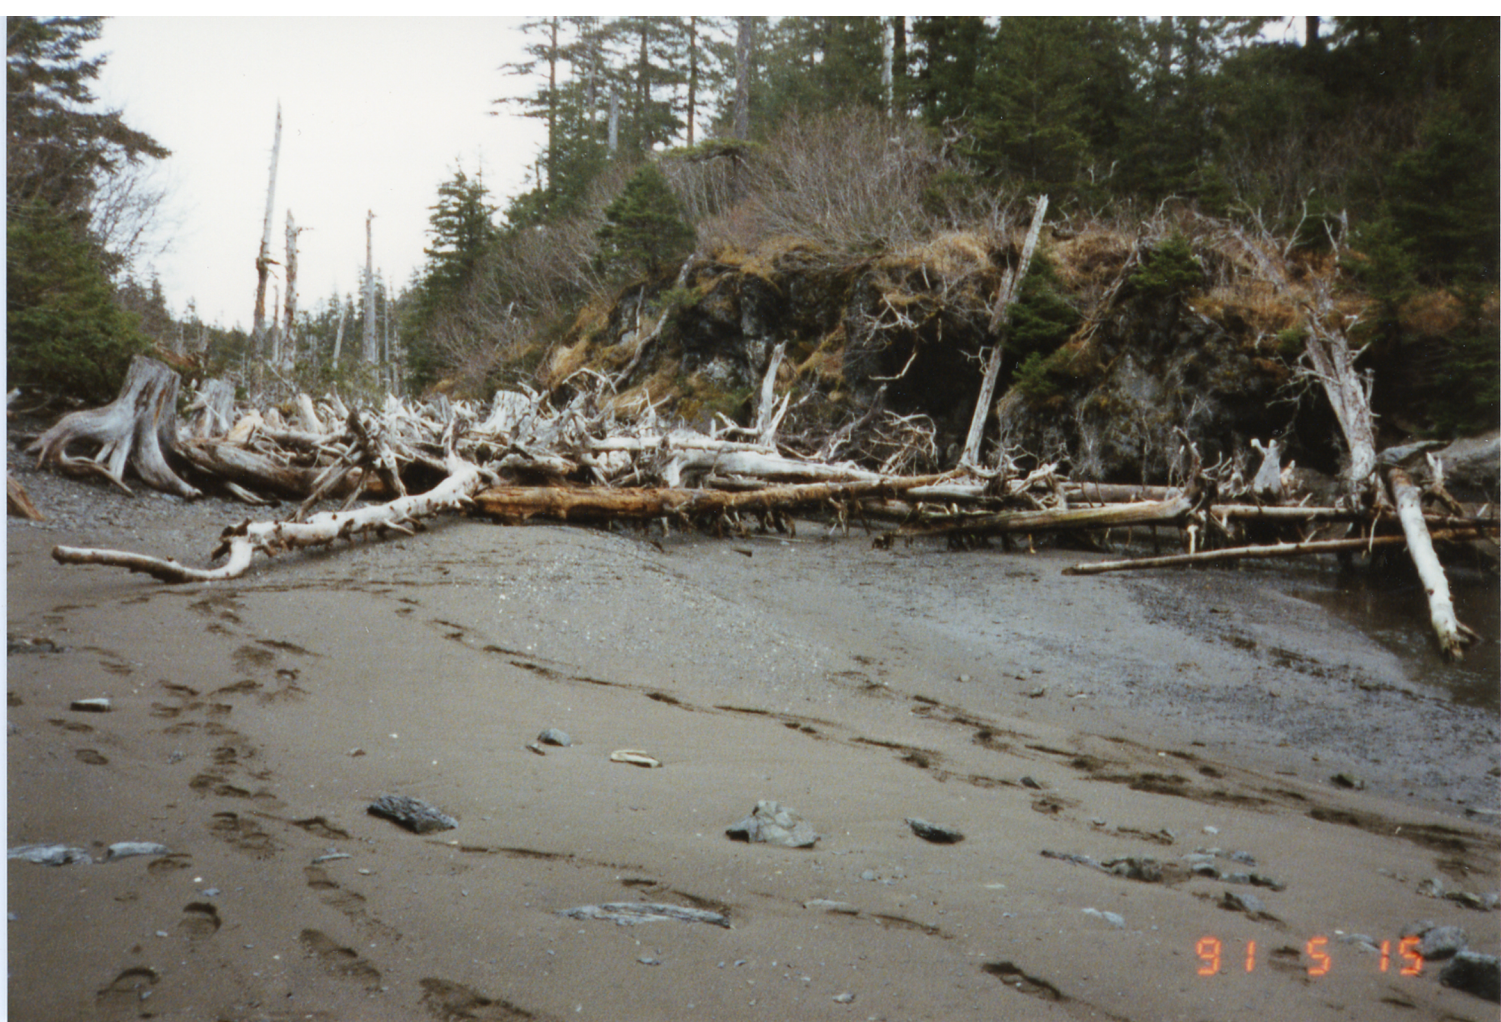
Segment No RB-3 Subdivision A
Date 5/15/91 Log Frame No 20
Photographer GARY SHIGENAKA
Location ROCKY BAY
Comments VIEW LOOKING UPSTREAM; ORIENTATION
IS NORTHERLY.

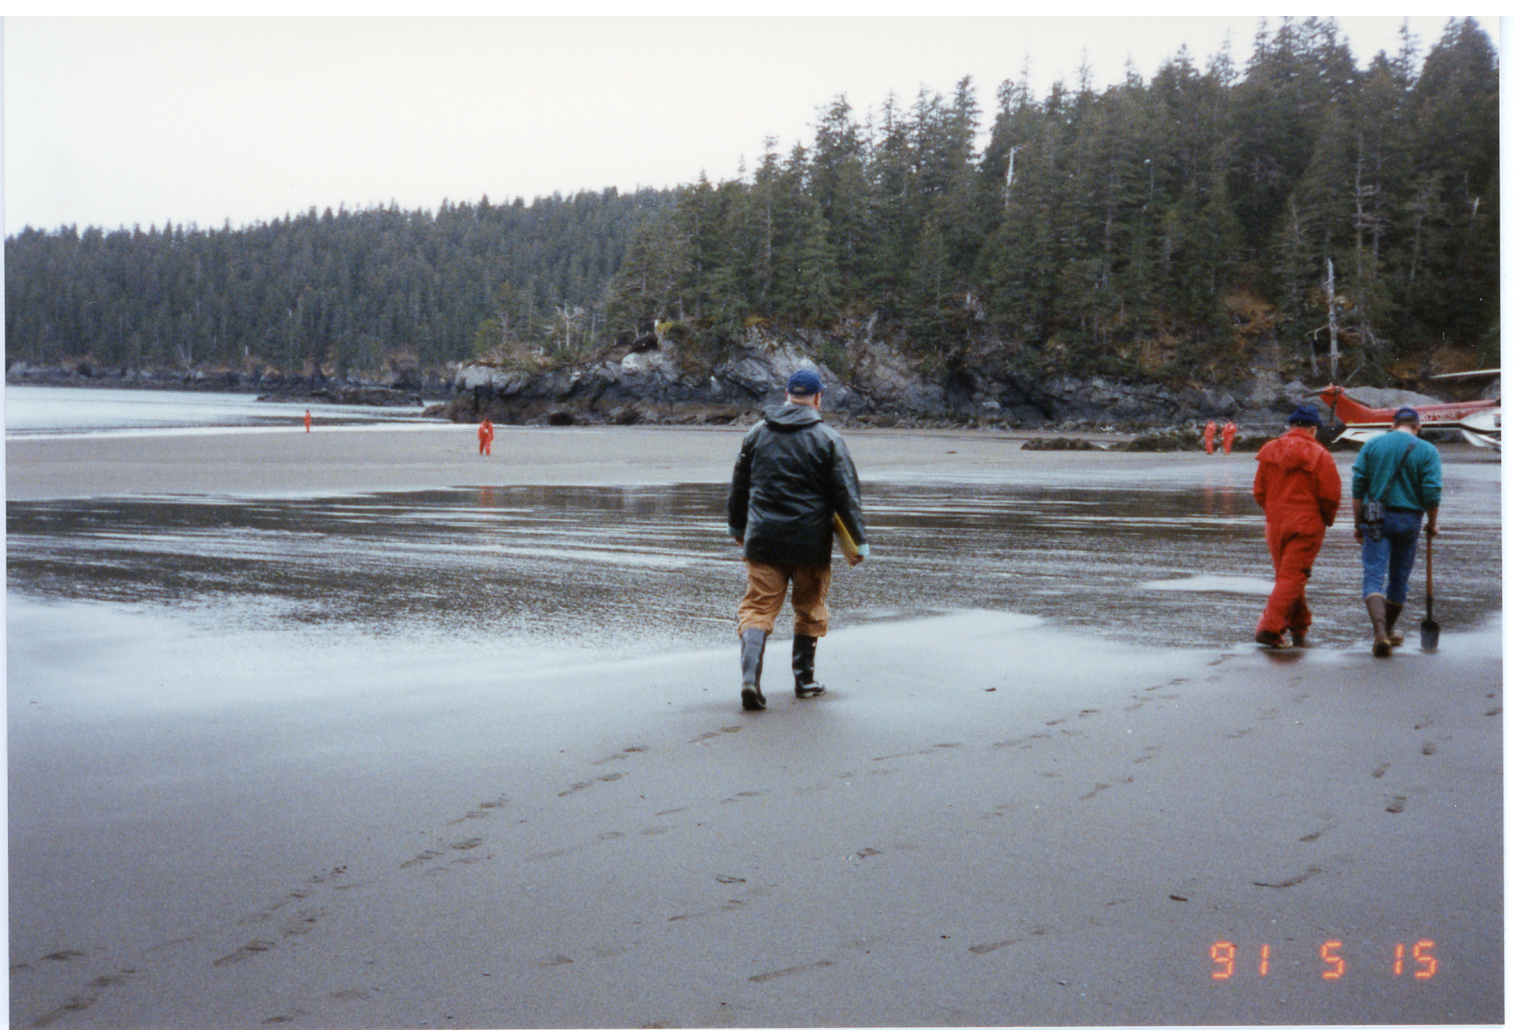
Segment No RB-3 Subdivision A
Date 5/15/91 Log Frame No 23
Photographer GARY SHIGENAKA
Location ROCKY BAY
Comments (PHOTOGRAPHER IS CERTAIN HE TOOK THIS
SHOT) VIEW ACROSS SAND BEACH - ORIENTATION
IS SOUTHWESTERLY.
