ASC NUMBER: 242-20-10160 SEGMENT NUMBER: WB-003 YR CATALOGED:

LOCATION: OCKP Windy Bay

STREAM NAME: Windy Right Ck

ADF&G MULTI-ASSESSMENT DATA FORM

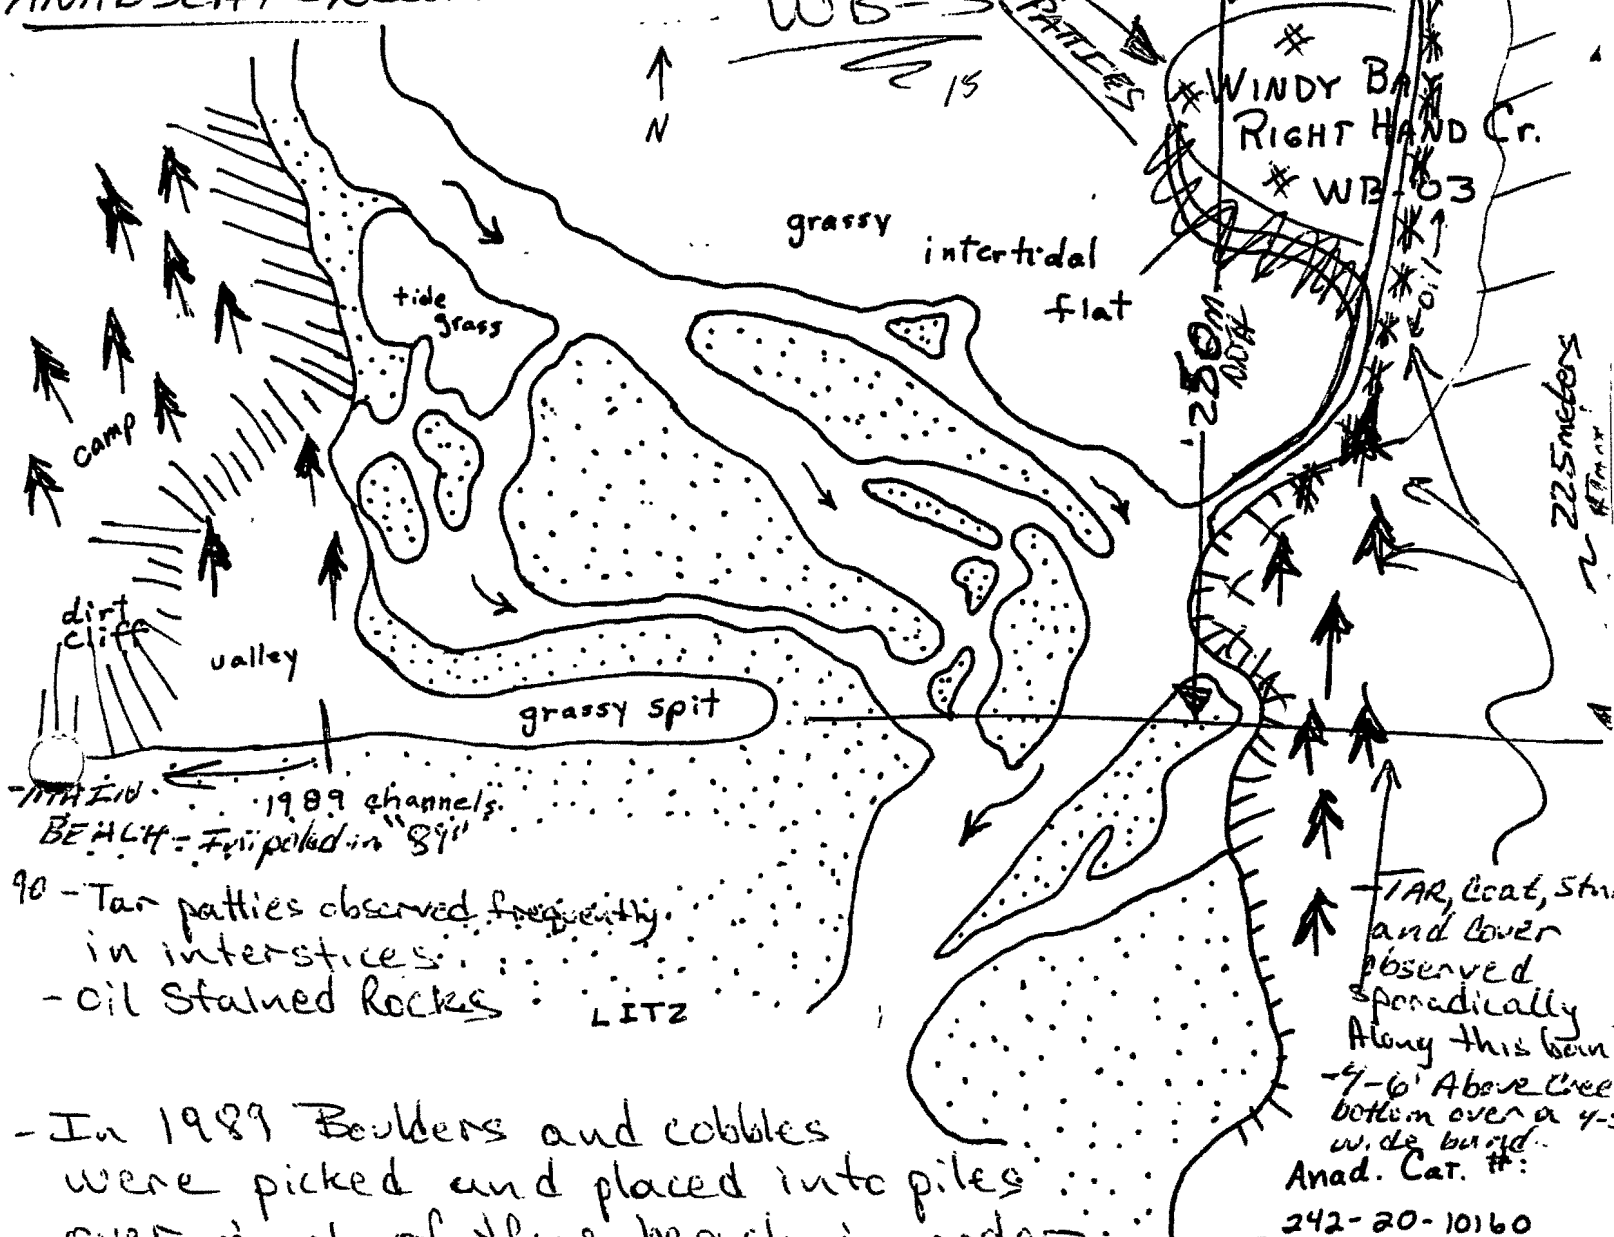
- In 1989 Boulders and cobbles were picked and placed into piles over much of this beach - in order to get at the heavy pooled oil beneath and in the interstices. Crews were later told to cease moving rocks (changing the beach morphology) - As NOAA/Exxon stated concerns that it could cause an erosional problem.

In 1990 none of the cairn/graveyard-like piles were evident - only a uniform-random natural looking beach was observed.

ANADSCAT - Recommended

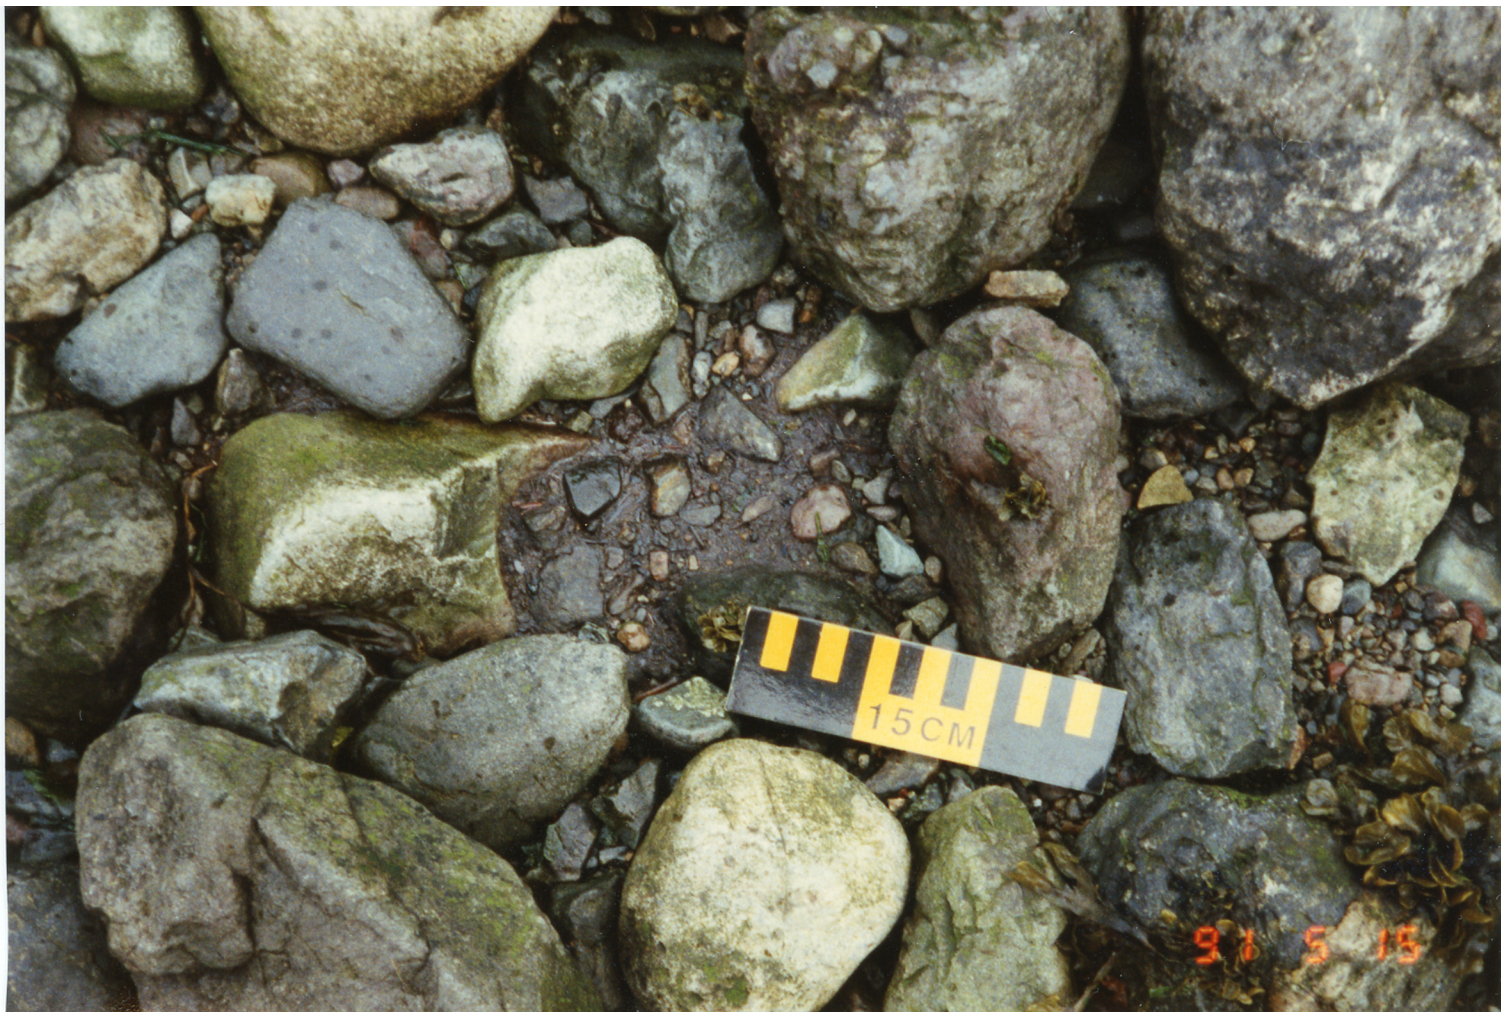
Date 5/15/91 Log Frame No 9

Comments SOR FOUND IN COBBLE BEACH ABOUT  
5 M NORTHEAST OF LOCATION FOR #8

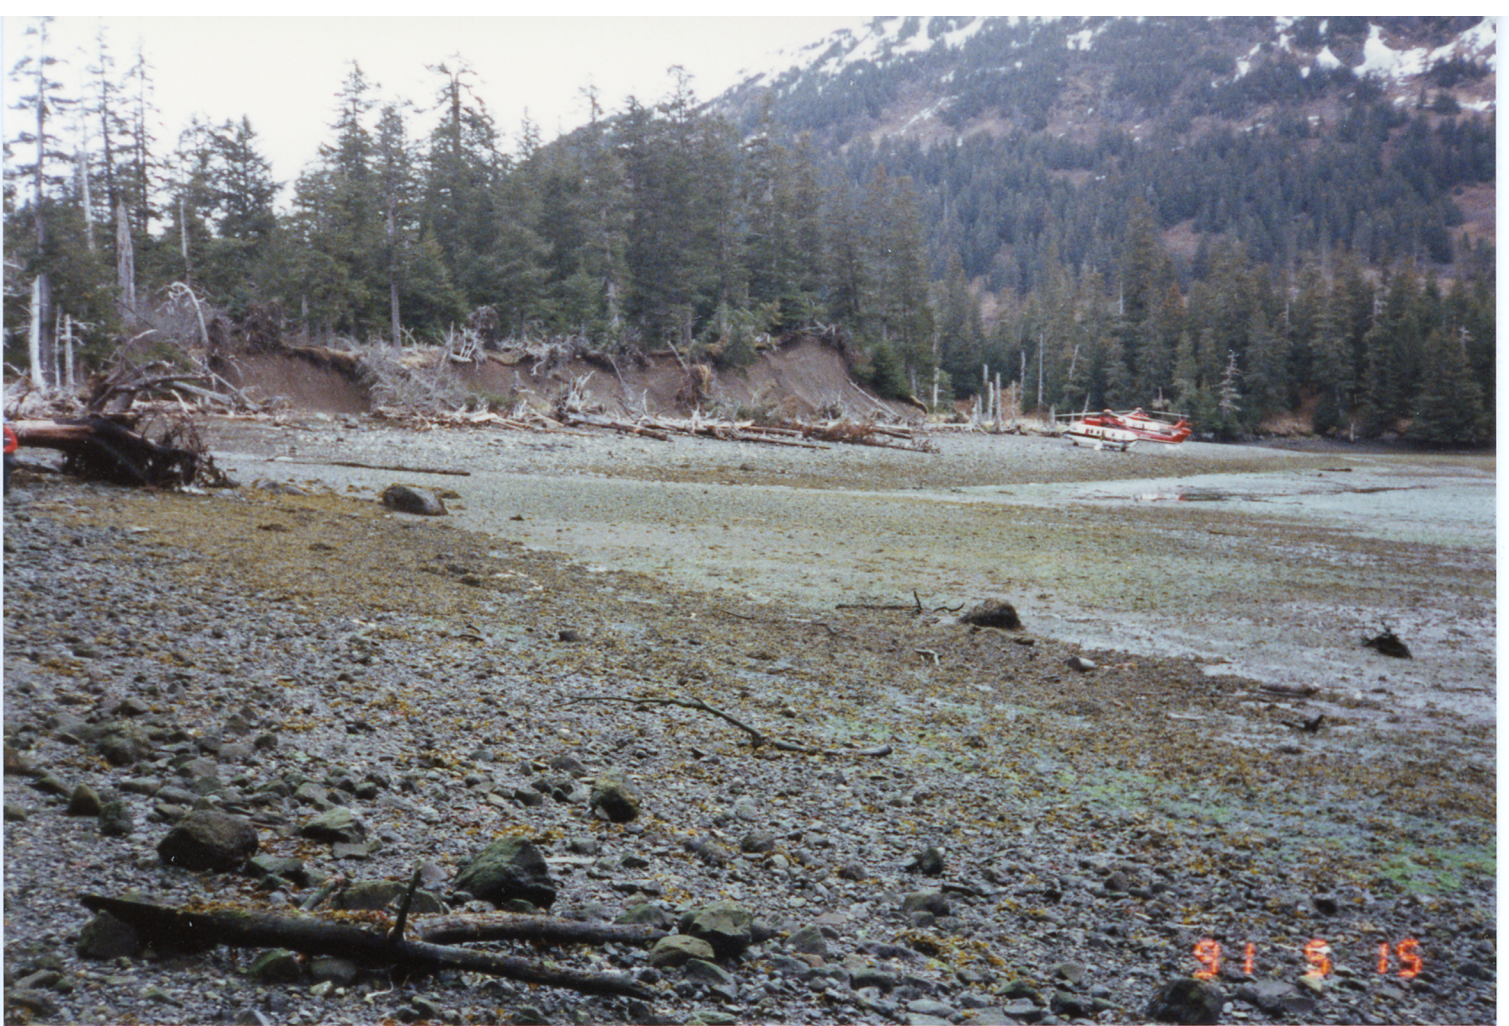
Segment No WB-3 Subdivision B  
Date 5/15/91 Log Frame No 7  
Photographer GARY SHIGENAKA  
Location WINDY BAY  
Comments VIEW FROM SOUTH END OF SURVEYED  
PORTION OF THE SEGMENT, FACING NORTH ACROSS  
BEACH.

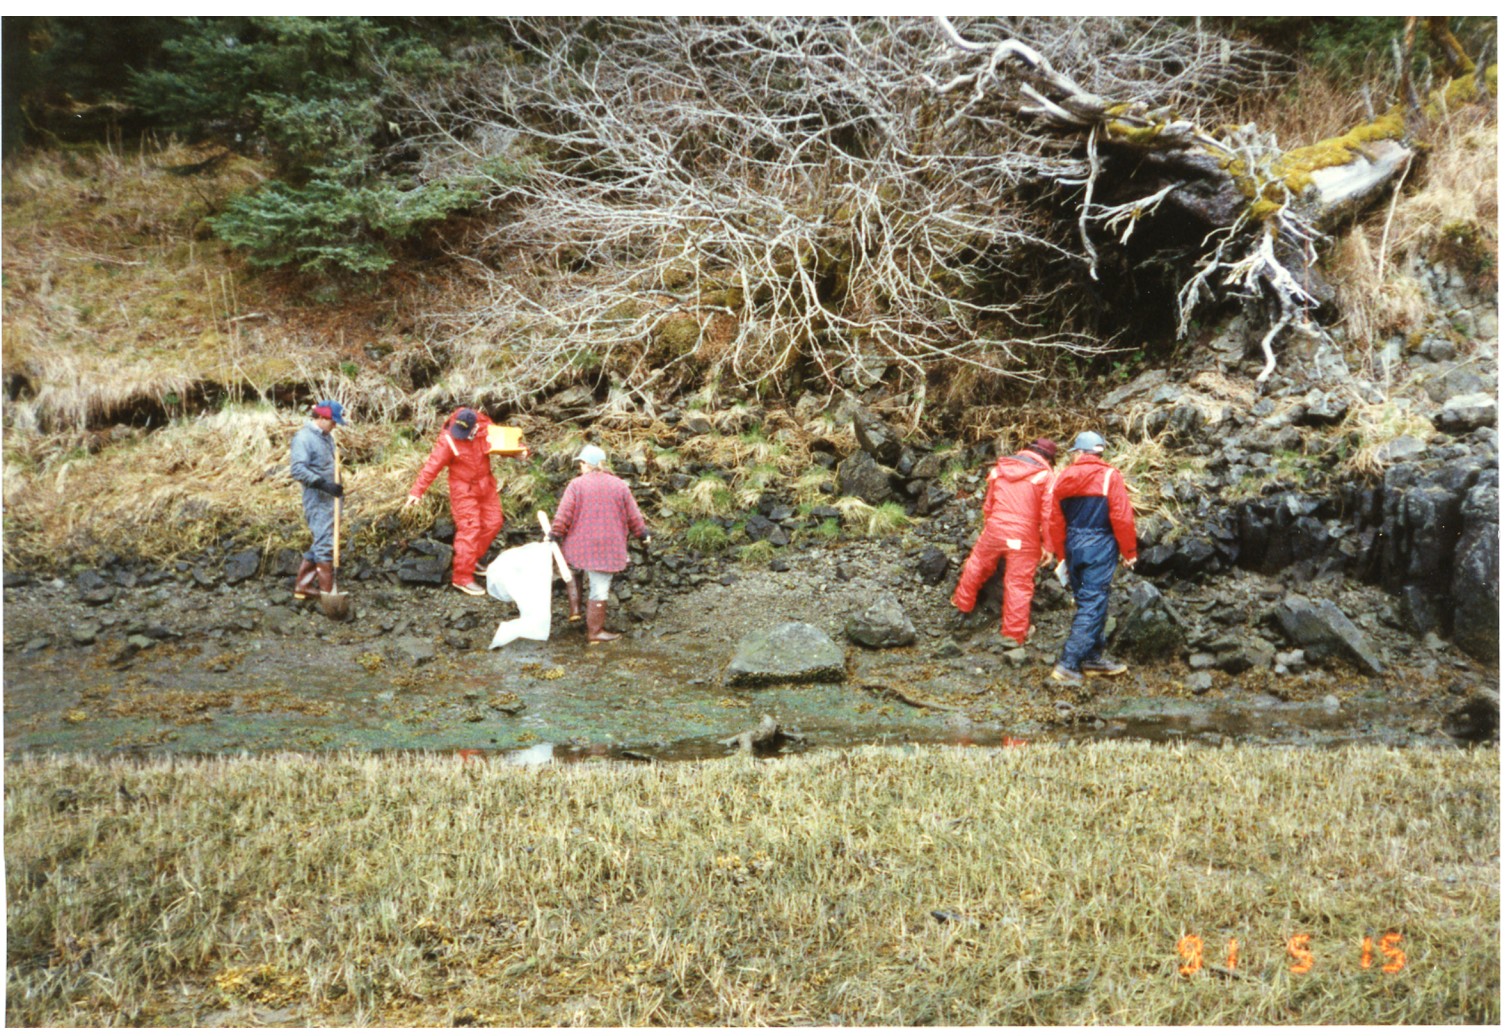
Date 5/15/91 Log Frame No 10

Comments VIEW OF COBBLE SHORELINE BORDERING  
SALTMARSH - SOR WAS FOUND IN THIS SUBSTRATE

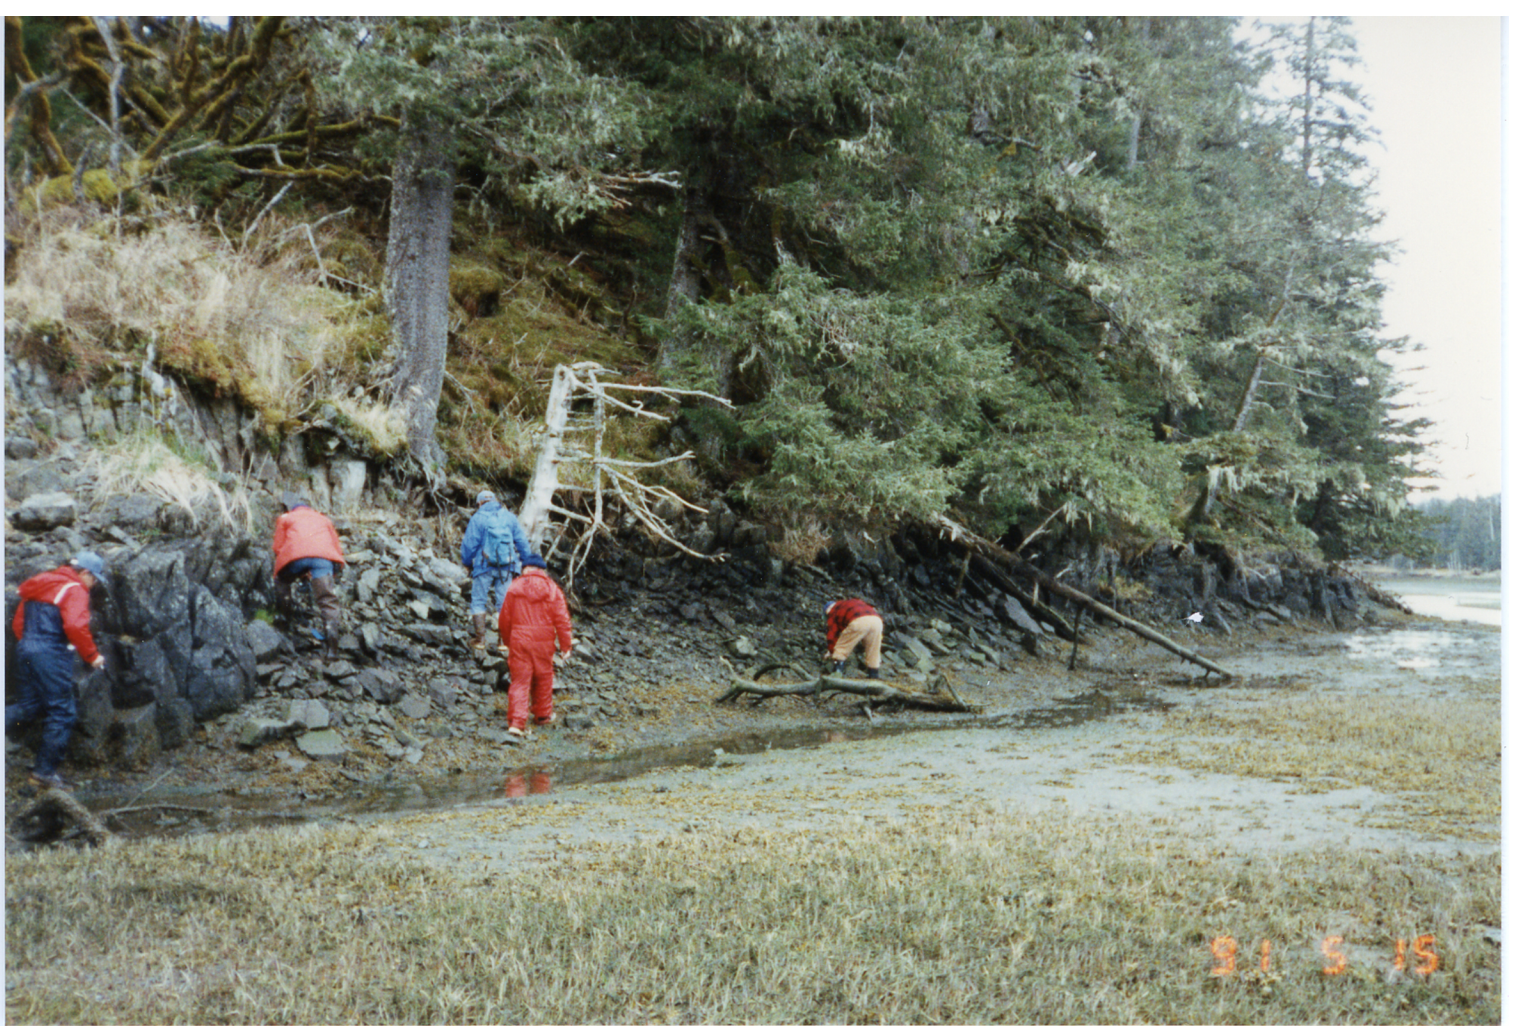
Segment No WB-3 Subdivision B  
Date 5/15/91 Log Frame No 11  
Photographer GARY SHIGENAKA  
Location WINDY BAY  
Comments SAME LOCATION AS PHOTO #10. ROTATED  
CLOCKWISE TO GIVE BROADER AREA VIEW
