ADF&G MULTI-ASSESSMENT FORM
1991 GENERAL ENTRY CHECKLIST

LOCATION: CHUGACH BAY

ADF&G MULTI-ASSESSMENT FORM
1991 OILING ENTRY CHECKLIST

FISH HABITAT ASSESSMENT FORM

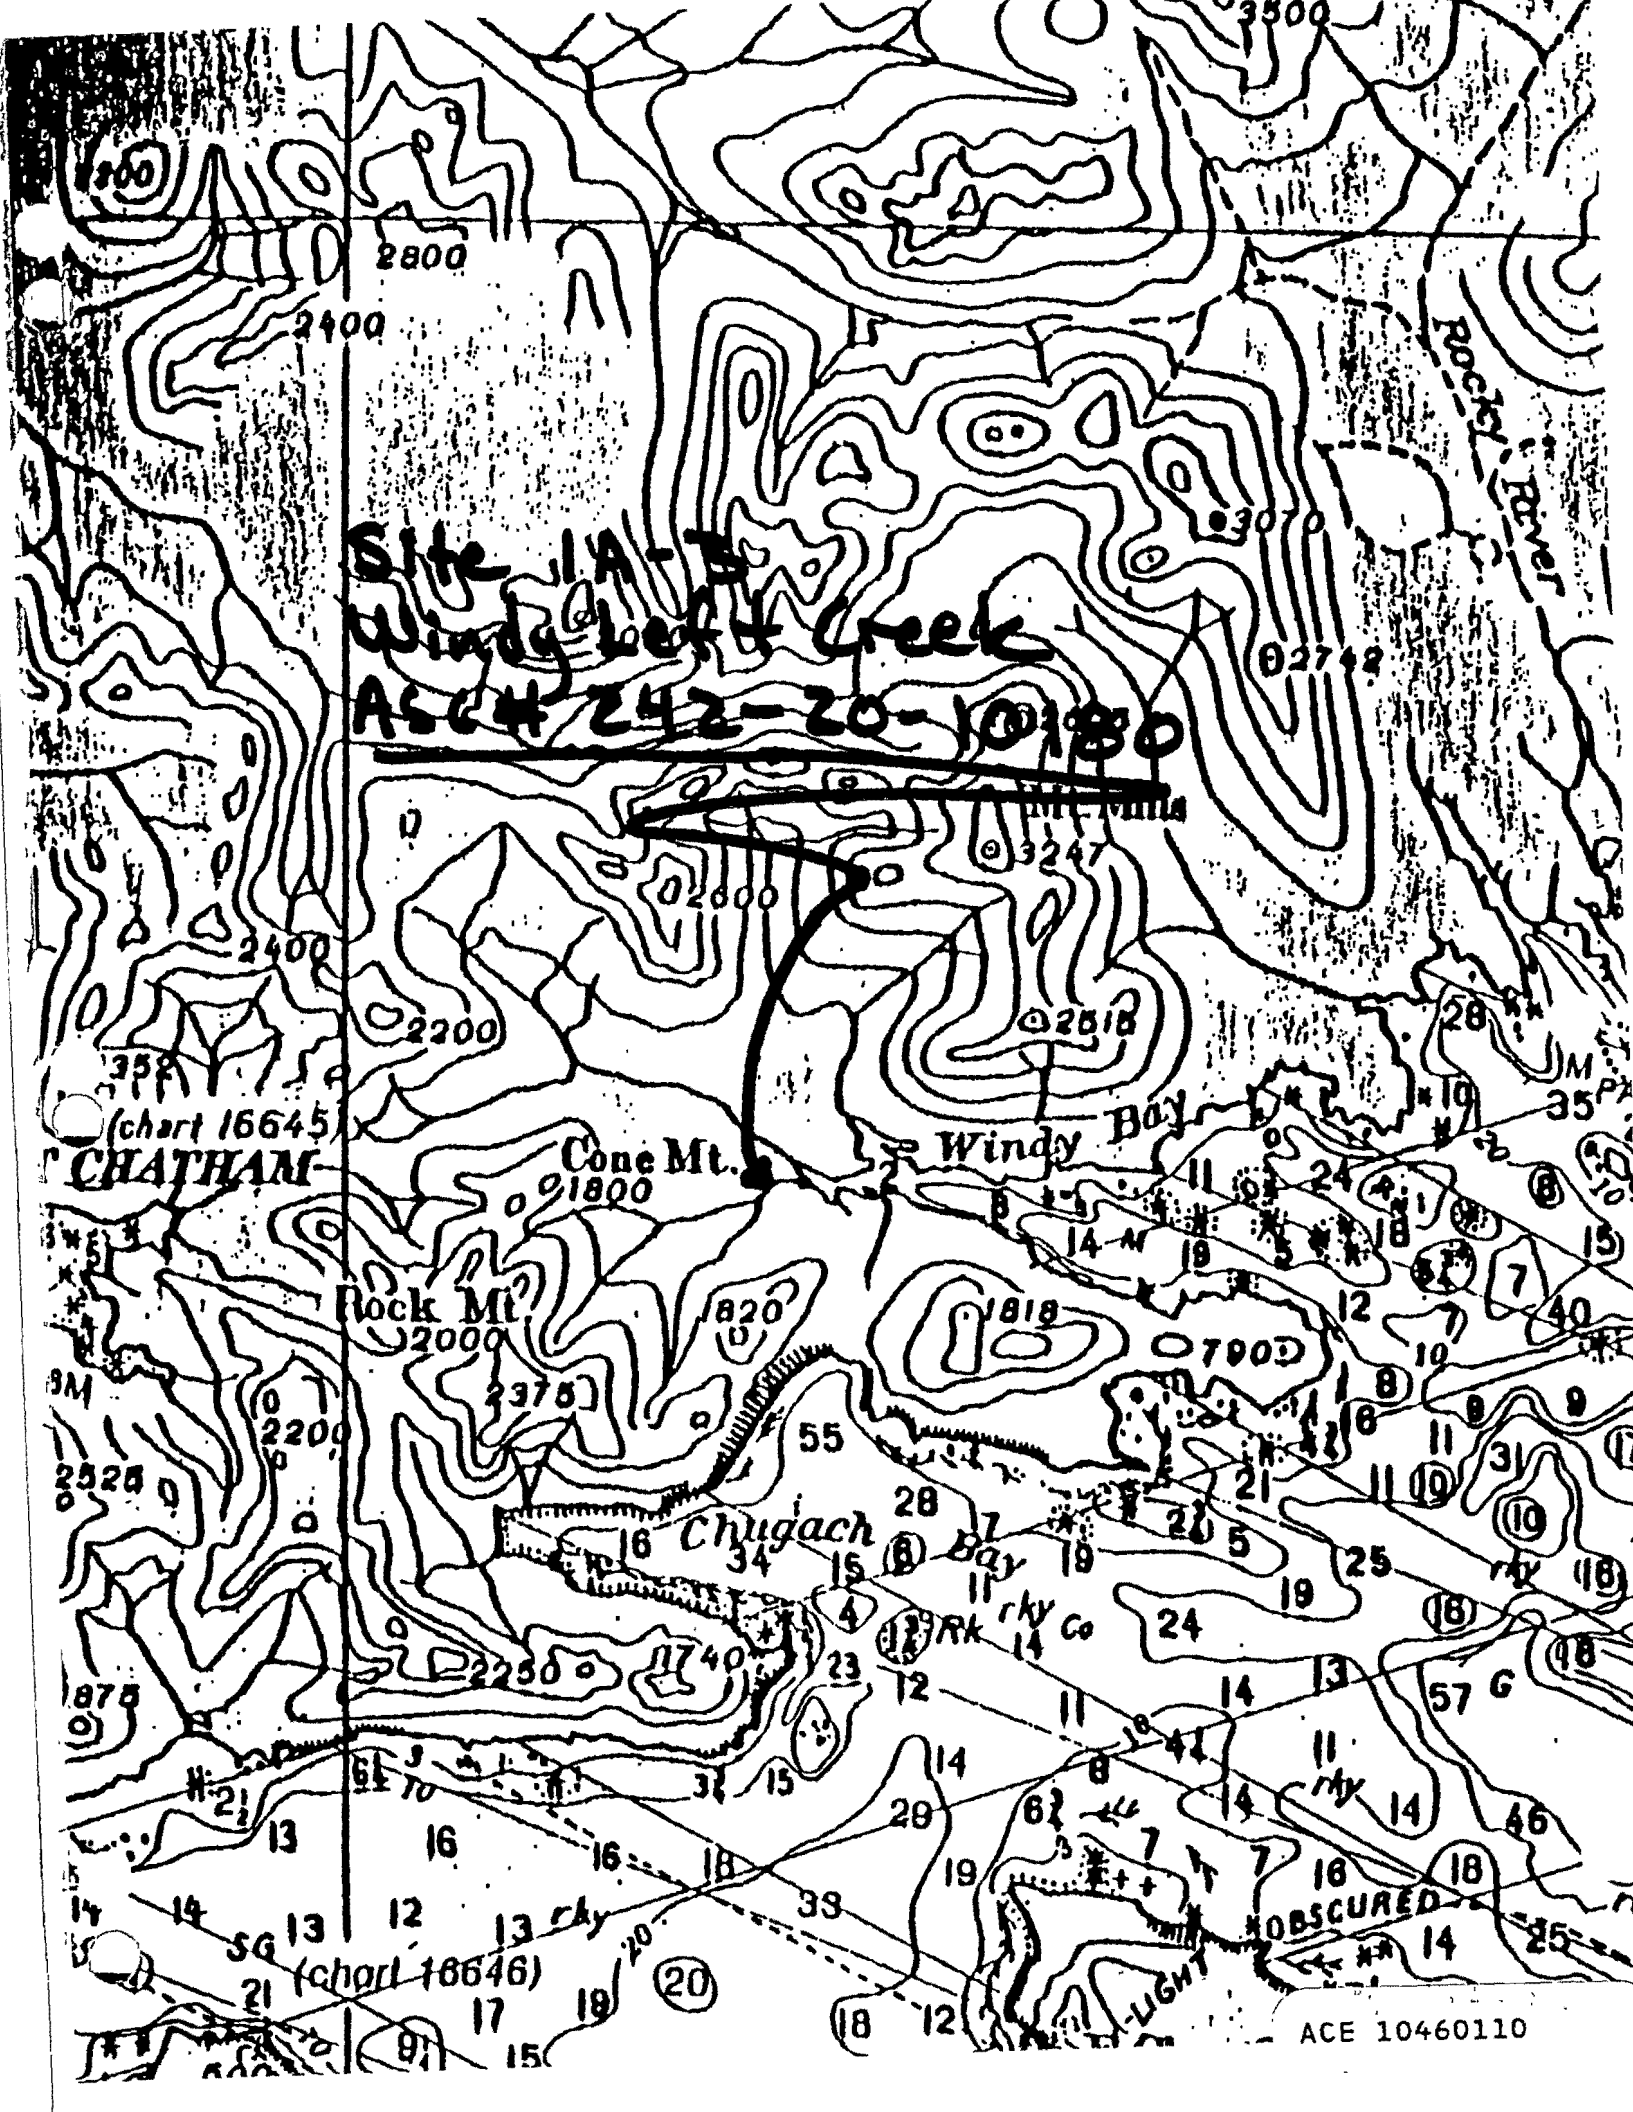
Site 1A-B
Windy Bay Creek
ASCH 242-20-10180

Windy Bay 5/15/89
heavy patch of mousse
