PORT DICK CRK

ASC NUMBER: 242-42-10460 SEGMENT NUMBER: PD-03  
LOCATION: PORT DICK CRK  
TEAM NAME:  
KODIAK K-UNIT: LOCAL STREAM #:  
USGS QUADRANGLE: Seldovia B-4  
SHORELINE TYPE: BEACH  
WAVE EXPOSURE: Moderate

May Shoreline Assessment Program  
1991

SEGMENT: PD-3  
SUBDIVISION: A  
DATE: 14 MAY 1991

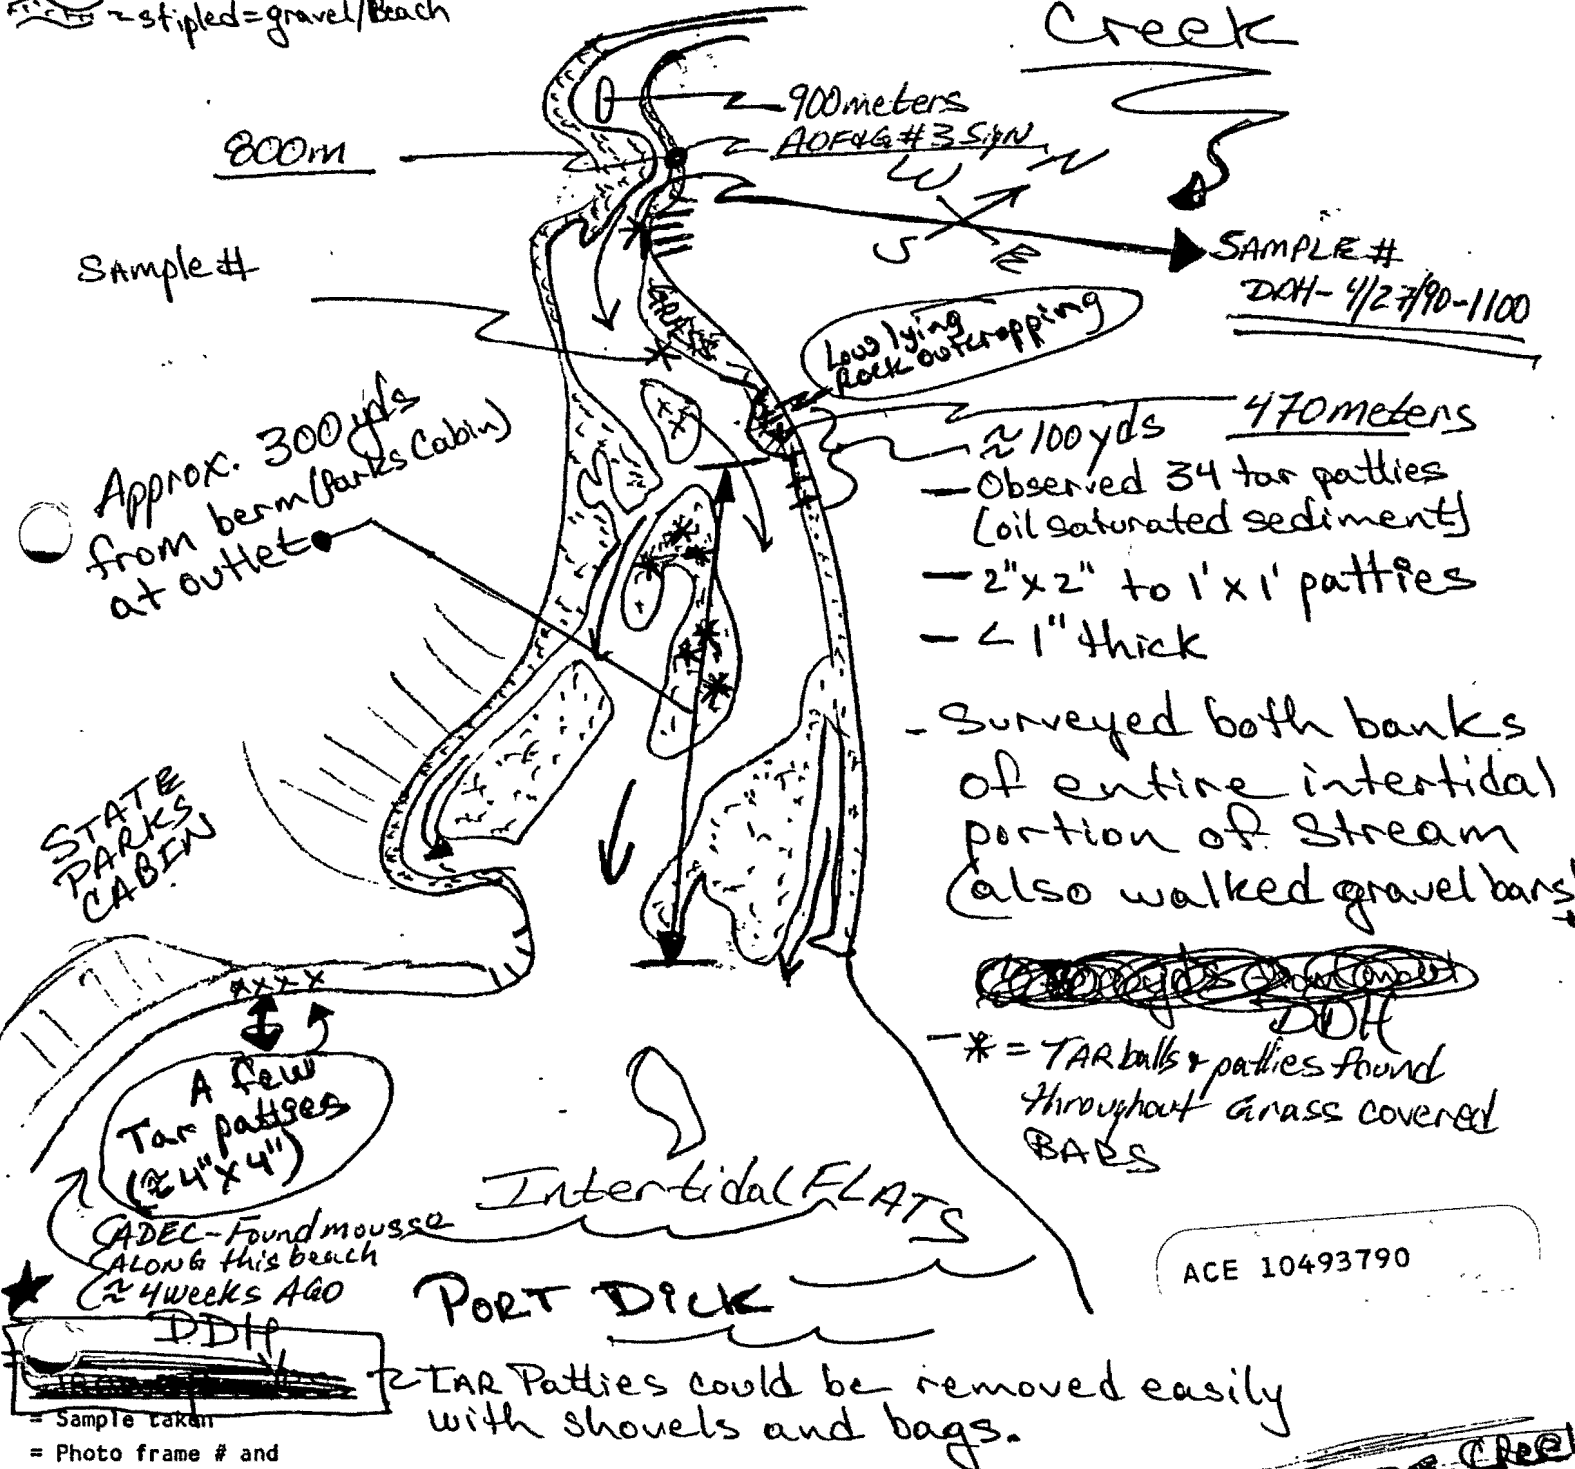
PORT Dick Creek

stippled = gravel/Beach

- $\approx 100$  yds 470 meters
- Observed 34 tar patties (oil saturated sediment)
- 2" x 2" to 1' x 1' patties
- < 1" thick

- Surveyed both banks of entire intertidal portion of stream (also walked gravel bars)

~~100 yds down stream~~  
DOH  
- \* = TAR balls & patties found throughout grass covered BARS

\* ANADSCAT Recommended

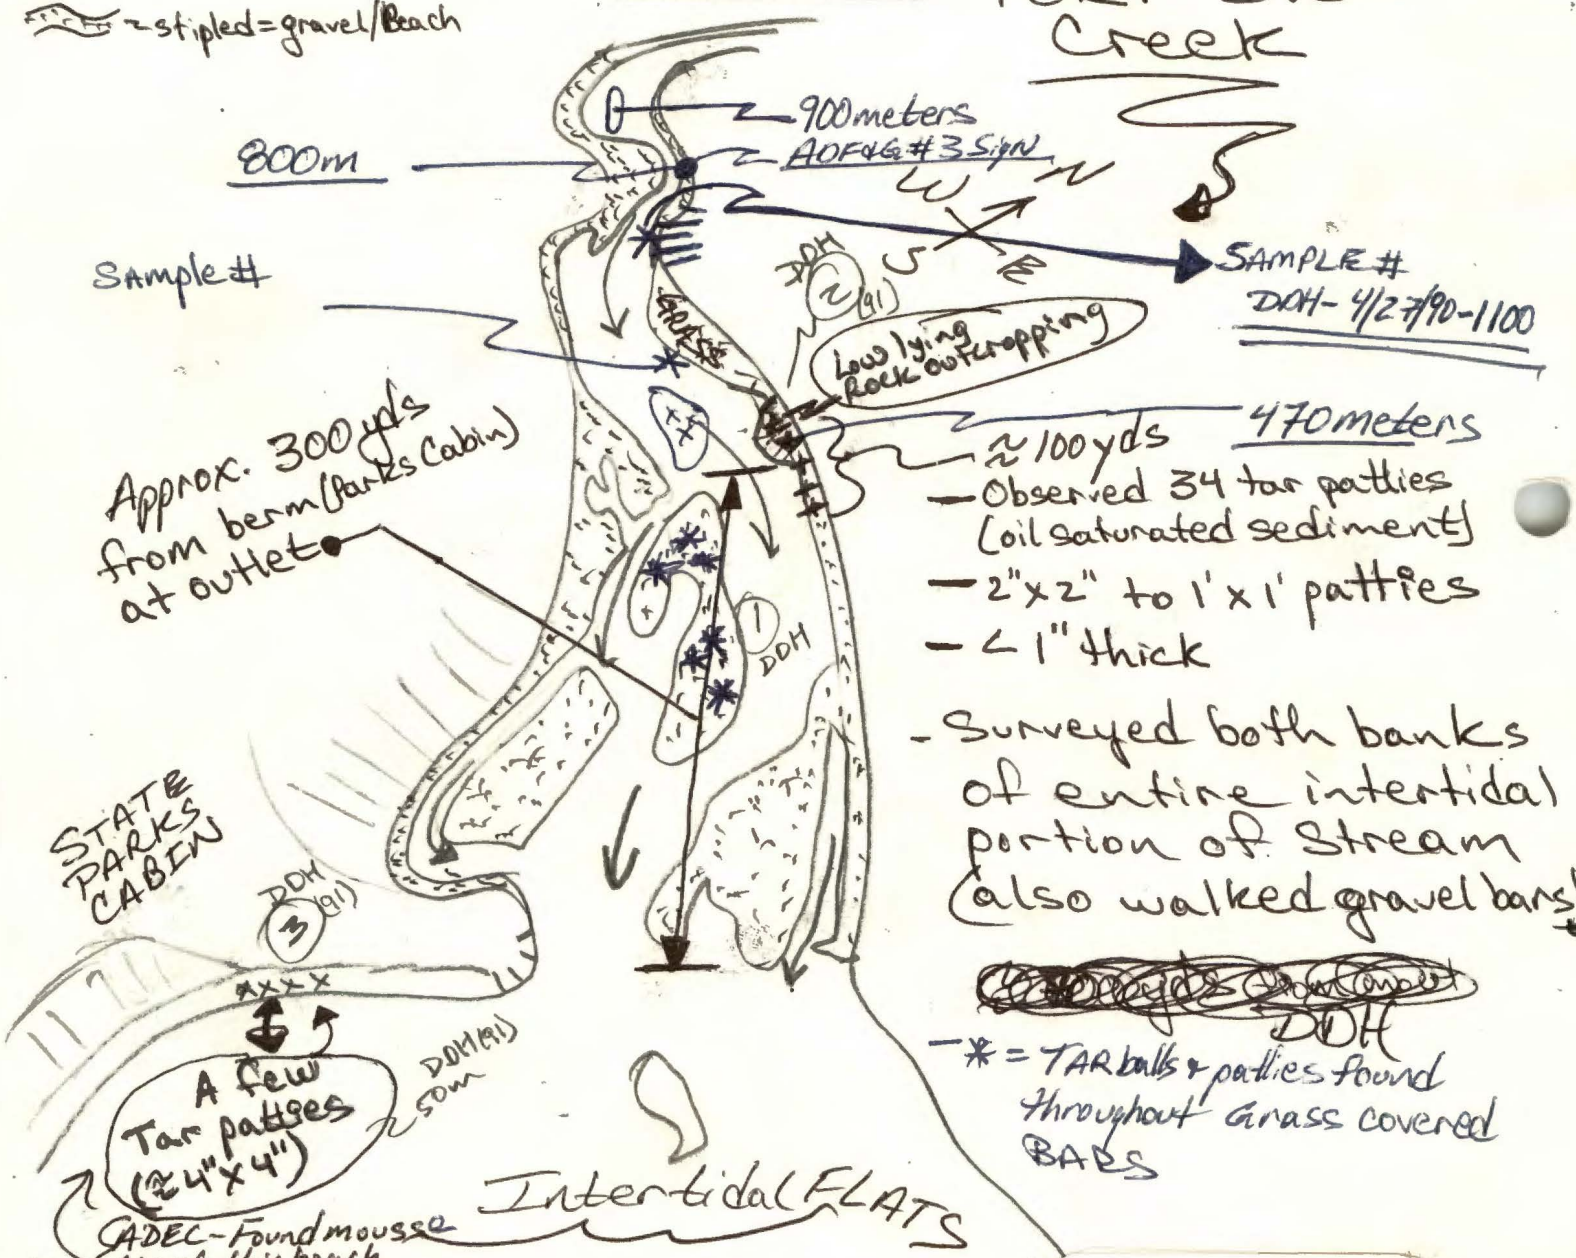
PORT Dick Creek

= stippled = gravel/Beach

Approx. 300 yds from berm (Parks Cabin) at outlet

~100 yds 470 meters  
- Observed 34 tar patties (oil saturated sediment)  
- 2" x 2" to 1" x 1" patties  
- < 1" thick

~~DDH (1) (91)~~  
DDH  
- \* = TAR balls & patties found throughout grass covered BARS

★  
A few Tar patties (~4" x 4")  
ADEC - Found mousse along this beach ~4 weeks ago  
DDH

\* ANADSCAT Recommended - ANADSCAT Complete 4/29/90

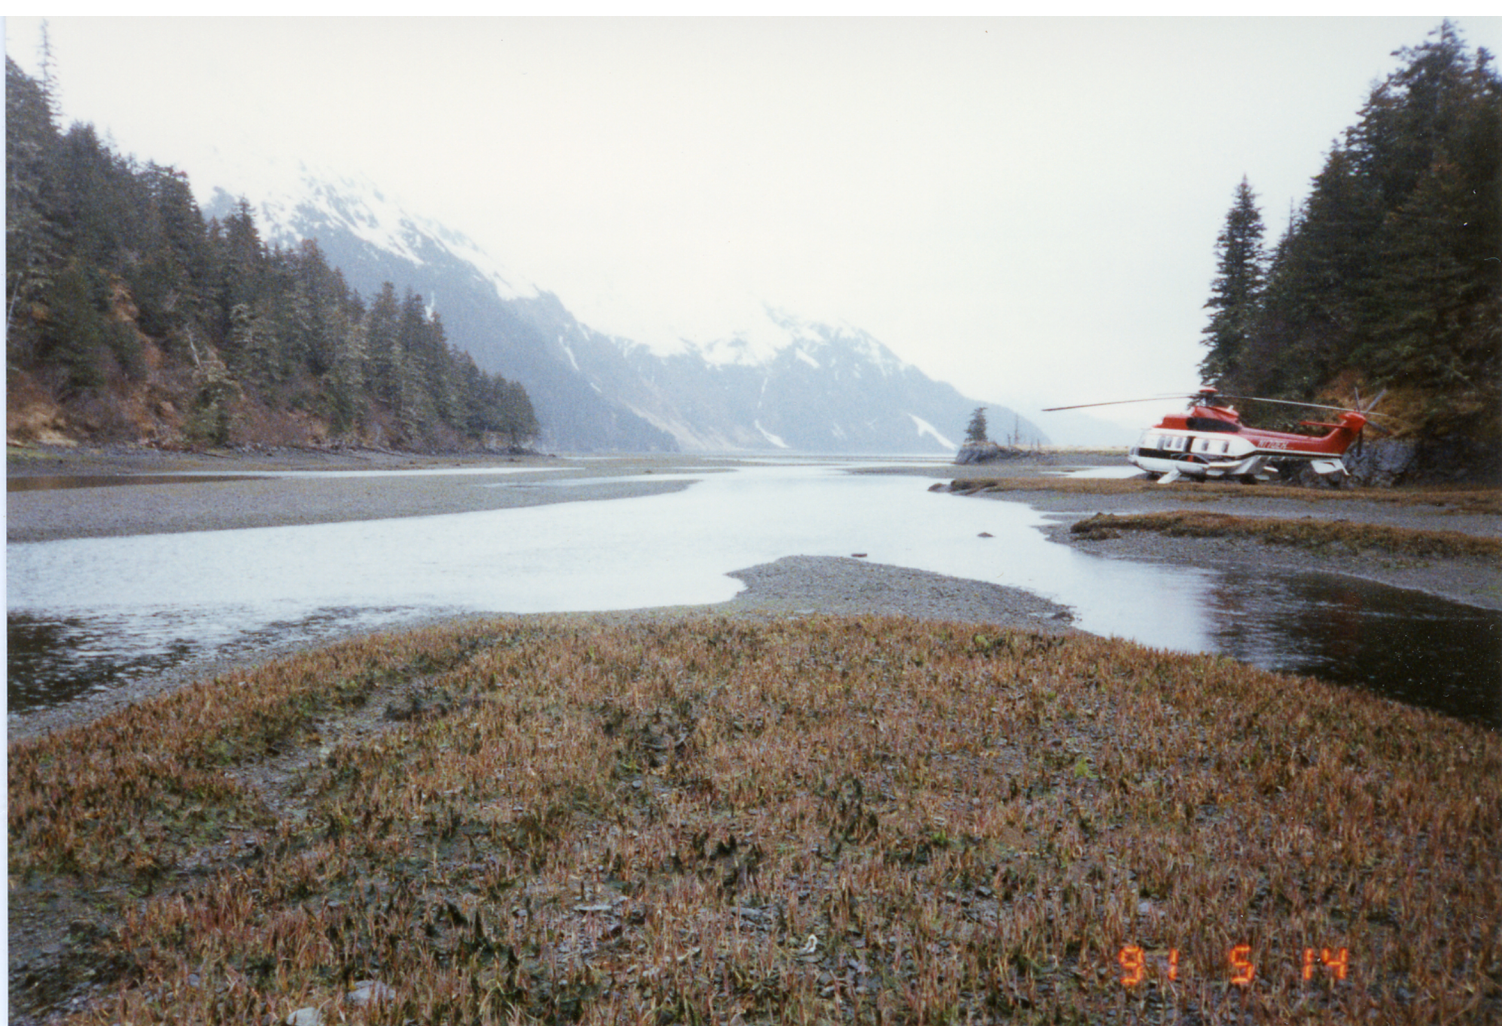
Segment No PD-3 Subdivision A  
Date 5/14/91 Log Frame No 15  
Photographer GARY SHIGENAKA  
Location PORT DICK - DICK CREEK  
Comments VIEW FROM SAME LOCATION AS # 14,  
PIVOTED 180° OR FACING EAST

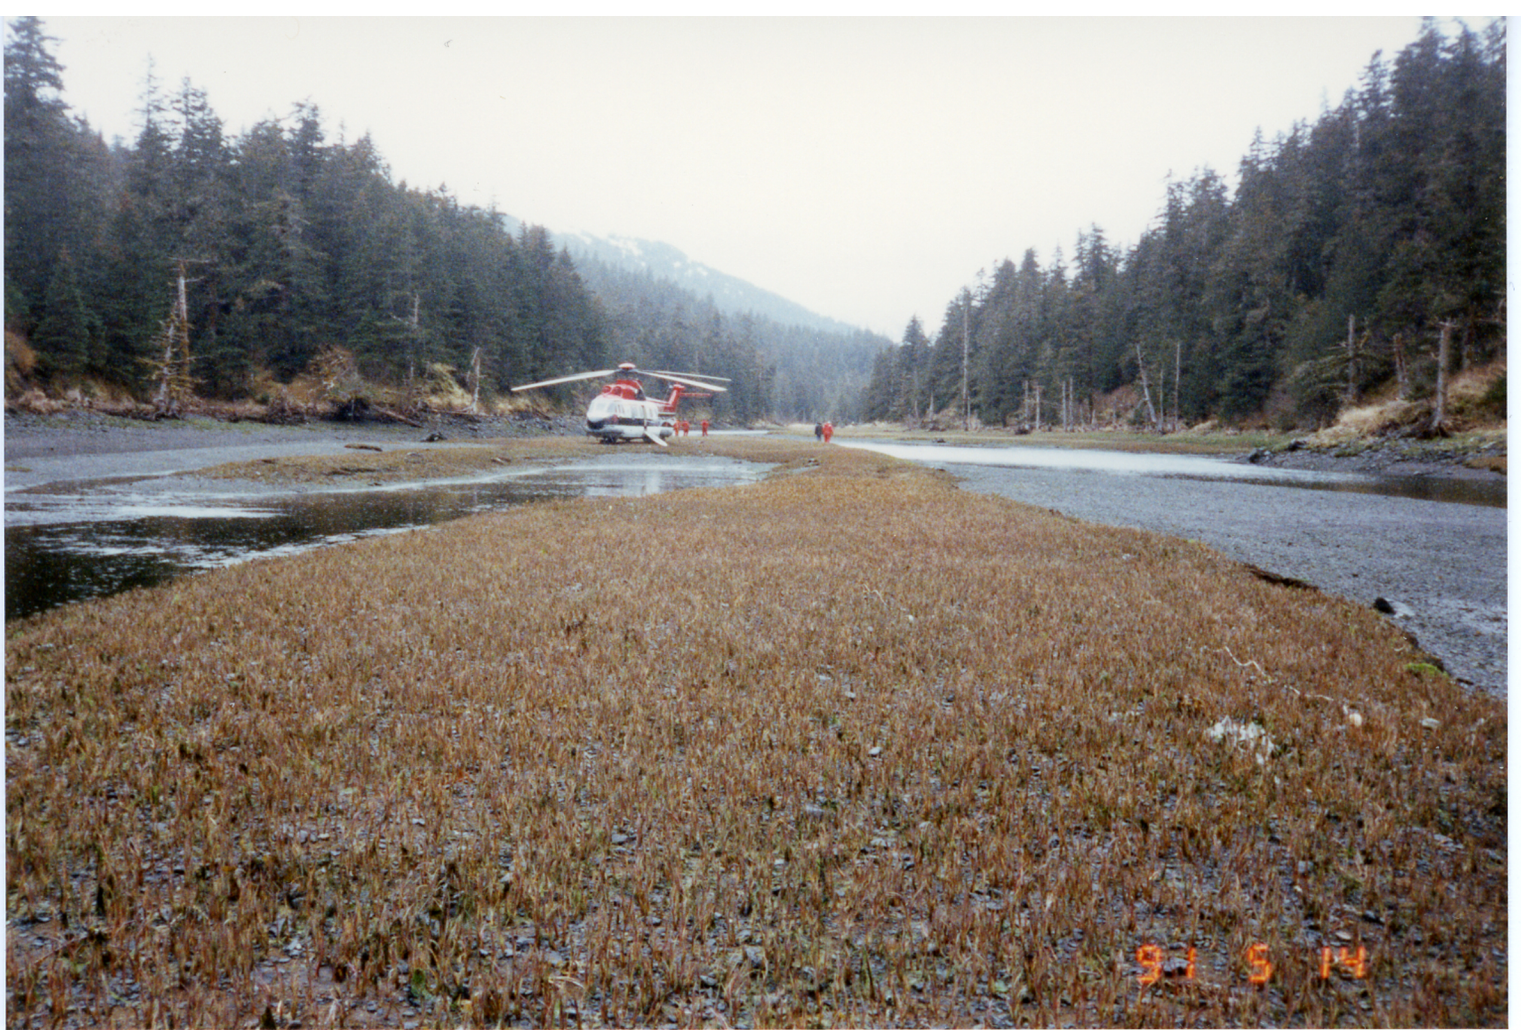
Segment No PD-3 Subdivision A  
Date 5/14/91 Log Frame No 14  
Photographer GARY SHIGENAKA  
Location PORT DICK - DICK CREEK  
Comments VIEW FROM ISLAND LOCATED IN THE MIDDLE  
OF DICK CREEK, LOOKING UPSTREAM OR WEST

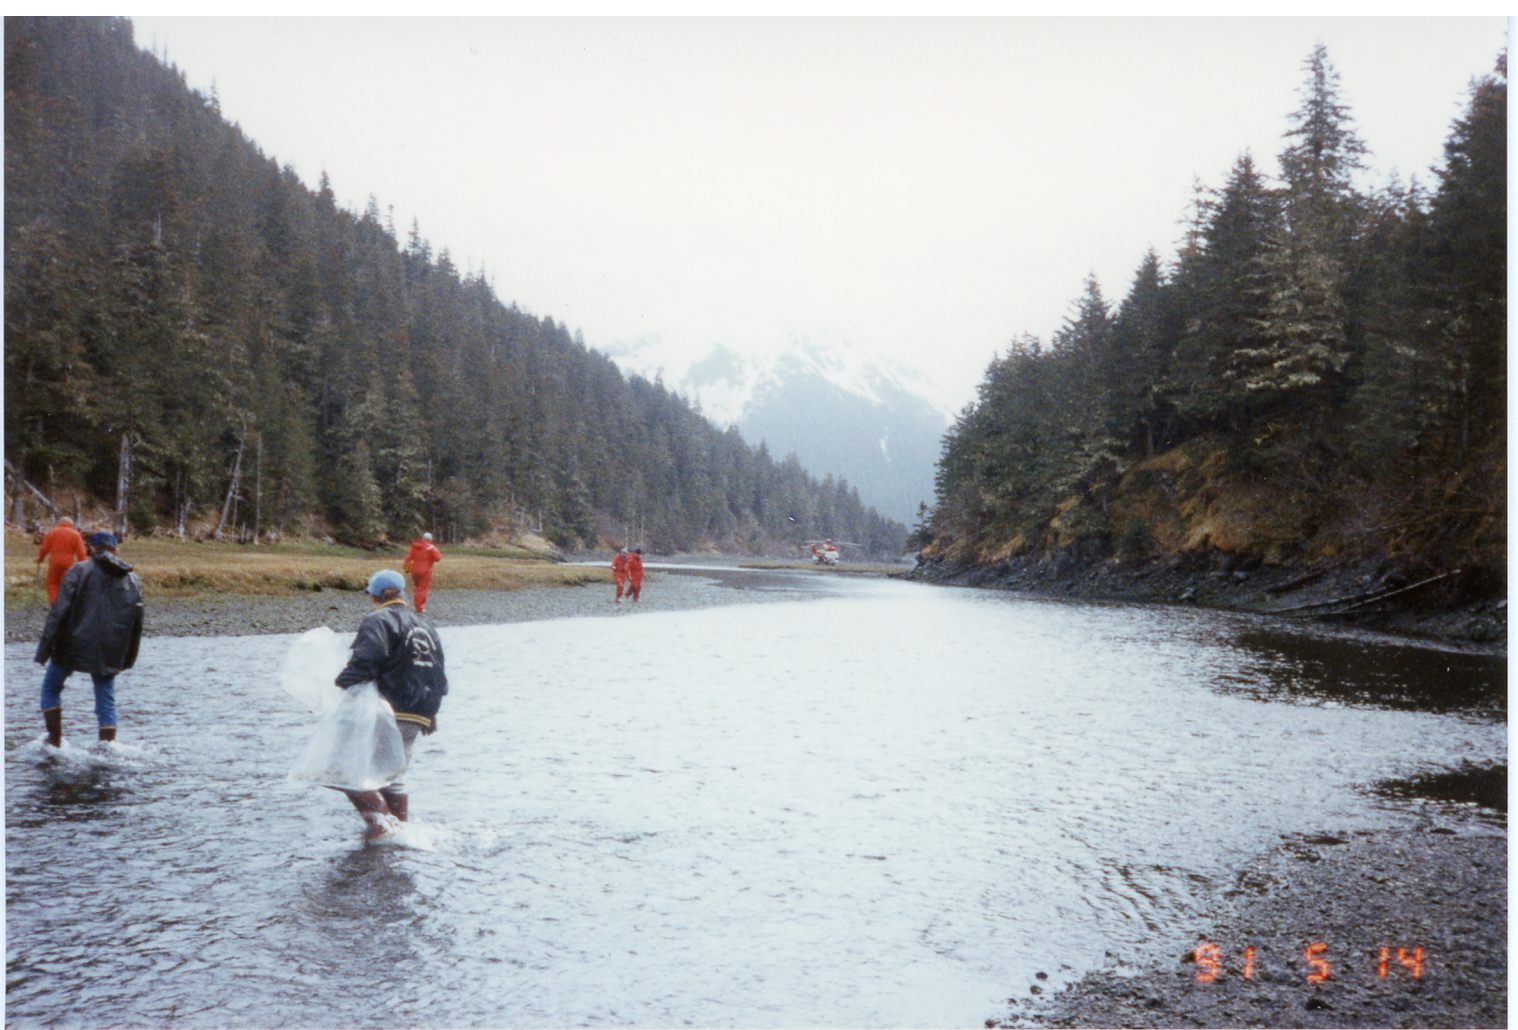
Segment No PD-3 Subdivision A  
Date 5/14/91 Log Frame No 16  
Photographer GARY SHIGENAKA  
Location PORT DICK - DICK CREEK  
Comments VIEW FROM UPSTREAM ISLAND (RELATIVE  
TO LOCATION FOR PHOTOS 14 AND 15) LOOKING  
DOWNSTREAM.
