KCI BEACH DATA INVENTORY - DATE AND LOCATION ENTRY 01/31/92

Enclosed are the  
revised habitat assessment  
forms.

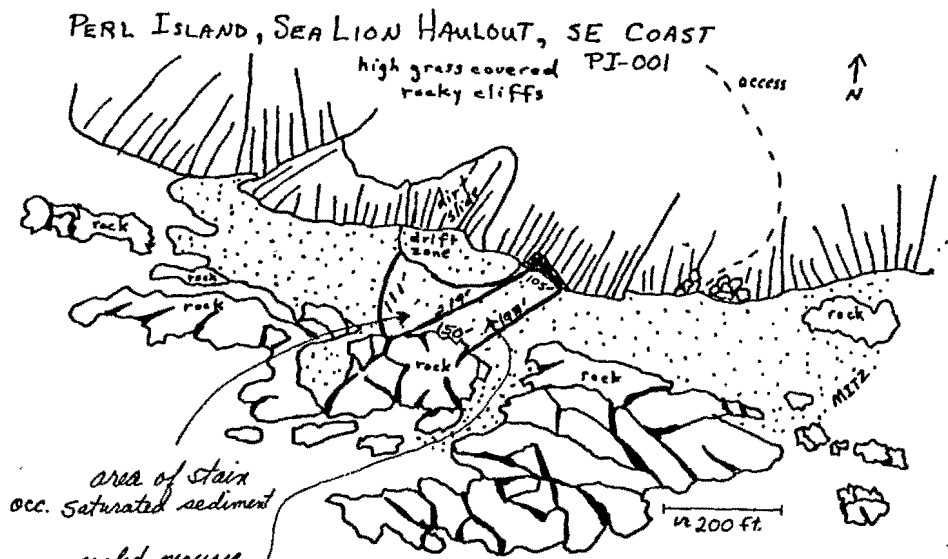
46 OIL DISTRIBUTION DIAGRAM

area of stain  
occ. saturated sediment  
pooled mousse  
in rocks  
asphalted-look

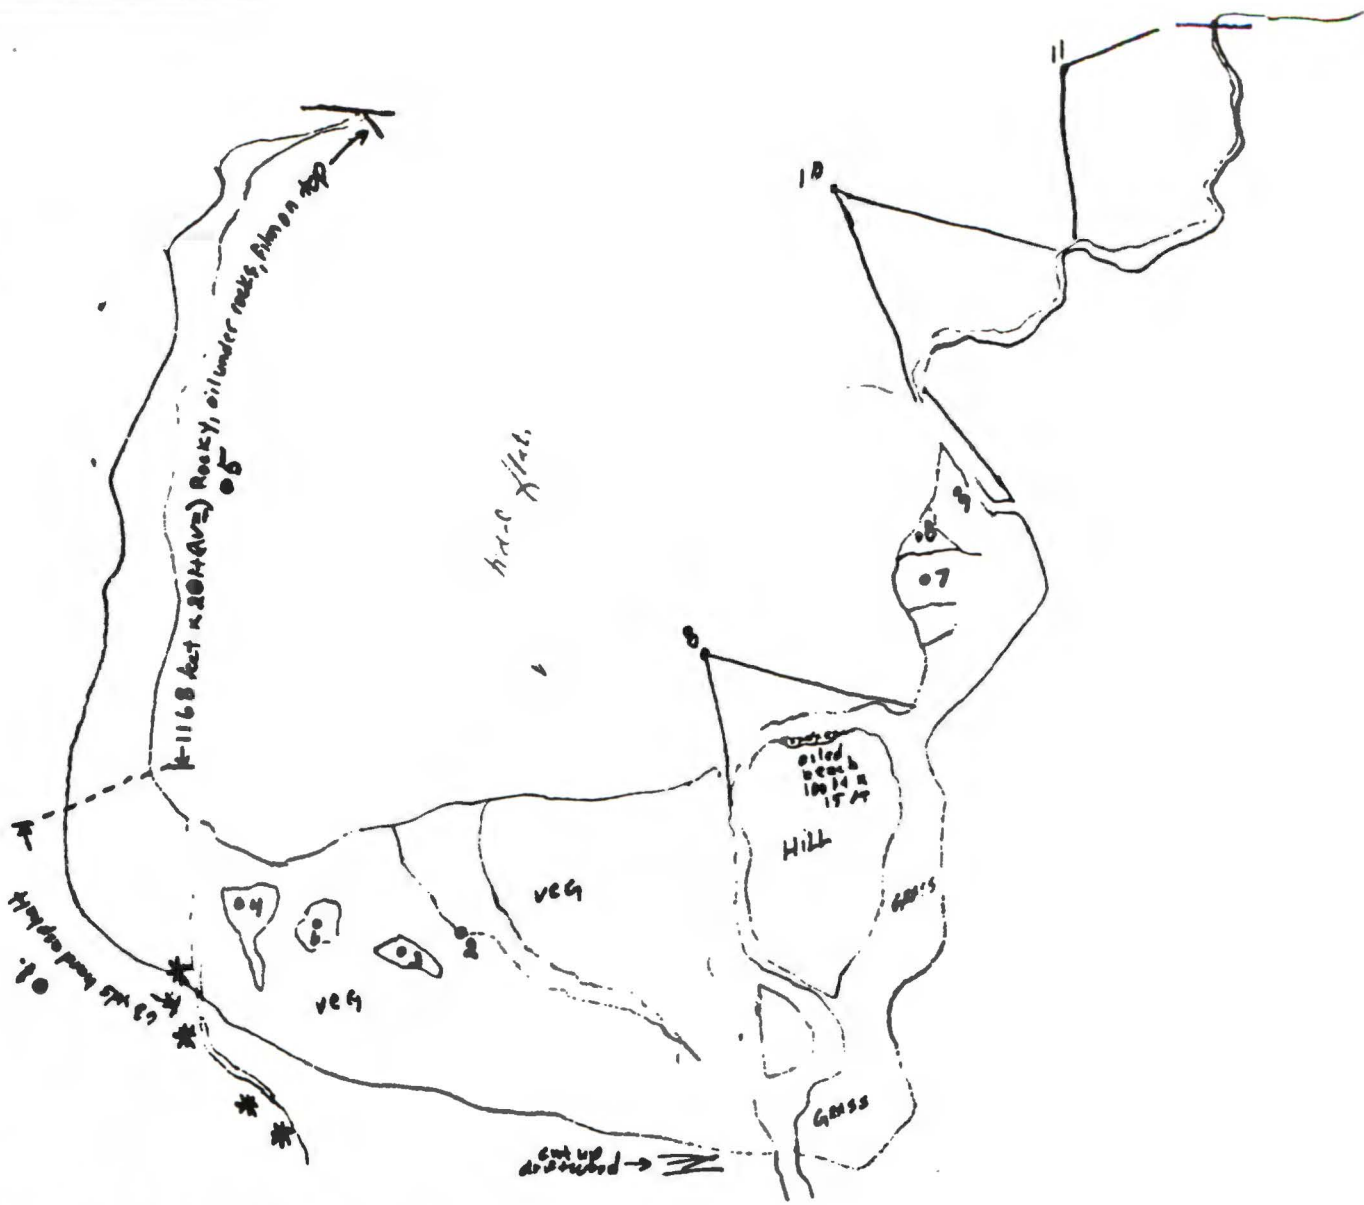
\* oiled cut up driftwood piles 6ft high x 12ft wide

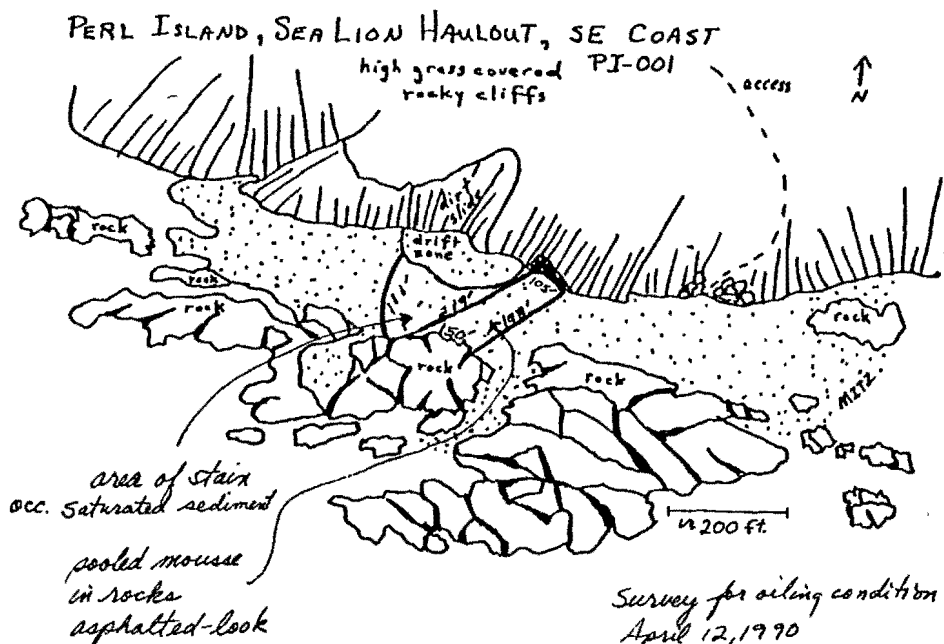
48 OIL DISTRIBUTION DIAGRAM

Oil not affected by winter storms except to darken a surface oil film, under film remains wet yellow-brown sticky mousse. Saturated sediments to 2.5 inches.

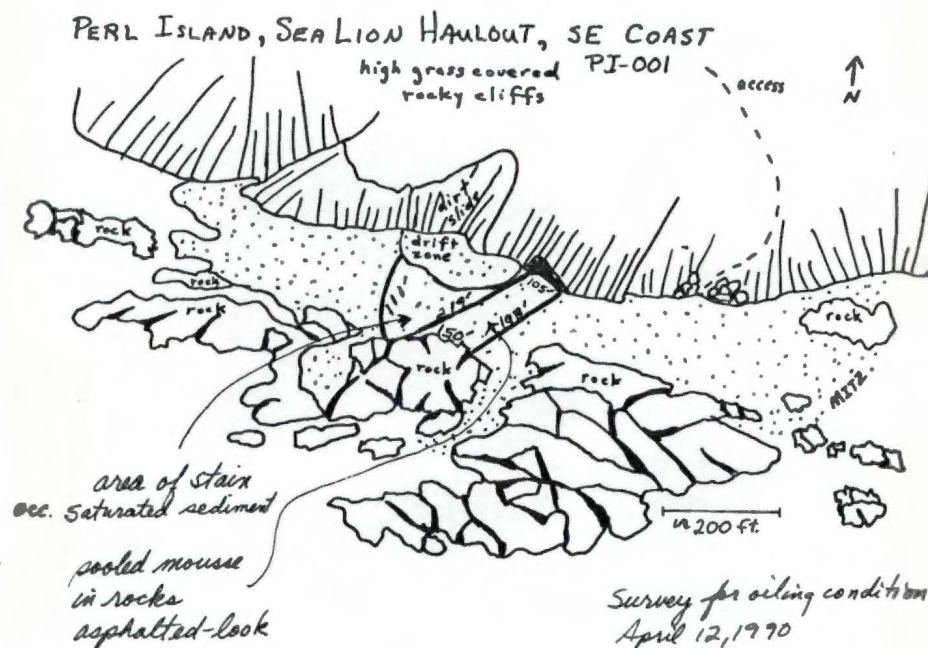
## 48 OIL DISTRIBUTION DIAGRAM

Oil not affected by winter storms except to darken a surface oil film, under film remains wet yellow-brown sticky mousse. Saturated sediments to 2.5 inches.

Sea lions haulout directly onto the oiled area. About 82 Stellar sea lions seen here in 1989. About 50 have been observed so far in 1990.
