POINT THOMSON  
COASTAL PROCESSES STUDY  
BEAUFORT SEA, ALASKA

PT. THOMSON COASTAL PROCESSES  
AND SEDIMENT DYNAMICS STUDY  
BEAUFORT SEA, ALASKA

PREPARED FOR:  
EXXON COMPANY U.S.A.  
CONTRACT NO. PTD-8206

JANUARY 1983

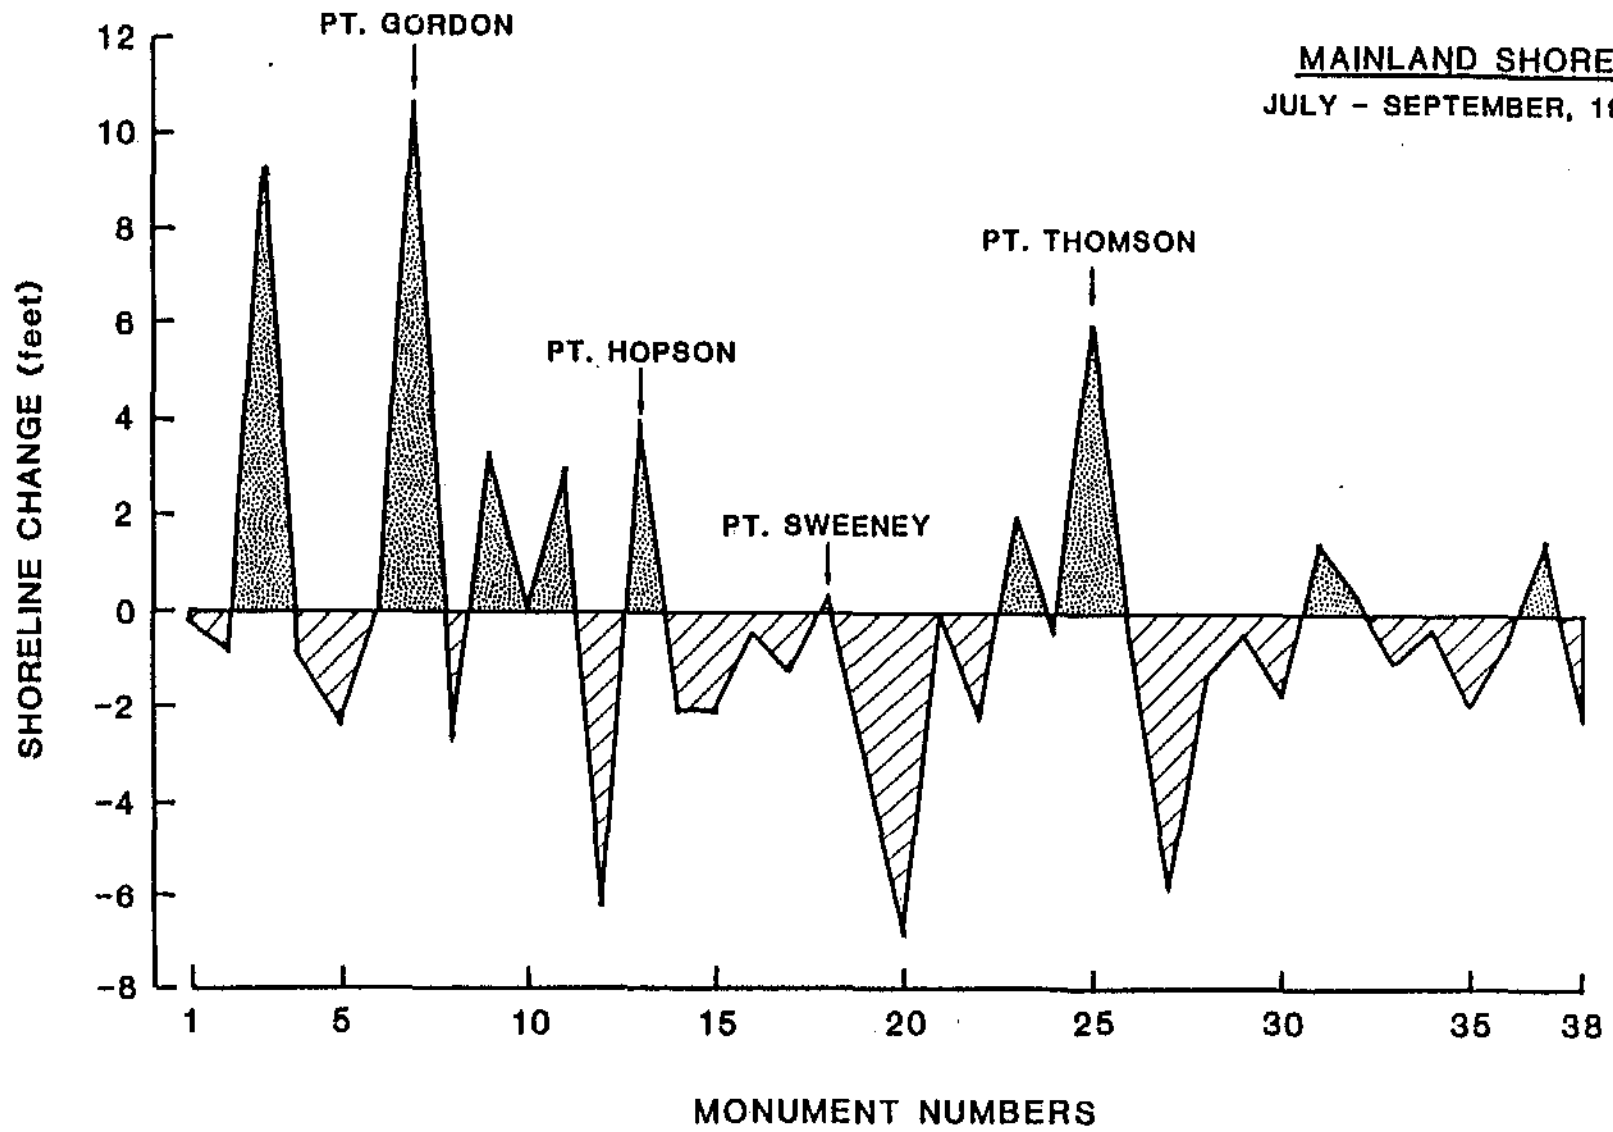
FIGURE 5.3 : CHANGES IN MAINLAND SHORE POSITION, 1982

The low-lying mainland shore is classified as a "chenier" beach formation, in which the sand and gravel beach sediments exist as a thin lens above a dense tundra foundation (King, 1961). During periods of strong westerly

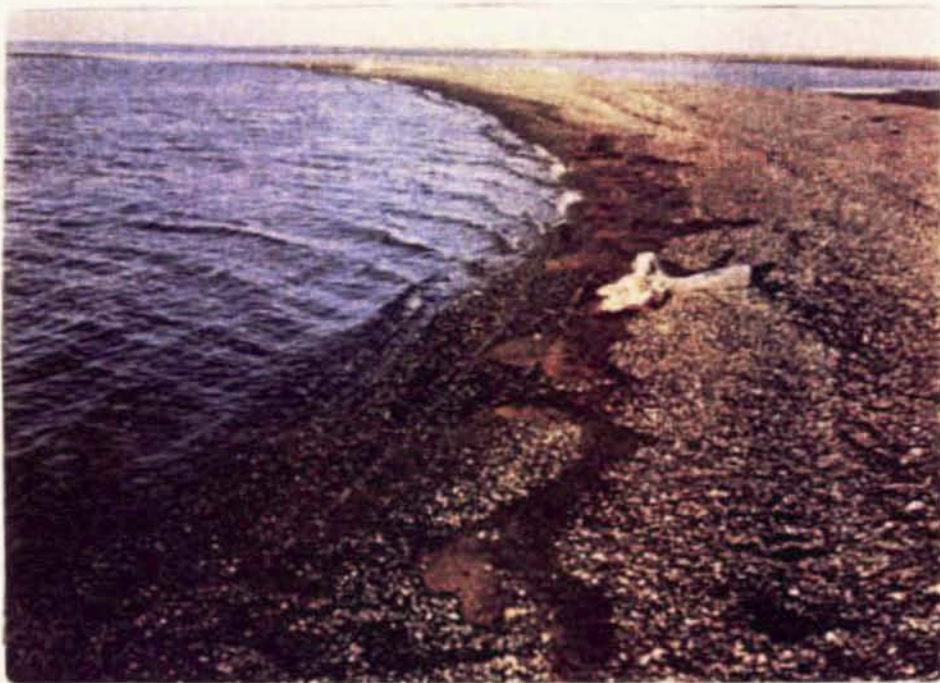
PHOTO 5. MAINLAND BEACH OVERLYING TUNDRA BASE. NOTE TUNDRA EXPOSURE NEAR WATER LEVEL.

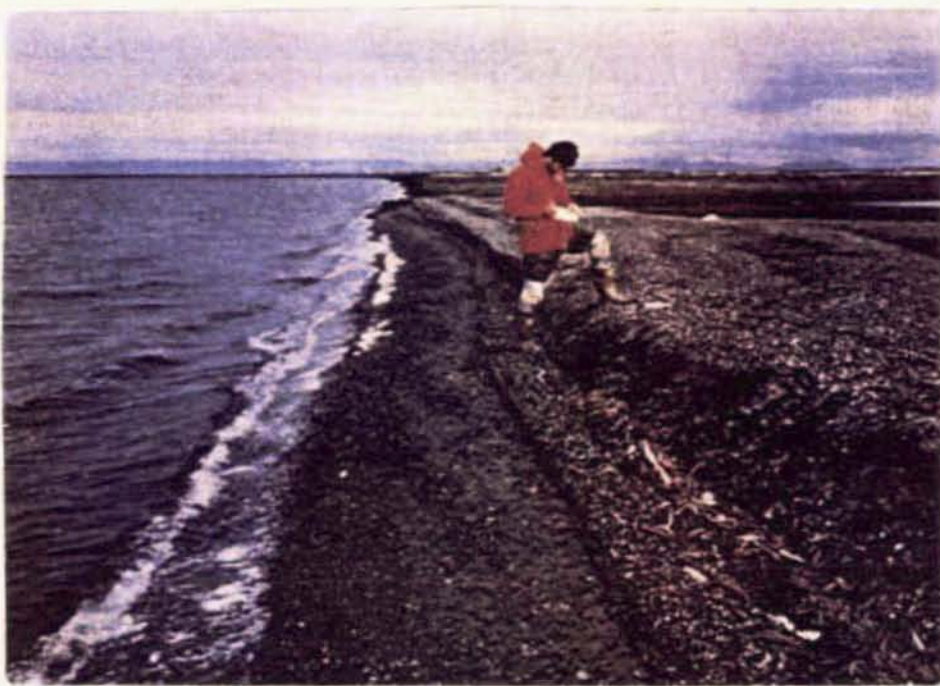
PHOTO 6. TYPICAL WAVE-GENERATED COASTAL SCARP NEAR TRANSECT #36, MAINLAND COAST.

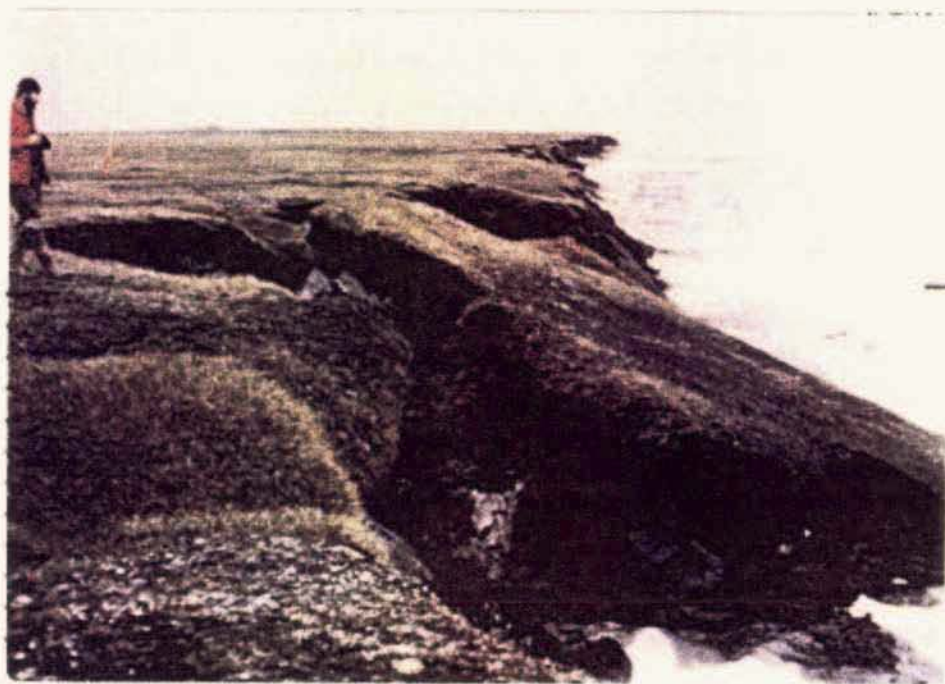
PHOTO 12. TYPICAL BLUFF EROSION, NORTHERN SHORE OF FLAXMAN ISLAND

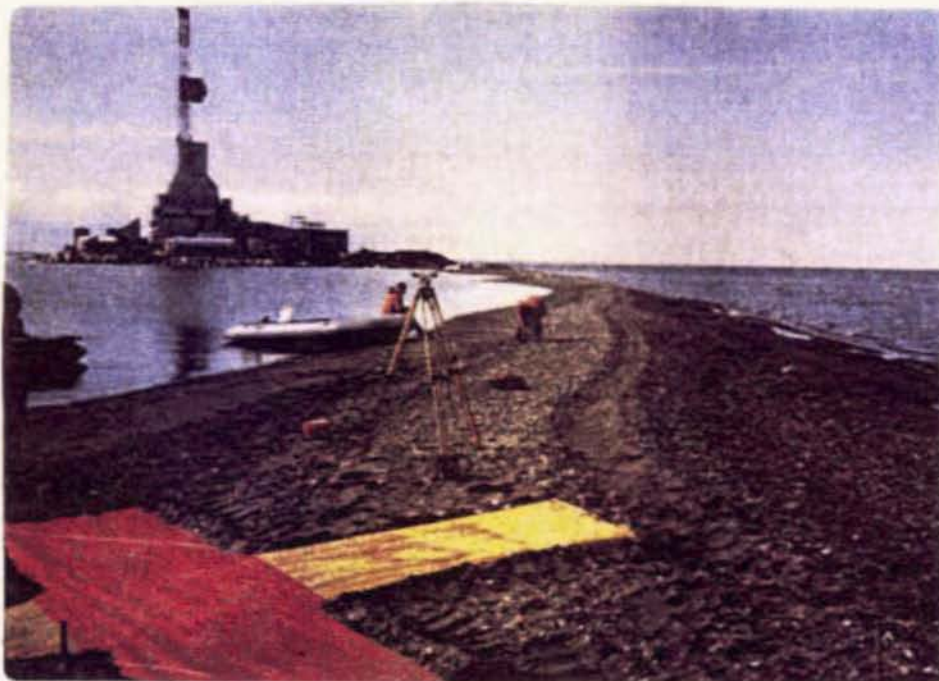
PHOTO 13. TRANSECT #61, EAST END OF ALASKA ISLAND, JULY 25, 1982. SOHIO'S EXPLORATION PAD IS SEEN IN THE BACKGROUND

During the summer surveys, major changes were observed at several survey transects along the barrier island chain. Photo 13 shows a view of Monument #61, located just east of the Alaska Island exploration pad, at the time of the initial survey target on July 25, 1982. Following a strong westerly storm on the following day, the target was observed to be partially buried by sand that had been transported onto the target during the storm (Photo 14). At the time of the September survey, the target had been buried to an even greater extent, as shown in Photo 15, by a subsequent westerly storm event or events. The depth of total burial was about six inches, as shown in the plot of comparative surveys, Figure 5.9. During the July-September period, the sediment that buried the target was apparently derived from

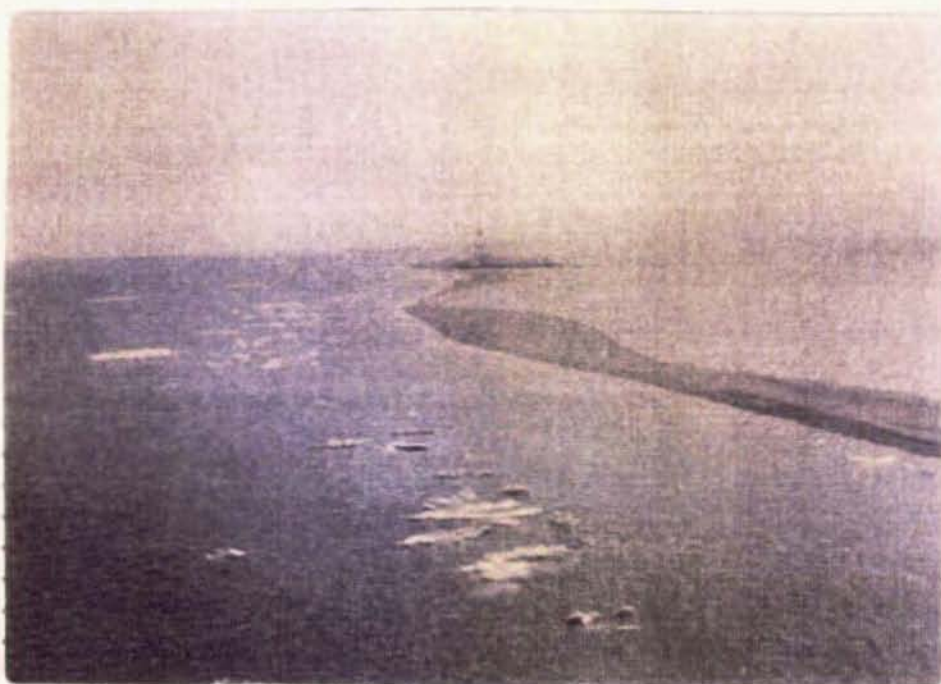
PHOTO 19. VIEW OF FILLED INLET THAT NOW CONNECTS  
DUCHESS AND NORTH STAR ISLANDS, JULY,  
1982. EXXON'S NORTH STAR DRILLING PAD  
IS SEEN IN THE BACKGROUND

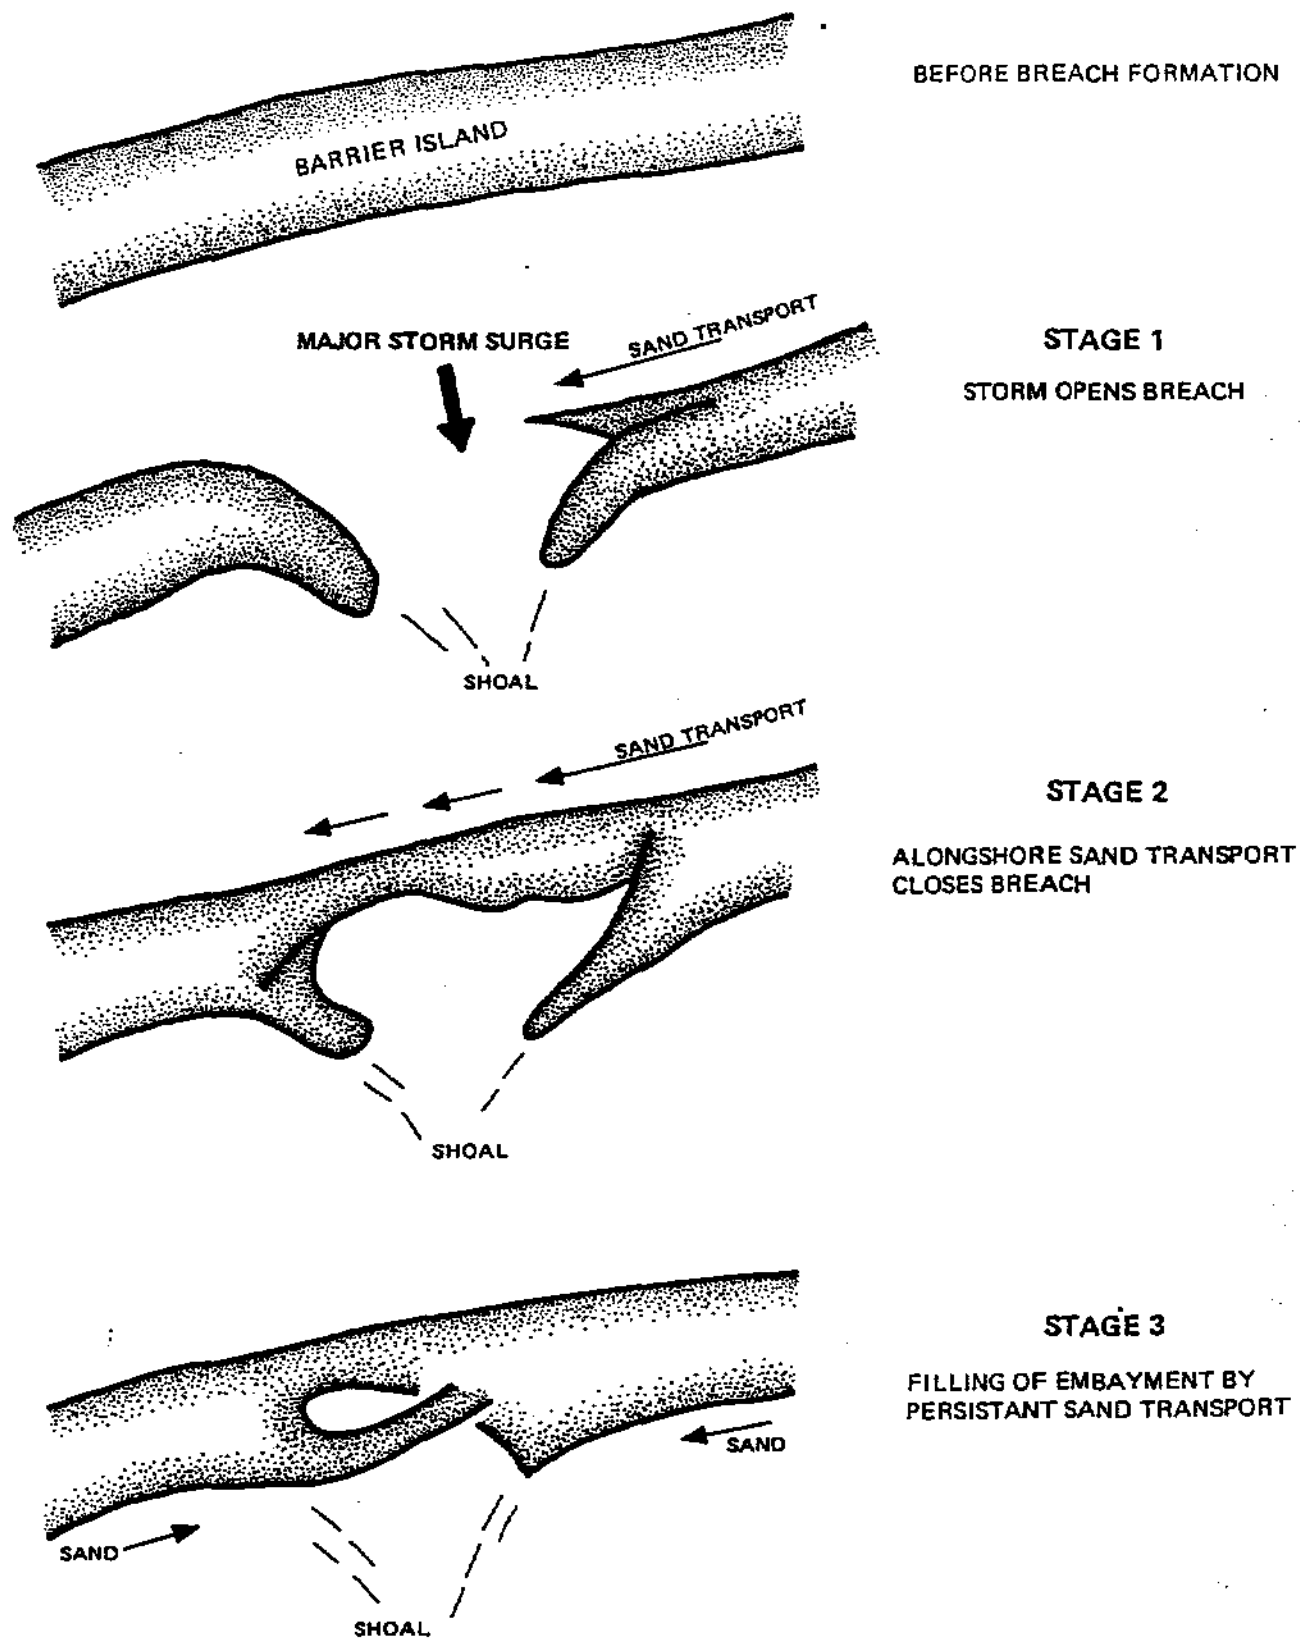
FIGURE 5.11 : BARRIER ISLAND INLET FORMATION

Figure 5.11 shows a conceptual view of inlet formation and filling. A large storm event can cause the initial breach formation which is followed by initial inlet deepening by tidal currents (Stage 1). With time, however, the persistent easterly wind and waves transport sediment in a westward direction, thereby reconnecting the two island segments with a thin strip of sand and gravel (Stage 2). As this sediment body continues to be nourished by the updrift sediment supply, the filling of the inlet proceeds (Stage 3). This total process can occur within a span of several years, as witnessed during the 1979-1981 period on No Name Island (Gadd, et al., 1982).

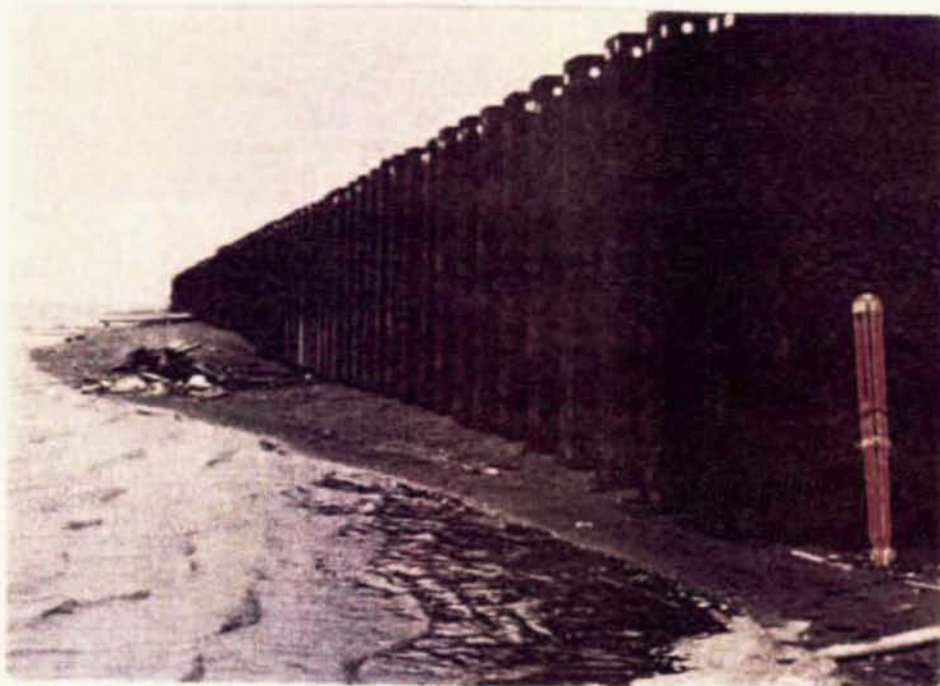
PHOTO 22. SHEET PILE WALL ON THE NORTH SIDE OF  
FLAXMAN ISLAND DRILLING PAD SHOWING  
THE CLOSE PROXIMITY OF THE WATERLINE

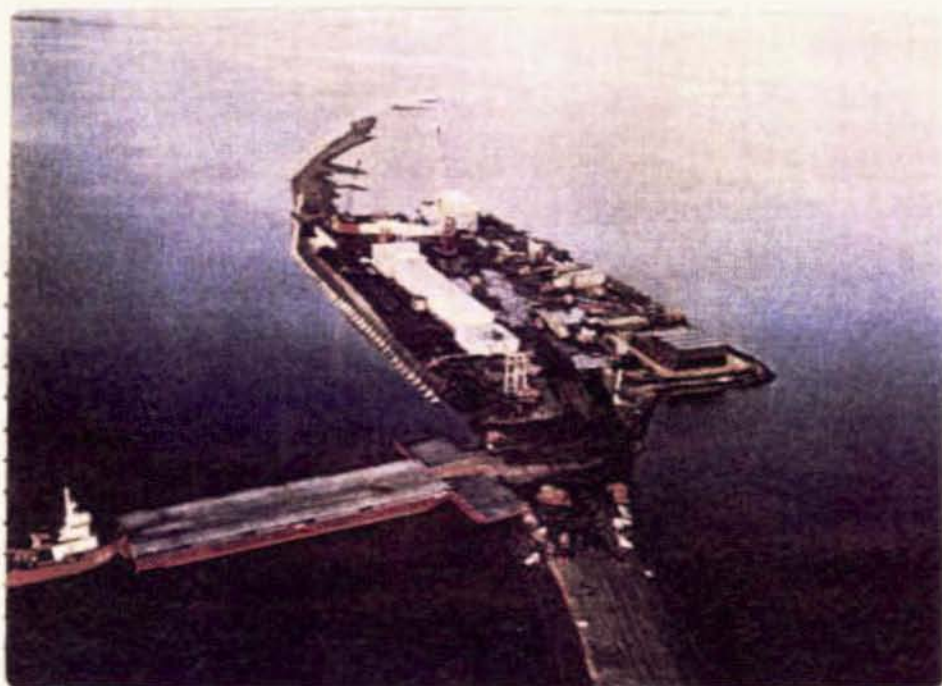
PHOTO 24. AERIAL VIEW, ALASKA ISLAND DRILLING PAD.  
NOTE DISTANCE TO WHICH SOUTHERN PORTION  
OF PAD EXTENDS INTO THE LAGOON

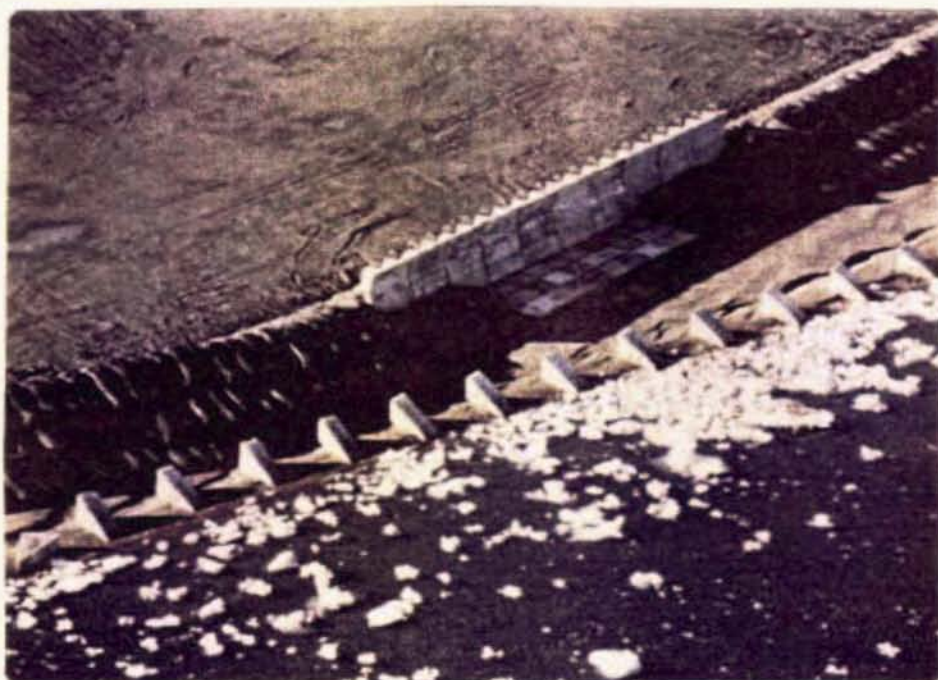
PHOTO 26. INNOVATIVE SLOPE PROTECTION SYSTEMS ON ALASKA ISLAND DRILLING PAD.

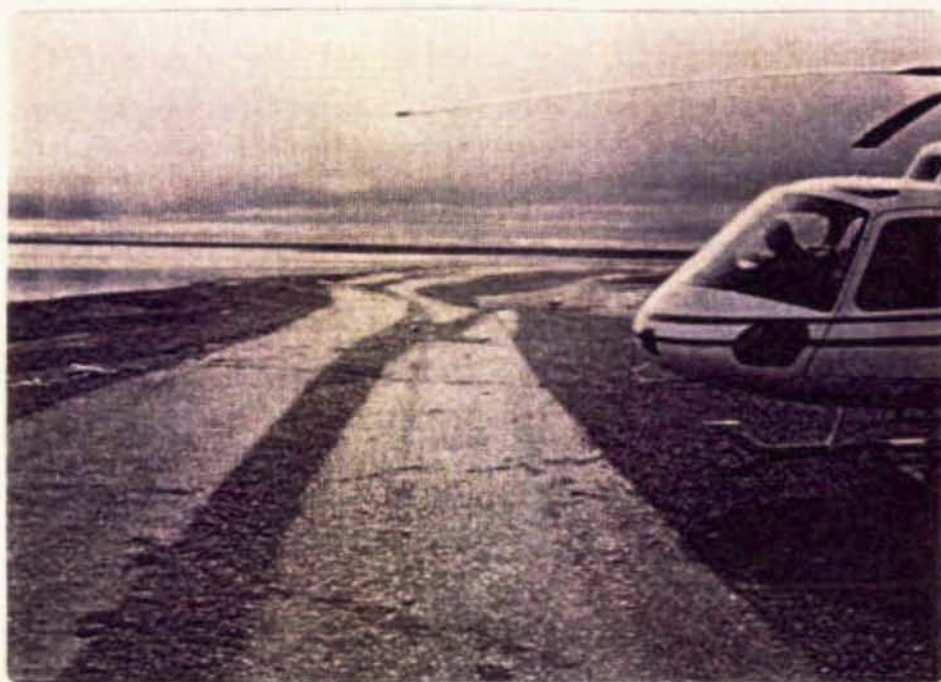
PHOTO 27. ROLLAGON TRACKS ON THE SURFACE OF THE MAINLAND COAST ILLUSTRATE THE UTILITY OF NATURAL CHENIER BEACH AS TRANSPORTATION ROUTE

- o Coastal Transportation Routes: In addition to the man-made engineering facilities within the study area, it is worthwhile to mention that the natural gravel beaches that exist along both the mainland shore and the barrier islands support vehicular travel during the winter and summer months. In Photo 27, taken near Transect #16, recent wide-wheel (rollagon) tracks can be seen atop the thin, narrow gravel beach. Thus, the gravel beaches of the study area may be considered to be viable transportation routes throughout the region.

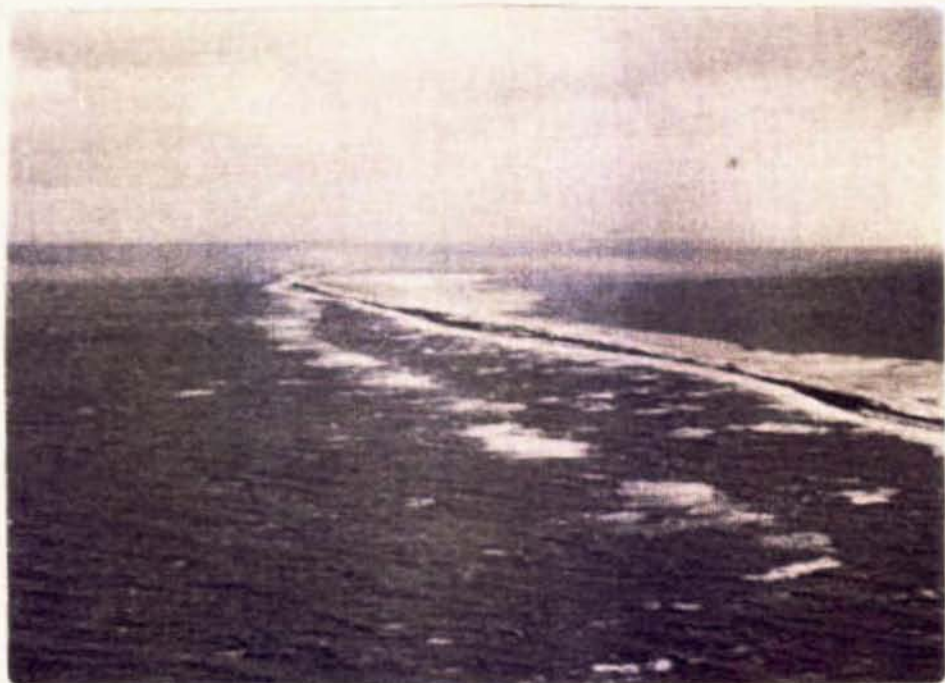
PHOTO 28. WAVES BREAKING ON LONGSHORE BARS  
FRONTING BARRIER ISLAND

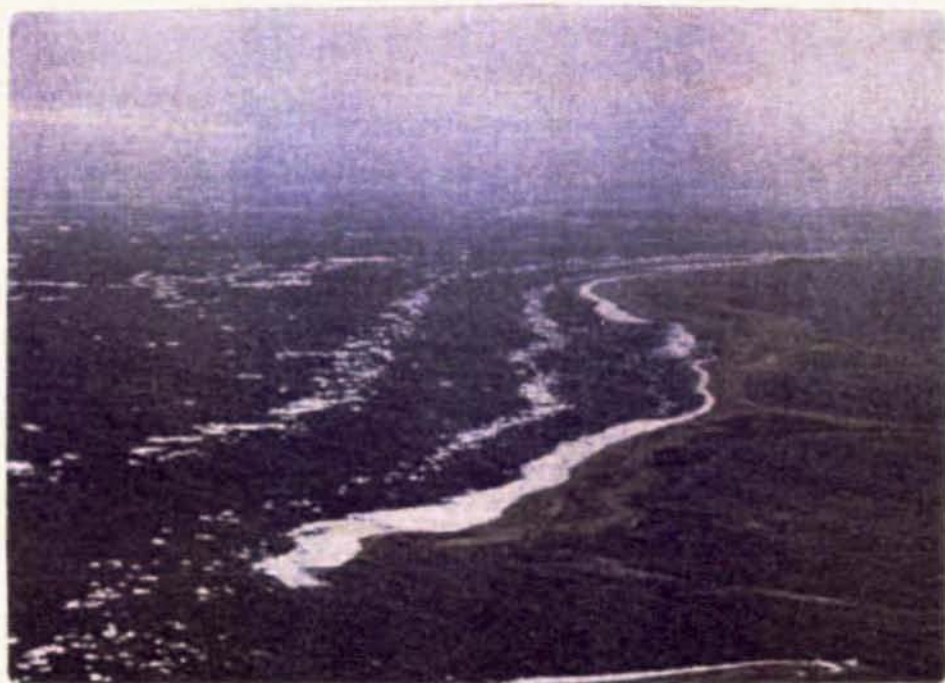
PHOTO 29. GROUNDED ICE FRAGMENTS CLEARLY SHOW  
THE POSITION OF OFFSHORE SAND BARS
