5. SURVEY FINDINGS

5.1 Areas of Relative Shoreline Stability

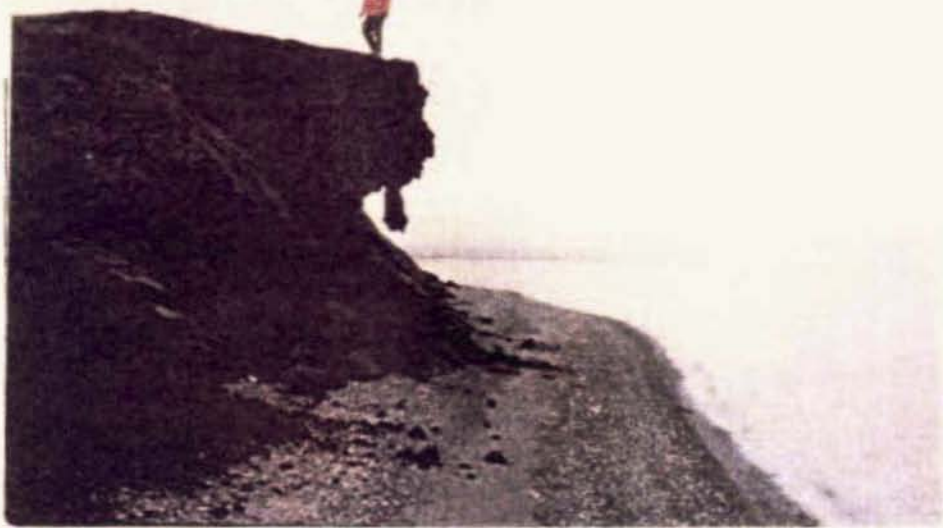
PHOTO 2. COASTAL BLUFF EROSION ON THE MAINLAND SHORE NEAR TRANSECT #5

Due in part to the protection provided by the sand and gravel beaches existing at the base of the bluffs, bluff recession along the majority of the mainland shore is relatively mild. At several unsurveyed locations, however, extensive bluff recession was observed in spite of the energy-dissipating beachfront, as shown in Photo 2, taken near Transect #5. The major mechanism of bluff erosion in this case is the thawing and subsequent failure of the ice-laden bluff sediments.

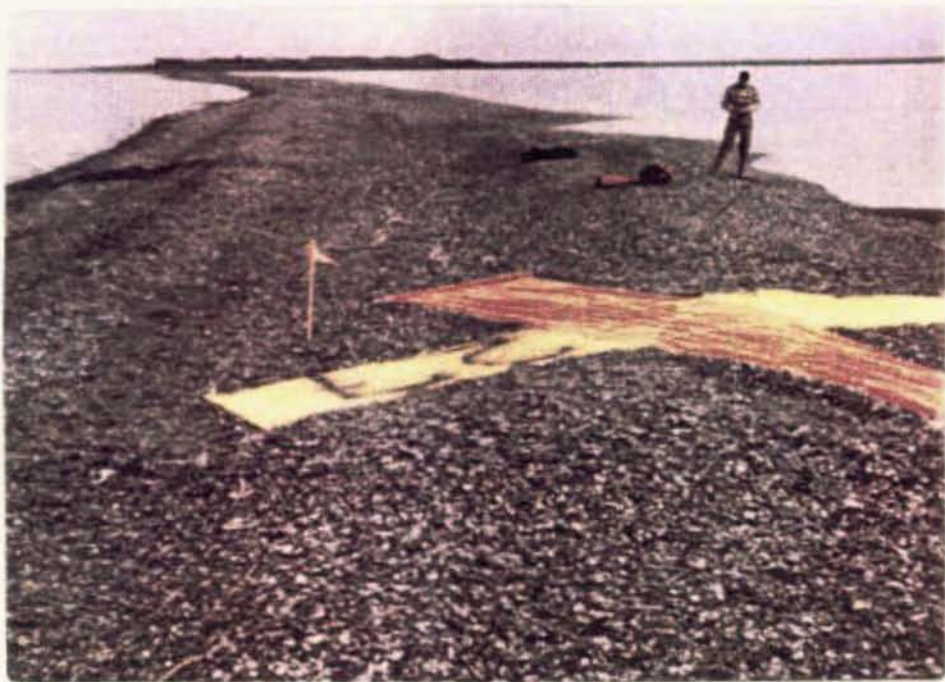
Photo 3 shows a typical coastal spit located at Transect #27. This spit projects westward from the Pt. Thomson pad location, which can be seen in the background. This site was chosen for the littoral drift experiment described in detail in Section 6.

PHOTO 3. TYPICAL GRAVEL SPIT ON MAINLAND COAST (AT TRANSECT # 27)

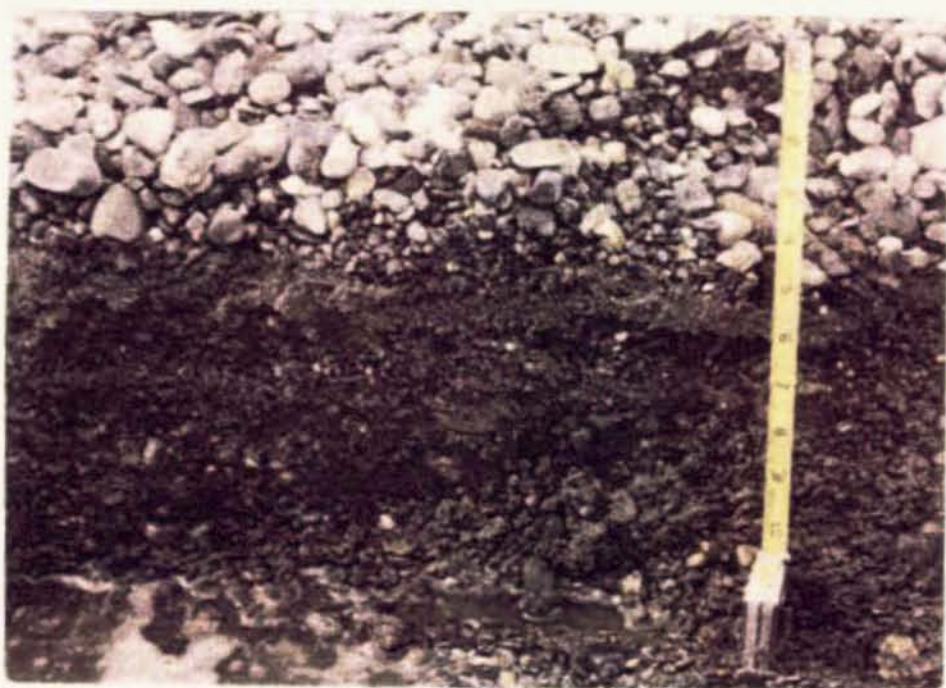
The surficial sediments of the coastal spits are a very uniform coarse gravel having a mean diameter of about one inch. In Photo 4, a trench that was excavated near Monument #27, shows the surface veneer of gravel quite clearly. At the time of the photo, the elevation of the spit was one foot above the prevailing still water level.

PHOTO 4. VERTICAL TRENCH SHOWING COMPOSITION AND DISTRIBUTION OF SEDIMENTS ON MAINLAND SPIT (TRANSECT #27)

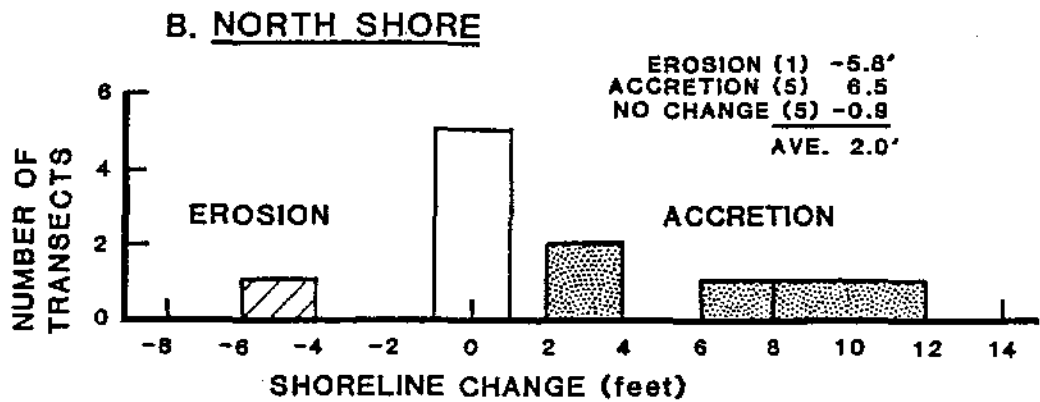
Figure 5.1(A) shows the changes observed in the unexposed southern shoreline of the eleven coastal spits that were surveyed. Nine showed negligible change indicating that minimal wave energy is associated with the small lagoons located to the south of the spits. The average erosion computed for the south shore of all eleven spits was -0.1 feet.

The recent changes in the north shore of the coastal spits are shown in Figure 5.1(B). Of the eleven mainland spits, one experienced erosion (-5.8 feet) and five experienced accretion (average accretion = +6.5 feet). In

FIGURE 5.1 : SHORELINE CHANGE HISTOGRAM, MAINLAND SPITS, 1982

addition, five transects experienced negligible change (less than two feet of measured change) that averaged 0.9 feet of erosion.

By combining the results of the data measured for the north and south shores of the surveyed spits, a histogram can be developed to show the changes in total spit width. As shown in Figure 5.1(C), the two spit transects that narrowed had an average loss of 4.5 feet. For the five spits that widened, the average accretion was 7.0 feet, while four spits showed negligible change. For all the coastal spits, the average change was 1.9 feet of accretion.

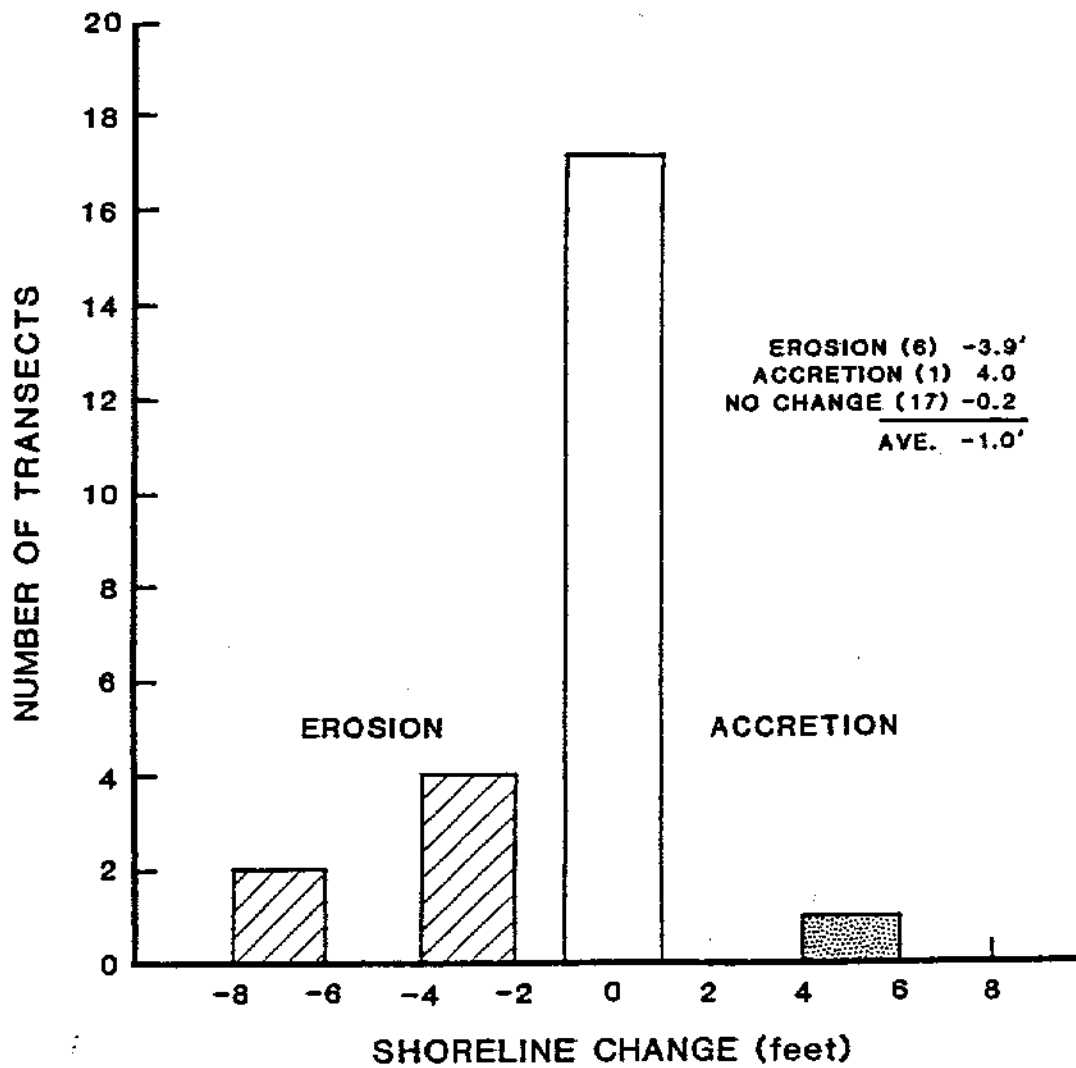
Twenty-four transects remain on the mainland coast when one eliminates the previously discussed coastal bluffs and spits. Table 5.3 lists the survey specifics of these low-lying profiles. A histogram illustrating the range of shoreline changes is presented as Figure 5.2. The data shows that the majority (71%) of the transects of this group exhibited negligible shoreline change which emphasizes the stability that has been recently observed. Six of the 24 transects experienced erosion, averaging -3.9 feet. The

FIGURE 5.2 : SHORELINE CHANGE HISTOGRAM, LOW MAINLAND SHORE, 1982

only significant accretion measured was +4.0 feet at Transect #13, located on Pt. Hopson. The overall average change in these 24 transects was erosion of -1.0 foot.

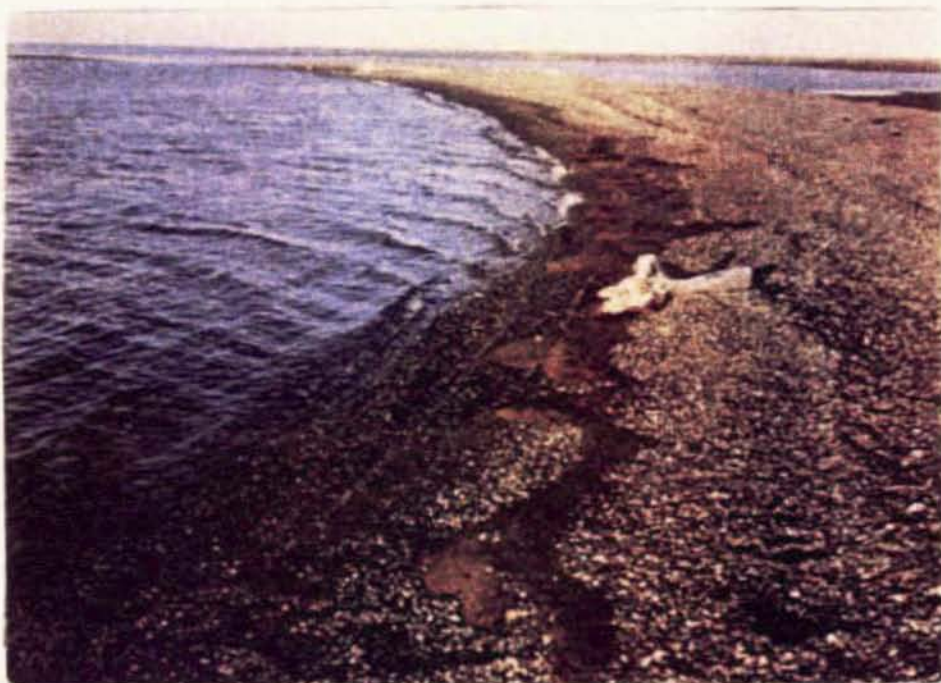
PHOTO 5. MAINLAND BEACH OVERLYING TUNDRA BASE. NOTE TUNDRA EXPOSURE NEAR WATER LEVEL.

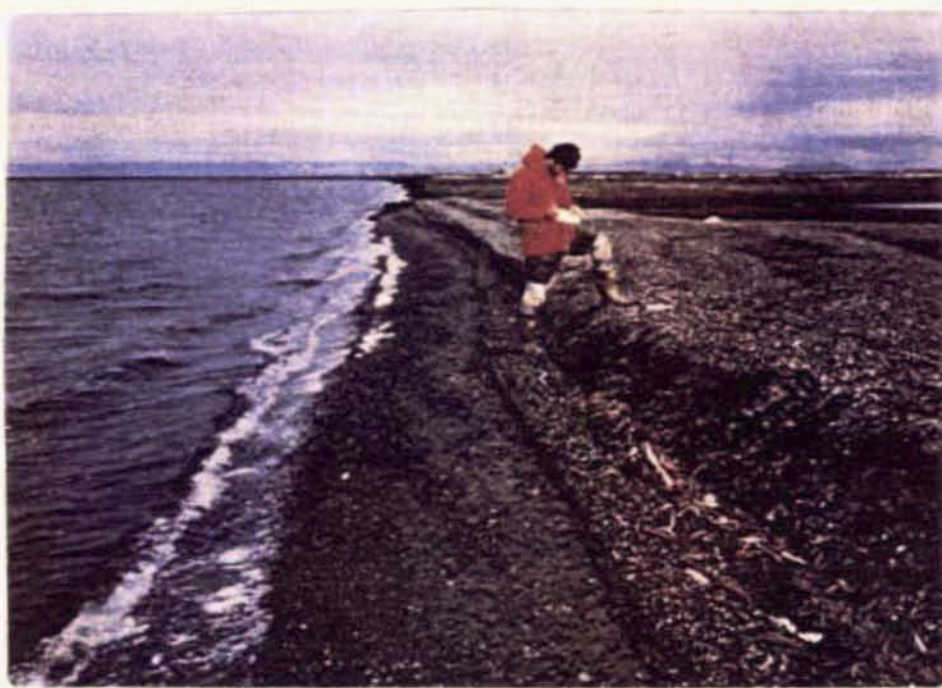
winds, the water level rises, allowing the waves to push the beach sediments further and higher on the tundra base. In many areas of the mainland shore where beach sediments are sparse, the tundra has been exposed by wave energy at the existing water line, as shown in Photo 5. At other coastal transects exhibiting a larger beach volume, a steep storm scarp exists which was formed in the chenier beach during a period of high wave activity. Photo 6, taken near Transect #36, is an example of a typical wave-generated scarp.

PHOTO 6. TYPICAL WAVE-GENERATED COASTAL SCARP NEAR TRANSECT #36, MAINLAND COAST.

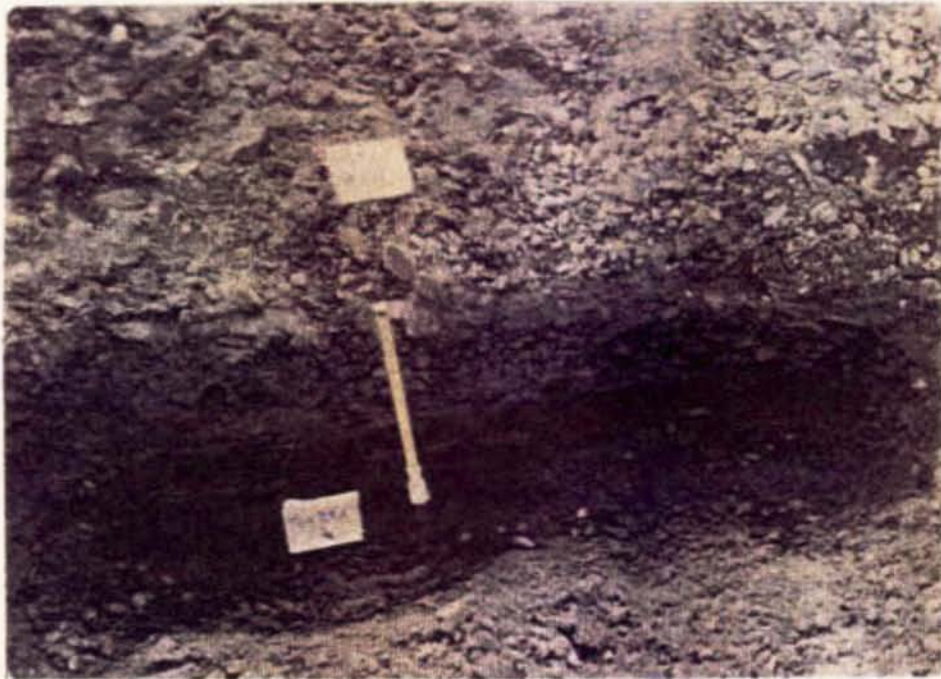
Trenching of the mainland beach sediments was found to expose the tundra foundation at depth, as shown in Photo 7. Successive trenching along a profile allowed estimation of the beach sediment volume.

PHOTO 7 VERTICAL TRENCH SHOWING SEDIMENT DISTRIBUTION OVER TUNDRA BASE

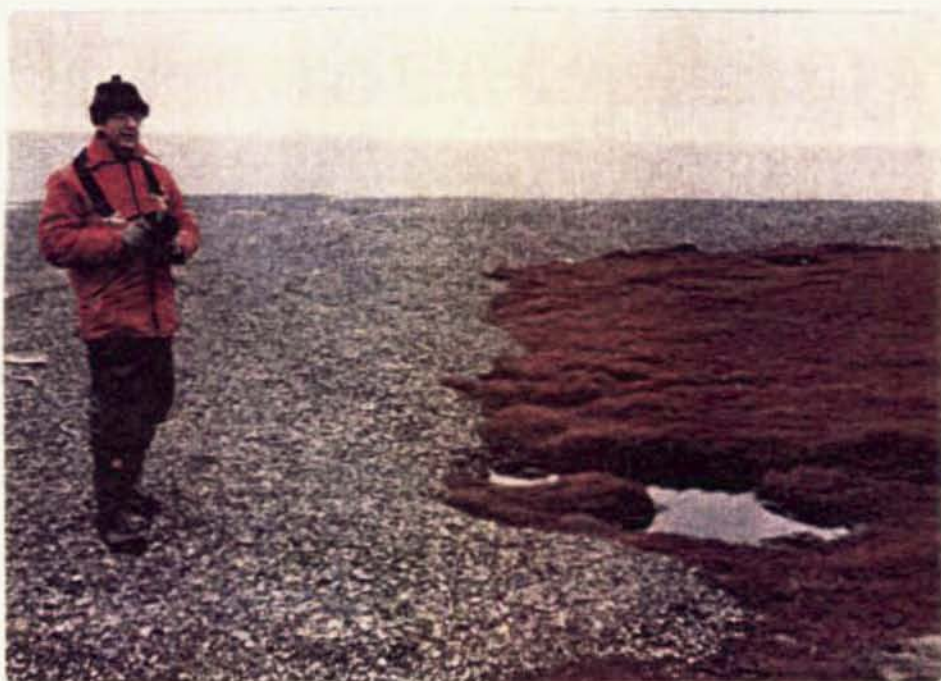
The distinct and sudden boundary between the beach sediments and the underlying tundra at the back of the beach is quite dramatic. Photo 8 illustrates the complete and well-defined coverage of the beach veneer over the tundra base. It is believed that this is due to the stability of the sediments at this elevation which are subject to waves and currents only during the rare, extreme storm events. During the interim calm weather periods, the vegetation existing on the tundra can flourish, thus, creating the very stable and distinct interface that is evident in the photo.

PHOTO 8. VIEW OF THE BACK OF MAINLAND "CHENIER"
BEACH SHOWING DISTINCT SEPARATION BE-
TWEEN BEACH AND TUNDRA

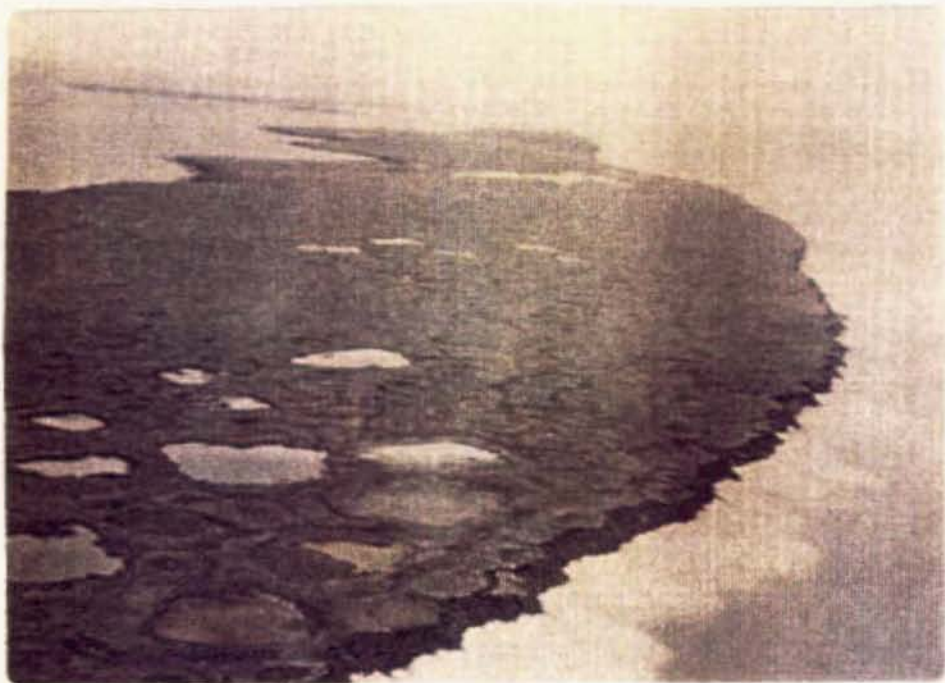
Flaxman Island has been noted to experience a high-level of bluff erosion dating back to the reports of the earliest explorers of the region. The high, flat island form is shown in Photo 9, taken in early July, 1982. The

PHOTO 9. AERIAL VIEW, EAST END OF FLAXMAN
ISLAND

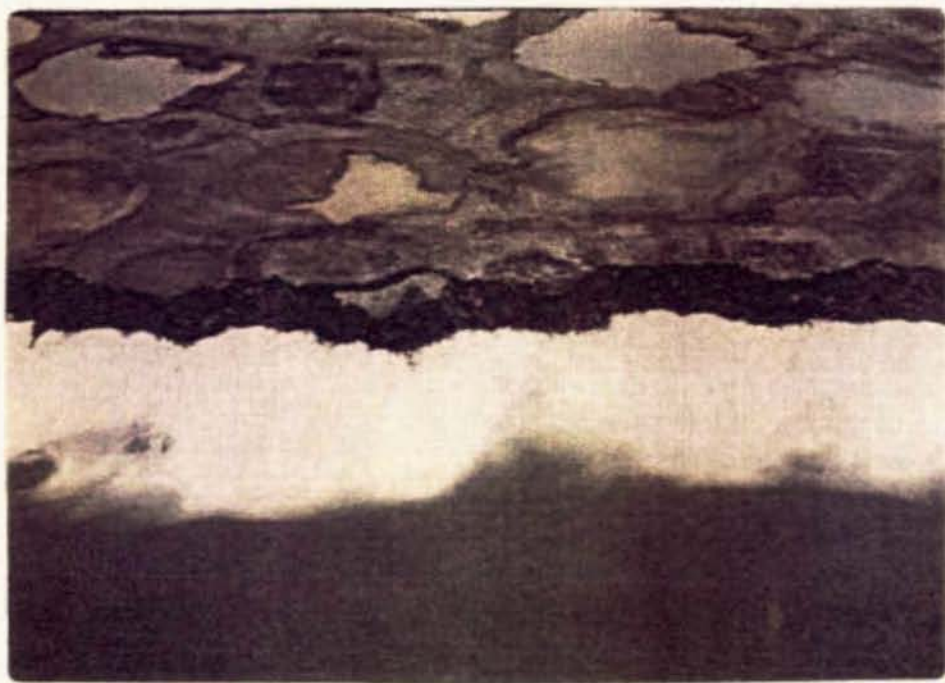
eroding bluff along the northern shore is shown in Photo 10 to be in contact with a protective ice foot at the bluff base. Until this ice foot melts or is dislodged, incoming wave energy cannot affect the stability of the bluff. A second view of the eroding bluff (Photo 11) shows a thick ice wedge that exists below the surface veneer of tundra. Also noteworthy is the variability of eroded sediment size, as illustrated by the large boulder that is on the verge of falling out of the bluff face. The unusual lithology of the Flaxman Island formation has been described previously in Section 2.1.

PHOTO 10. AERIAL VIEW OF ERODING NORTHERN BLUFF,
FLAXMAN ISLAND, JULY, 1982. NOTE ICE
ATTACHED TO BLUFF TOE

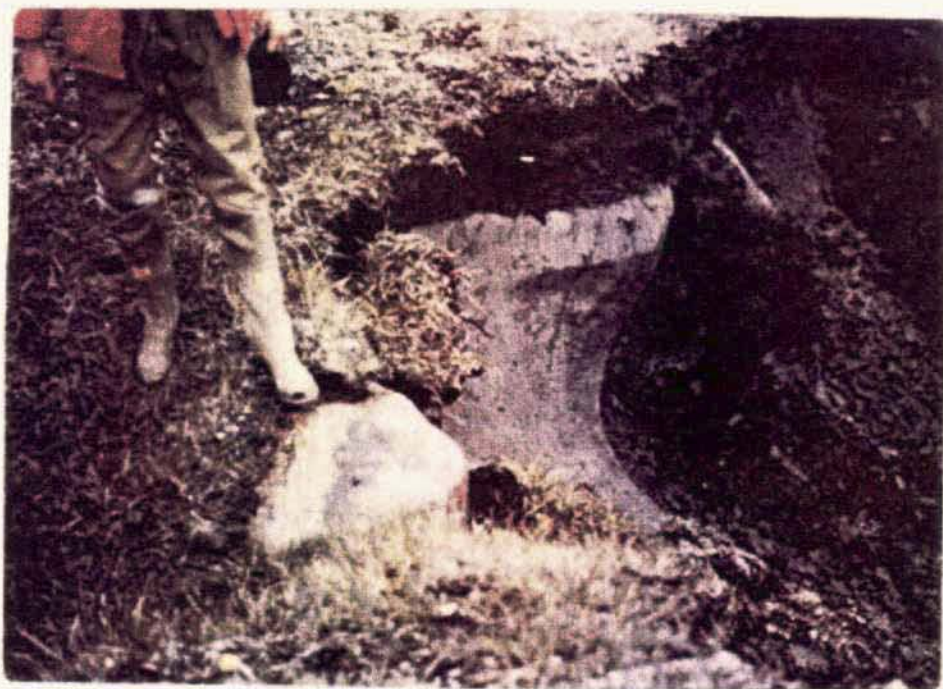
PHOTO 11. ERODING BLUFF ON FLAXMAN ISLAND SHOWING UNDERLYING ICE LENS AND LARGE BOULDER

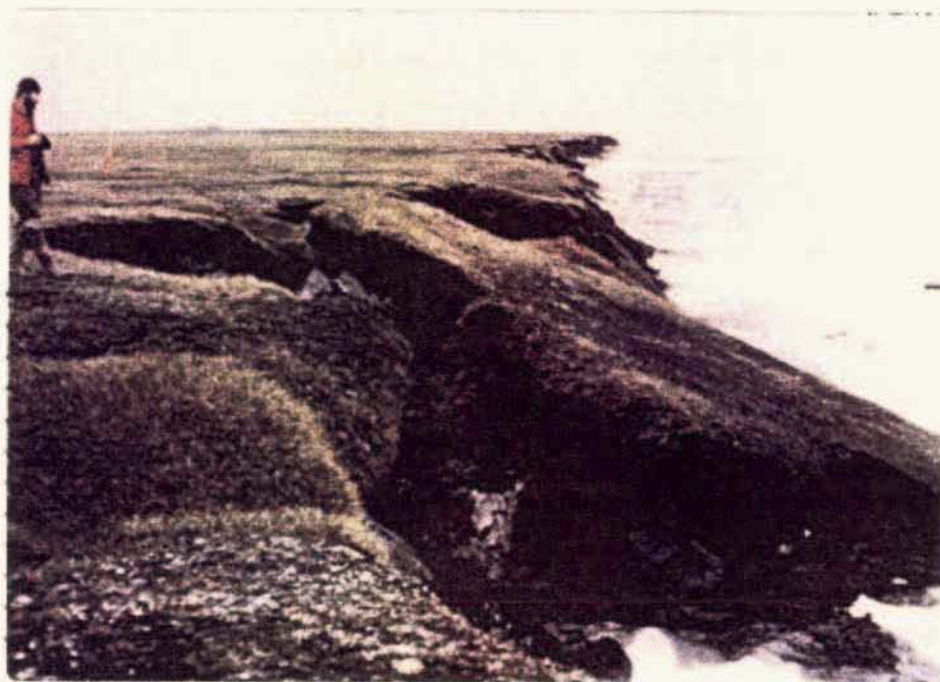
The northern bluffs of Flaxman Island are characterized by the massive blocks of tundra that are slumping downslope. Unlike beach erosion that can progress in small increments, much of the bluff erosion witnessed on Flaxman Island occurred in large sections measuring approximately fifty feet in length and 10-20 feet in the offshore direction. Photo 12 illustrates an example of an eroded bluff portion of this size. This eroded block of tundra may serve to protect and insulate the remaining bluff face, thereby slowing the future bluff erosion at this location until the block erodes.

PHOTO 12. TYPICAL BLUFF EROSION, NORTHERN SHORE OF FLAXMAN ISLAND

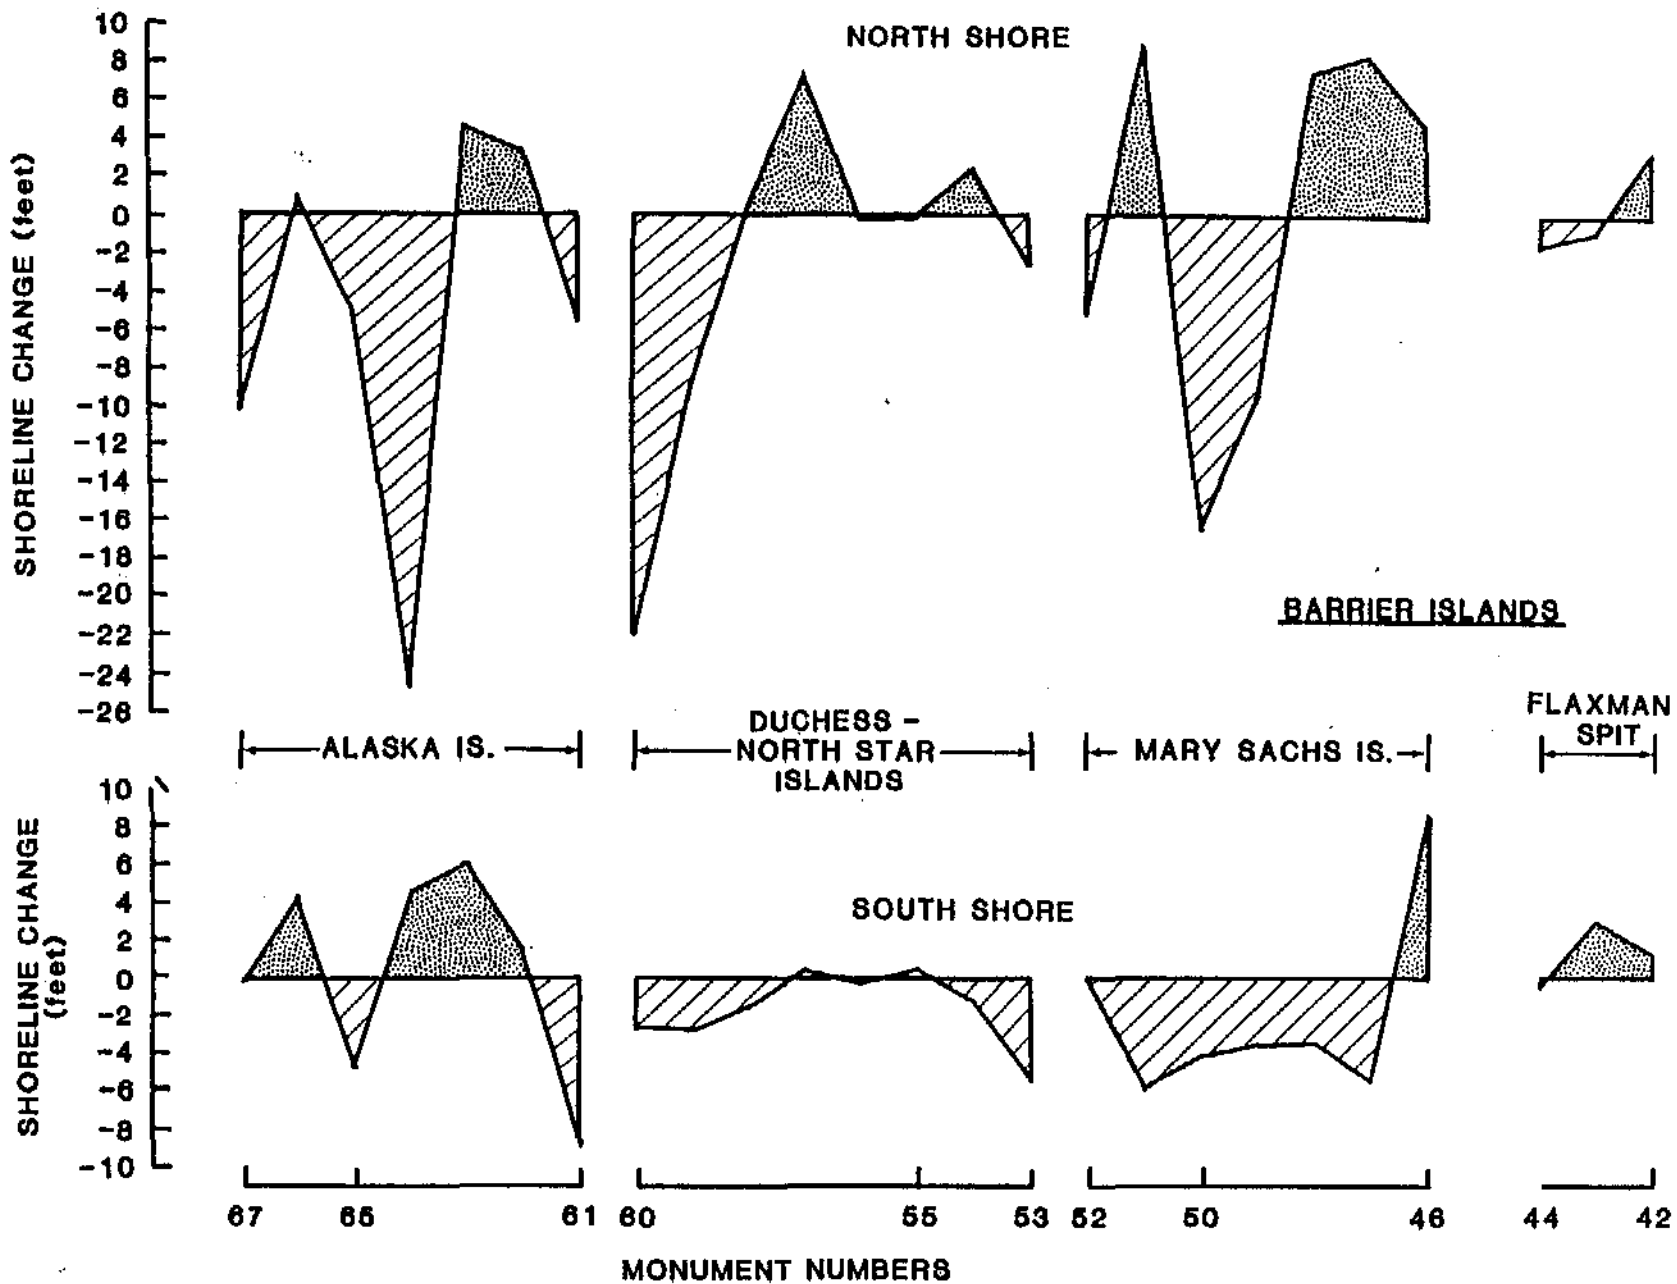
Figure 5.8 summarizes the recent changes in shoreline position associated with the entire barrier island chain under study, bounded by the east end of the Flaxman Island spit (Transect #42) and the west end of Alaska Island (Transect #67). On the northern shores, moderate accretion (4-10 feet) occurred at four distinct areas of the central portions of each of the island complexes. Erosion of large magnitude (15-25 feet) occurred near the center of Mary Sachs and Alaska Islands, and on the west end of Duchess Island.

Along the southern shore, less dramatic changes occurred. Erosion appears to dominate the south shore of Mary Sachs Island. On Duchess-North Star Island, virtually

FIGURE 5.8 : BARRIER ISLAND SHORELINE CHANGES, 1982

no changes have occurred along the central island south shore. On Alaska Island, the south shore fluctuates between mild erosion and accretion.

It is significant to note in Figure 5.8 that the ends of islands adjacent to major inlets are showing a recent erosional trend. The trend towards island erosion at these inlets is caused by a number of factors which include high speed currents generated by tides and meteorological events and a high degree of wave-induced sediment transport. The sediments that migrate off the island end and into the inlets cannot be recovered in total when the wind and wave conditions reverse.

The very small inlet that has formed between Flaxman and Mary Sachs Islands has not caused erosion on the adjoining island ends (see Figure 5.8). This narrow, shallow feature is relatively protected and may be subject to predominant sediment deposition at the present time.

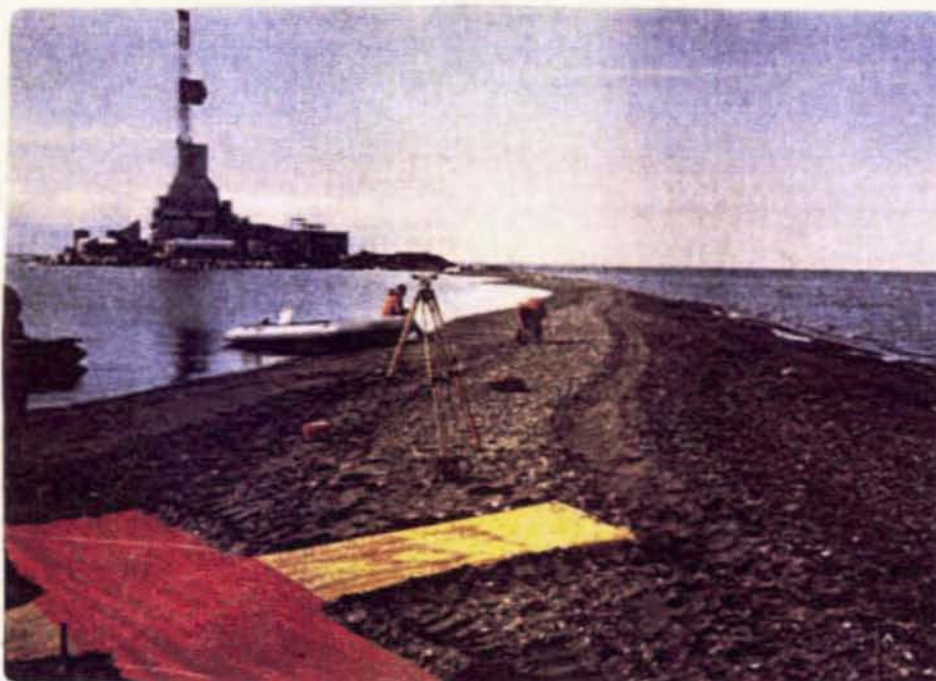
During the summer surveys, major changes were observed at several survey transects along the barrier island chain. Photo 13 shows a view of Monument #61, located just east of the Alaska Island exploration pad, at the time of the initial survey target on July 25, 1982. Following a strong westerly storm on the following day, the target was observed to be partially buried by sand that had been transported onto the target during the storm (Photo 14). At the time of the September survey, the target had been buried to an even greater extent, as shown in Photo 15, by a subsequent westerly storm event or events. The depth of total burial was about six inches, as shown in the plot of comparative surveys, Figure 5.9. During the July-September period, the sediment that buried the target was apparently derived from

PHOTO 13. TRANSECT #61, EAST END OF ALASKA ISLAND, JULY 25, 1982. SOHIO'S EXPLORATION PAD IS SEEN IN THE BACKGROUND

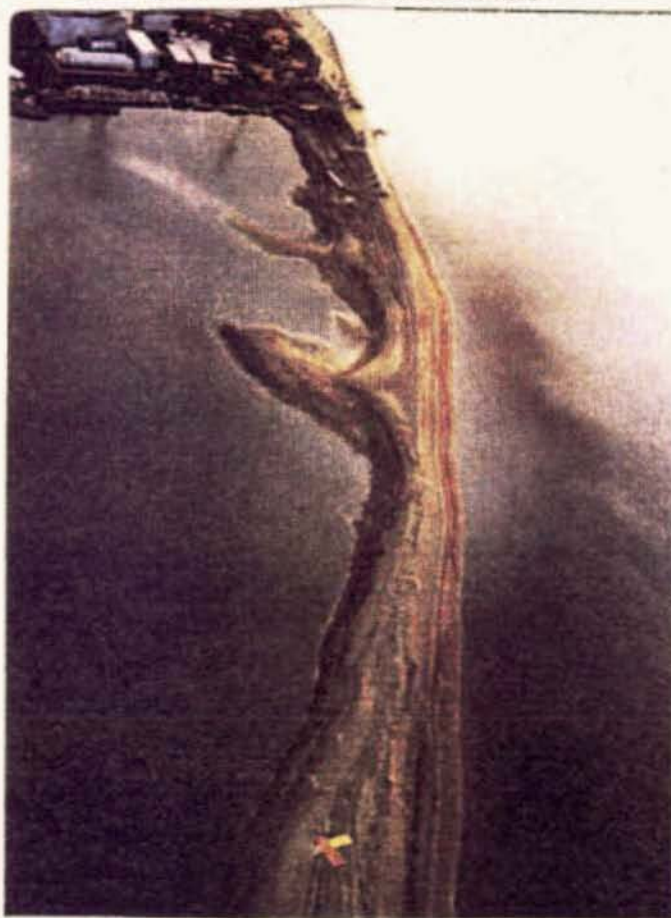
PHOTO 14. AERIAL VIEW SHOWING PARTIAL BURIAL OF TARGET AT TRANSECT #61 IMMEDIATELY FOLLOWING WESTERLY STORM OF JULY 26, 1982

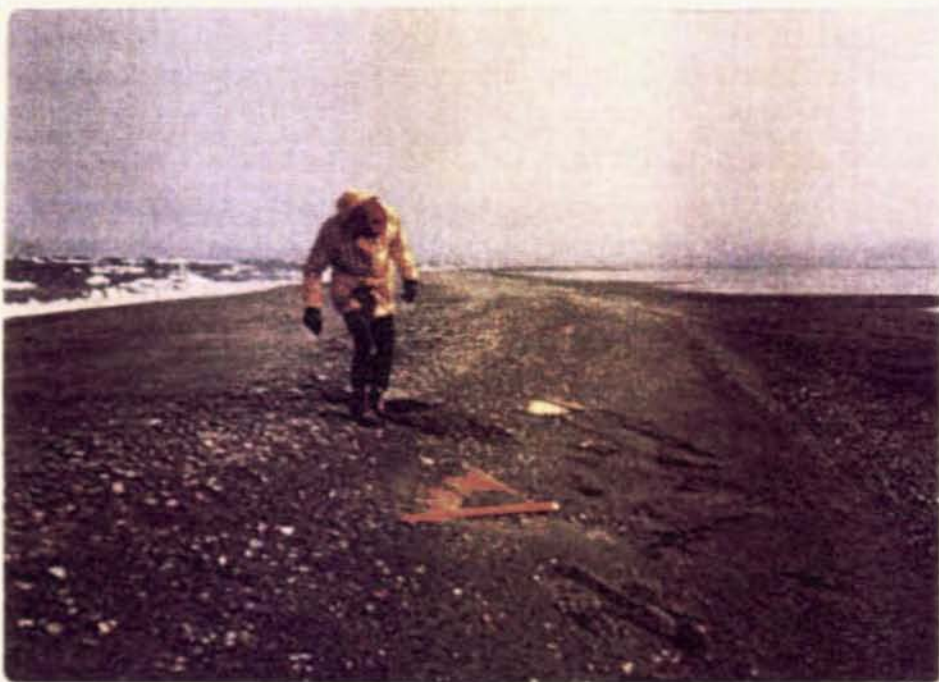
PHOTO 15. TARGET BURIAL AT TRANSECT #61,
SEPTEMBER 11, 1982

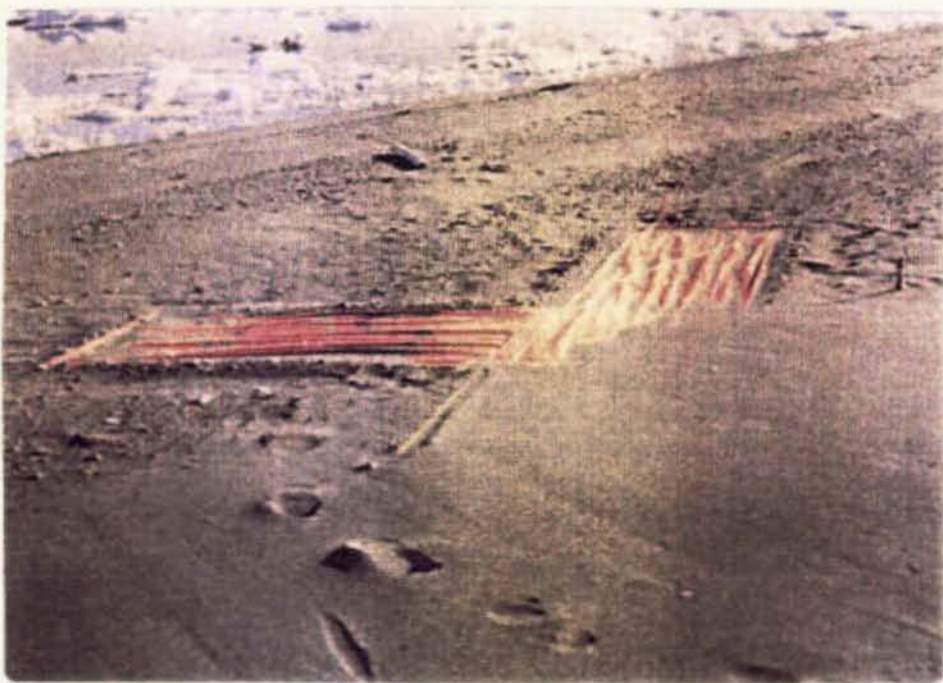
PHOTO 16. PARTIAL TARGET BURIAL CAUSED BY WESTERLY
STORM EVENTS AT TRANSECT #53, EAST END OF
NORTH STAR ISLAND, SEPTEMBER 11, 1982

A similar depositional event occurred on North Star Island at Monument #53, as shown in Photo 16. A layer of sediment (10 inches thick) is seen to overlie the target at this location. These two cases of major sediment deposition atop the island surface occurred at sites of similar exposure to westerly storm events. Monument #61 is located on the southwest-facing shore of Alaska Island, while Monument #53 has the identical orientation on the east end of North Star Island.

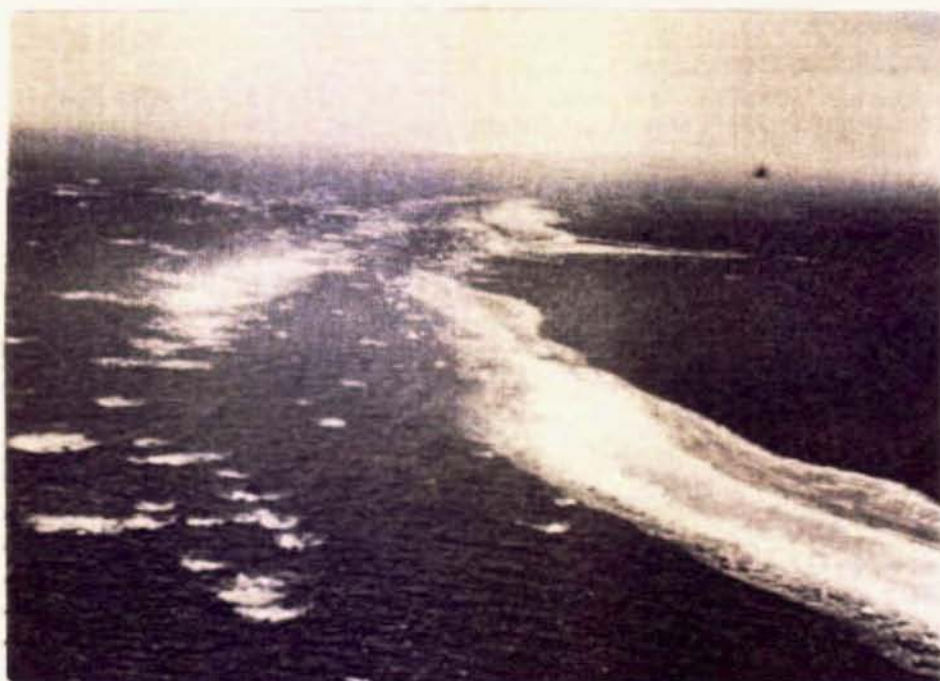
A major island breach existed in 1955 between North Star and Duchess Islands. On the NOAA chart, an inlet depth of seven feet was measured in 1950. At the present time, the inlet has been filled and a continuous island exists in this area, located just west of the North Star exploration pad. A photographic comparison has been achieved by presenting a 1982 survey photo and one collected by Dr. Andrew Short in 1972. In Photo 18, a view of the inlet between Duchess and North Star Island is shown in 1972. Breaking waves can be seen within the inlet. In July, 1982, Photo 19 was taken from approximately the same location showing a thin sediment strip that presently exists over the former inlet.

PHOTO 18. AERIAL VIEW OF INLET BETWEEN NORTH STAR
AND DUCHESS ISLAND, AUGUST, 1972
(SOURCE: DR. ANDREW SHORT)

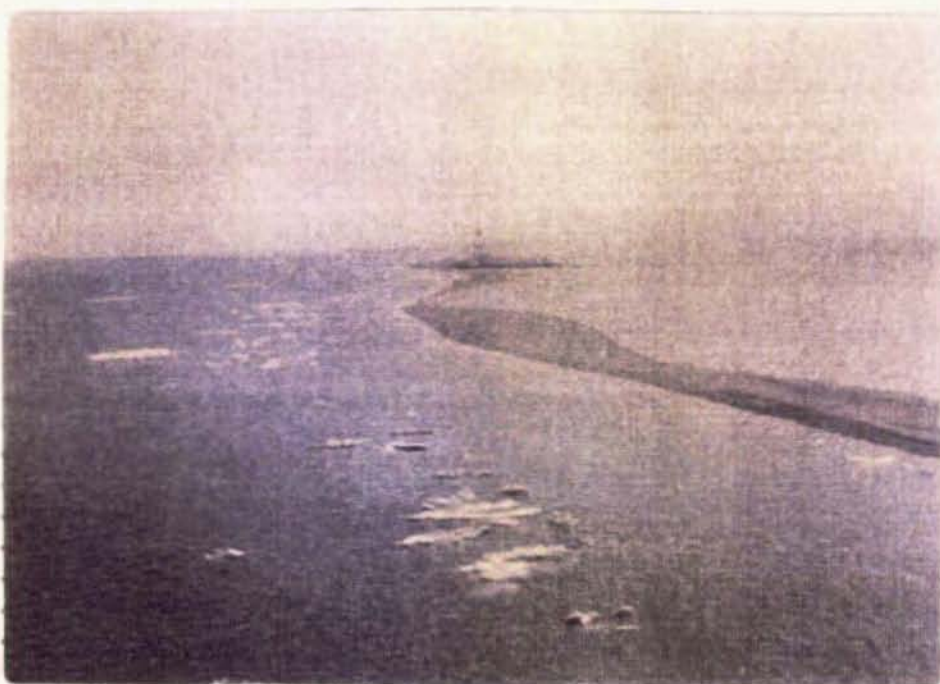
Also evident in these photos is the location of Exxon's North Star drilling pad relative to the site of the inlet, and the similar shape of the island shoreline in both 1972 and at the present. The recent filling of the inlet, documented in these photographs, is a process that is common to barrier island environments.

PHOTO 19. VIEW OF FILLED INLET THAT NOW CONNECTS
DUCHESS AND NORTH STAR ISLANDS, JULY,
1982. EXXON'S NORTH STAR DRILLING PAD
IS SEEN IN THE BACKGROUND
