Assisted and Natural Tundra Recolonization Prudhoe Bay Oil Field, Alaska

A Quarter-Century of Soil and Plant Studies Including
Physical Removal of Soil and Plants, Hydrocarbon Spills,
Gravel Revegetation, Sand Stabilization,
and Soil Salinization

Jay D. McKendrick
Professor of Agronomy Emeritus
University of Alaska Fairbanks
Palmer, Alaska

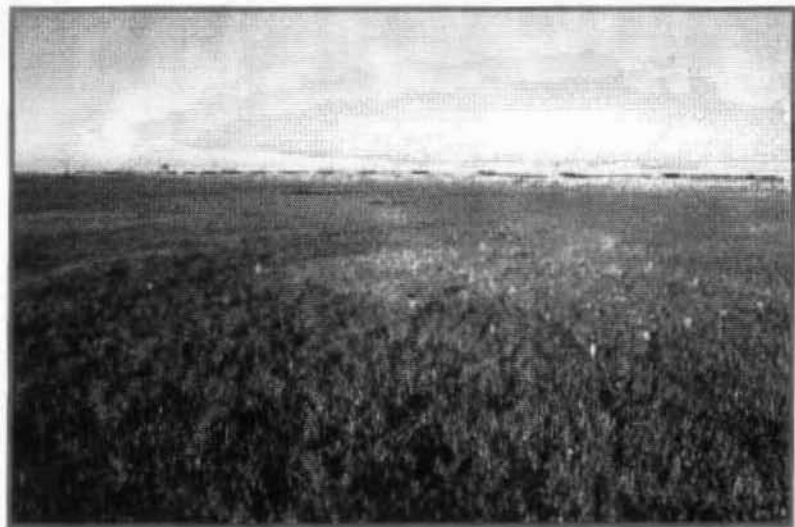
- Photo 4. Within 3 months after applying fertilizer, mosses and sedges were growing in the fertilizer plots in the burned portion of the spill. We were uncertain as to which elements in the fertilizer application were responsible for this plant growth. Additional plots were installed a year later (1973) to identify the effective agents. These plots were located adjacent to the original six plots. In this photo the oil spill was 25.5 years of age. It was clear that the effects from the single fertilizer application was still influencing the plant growth after 25 years. The surrounding area was only sparsely colonized for a number of years. After about 10-15 years the vegetation started to blend with the unaffected surroundings. Now the effects of the oil spill have been obscured by the vegetation. Traces of oil in the peat can still be found. In phosphorus-treated plots the vegetation recovered most rapidly. There was a small response to potassium. However, there was no response from nitrogen when applied alone.

- Photo 4. Within 3 months after applying fertilizer, mosses and sedges were growing in the fertilizer plots in the burned portion of the spill. We were uncertain as to which elements in the fertilizer application were responsible for this plant growth. Additional plots were installed a year later (1973) to identify the effective agents. These plots were located adjacent to the original six plots. In this photo the oil spill was 25.5 years of age. It was clear that the effects from the single fertilizer application was still influencing the plant growth after 25 years. The surrounding area was only sparsely colonized for a number of years. After about 10-15 years the vegetation started to blend with the unaffected surroundings. Now the effects of the oil spill have been obscured by the vegetation. Traces of oil in the peat can still be found. In phosphorus-treated plots the vegetation recovered most rapidly. There was a small response to potassium. However, there was no response from nitrogen when applied alone.

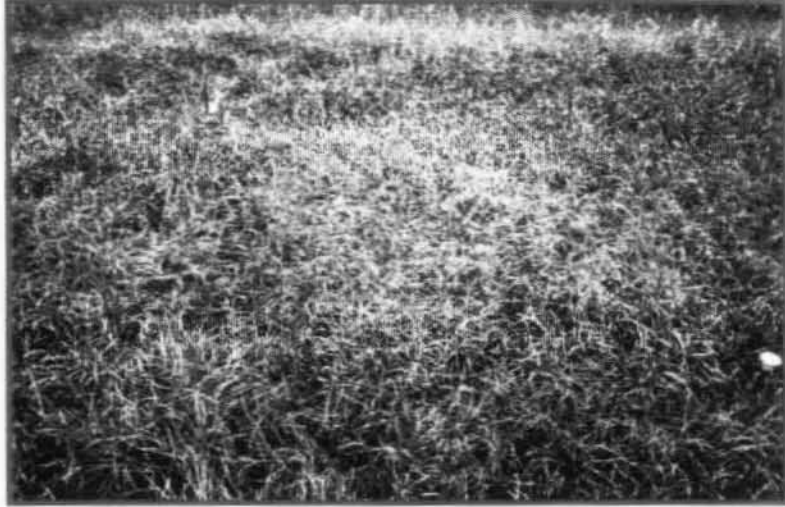
6

Photo 6. View of a 4-square meter wet sedge meadow plot to which 40 l/m^2 of fresh crude oil was applied and left in place 25 years prior (photographed 20 August 1997).

- Photo 5. View of a 4-square meter wet sedge meadow plot to which 40 l/m^2 of fresh crude oil was applied and burned immediately 25 years prior (photographed 20 August 1997).
- Photo 6. View of a 4-square meter wet sedge meadow plot to which 40 l/m^2 of fresh crude oil was applied and left in place 25 years prior (photographed 20 August 1997).
- Photo 7. View of a 4-square meter mesic tundra plot to which 40 l/m^2 of fresh crude oil was applied and left in place 25 years prior (photographed 20 August 1997).

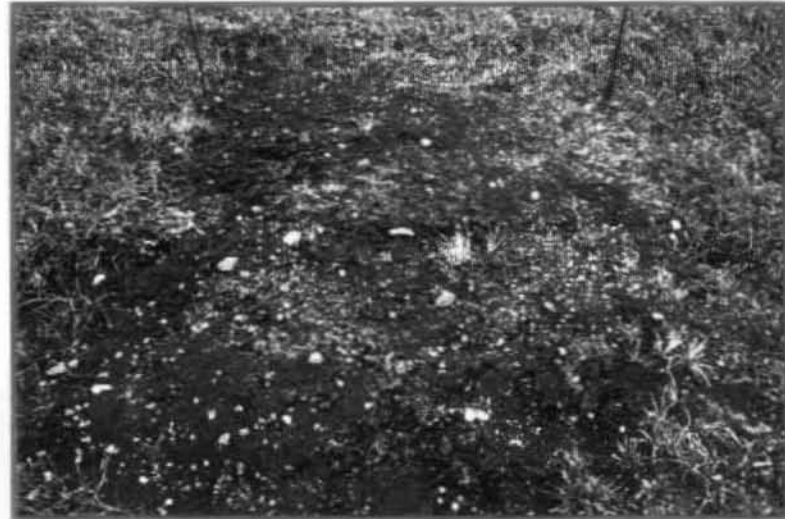
7

Photo 7. View of a 4-square meter mesic tundra plot to which 40 l/m^2 of fresh crude oil was applied and left in place 25 years prior (photographed 20 August 1997).

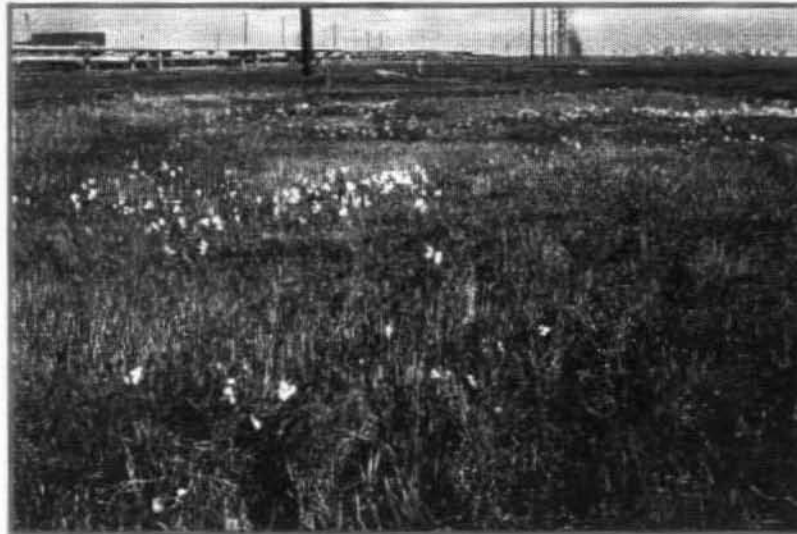
10

EXPERIMENTAL TUNDRA VEGETATION REMOVAL (SCRAPED SITE)

Phosphorus, potassium, and magnesium fertilizers were tested on the scraped site with *Puccinellia arctica* as the indicator plant. Plots were established in September 1974. The emergence and establishment of the seeded grass occurred only in plots containing phosphorus fertilizer. Subsequently, the entire area was overtaken by natural wet sedge tundra plant species.

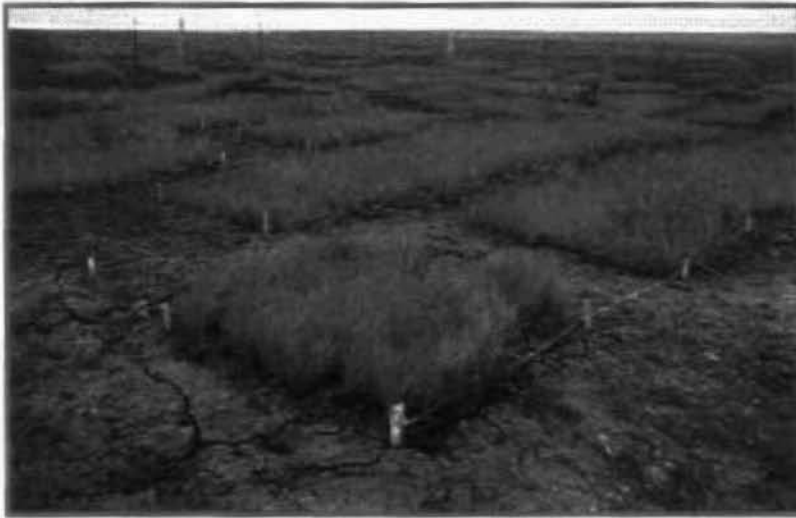
12

Photo 12. Plots with *Puccinellia arctica*, four growing seasons after seeding (1 September 1978).

Photo 12. Plots with *Puccinellia arctica*, four growing seasons after seeding (1 September 1978).

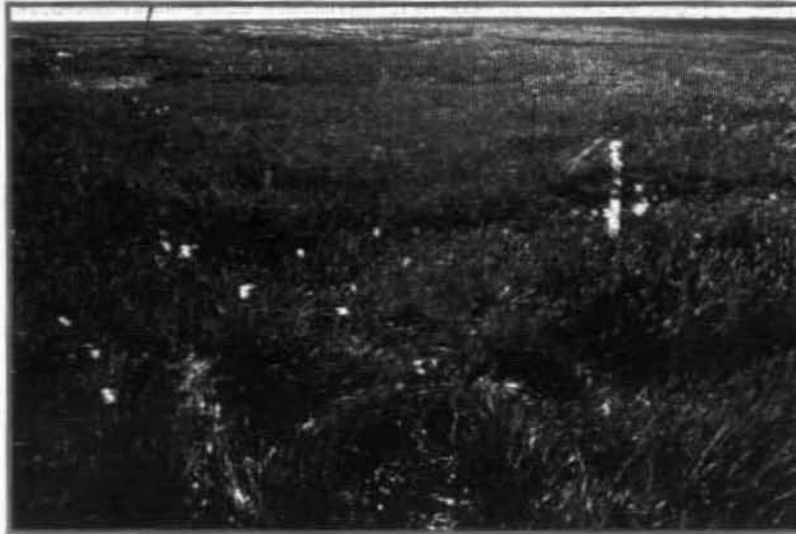
13

Photo 13. Plots dominated by natural wet-sedge tundra species 23 growing seasons after seeding (9 September 1997).

Photo 13. Plots dominated by natural wet-sedge tundra species 23 growing seasons after seeding (9 September 1997).

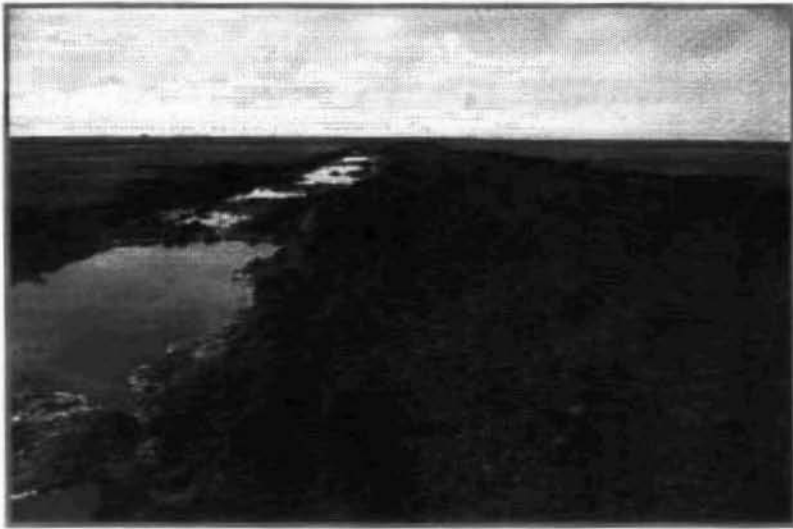
14

Photo 14. Winter Haul Road between DS-2 and Borough Landfill as it appeared on 27 June 1972. Age 3 years.

Photo 14. Winter Haul Road between DS-2 and Borough Landfill as it appeared on 27 June 1972; age 3 years.

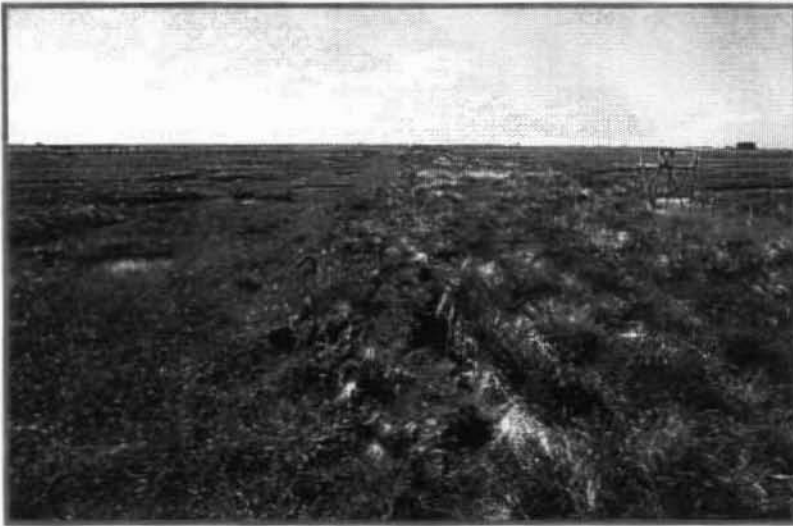
15

Photo 15. Same view of Winter Haul Road 25 July 1994; age 25 years.

Photo 15. Same view of Winter Haul Road 25 July 1994; age 25 years.

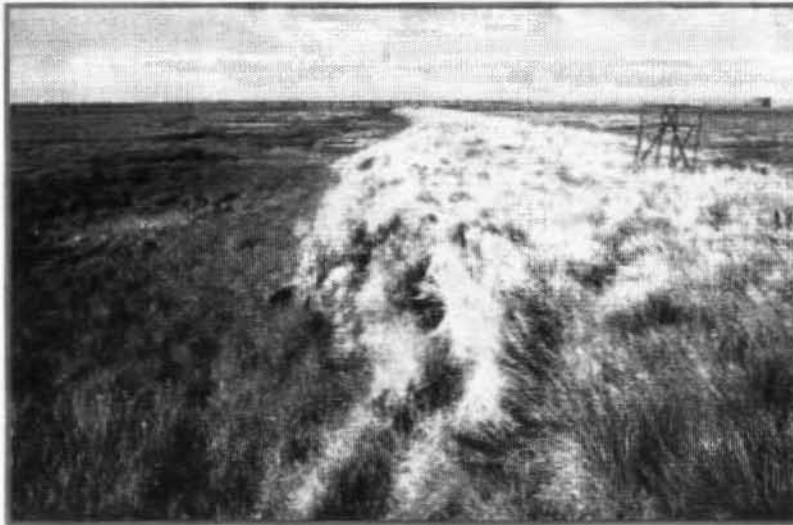
16

Photo 16. Same view of Winter Haul Road 10 September 1997; age 28 years.

Photo 16. Same view of Winter Haul Road 10 September 1997; age 28 years.

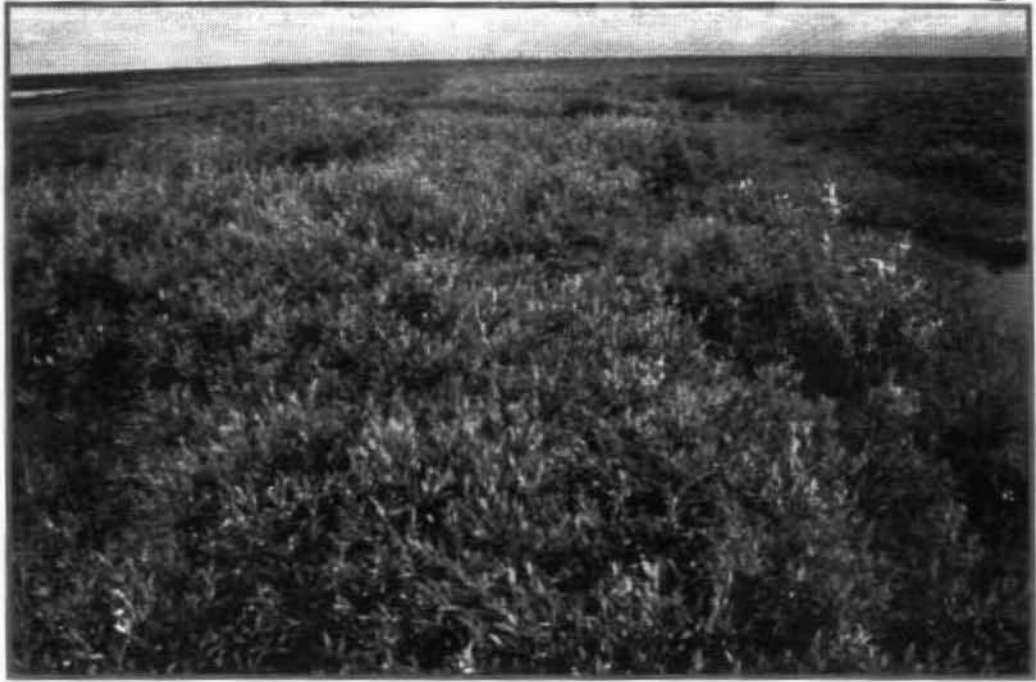
17

- Photo 17. View of winter haul road in foothill region east of Umiat, Alaska. This road was constructed by British Petroleum in August 1964. Photo was taken 16 July 1991; age 28 years. Natural recolonization is responsible for all vegetation recovery on this site.
- Photo 18. View of winter haul road on coastal plain west of Oxbow Road, Prudhoe Bay, Alaska. Road was constructed by British Petroleum in 1969. Photo was taken 9 September 1997; age 28 years. Natural recolonization is responsible for all vegetation recovery on this site.

Photo 17. View of winter haul road in foothill region east of Umiat, Alaska. This road was constructed by British Petroleum in August 1964. Photo was taken 16 July 1991; age 28 years. Natural recolonization is responsible for all vegetation recovery on this site.

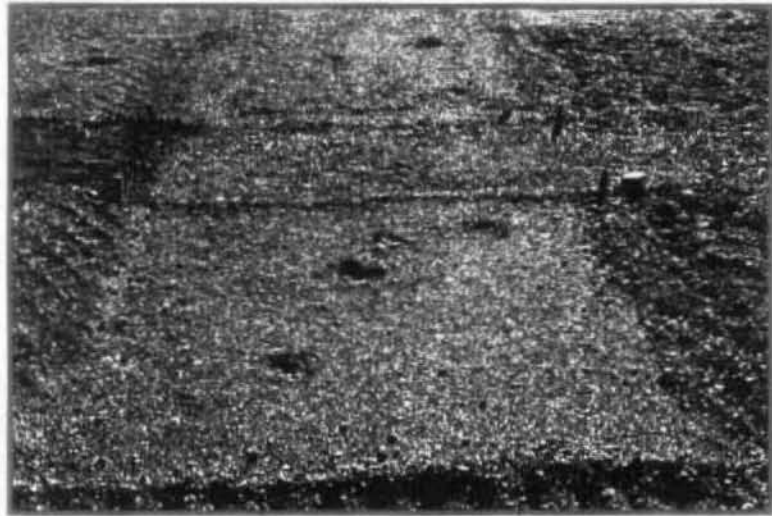
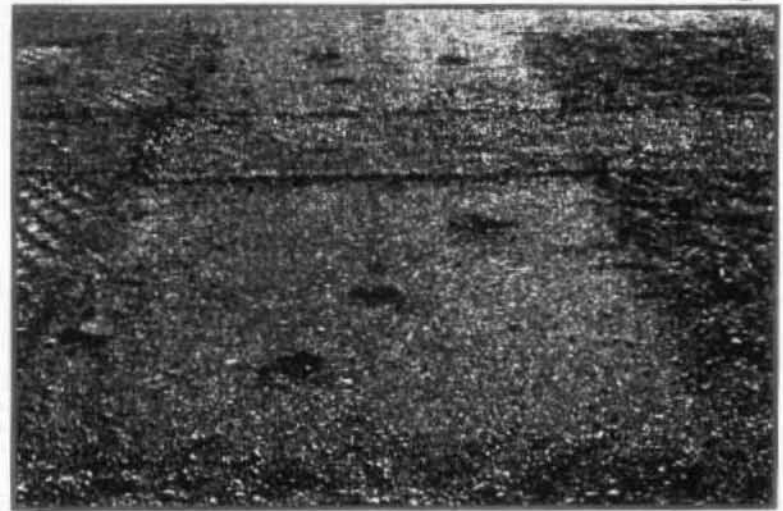
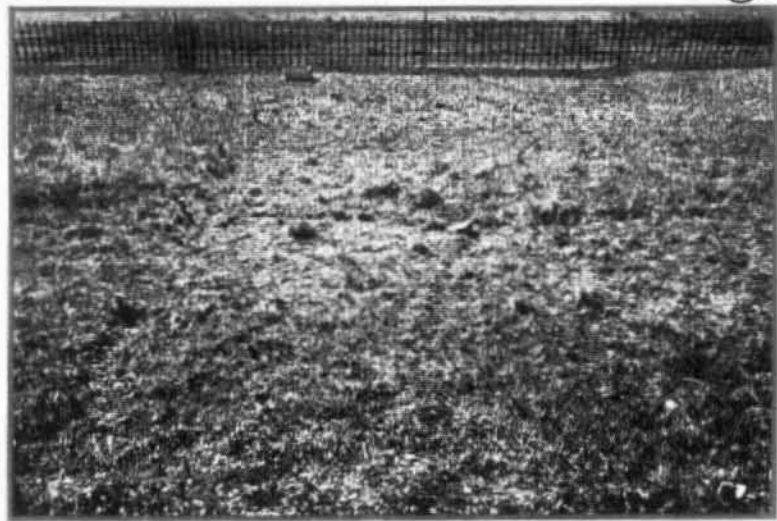
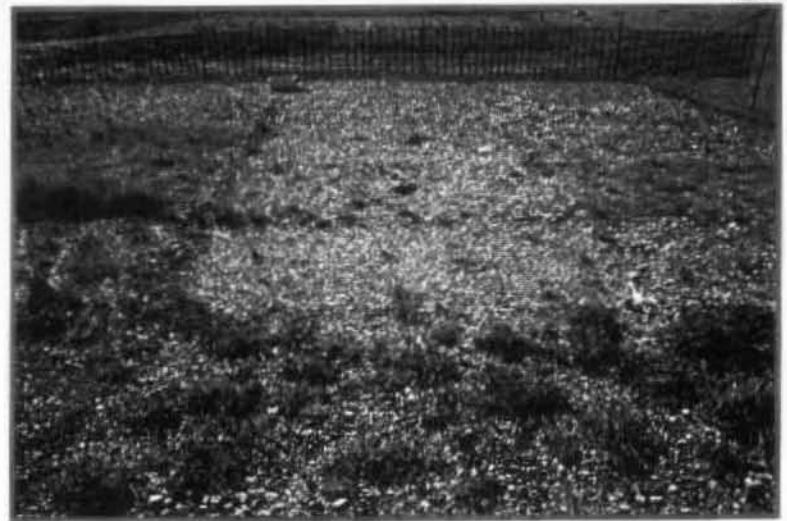
- Photo 20. View of barren gravel fill plot, Block 1, Rep III, 2-ft lift, no-topsoil, no-till. Upper center plot seeded approximately 1 month prior to this photo (23 July 1991).
- Photo 21. View of same plot shown in Photo 20. Age of the first-seeded plot eight growing seasons (28 July 1997). Foreground plot seeded 1991. Brown cast due to moss natural colonization.
- Photo 22. View of barren gravel fill plot, Block 1, Rep III, 5-ft lift, no-topsoil, no-till. Upper center plot seeded approximately 1 month prior to this photo (23 July 1991).
- Photo 23. View of same plot shown in Photo 22. Age of the first-seeded plot eight growing seasons (28 July 1997). Foreground plot seeded 1991. Note absence of moss on this lift and abundance of legume establishment, in contrast with photo 21, same treatment at 2-ft lift.

- Photo 20. View of barren gravel fill plot, Block 1, Rep III, 2-ft lift, no-topsoil, no-till. Upper center plot seeded approximately 1 month prior to this photo (23 July 1991).
- Photo 21. View of same plot shown in Photo 20. Age of the first-seeded plot eight growing seasons (28 July 1997). Foreground plot seeded 1991. Brown cast in this image is the result of natural colonization by mosses.
- Photo 22. View of barren gravel fill plot, Block 1, Rep III, 5-ft lift, no-topsoil, no-till. Upper center plot seeded approximately 1 month prior to this photo (23 July 1991).
- Photo 23. View of same plot shown in Photo 22. Age of the first-seeded plot eight growing seasons (28 July 1997). Foreground plot seeded 1991. Note absence of moss on this lift and abundance of legume establishment, in contrast with photo 21, same treatment at 2-ft lift.
