**YUKON GOLD ICE PAD TUNDRA VEGETATION ASSESSMENT:
1993 Through 1995**

Final Report

LGL ALASKA RESEARCH ASSOCIATES, INC.
4175 Tudor Centre Drive, Suite 101
Anchorage, Alaska 99508

BP EXPLORATION (ALASKA) INC.
P.O. Box 196612
Anchorage, Alaska 99519-6612

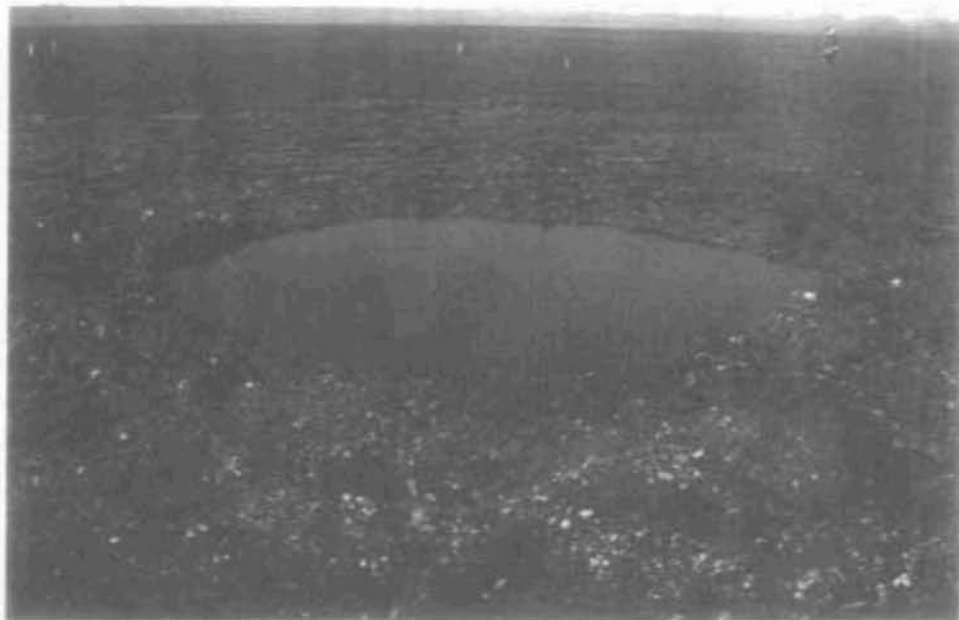
Figure 7. Area of subsidence and an area of decreased live vegetation near the well head within the Yukon Gold site footprint, photos 29 July 1995. A.—well head. B.—area of decrease live vegetation near well head.

No thaw depths have been recorded during monitoring, and the only areas of obvious thermokarst were near the well head and the trench. The southeast corner of the pad appears to be low, but this low area extends beyond the footprint edge heading northeast and appears to be a normal depression. Rains prior to monitoring on 27–29 July caused extensive areas of standing water and saturated soils within and around the pad footprint. This flooding also appeared normal. There was no obvious increase in ponding or subsidence of the tundra surface within the pad footprint, which would indicate an increased thaw depth. Standing water was more visible within the impact area because of the decreased live vegetation cover and increased barren cover.

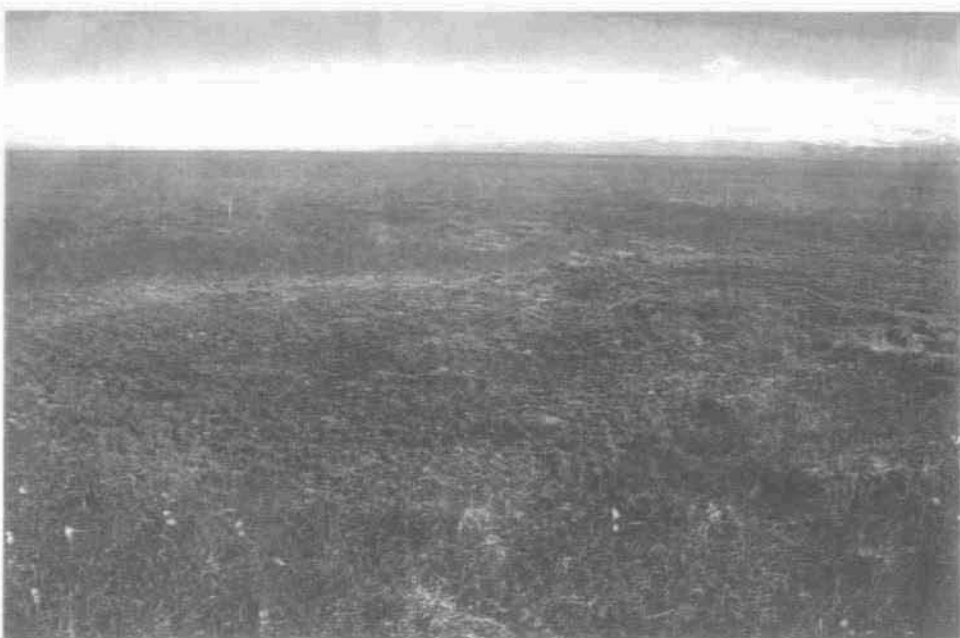
2. Several additional irregularly shaped areas of plant mortality extended from the edge into the pad’s footprint, especially along the east pad edge and at one location on the south pad edge. These areas were less conspicuous and generally showed greater vegetative recovery than the edges. Plots 14 and 16 within these areas averaged 25% live cover (Fig. 4, Appendix D). However, some of the mortality along the east edge of the pad footprint may be a result of surface water spread of a nearby diesel spill.

Figure 8. Diesel spill area within the footprint of the Yukon Gold site, Alaska, photos 29 July 1995. A.—close view of spill area. B.—southeast corner of ice pad footprint and spill area. (Note *Eriophorum* inflorescence in foreground and background.)
