**YUKON GOLD ICE PAD TUNDRA VEGETATION ASSESSMENT:  
1993 Through 1995**

Final Report

In Compliance to Department of the Army Permit Number 4-930426 (Staines River 1)

29 March 1996

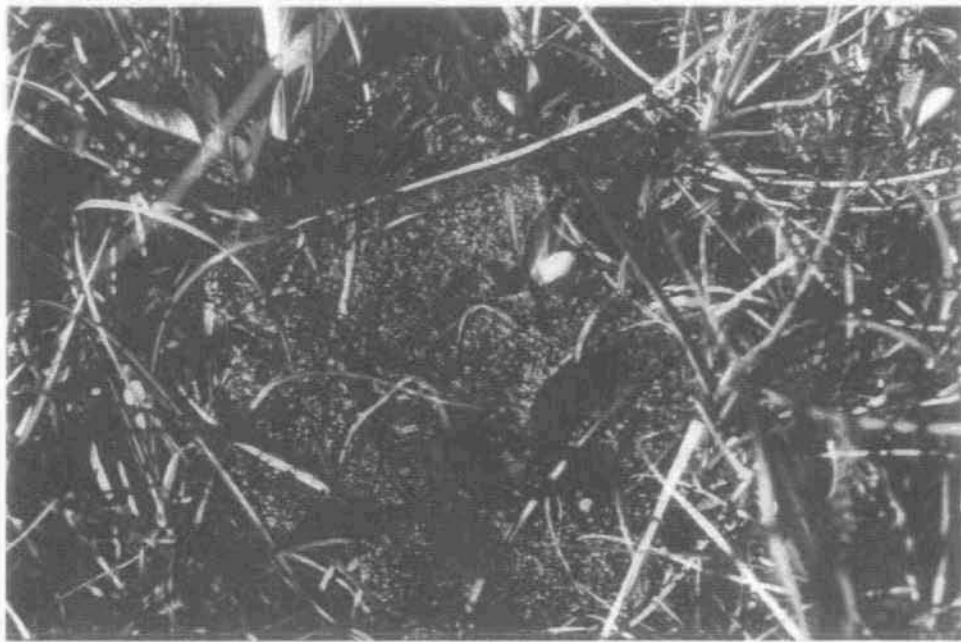
3. The strangmoor ridges within the pad area continued to show damage due to compression and, in a few cases, scraping. These areas appear as light worm-like tracks on the color infrared image (Fig. 4). In contrast, the intervening, low-lying wet areas sometimes appeared scarcely different from similar areas outside of the pad. Figure 6 illustrates the lack of vascular plant cover on ridges and the damaged moss mat, especially as compared to a nearby normal ridge.

Figure 6. Strangmoor ridges within and outside the Yukon Gold site footprint, Alaska, illustrating the effect of compaction and the extent of recovery after two growing seasons, photos 29 July 1995. A.—strangmoor ridge within pad footprint. B.—strangmoor ridge outside of pad footprint.

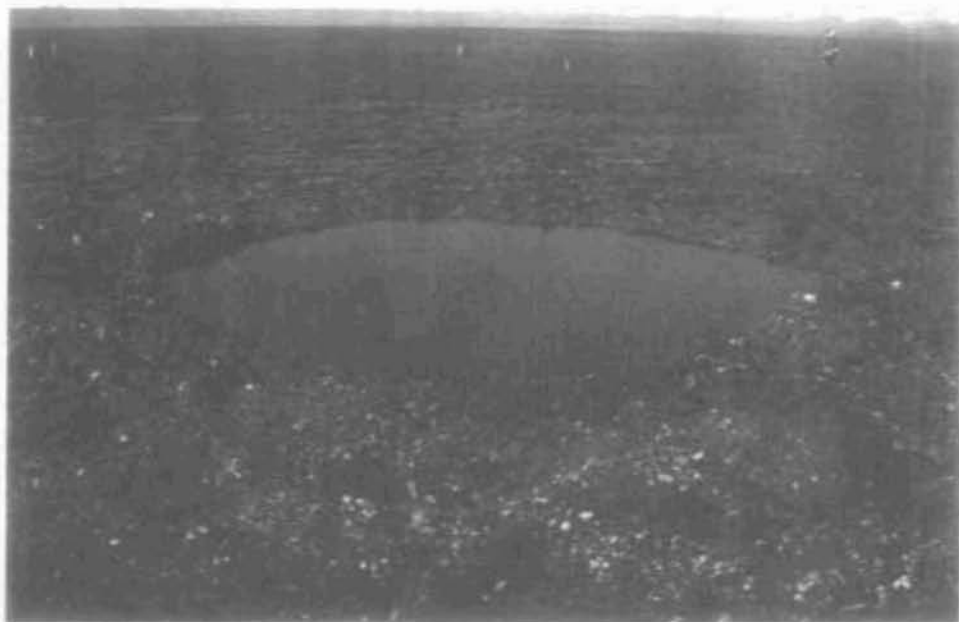
1. The area surrounding the well head had subsided to  $\geq 1.3$  m depth (Fig. 7). This depression was filled with water during sampling and covered approximately 0.03 acres, or 1%, of the pad area. The area of decreased live cover near the well head, which may be due to the temporary storage of drilling cuttings on the ice pad, covers approximately 0.15 acres, or 5%, of the pad area (Figs. 4 and 7).

Figure 7. Area of subsidence and an area of decreased live vegetation near the well head within the Yukon Gold site footprint, photos 29 July 1995. A.—well head. B.—area of decrease live vegetation near well head.

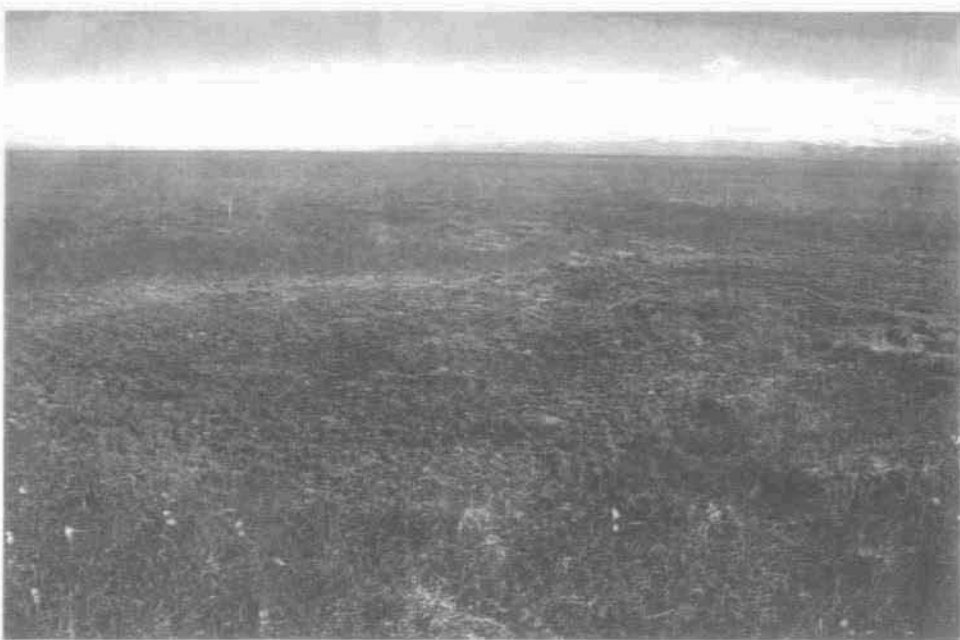
2. An area of tundra vegetation approximately 0.03 acres or 1% of the pad area, located in the southeast corner was impacted by a diesel fuel spill (Figs. 4 and 8). It may be likely that a portion of the area in the pad corner was impacted by spreading of the diesel spill by surface water, possibly increasing the impact area to 0.08 acres, or 3%, of the pad area. Some live vegetation was beginning to grow within the diesel spill area.

Figure 8. Diesel spill area within the footprint of the Yukon Gold site, Alaska, photos 29 July 1995. A.—close view of spill area. B.—southeast corner of ice pad footprint and spill area. (Note *Eriophorum* inflorescence in foreground and background.)

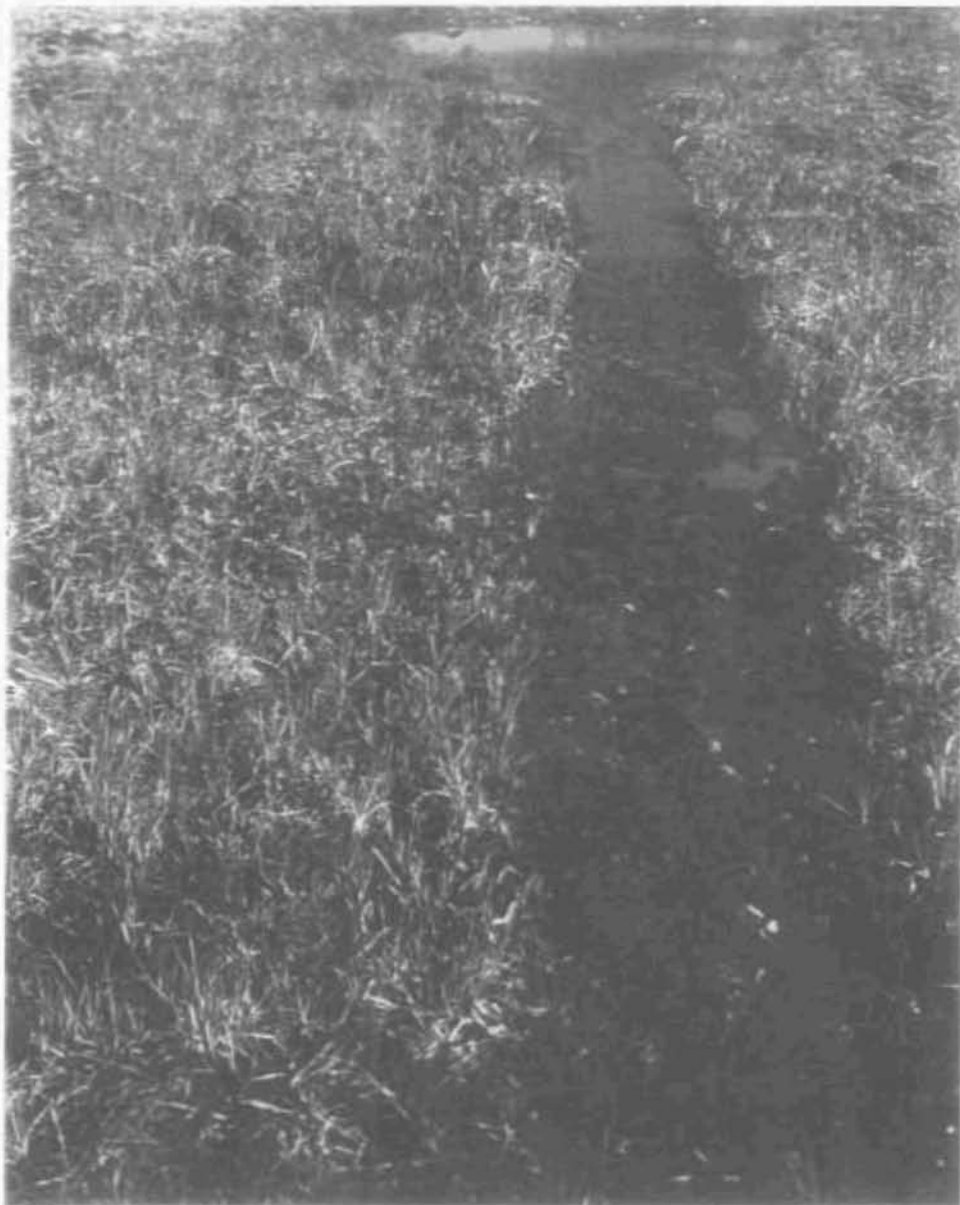
3. A small trench up to 0.6 m deep and 1 m wide was dug to provide space for camp utility lines. This area covers about 0.02 acres or 0.8% of the ice pad area (Figs. 4 and 9).

Figure 9. Trench on the south edge of the Yukon Gold site, Alaska, facing east, photo 29 July 1995.
