Permafrost
erosion
along the
Beaufort Sea
coast

March 1970

PERMAFROST EROSION ALONG THE BEAUFORT SEA COAST

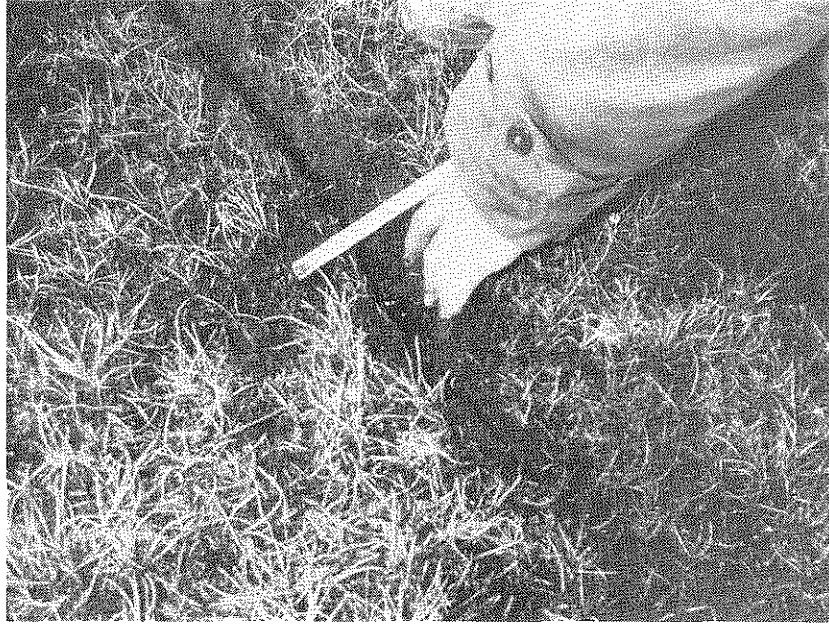
Fig. 2. This photograph illustrates the vertical tension crack in the tundra soils. This crack overlies a vertical wedge-shaped vein of ice.

The polygonal ground patterns of this region are indications of permafrost. The polygonal form is generated by the thermal contraction of frozen ground during the arctic winter. The ground contraction processes form vertical tension cracks in a honeycomb pattern. During the thaw season, waters from the melting snow and ice drain down into the contraction cracks and form a vein of ice (Fig. 2). This annual cycle produces a wedge-shaped ice mass (Lachenbruch, 1968, p. 837). The ice wedges are one to two meters (3 to 7 feet) wide and two to three meters (7 to 10 feet) deep. In addition to the wedges, tabular ice masses a few meters thick and small ice lenses up to a few centimeters thick can occur together or singly over the entire North Slope of Alaska. Leffingwell's work published in 1915 and 1919 was some of the most significant research on the origin and nature of ice wedges in Alaska. More recently, the research of Lachenbruch, 1962, considers the theoretical aspects of ice wedge formation.

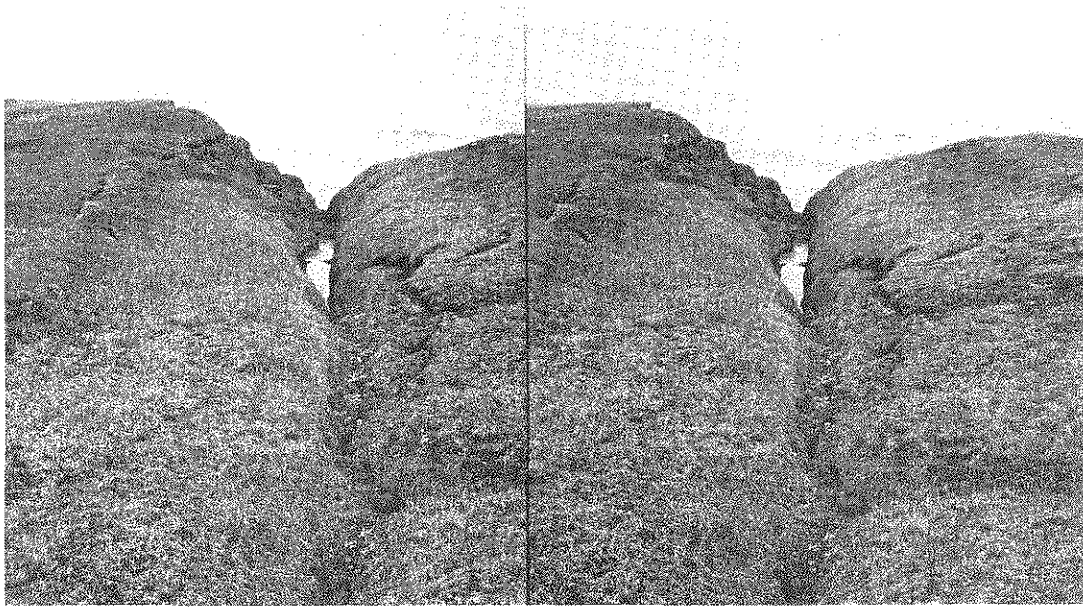
Fig. 7. The fourth stereogram illustrates the advanced stage of ice-wedge ice and permafrost degradation along the polygon trough which overlies the ice-wedge ice. The tundra surface subsides and slumps as the volume of ice decreases. The total topographic relief is about 2 to 3 meters (6.6 to 10 feet).

Sequential aerial photography and ground photographs were used by Lewellen (1965) to study the thermal erosion along the Elson Lagoon shoreline near Point Barrow (Figs. 3, 4, 5, 6, and 7). Rates of erosion varied from a few decimeters to 10 meters (33 feet) per summer thaw season. The maximum rates were observed where the permafrost shore line was exposed to the open sea by a pass in the barrier islands.
