Permafrost erosion along the Beaufort Sea coast

Robert I. Lewellen
 Geography and Geology Department
 University of Denver
 Denver, Colorado 80210

March 1970

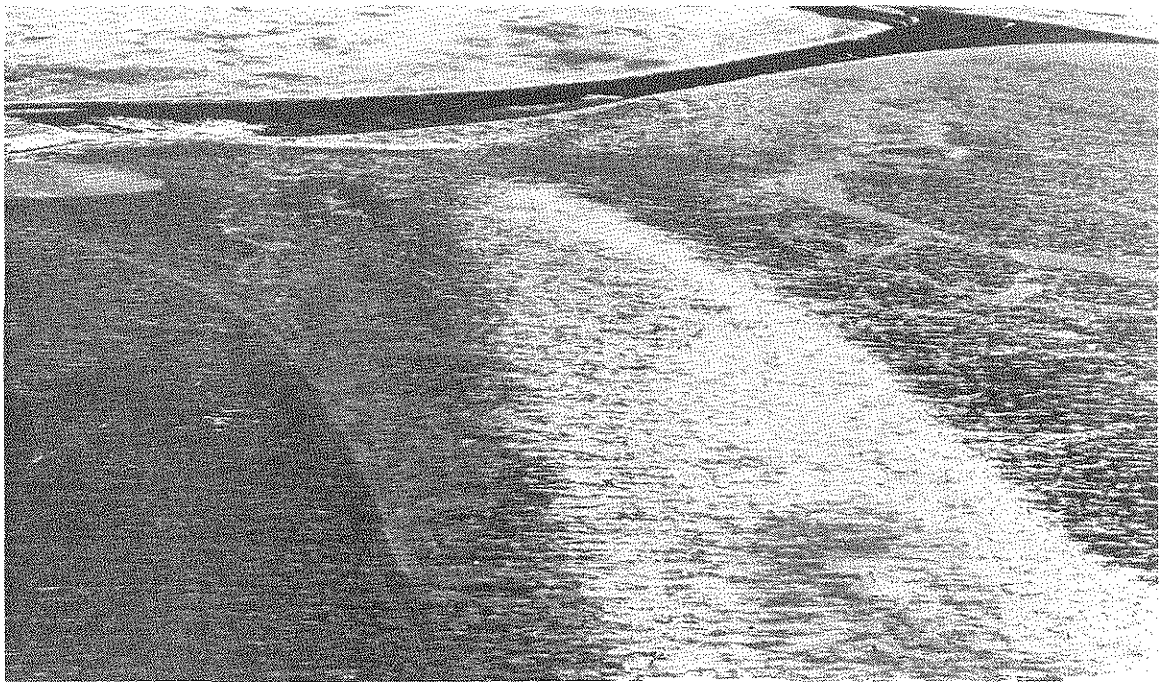
Fig. 9. An aerial oblique photograph showing the large bar of fine sands and silts which have been deposited north of Tekegakrok Point, Elson Lagoon (see Fig. 8). The bar outline is accentuated by the decaying ice. This bar protects the western coastline from Brant Point to Ikpik. Point Barrow can be seen in the right background of the photograph. The patterns made by the decaying ice are useful in the study of the near shore environments. The photograph was taken 15 June 1967.

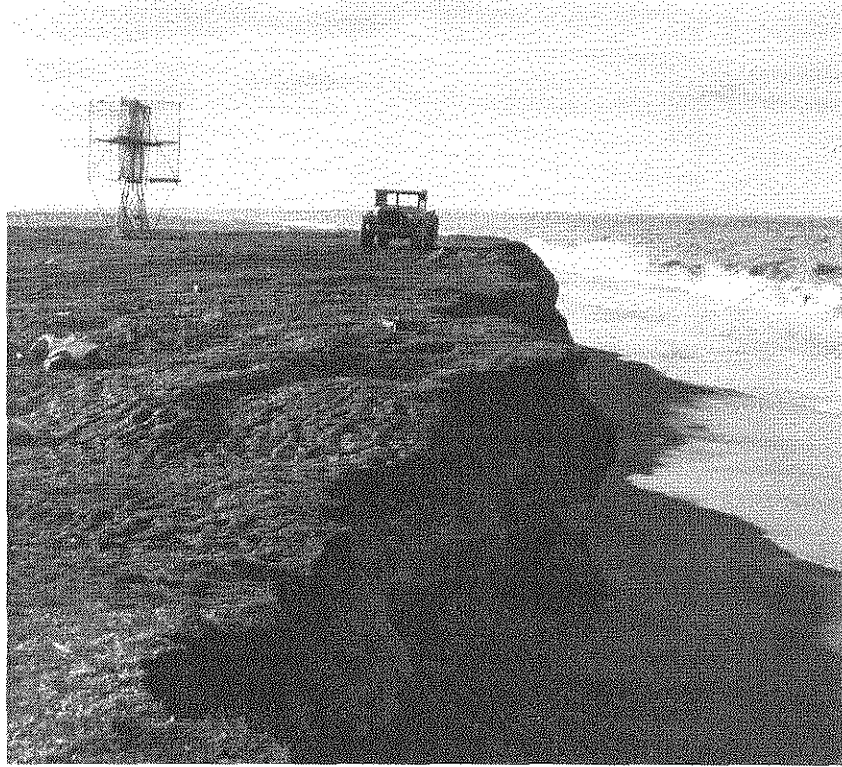
Fig. 15. A photograph taken of Point Barrow (September 1963) just before the marine storm of 3 October 1963. The normal coastline retreat is about 3 meters (10 feet) per year. Compare this photograph with Fig. 16.

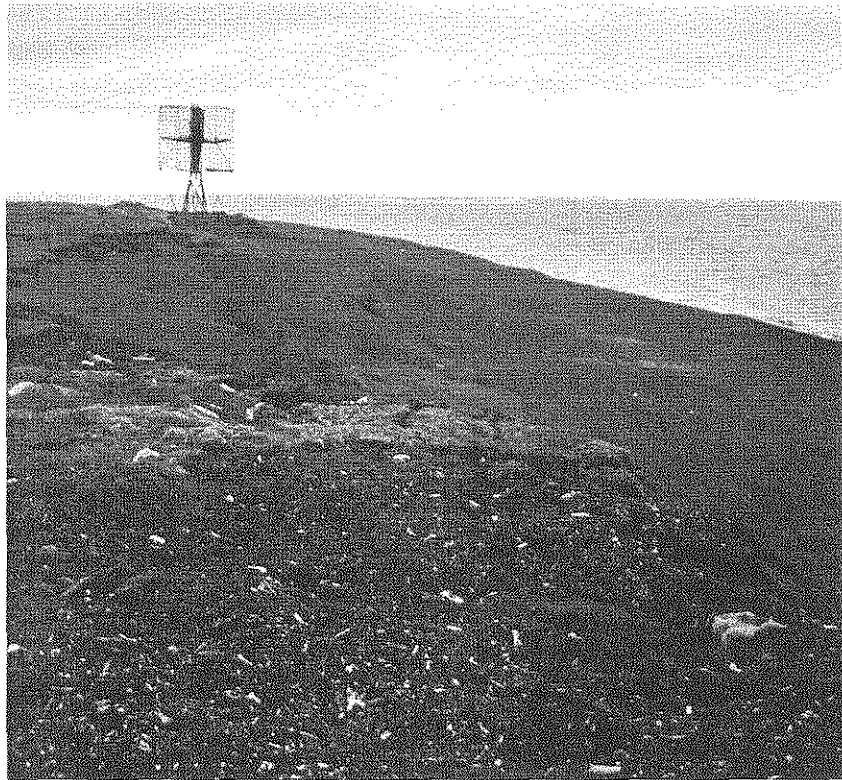
Fig. 16. Point Barrow after the storm of 3 October 1963. About 8 meters (26 feet) was eroded by this single storm. Whale bone and debris from an old Eskimo village litter the foreground. The photograph was taken 16 August 1965.

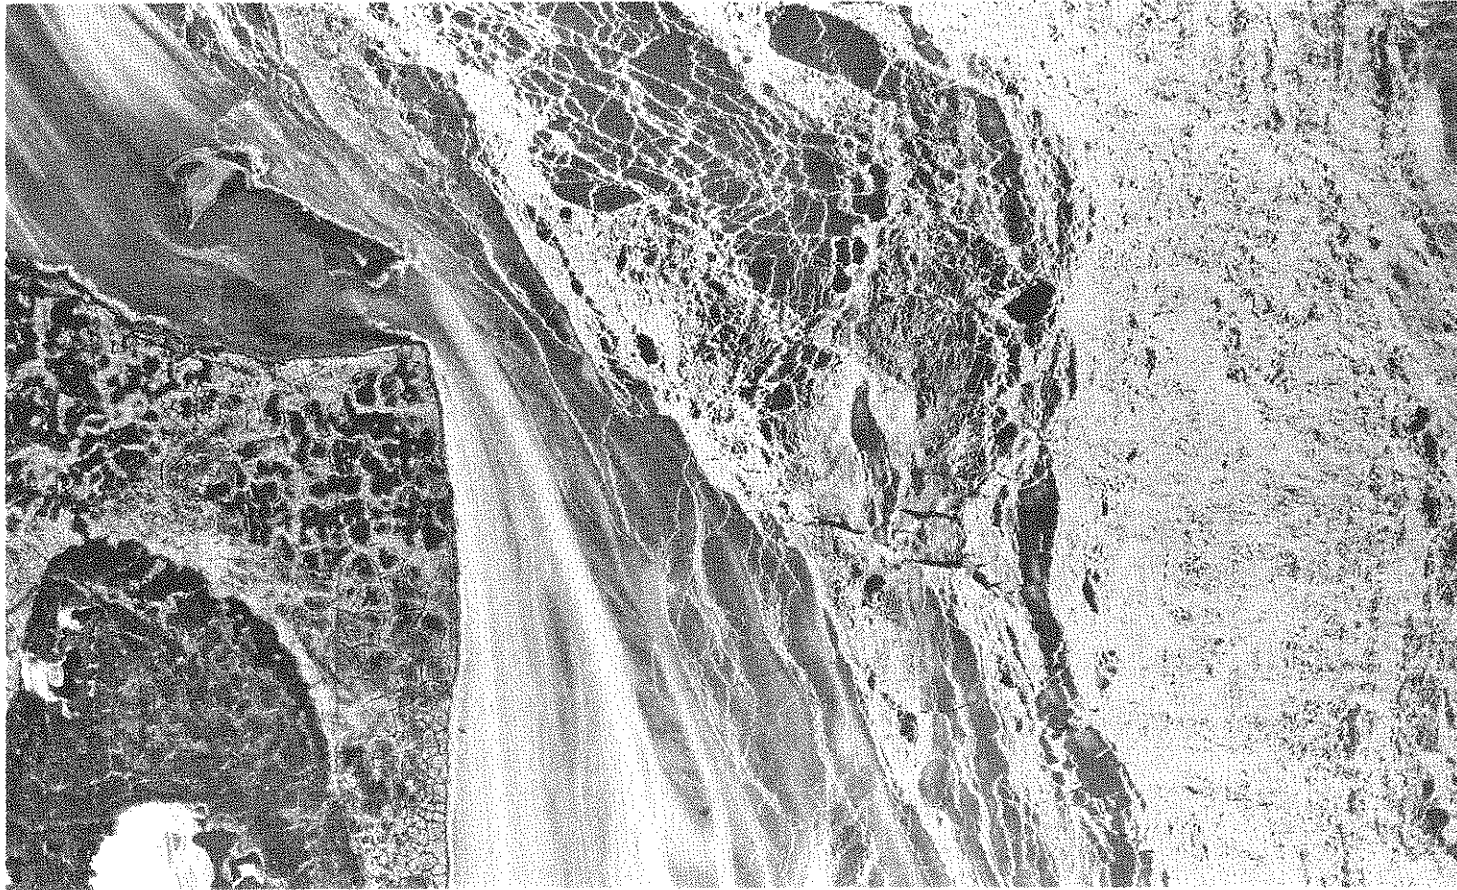
Fig. 18. This aerial photograph illustrates the strands of frazil ice and skim ice which form during the initial phase of the annual freeze-up. The formation of frazil and skim ice stops the erosive wave action. The photograph was taken over Brant Point, Elson Lagoon on 5 September 1956 at a scale of 1/10750.

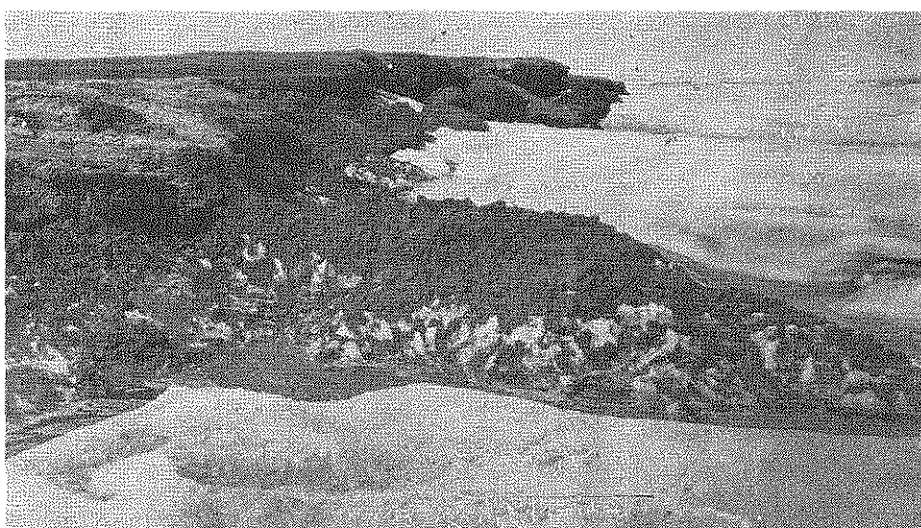
Fig. 20. Temporary preservation of sea ice under a slumping bank on Flaxman Island (photograph by Leffingwell, 1919, Plate XXVI.)

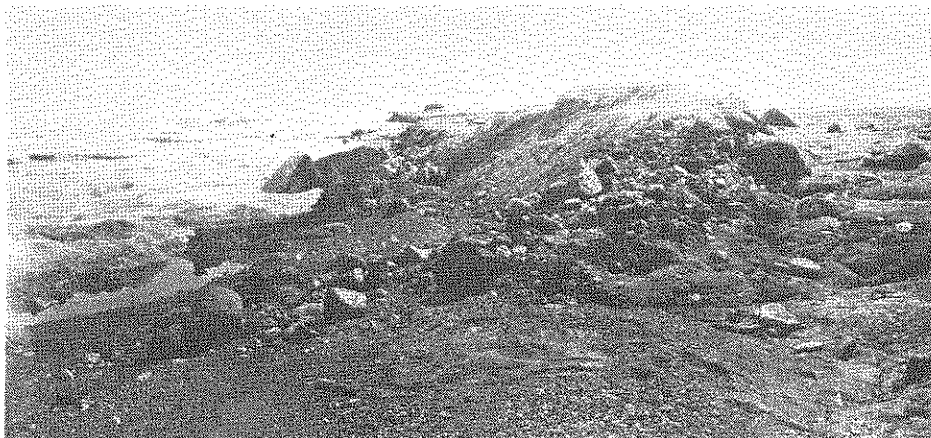
Fig. 24. Mound of sand, gravel, and boulders shoved up by the sea ice as the ice mounts the beach (photograph by Leffingwell, 1919, Plate XXV).

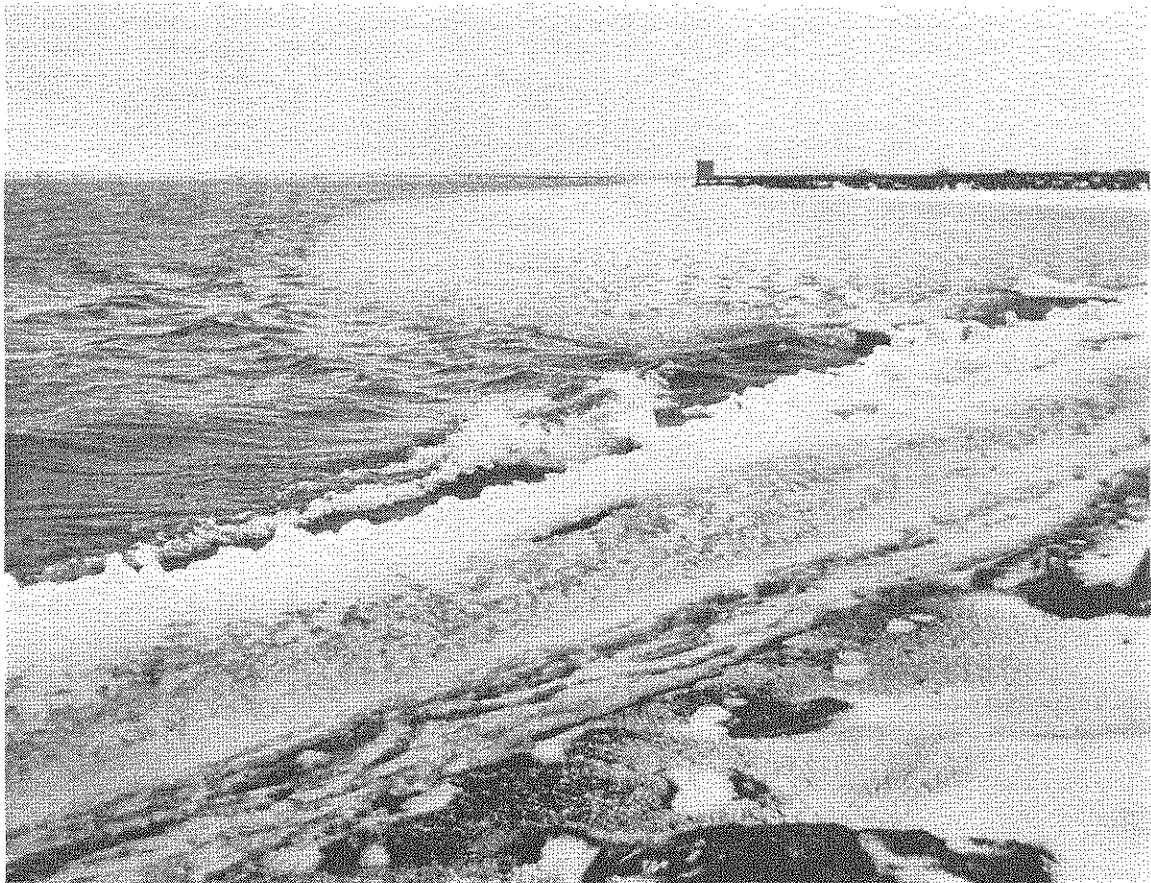
Fig. 34. Frazil ice and freezing spray accumulating along the western shore of Imikpuk Lake, Barrow, Alaska (27 September 1966). This lake is the fresh water supply for the Barrow Naval Camp. The water collection point is marked by the small building in the background of the photograph. Generally, the waves propagate about 10 to 15 meters (33 to 50 feet) into the strands of frazil ice before the waves are completely damped.
