A Hydrogeologic Susceptibility and Vulnerability Assessment for Veco Beluga Construction Camp Public Drinking Water System, Beluga, Alaska PWSID # 246999.001

DRINKING WATER PROTECTION REPORT 1711

Alaska Department of Environmental Conservation

December, 2008

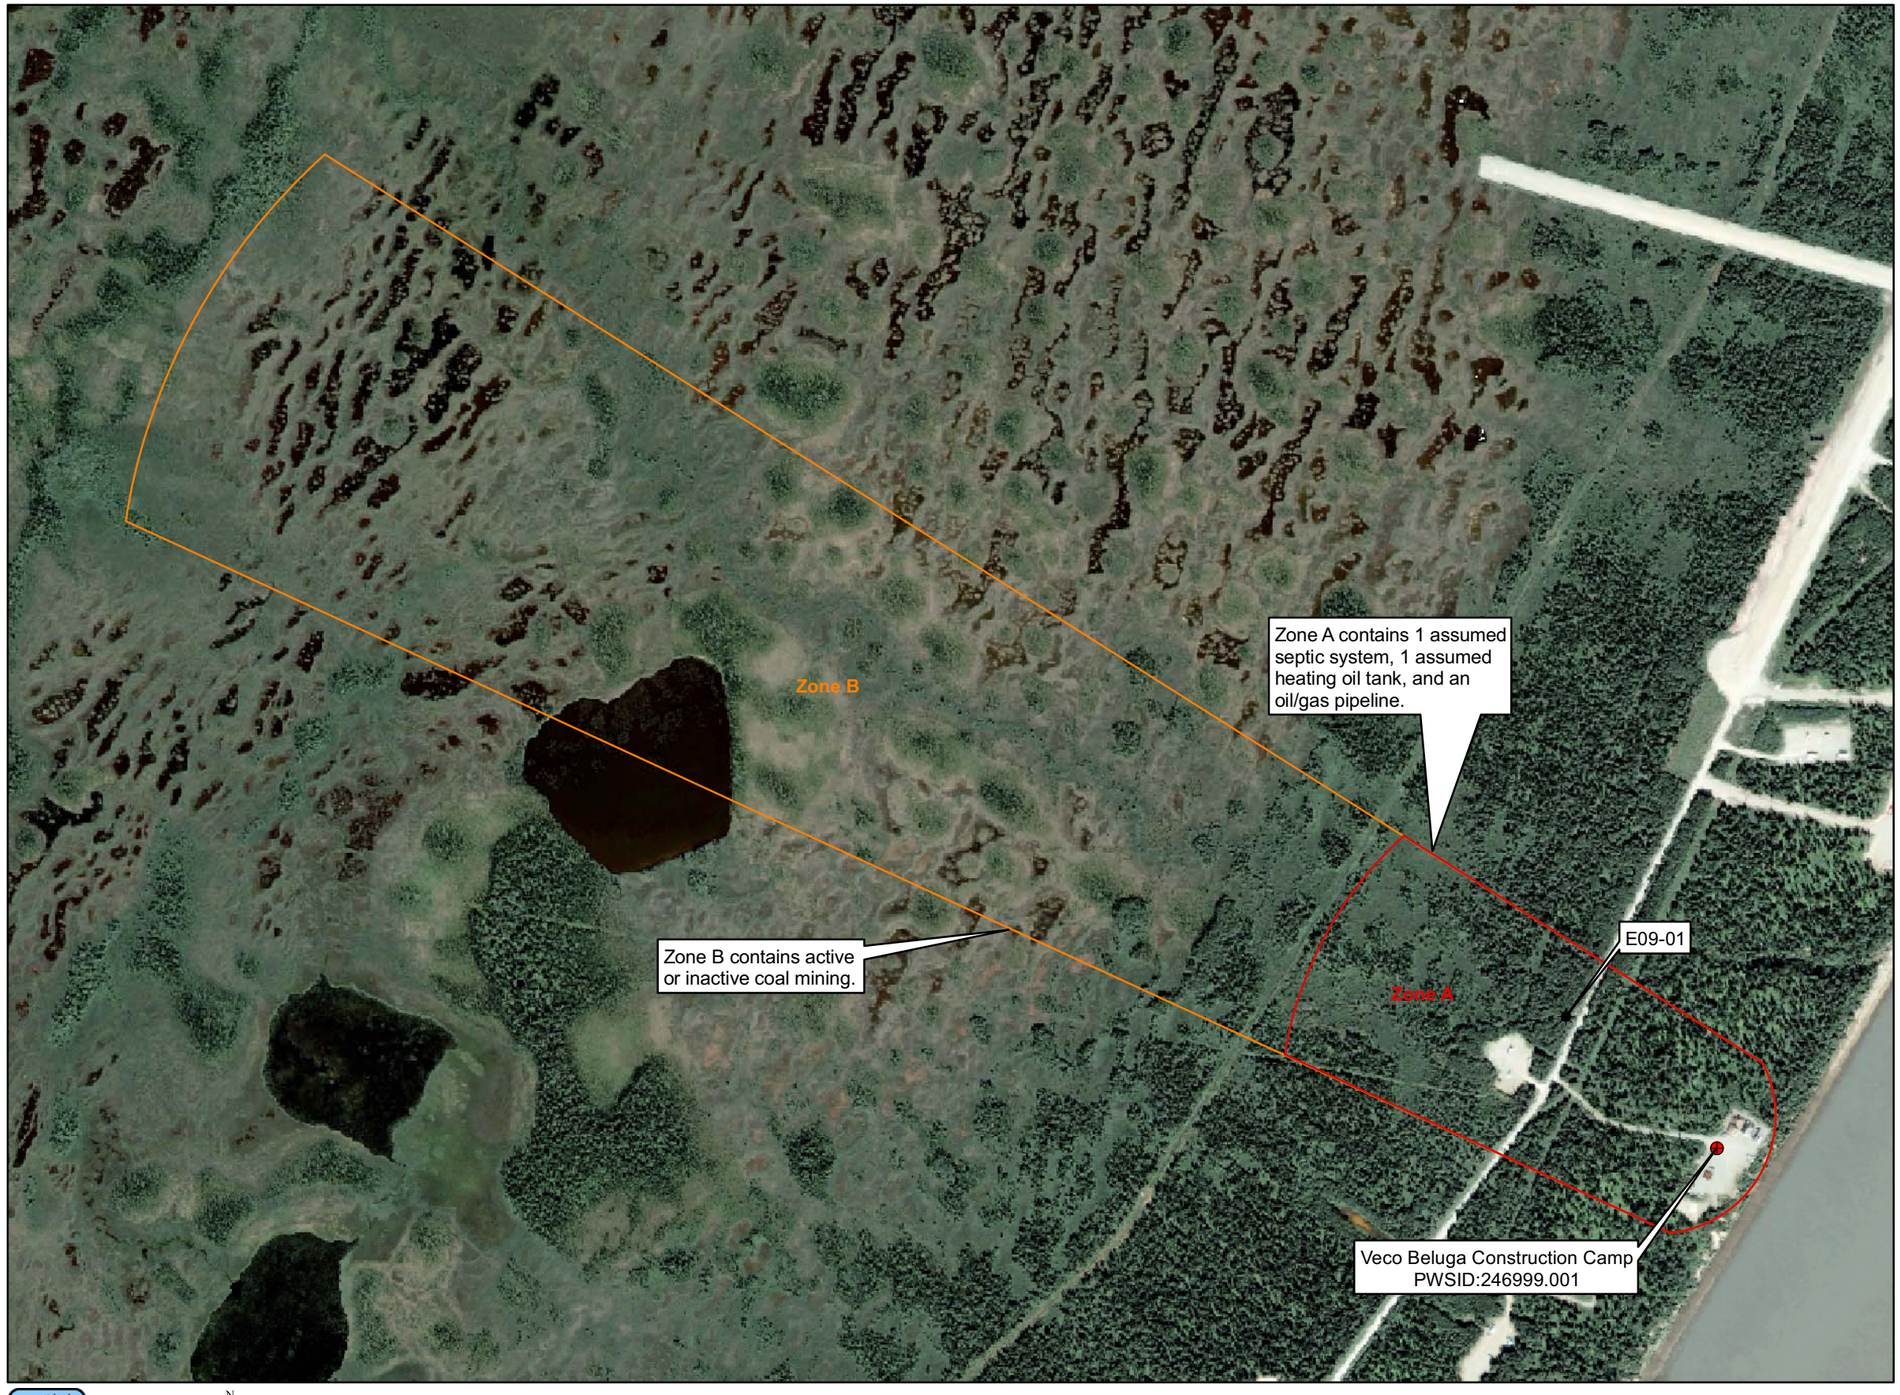
Appendix C Map C

The sources are displayed on Map C of Appendix C and summarized in Table 1 of Appendix B.

The contaminant risk for volatile organic chemicals is **High**, with a petroleum recovery operation, a septic system, a heating oil tank, and a coal mining area contributing to the risk to the drinking water well.
