Source Water Assessment

A Hydrogeologic Susceptibility and Vulnerability Assessment for Bethel Native Corporation Apartments Drinking Water System, Bethel, Alaska

PWSID # 270469.001

April 2004

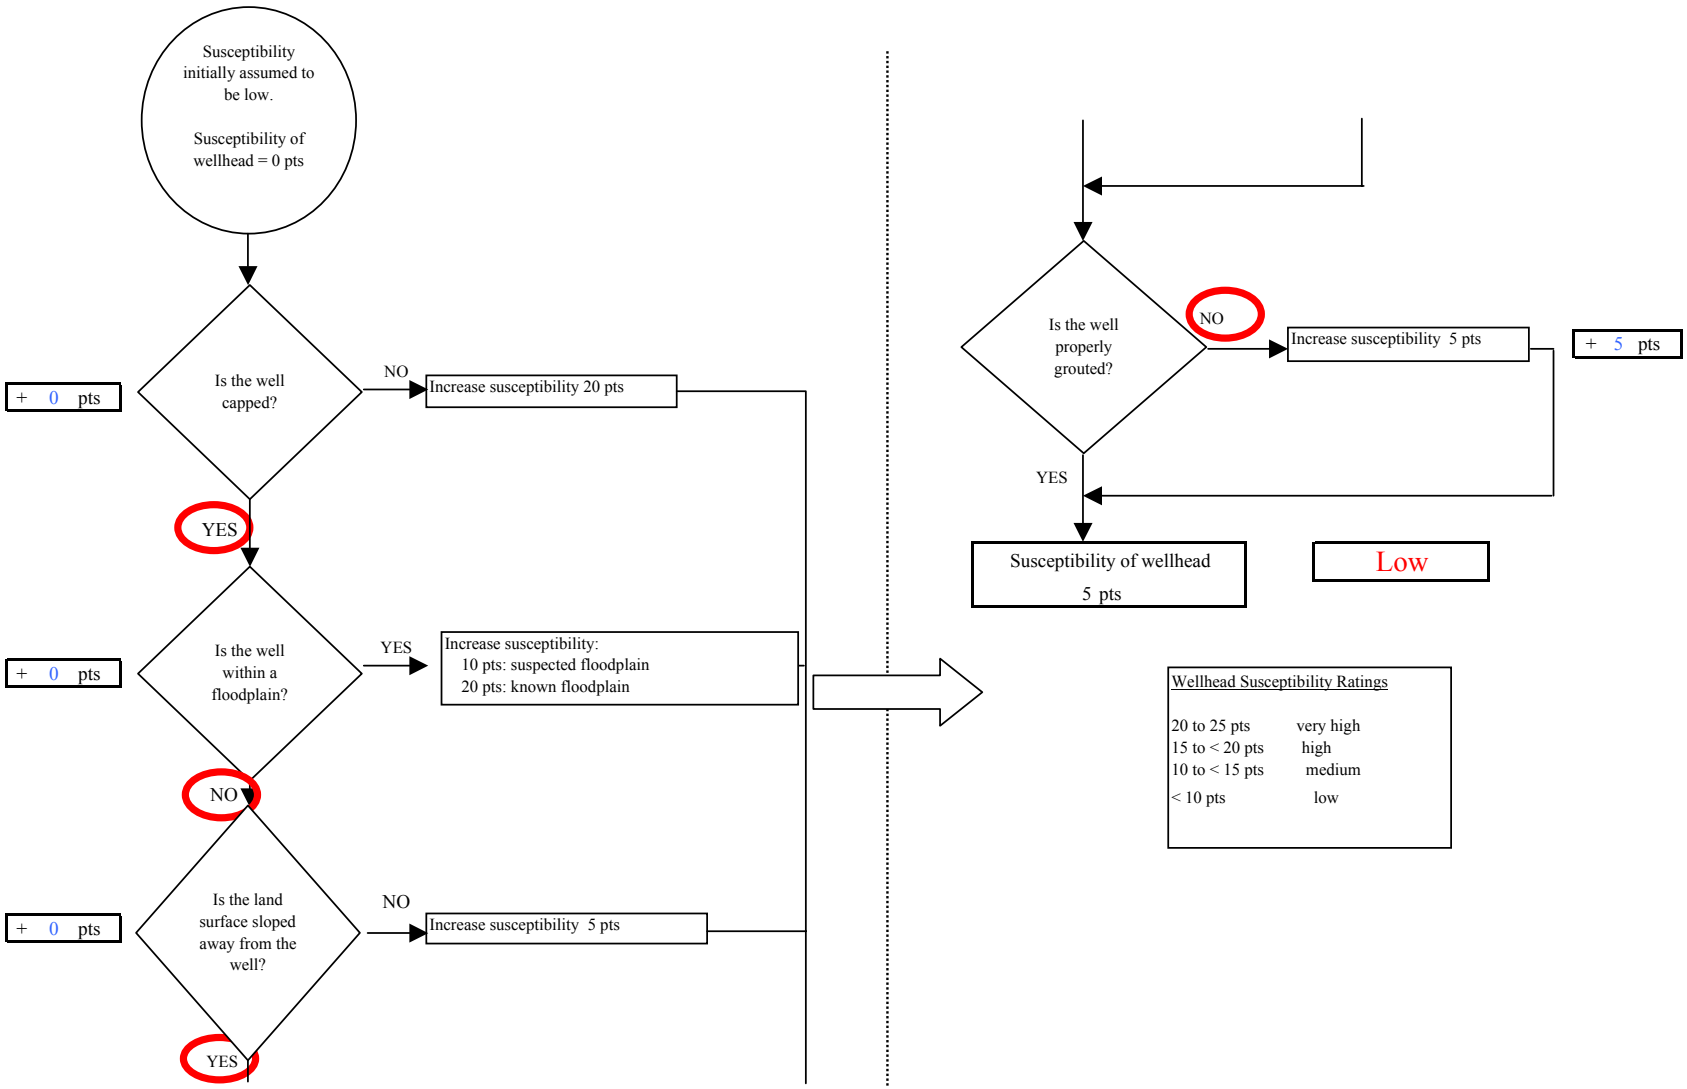
Chart 1. Susceptibility of the wellhead - Bethel Native Corp. Apts. (PWS No. 270469.001)

Score	Rating
Susceptibility of the Wellhead	5	Low
Susceptibility of the Aquifer	15	High
Natural Susceptibility	20	Medium

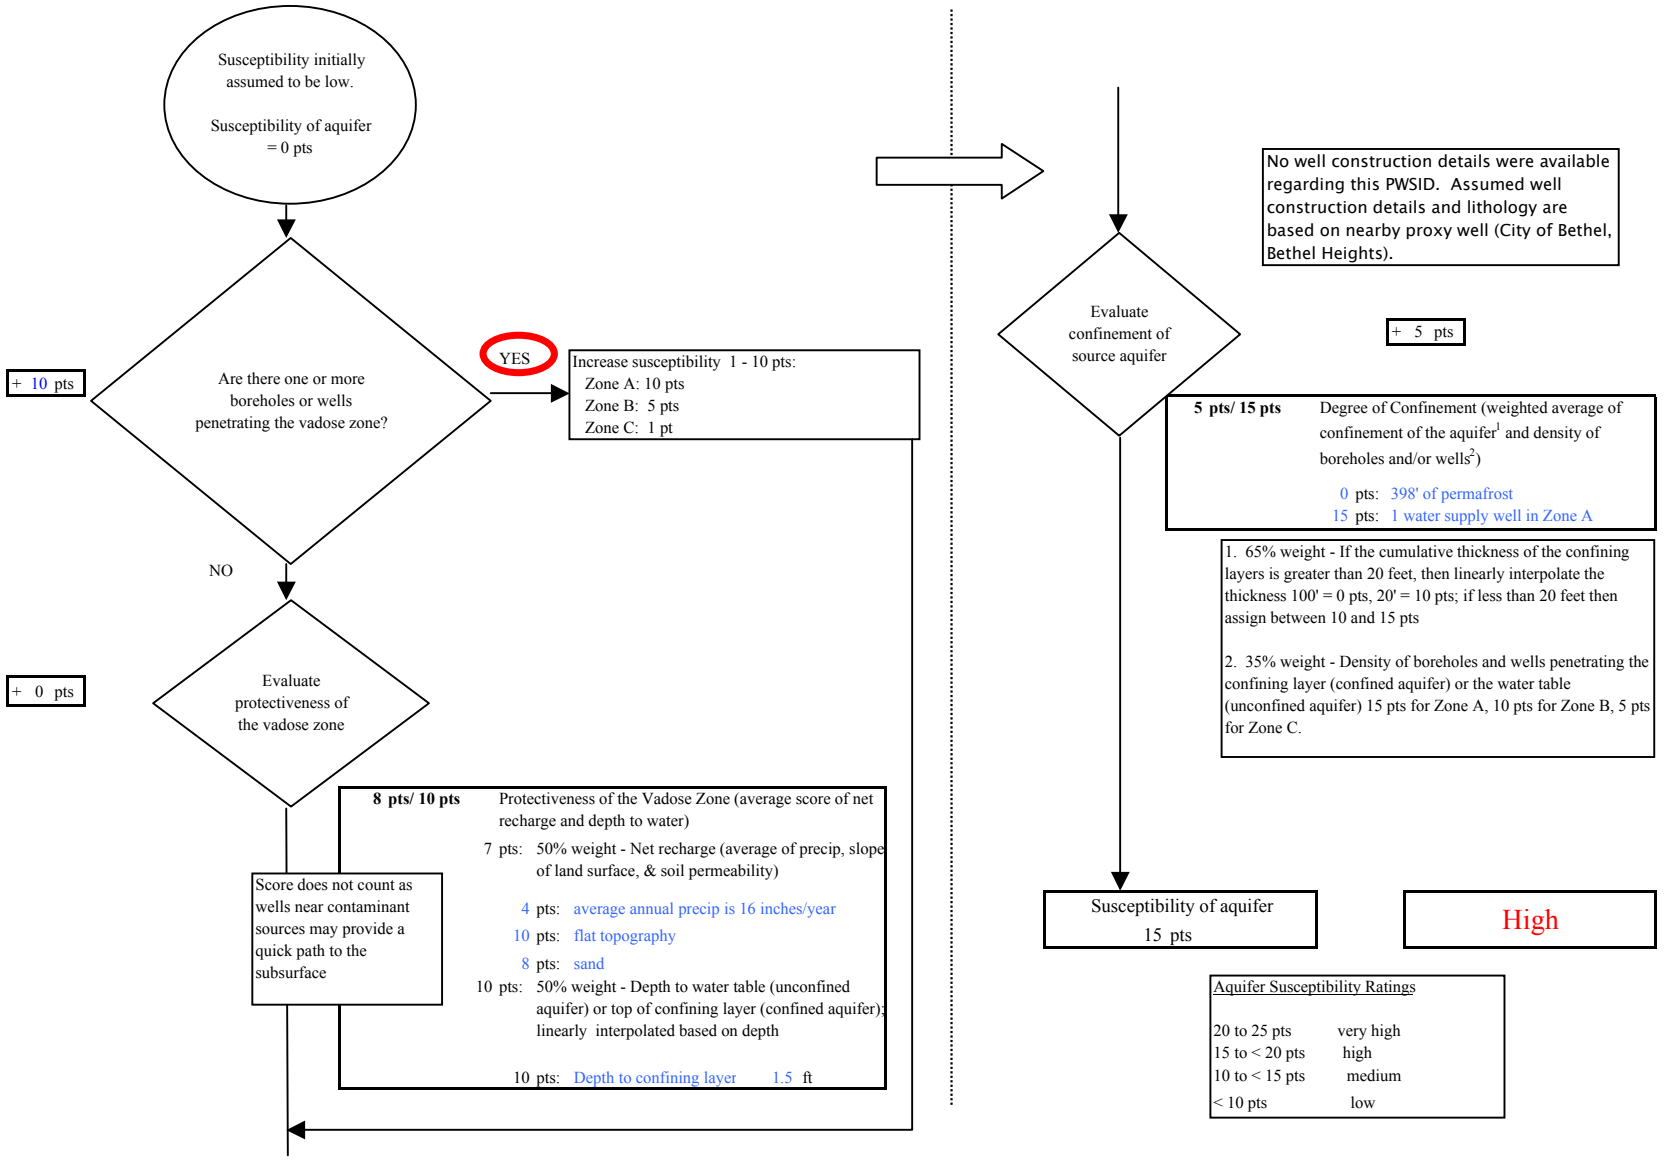
Chart 2. Susceptibility of the aquifer Bethel Native Corp. Apts. (PWS No. 270469.001)

The Bethel Native Corporation Apartments' water well is in a confined aquifer. Confined aquifers are less susceptible to potential groundwater quality impacts posed by the migration of surface water contaminants downward from the surface. Table 2 shows the susceptibility scores and ratings for this PWS.

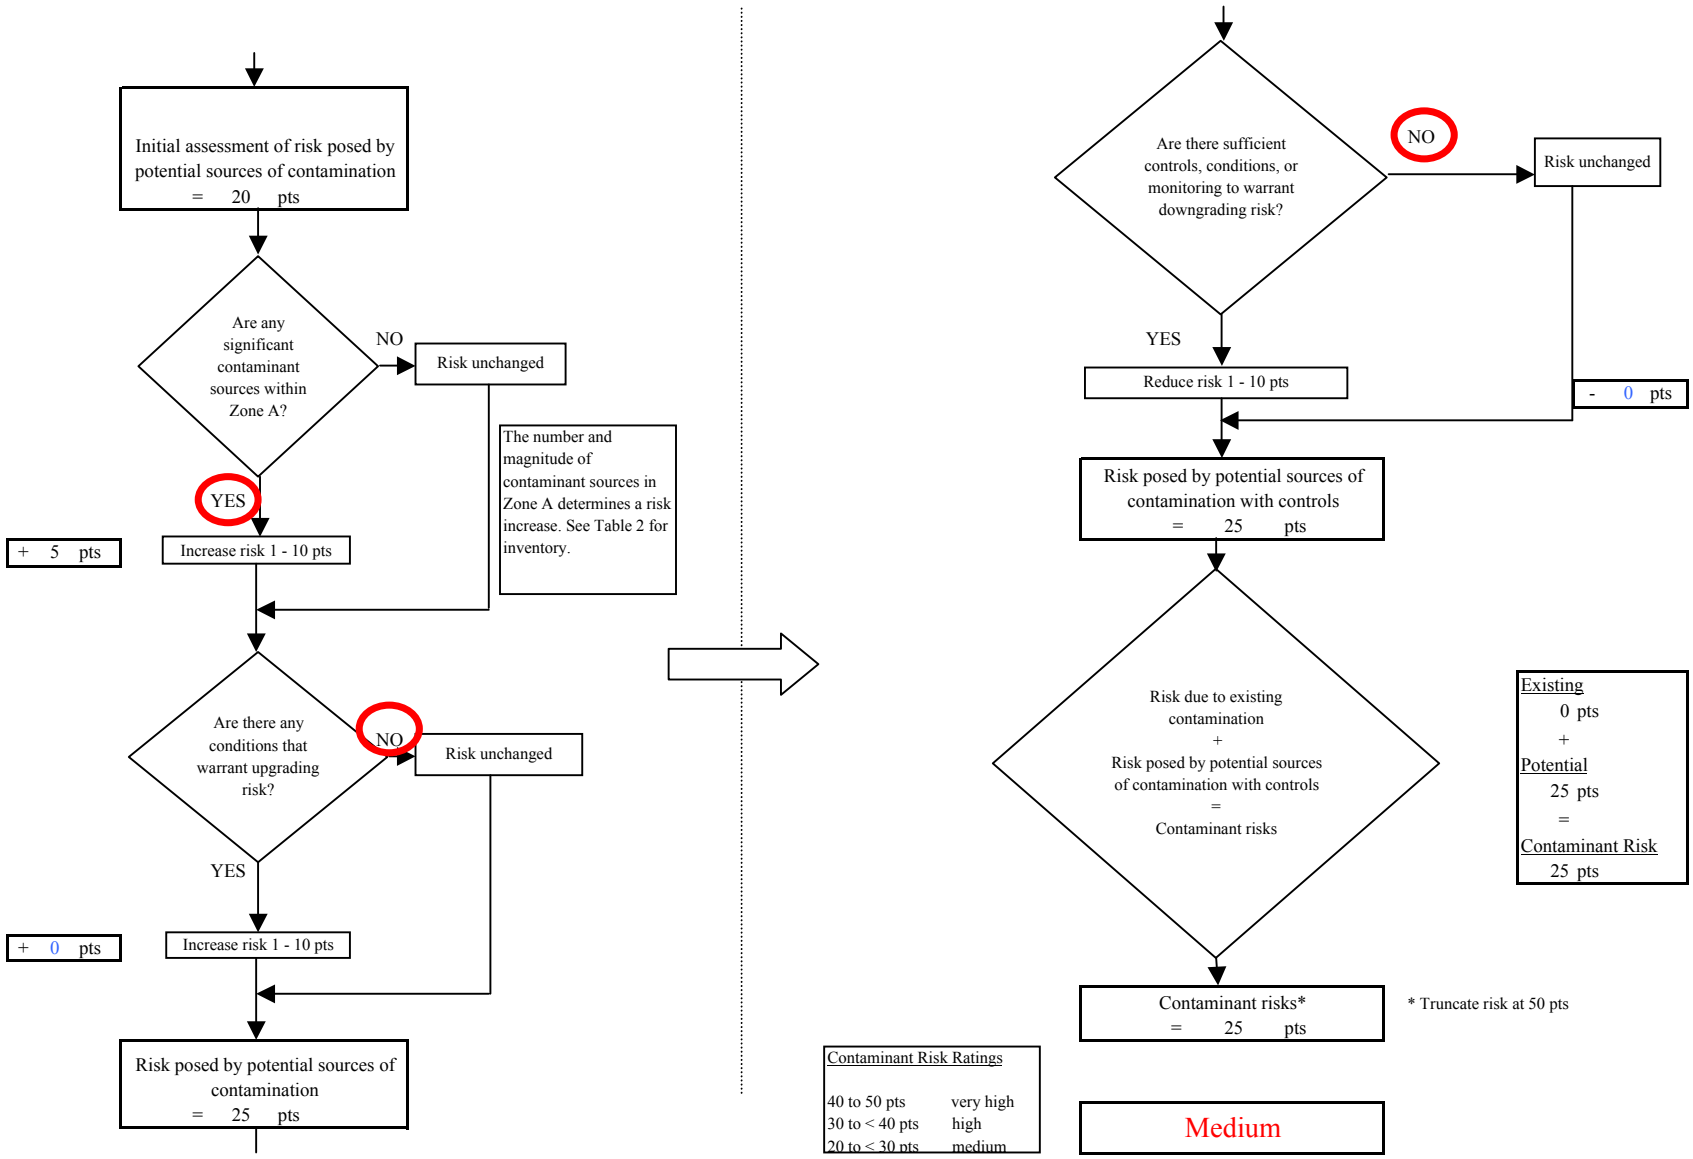
Chart 3. Contaminant risks for Bethel Native Corp. Apts. (PWS No. 270469.001) - Bacteria & Viruses

The contaminant risk for bacteria and viruses is **Medium**. The risk is primarily attributed to the presence of a domestic wastewater treatment plant disposal pond/lagoon and landfills in Zones C and D (see Table 2 – Appendix B).

A positive bacteria count has not been reported in recent (within five years) sampling events (See Chart 3 – Contaminant Risks for Bacteria and Viruses in Appendix D). Only a small amount of bacteria and viruses are required to endanger public health.

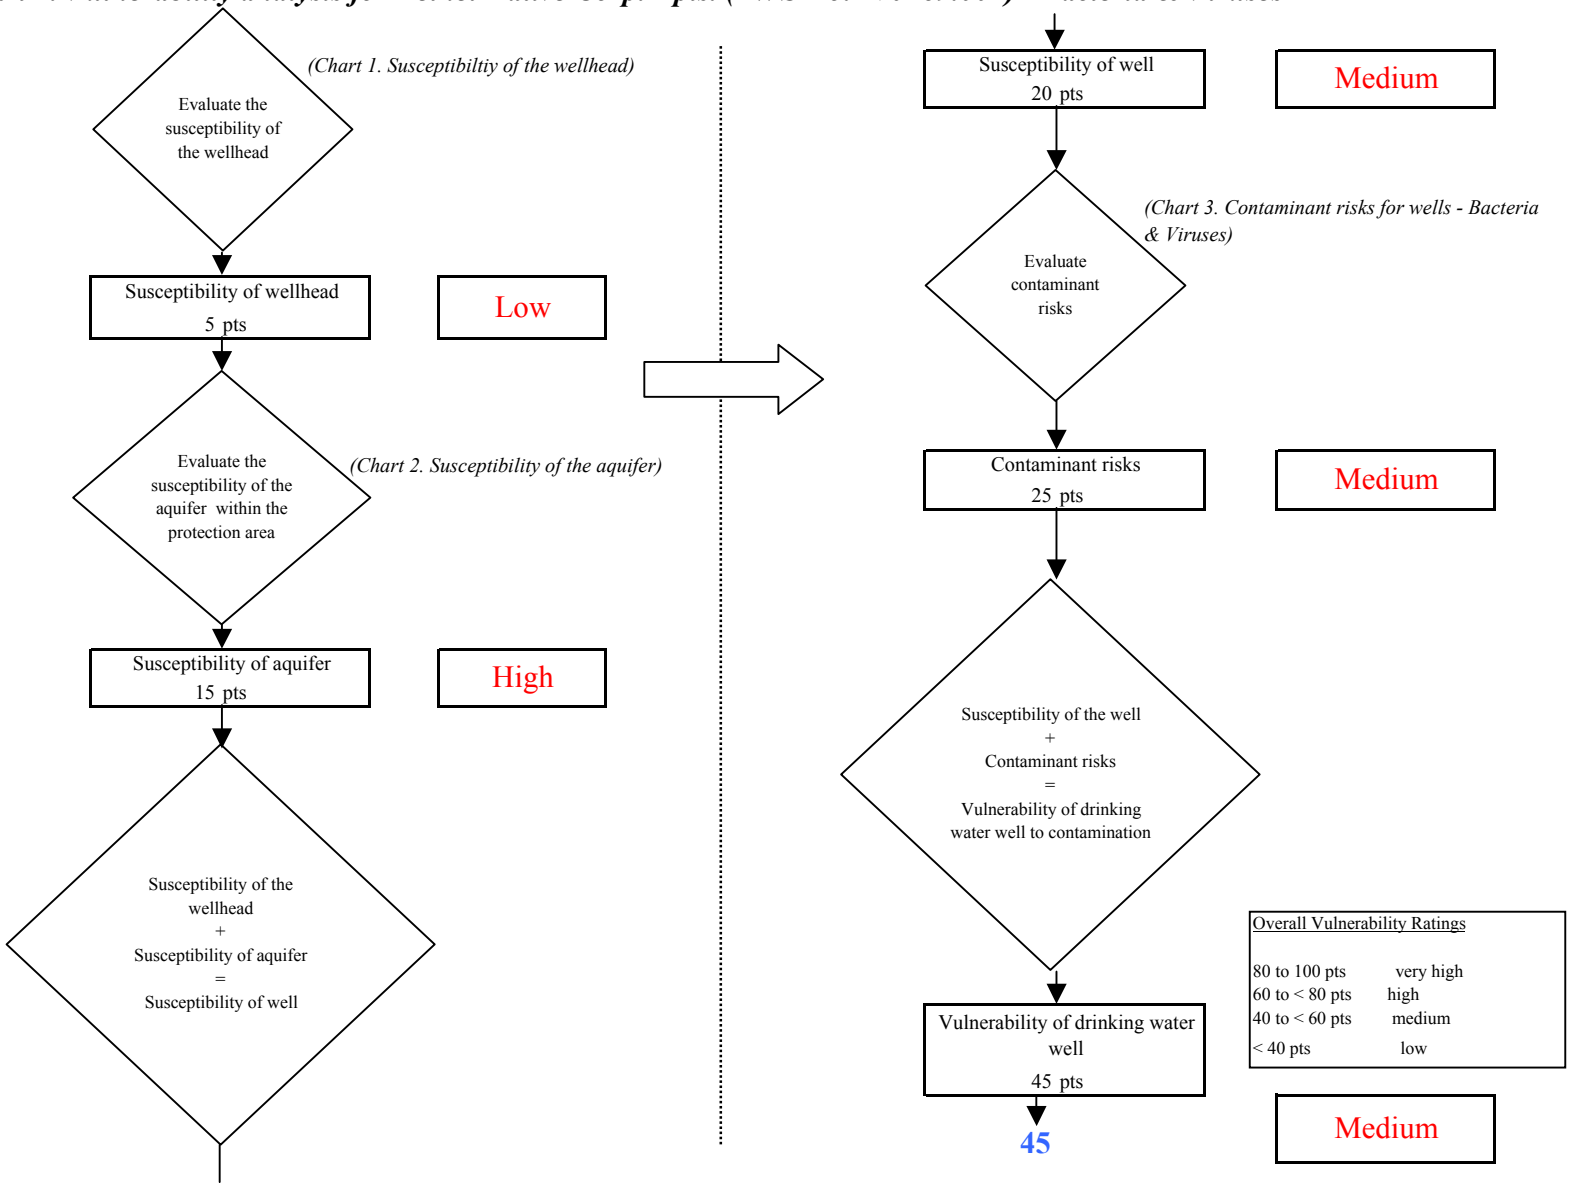
Chart 4. Vulnerability analysis for Bethel Native Corp. Apts. (PWS No. 270469.001) - Bacteria & Viruses

After combining the contaminant risk for bacteria and viruses with the natural susceptibility of the well, the overall vulnerability of the well to contamination is **Medium**.

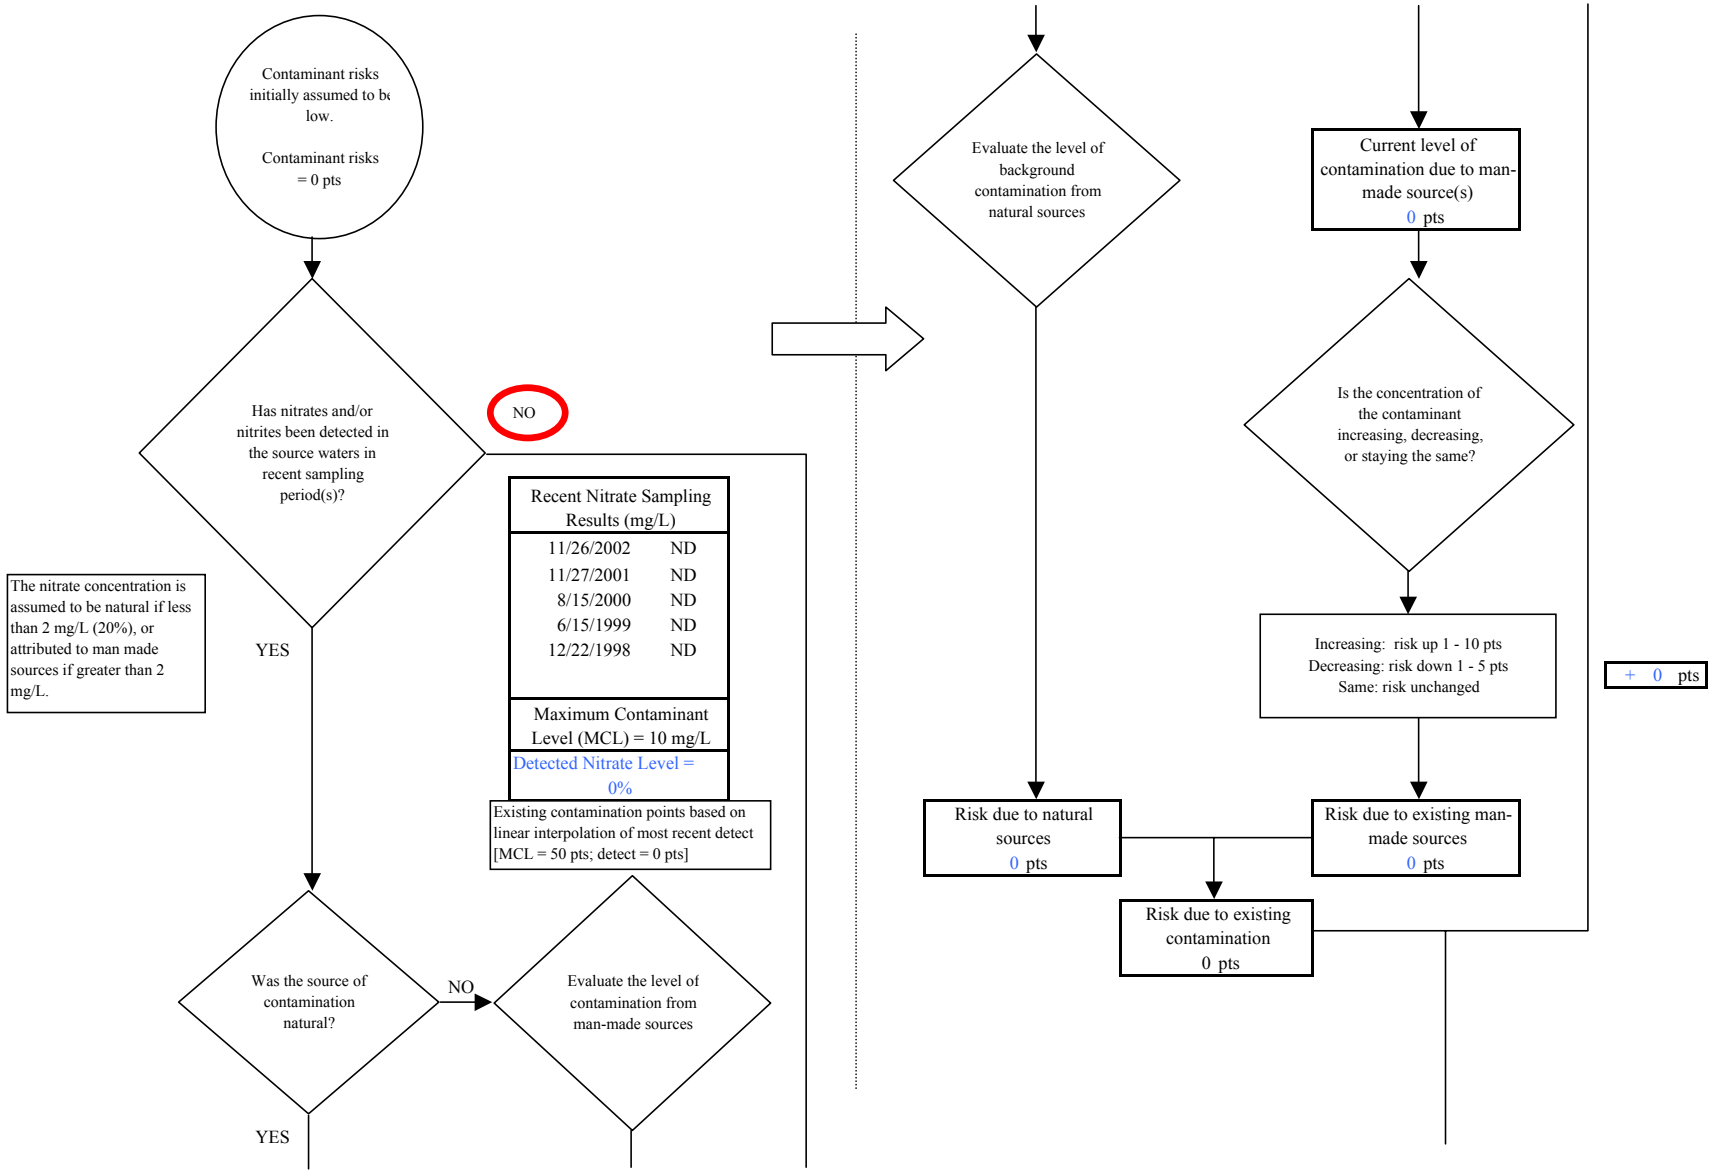
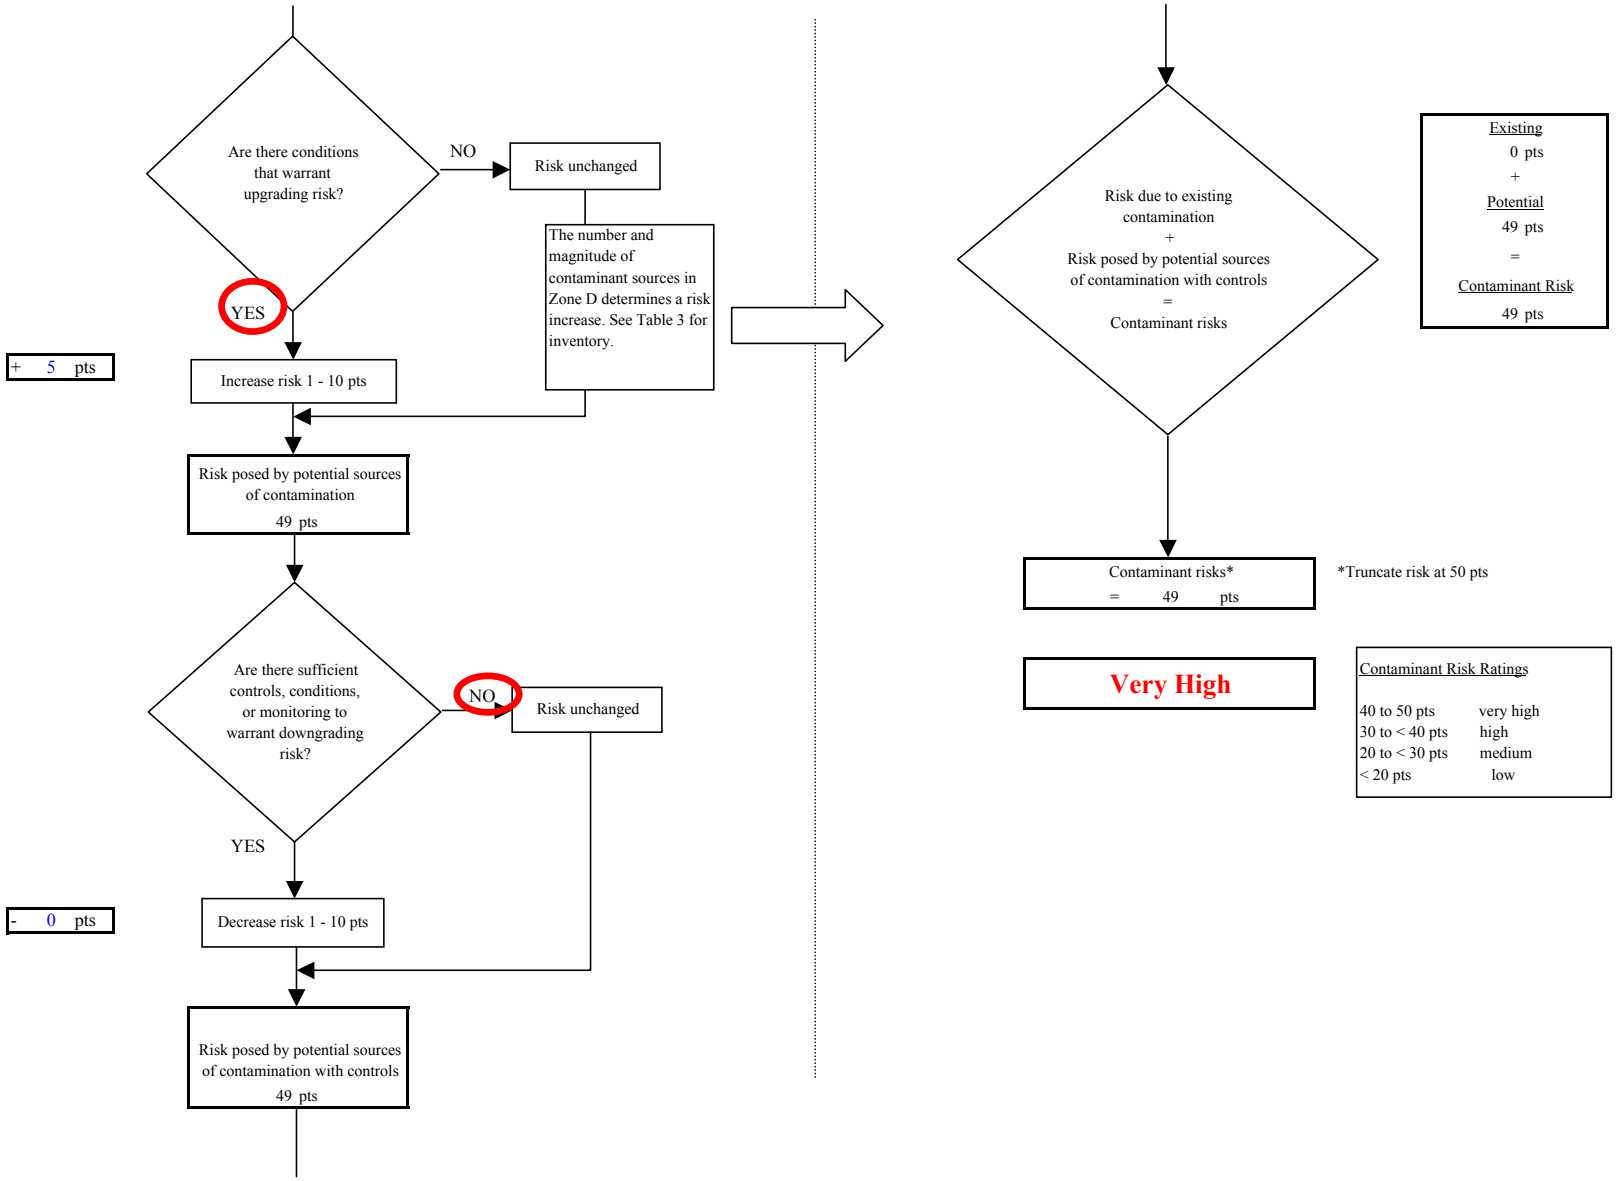
Chart 5. Contaminant risks for Bethel Native Corp. Apts. (PWS No. 270469.001) - Nitrates and Nitrites

The contaminant risk for nitrates and nitrites is **Very High**. The risk to this source of public drinking water is primarily attributed to the presence of a domestic wastewater treatment plant disposal pond/lagoon, and landfills in Zones C and D (see Table 3 – Appendix B).

Nitrates are very mobile, moving at approximately the same rate as water. The sampling history for this well indicates that nitrates have not been detected in recent sampling events. Nitrate concentrations in uncontaminated groundwater are typically less than 2 mg/L; therefore, nitrate concentrations above 2 mg/L may be indicative of man-made sources (See Chart 5 - Contaminant Risks for Nitrates and/or Nitrites in Appendix D).

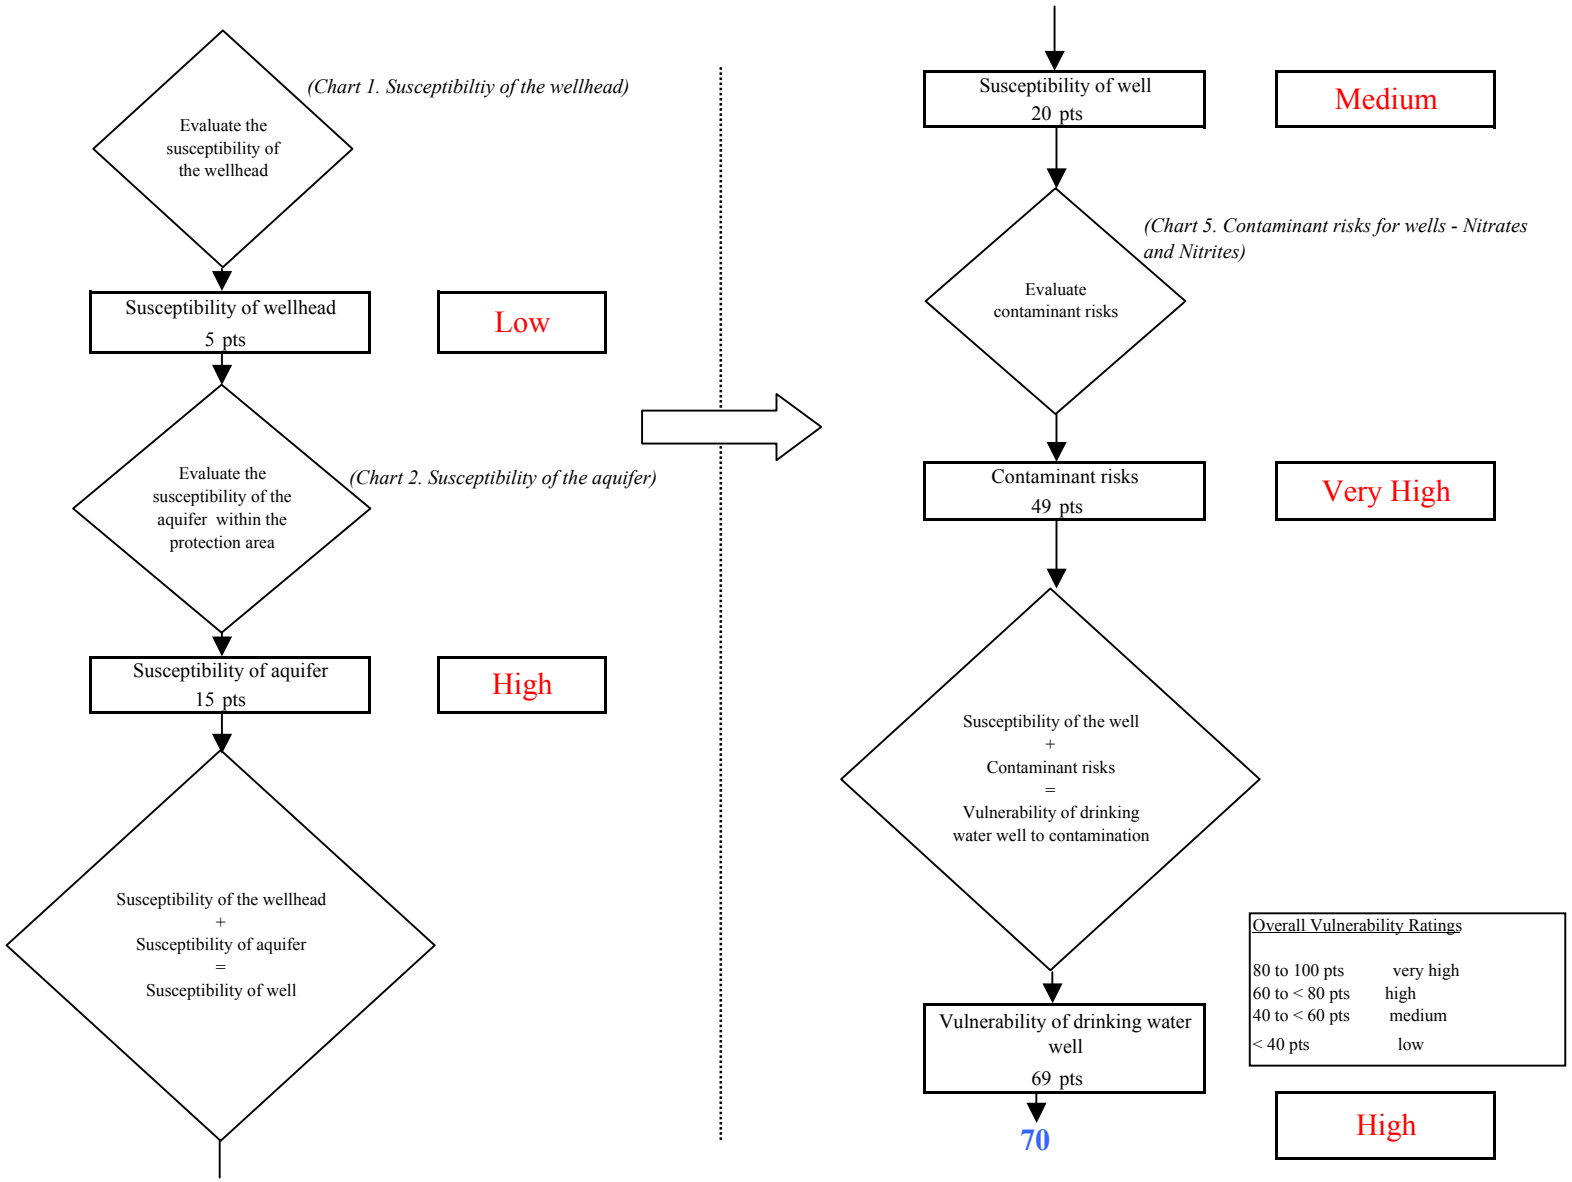
Chart 6. Vulnerability analysis for Bethel Native Corp. Apts. (PWS No. 270469.001) - Nitrates and Nitrites

Nitrate levels are often derived from the decomposition of organic matter in soils. Although the nitrate source is unknown, such occurrences may be attributed to septic systems or other sources. After combining the contaminant risk for nitrates and nitrites with the natural susceptibility of the well, the overall vulnerability of the well to nitrate and nitrite contamination is **High**.

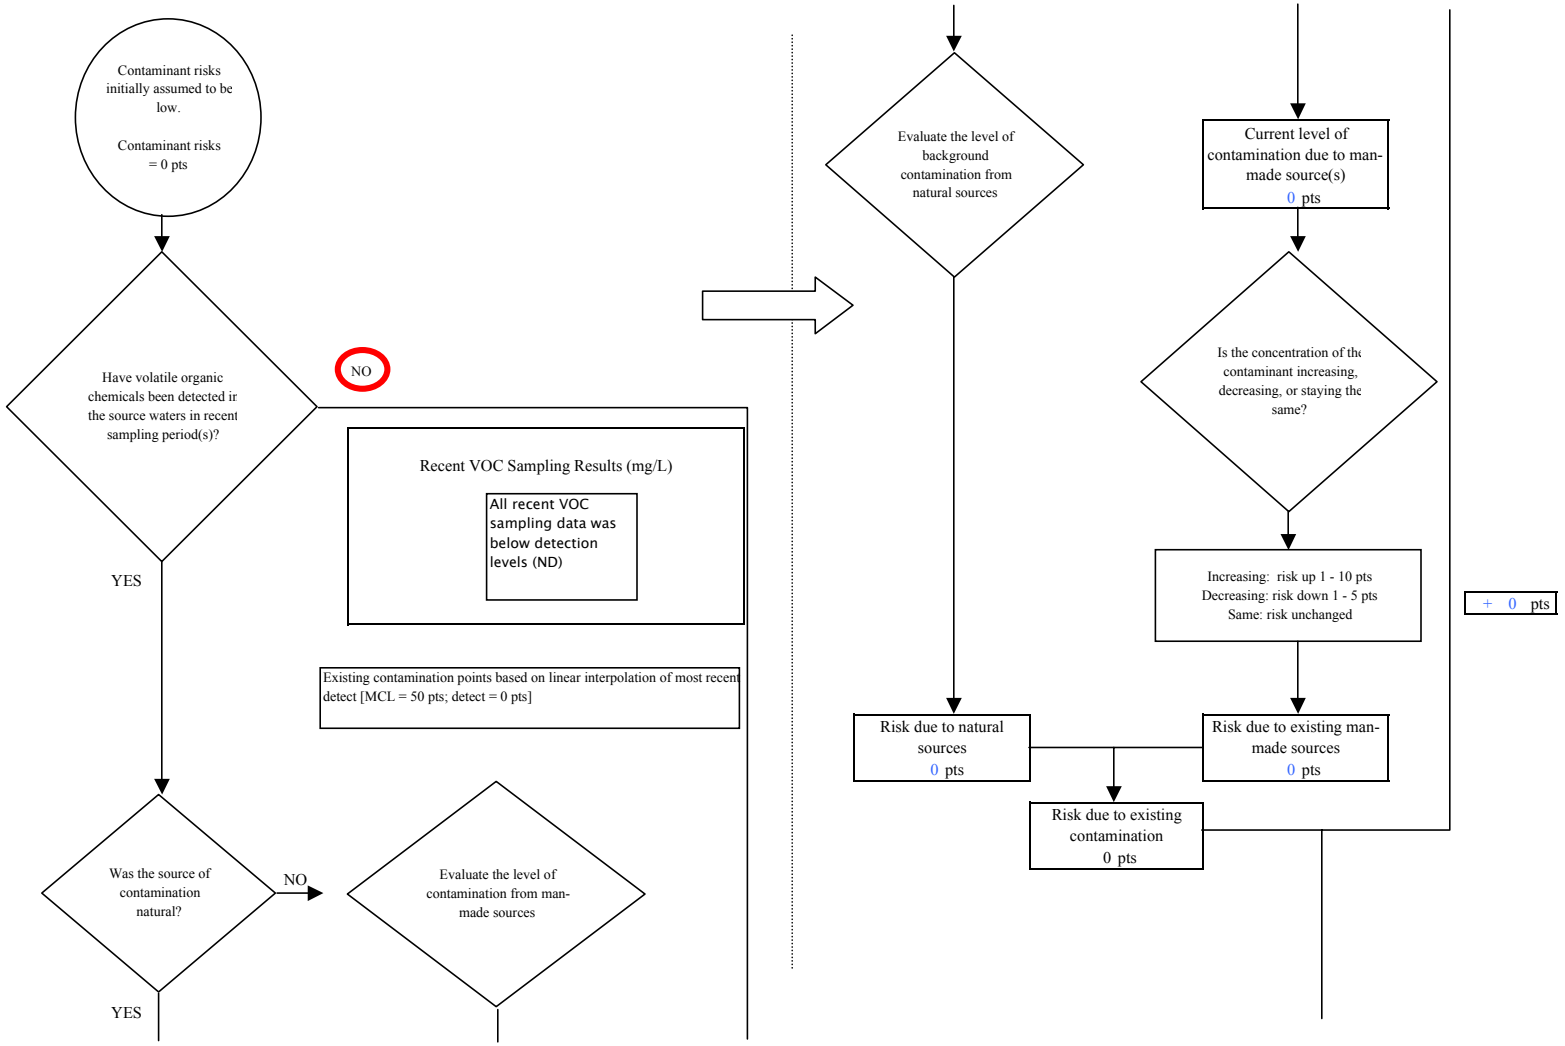
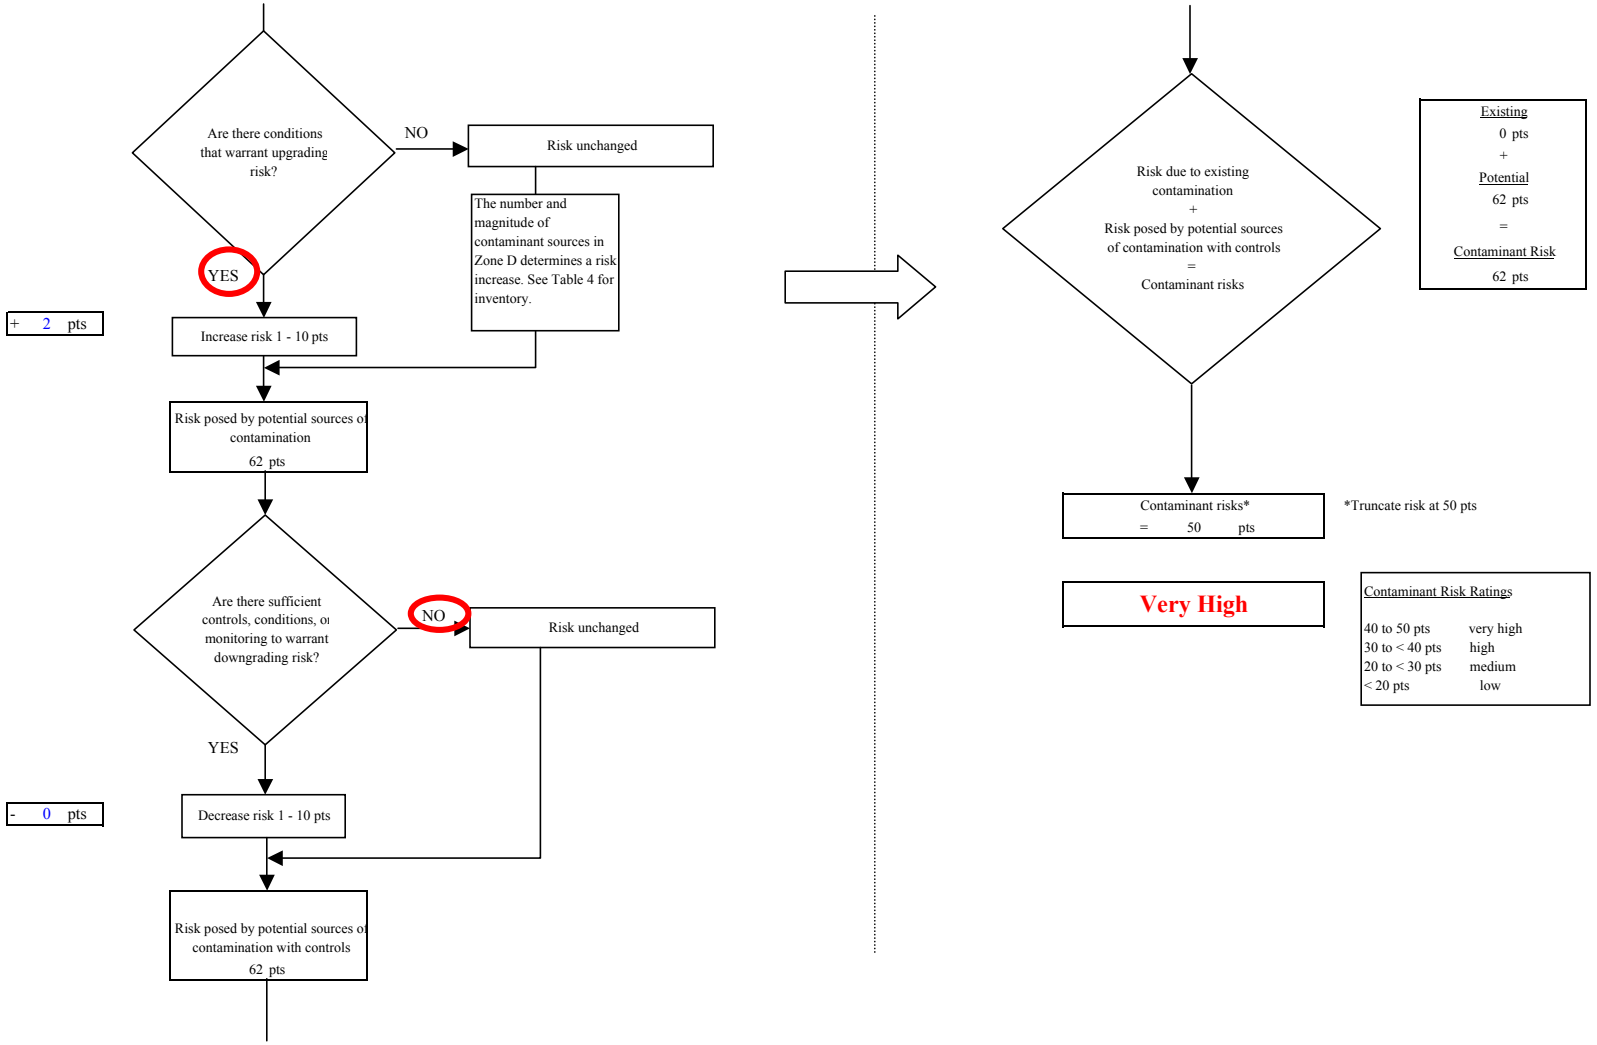
Chart 7. Contaminant risks for Bethel Native Corp. Apts. (PWS No. 270469.001) - Volatile Organic Chemicals

The contaminant risk for volatile organic chemicals is **Very High**. The risk is primarily attributed to the presence of petroleum product bulk station/terminals, a LUST site, and landfills in Zones A, C, and D. Numerous other potential contaminant sources are also found within the protection area (see Table 4 – Appendix B).

All recent sampling data for VOCs were below detection levels (See Chart 7 – Contaminant Risks for Volatile Organic Chemicals in Appendix D).

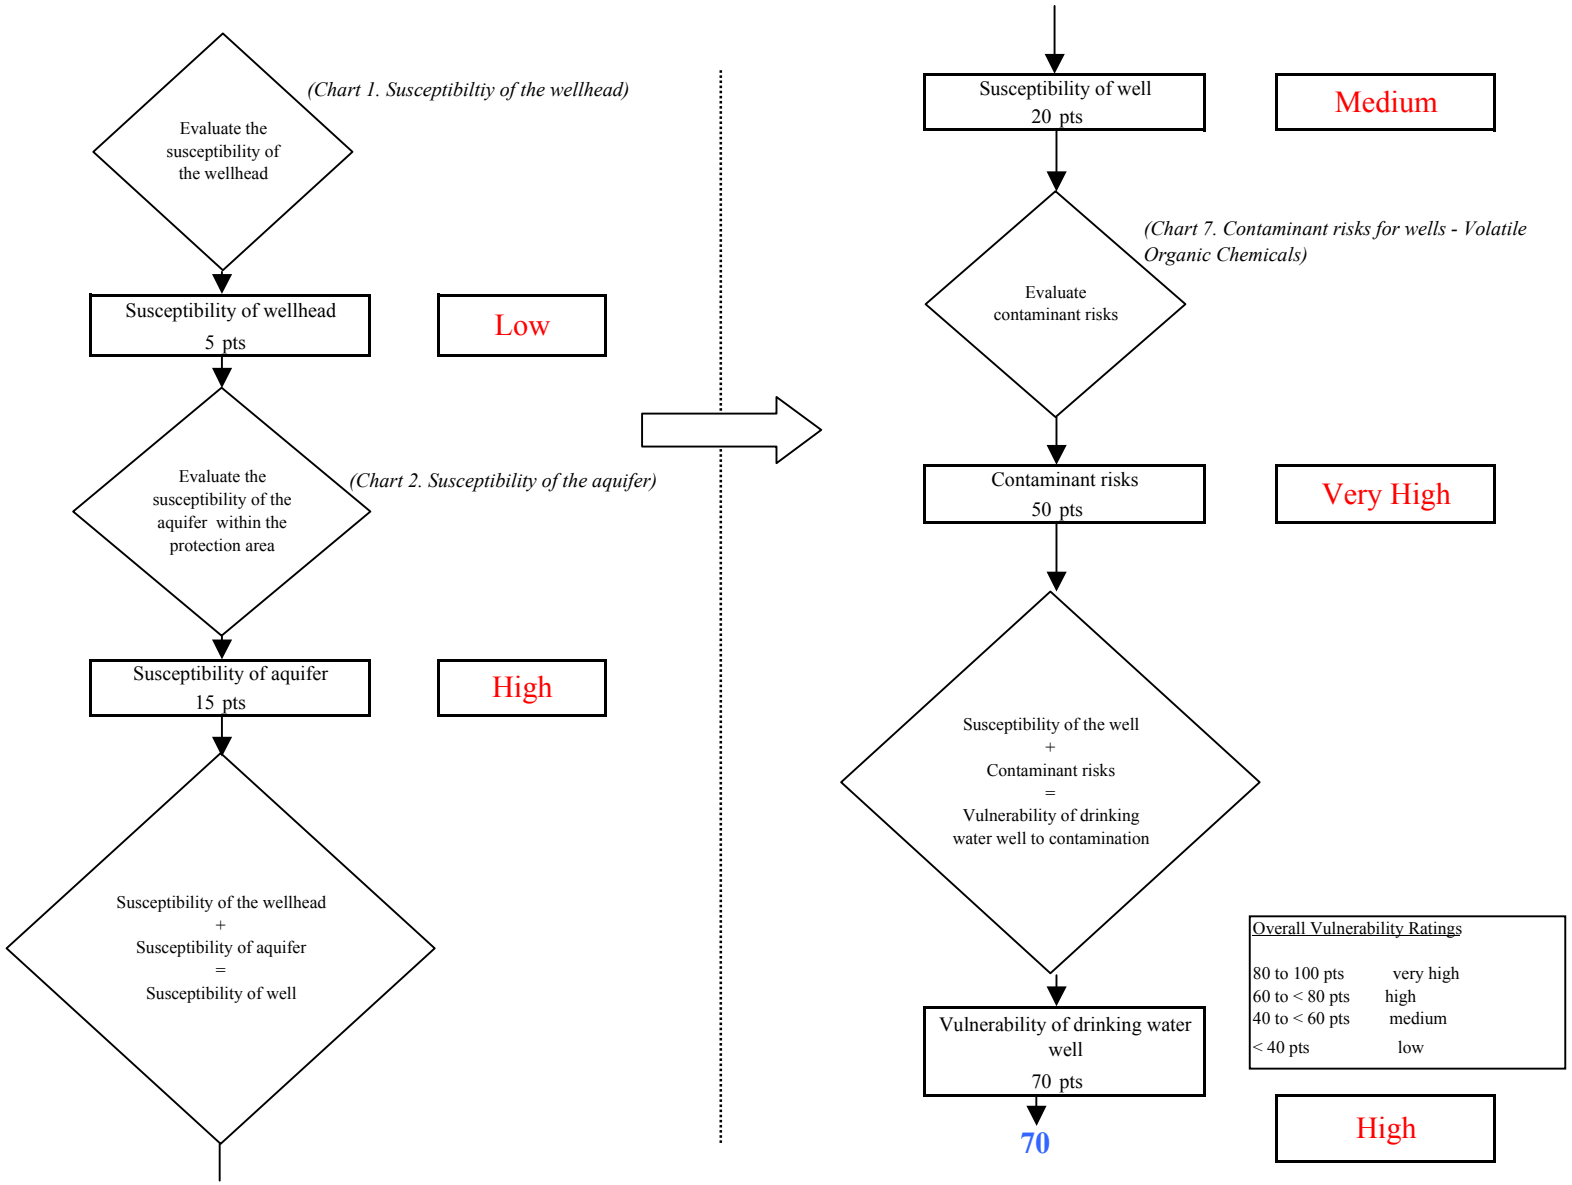
Chart 8. Vulnerability analysis for Bethel Native Corp. Apts. (PWS No. 270469.001) - Volatile Organic Chemicals

After combining the contaminant risk for volatile organic chemicals with the natural susceptibility of the well, the overall vulnerability of the well to contamination is **High**.
