Source Water Assessment

A Hydrogeologic Susceptibility and Vulnerability Assessment for Bethel Native Corporation Apartments Drinking Water System, Bethel, Alaska

PWSID # 270469.001

April 2004

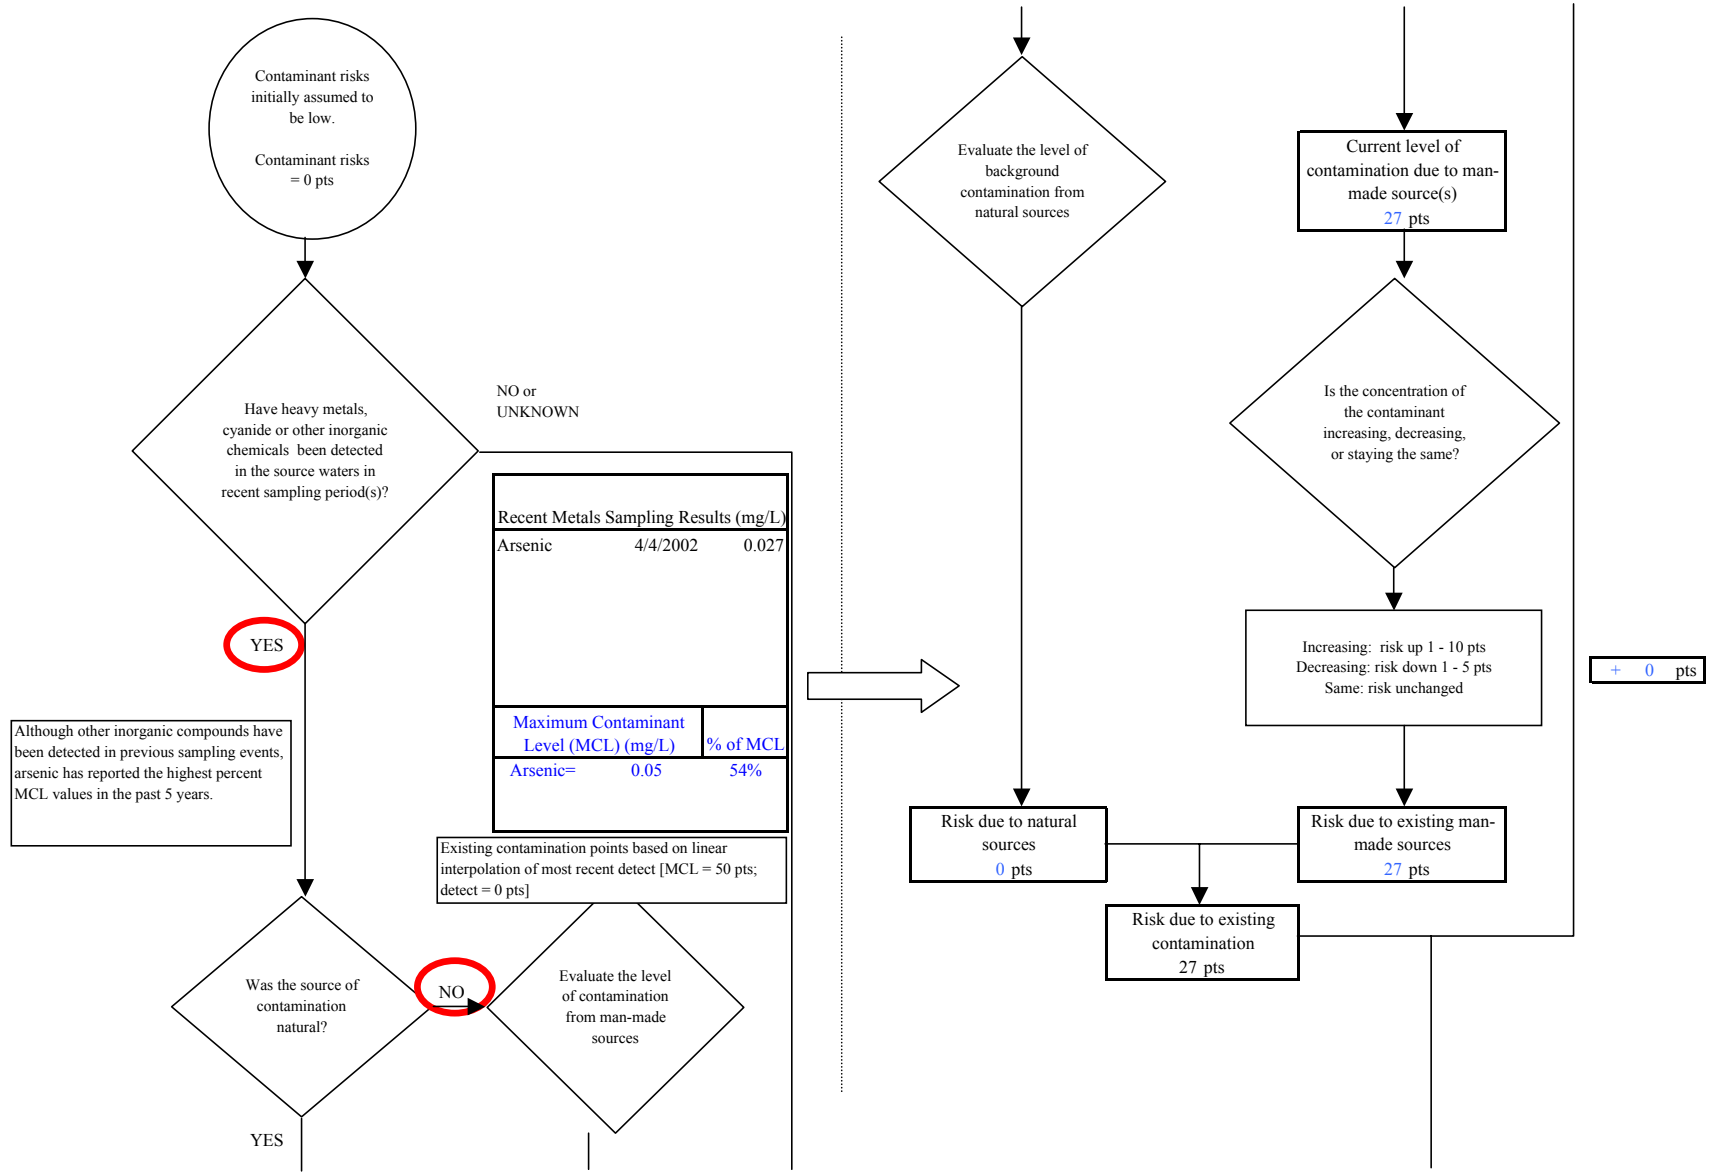
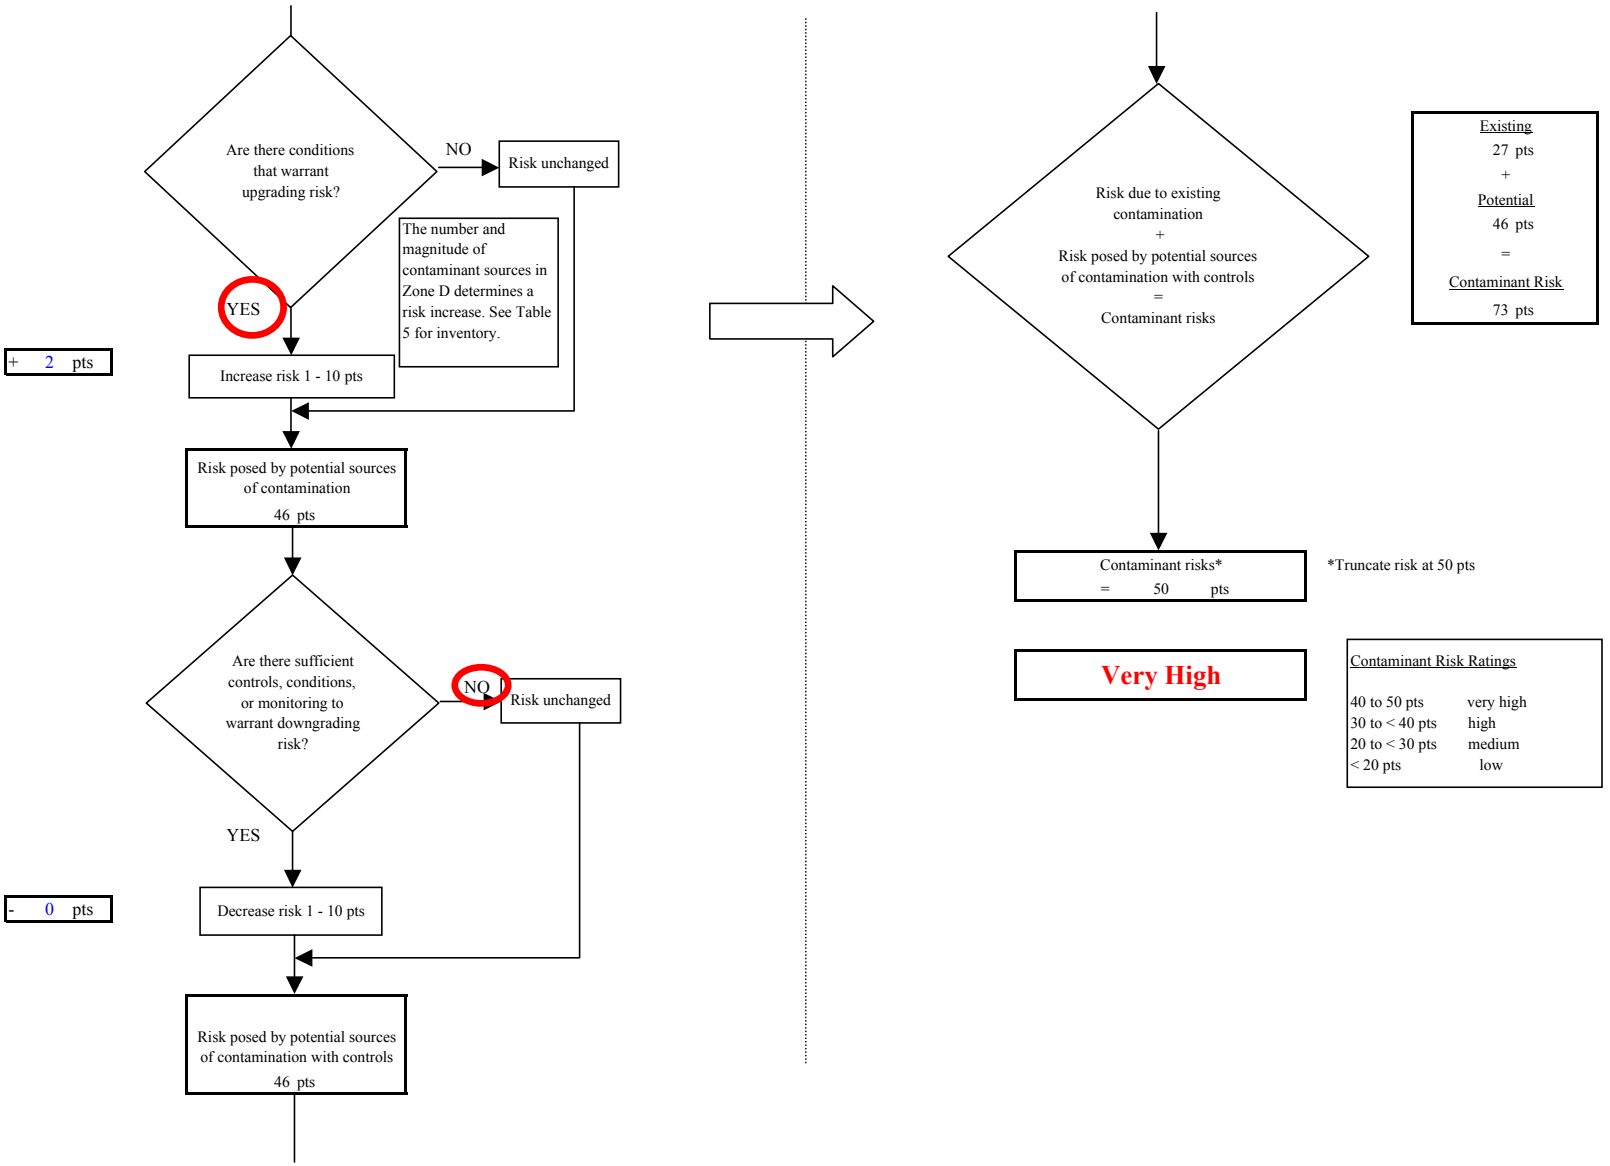
Chart 9. Contaminant risks for Bethel Native Corp. Apts. (PWS No. 270469.001) - Heavy Metals, Cyanide and Other Inorganic Chemicals

The contaminant risk for heavy metals, cyanide and other inorganic chemicals is **Very High**. The risk is primarily attributed to the presence of landfills and a LUST site in Zones C and D. Numerous other potential contaminant sources are also found within the protection area (see Table 5 – Appendix B).

Based on review of recent sampling records for this public water system, moderate levels of arsenic have been detected in recent sampling history, but have not exceeded the MCL of 0.05 mg/L (see Chart 9 – Contaminant Risks for Heavy Metals, Cyanide, and Other Inorganic Chemicals in Appendix D).

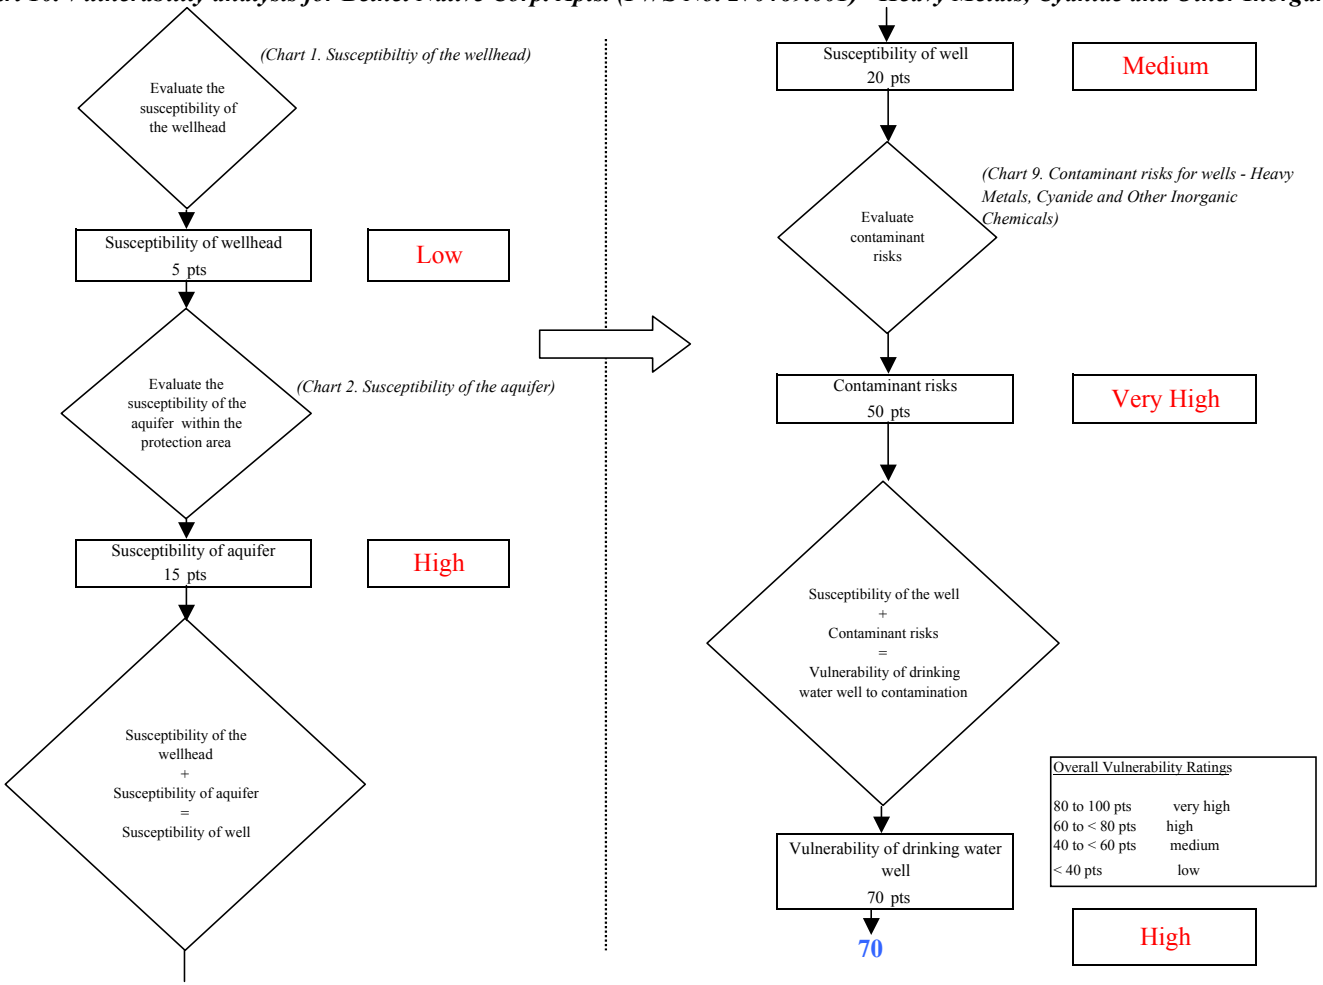
Chart 10. Vulnerability analysis for Bethel Native Corp. Apts. (PWS No. 270469.001) - Heavy Metals, Cyanide and Other Inorganic Chemicals

After combining the contaminant risk for heavy metals, cyanide and other inorganic chemicals with the natural susceptibility of the well, the overall vulnerability of the well to contamination is **High**.

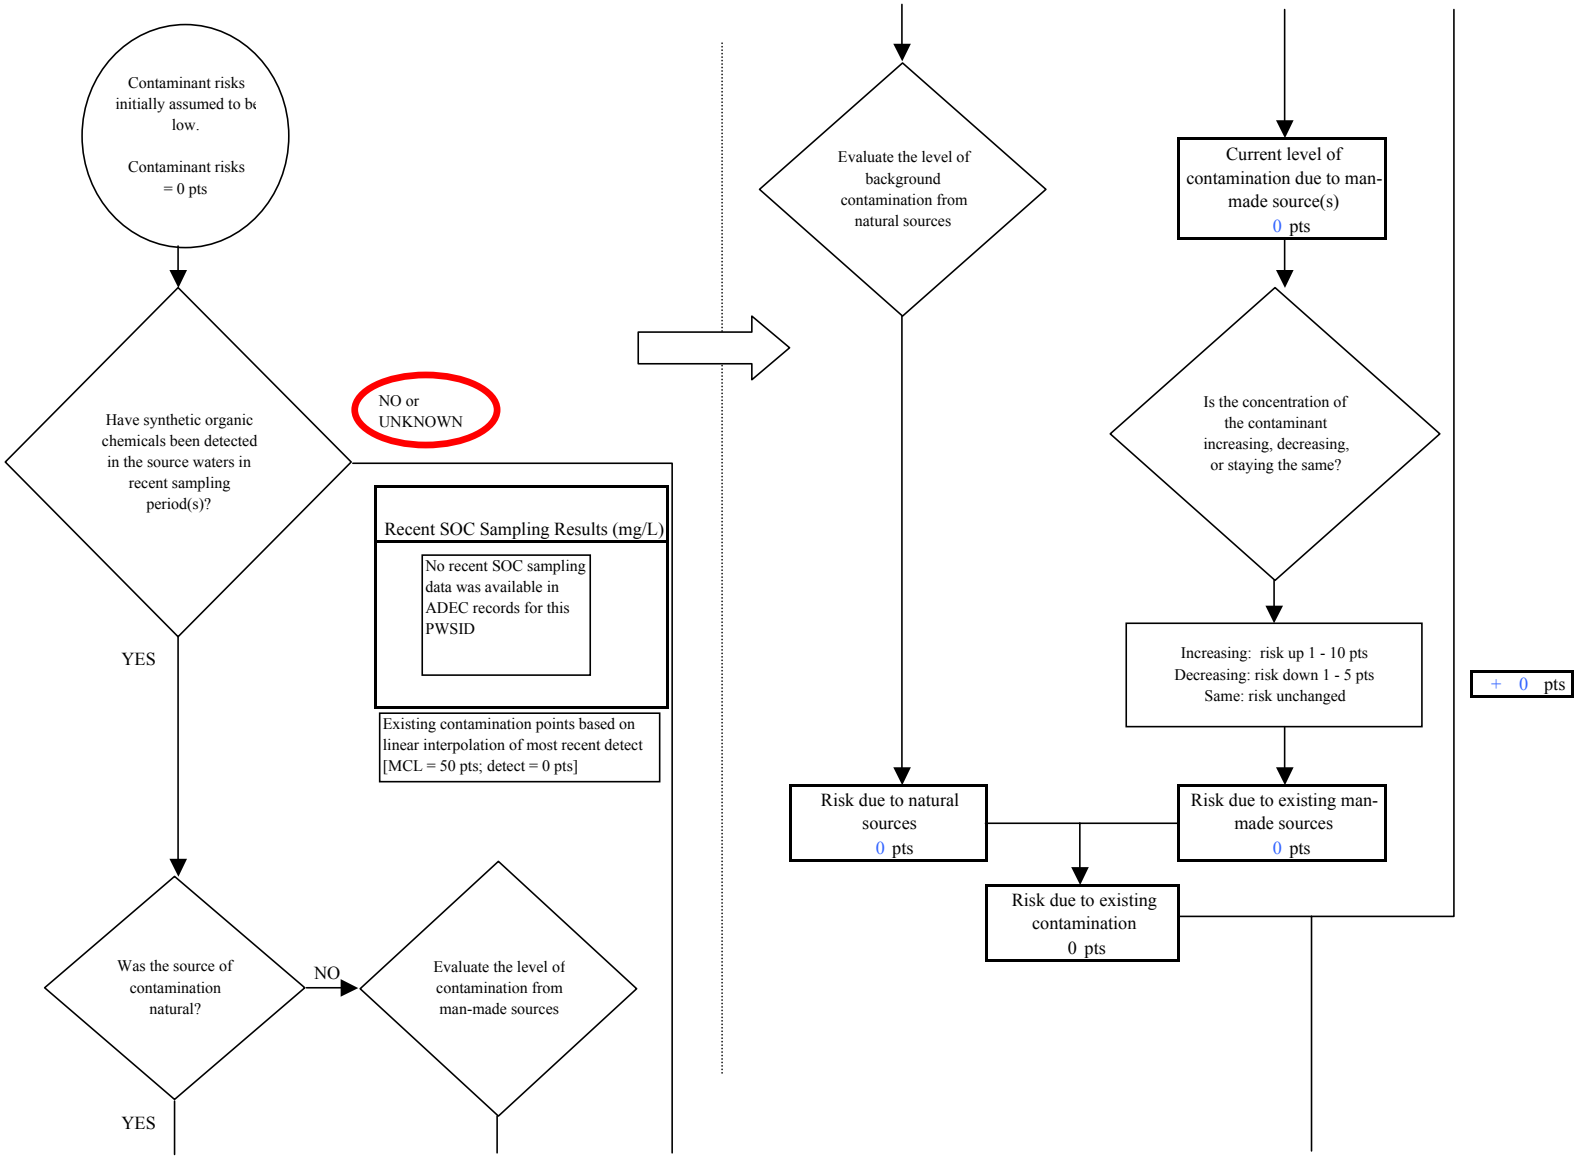
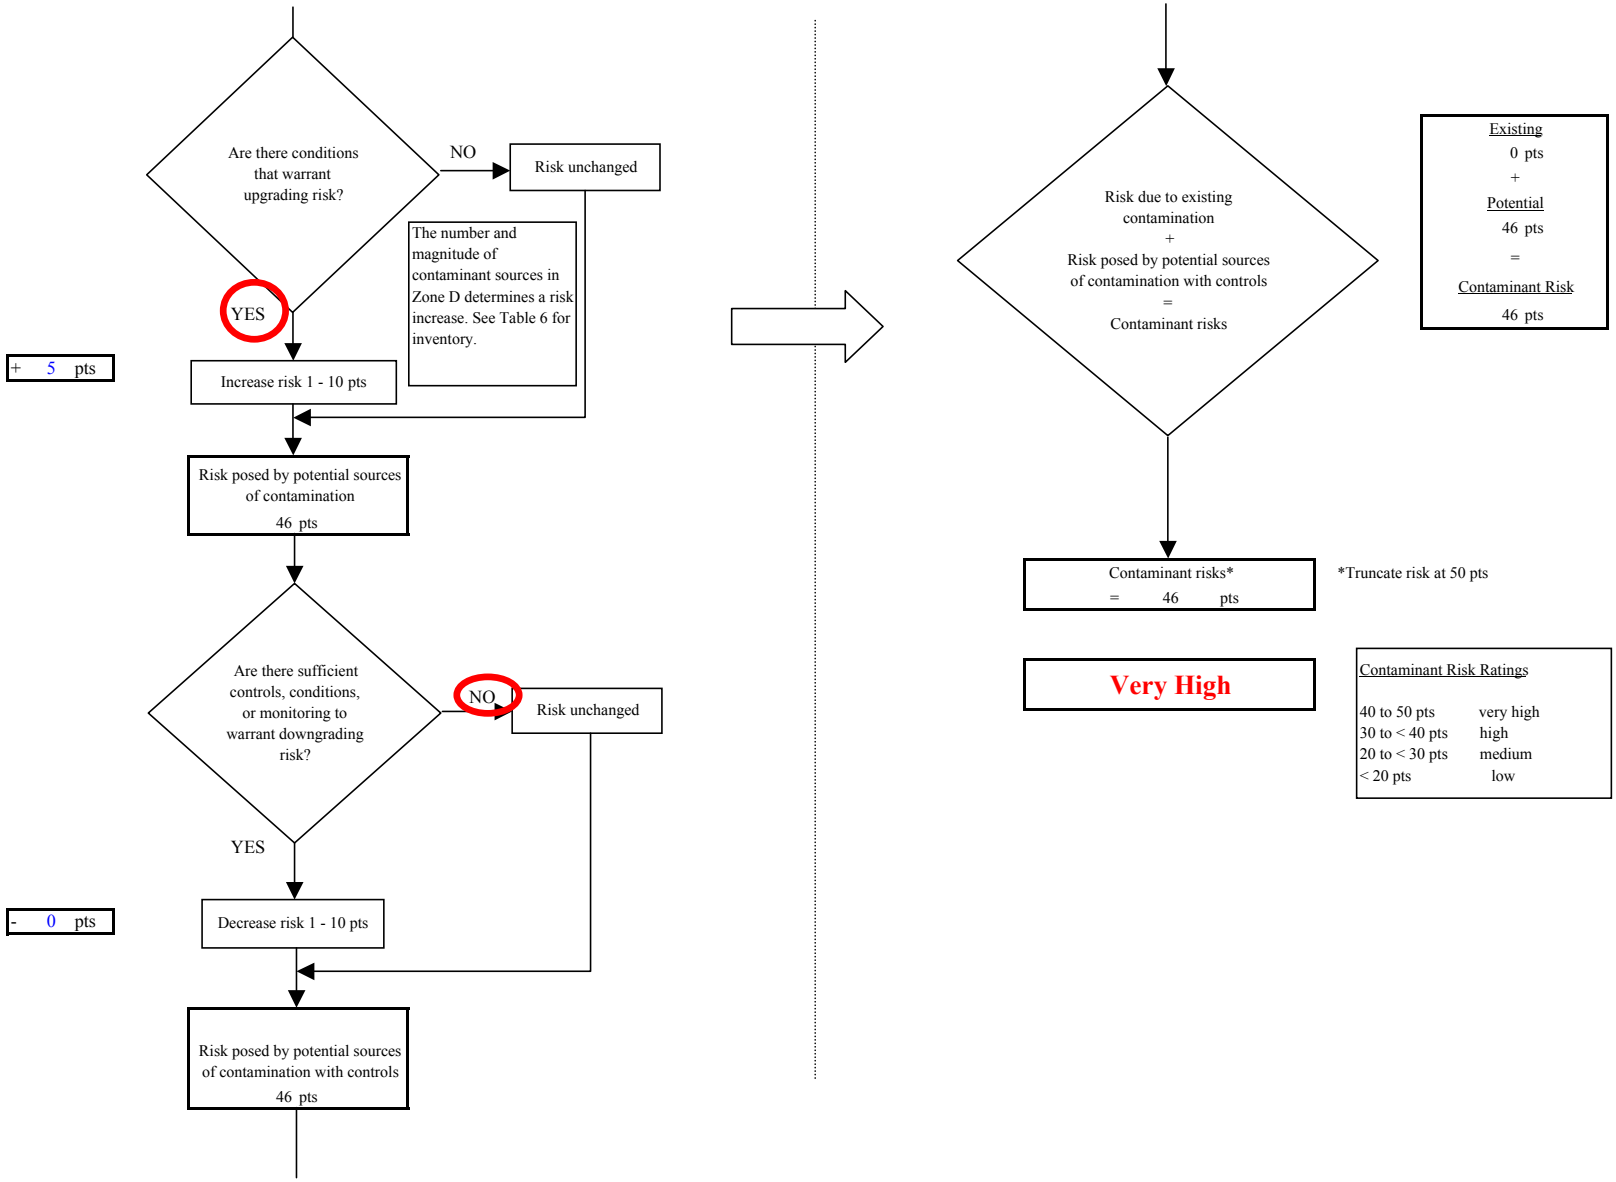
Chart 11. Contaminant risks for Bethel Native Corp. Apts. (PWS No. 270469.001) - Synthetic Organic Chemicals

The contaminant risk for synthetic organic chemicals is **Very High**. The risk is primarily attributed to the presence of landfills in Zones C and D (see Table 6 – Appendix B).

No recent sampling data was available in ADEC records for the Bethel Native Corporation Apartments (See Chart 11 – Contaminant Risks for Synthetic Organic Chemicals in Appendix D).

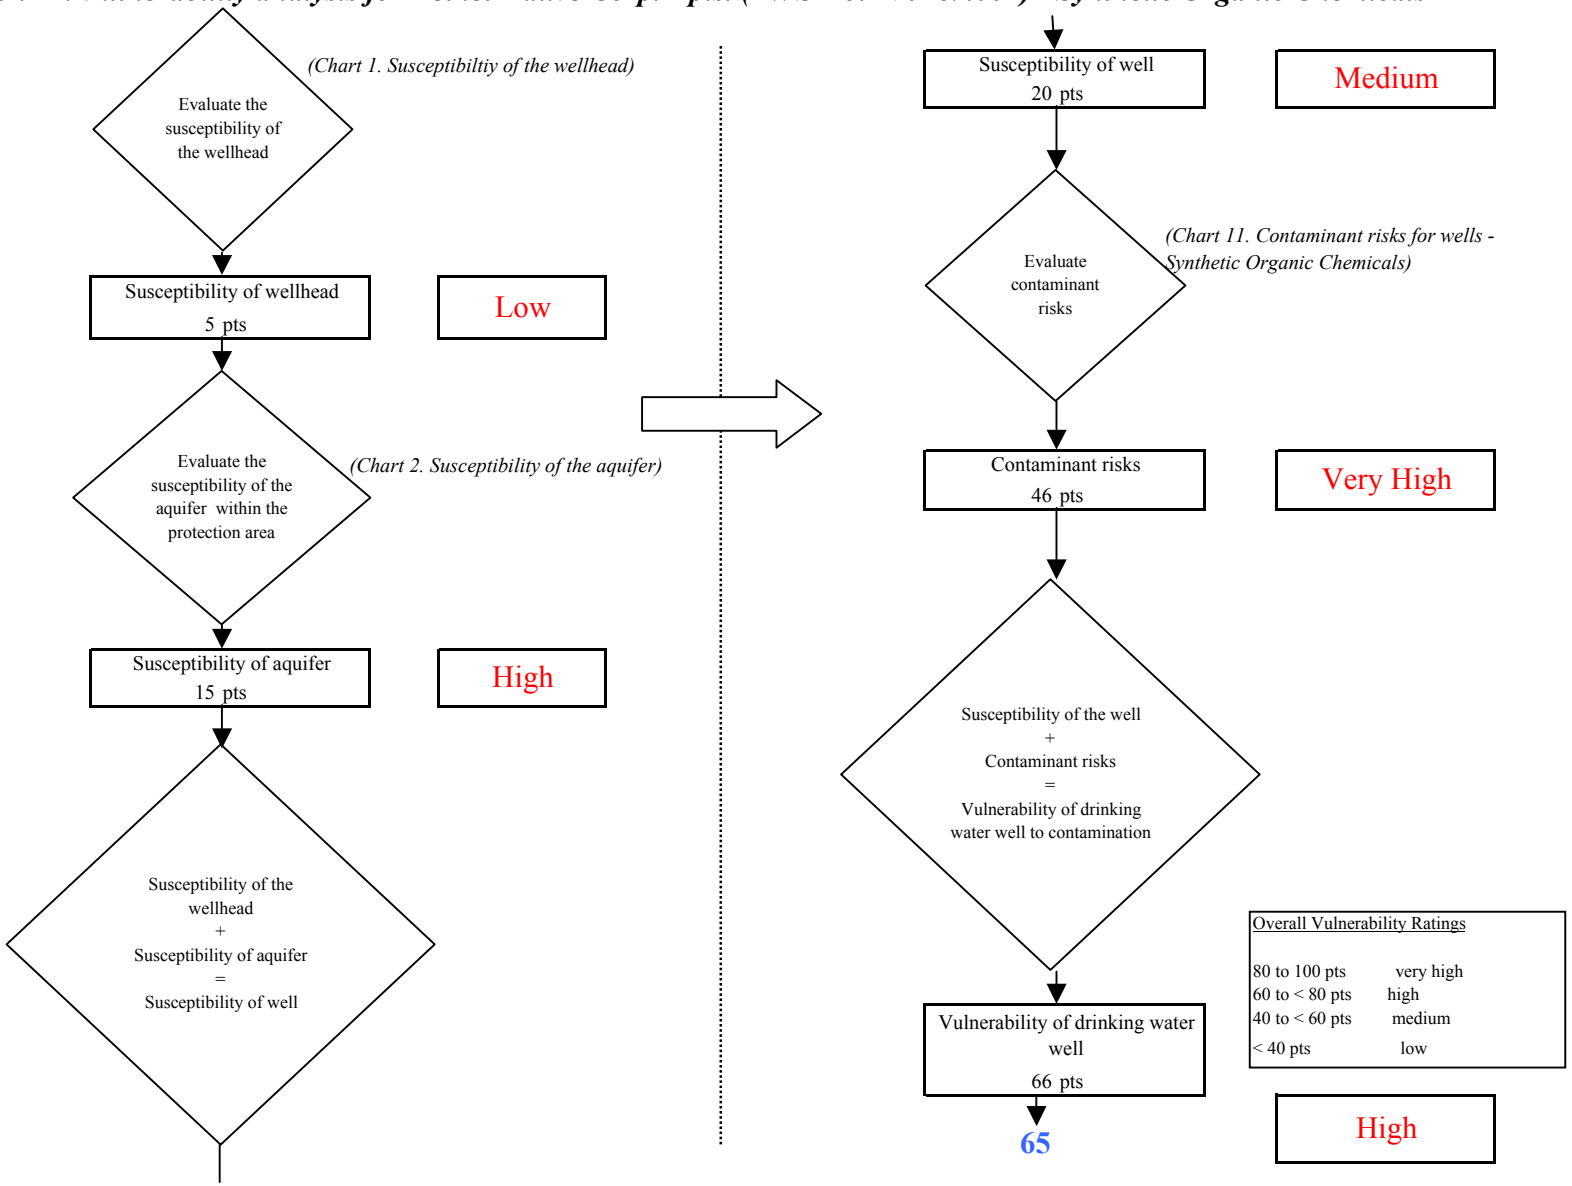
Chart 12. Vulnerability analysis for Bethel Native Corp. Apts. (PWS No. 270469.001) - Synthetic Organic Chemicals

After combining the contaminant risk for synthetic organic chemicals with the natural susceptibility of the well, the overall vulnerability of the well to contamination is **High**.
