Source Water Assessment

A Hydrogeologic Susceptibility and Vulnerability Assessment for LKSD Kilbuck Elementary Drinking Water System, Bethel, Alaska

PWSID # 270493.001

April 2004

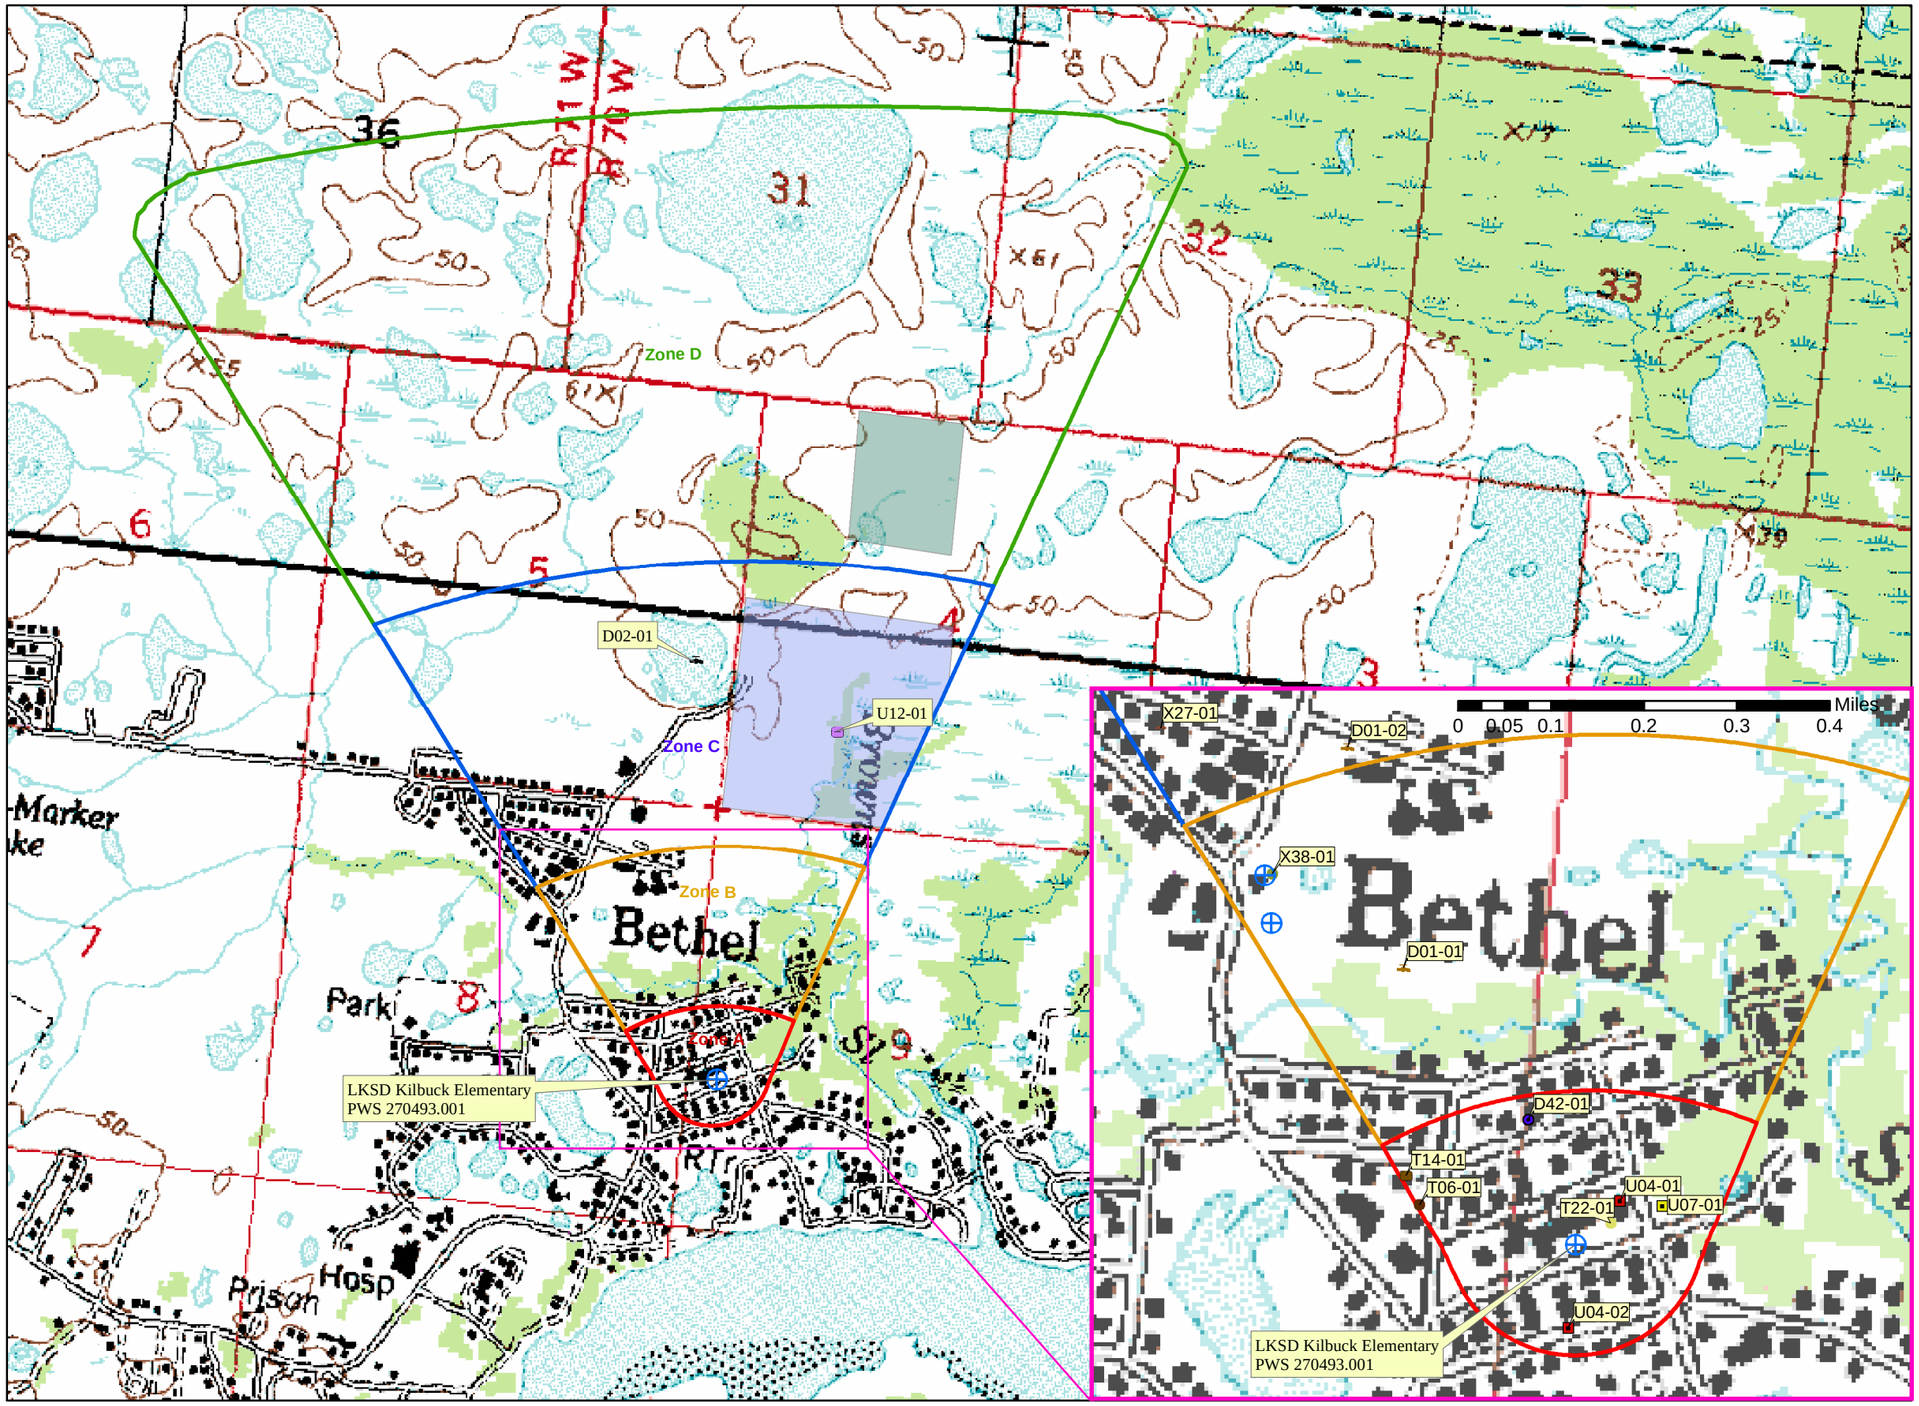
Drinking Water Protection Area
and Potential and Existing Contaminant Sources
(Map C)

Identified potential and current sources of contaminants for the public drinking water source include: an injection well, aboveground fuel tanks, wastewater holding tanks, ADEC recognized contaminated site and leaking underground storage tank (LUST) sites, roads, domestic wastewater collection systems, firehouses, a domestic wastewater treatment plant disposal pond/lagoon, landfills, and a motor vehicle/general storage yard/facility. These identified potential and existing sources of contamination are considered as sources of bacteria and viruses, nitrates and/or nitrites, volatile organic chemicals, heavy metals, cyanide and other inorganic chemicals, synthetic organic chemicals, and other organic chemicals contaminant categories.

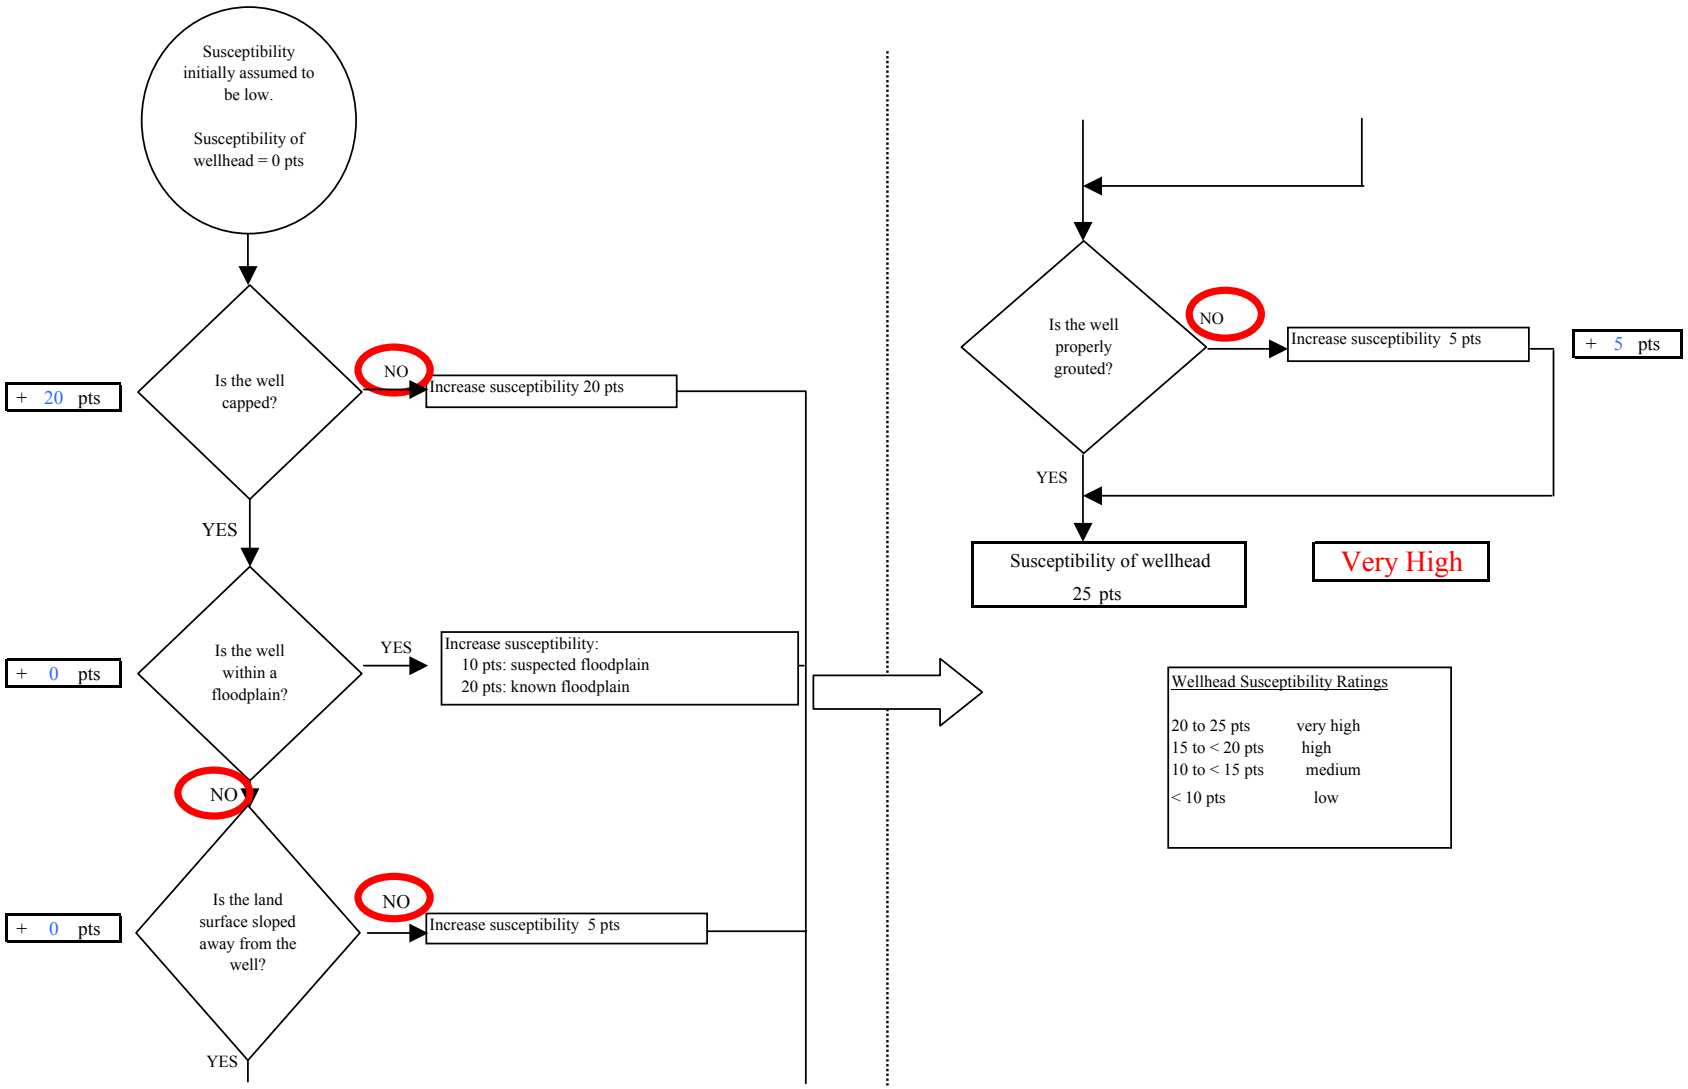
Chart 1. Susceptibility of the wellhead - LKSD Kilbuck Elementary School (PWS No. 270493.001)

Information acquired from a December 2002 sanitary survey for the public water system indicated that the land surface was not sloped away from the well. Generally, land surfaces that slope away from the wellhead promote surface water drainage, which

reduces the potential of contaminant migration down the well casing annulus. The sanitary survey indicates that the well is not grouted according to ADEC regulations. Proper grouting provides added protection against contaminants traveling along the well casing annulus and into source waters.

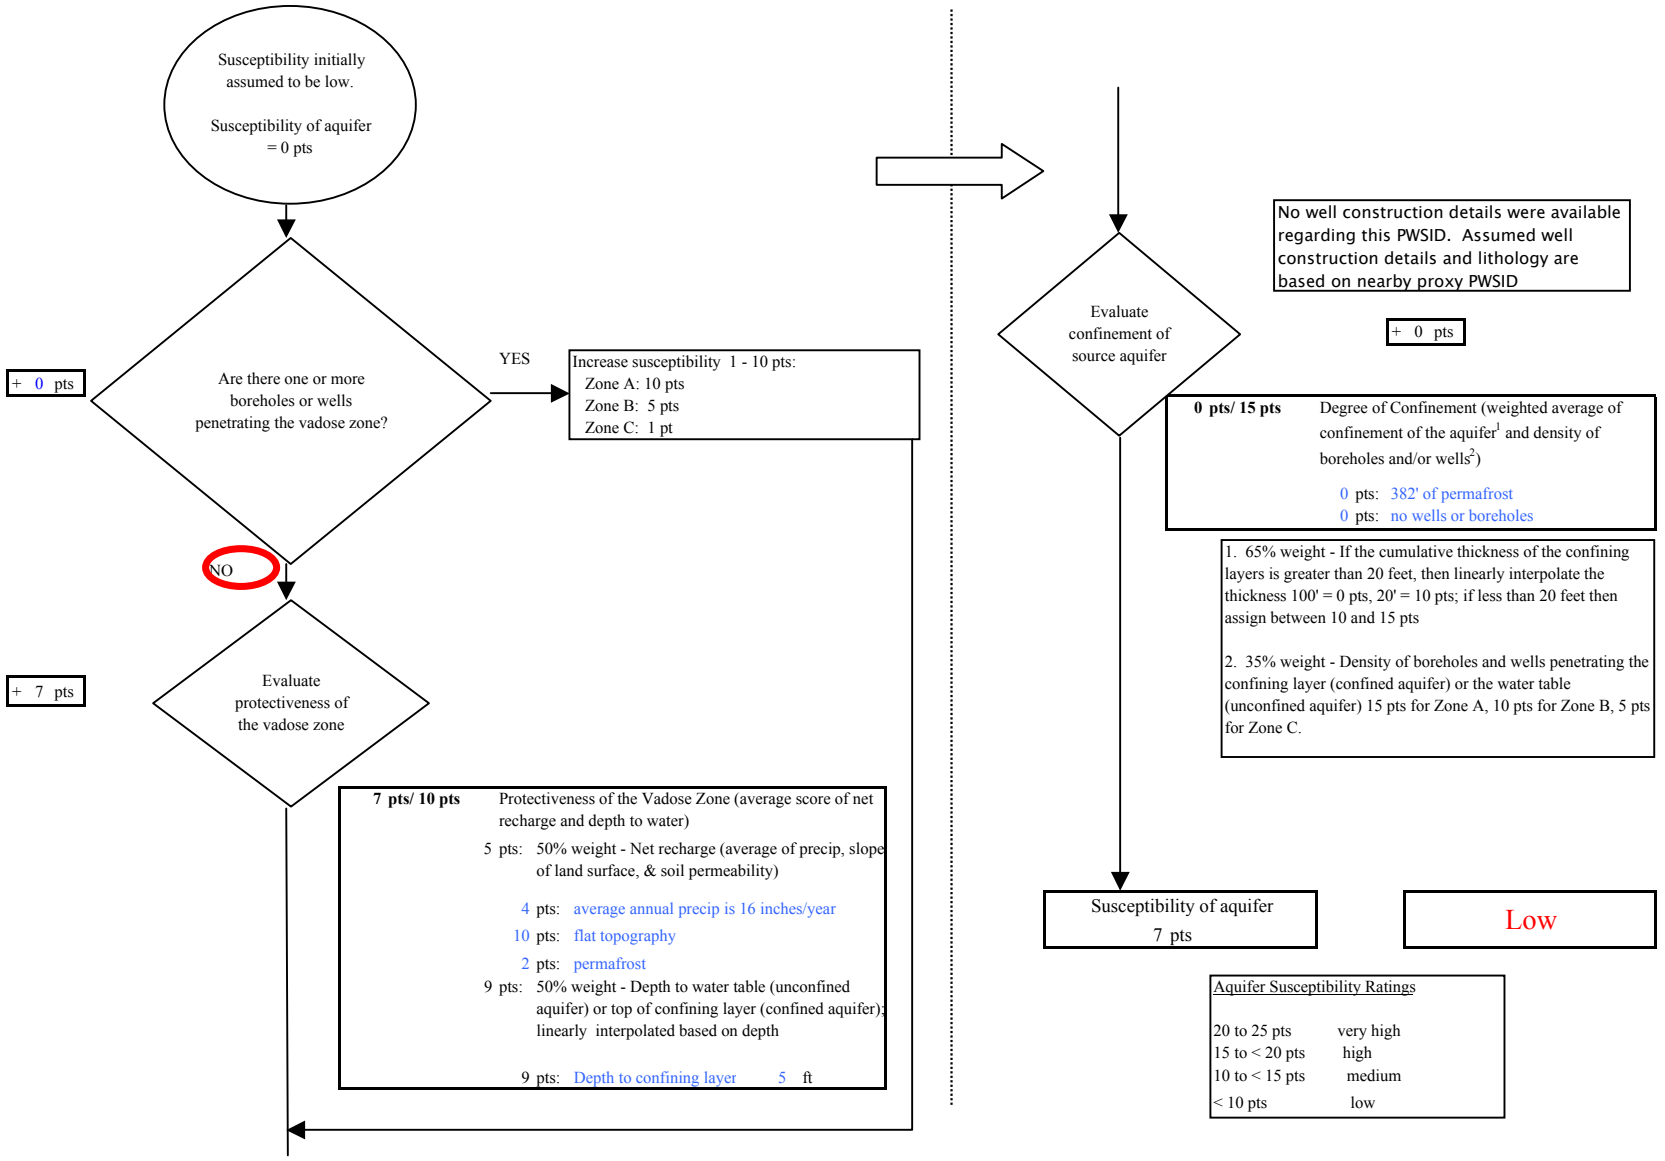
Chart 2. Susceptibility of the aquifer LKSD Kilbuck Elementary School (PWS No. 270493.001)

The LKSD Kilbuck Elementary water well is in a confined aquifer. Confined aquifers are less susceptible to potential groundwater quality impacts posed by the migration of surface water contaminants downward from the surface. Table 2 shows the susceptibility scores and ratings for this PWS.
