Source Water Assessment

A Hydrogeologic Susceptibility and Vulnerability Assessment for Tundra Center Drinking Water System, Bethel, Alaska

PWSID # 271473.001

February 2004

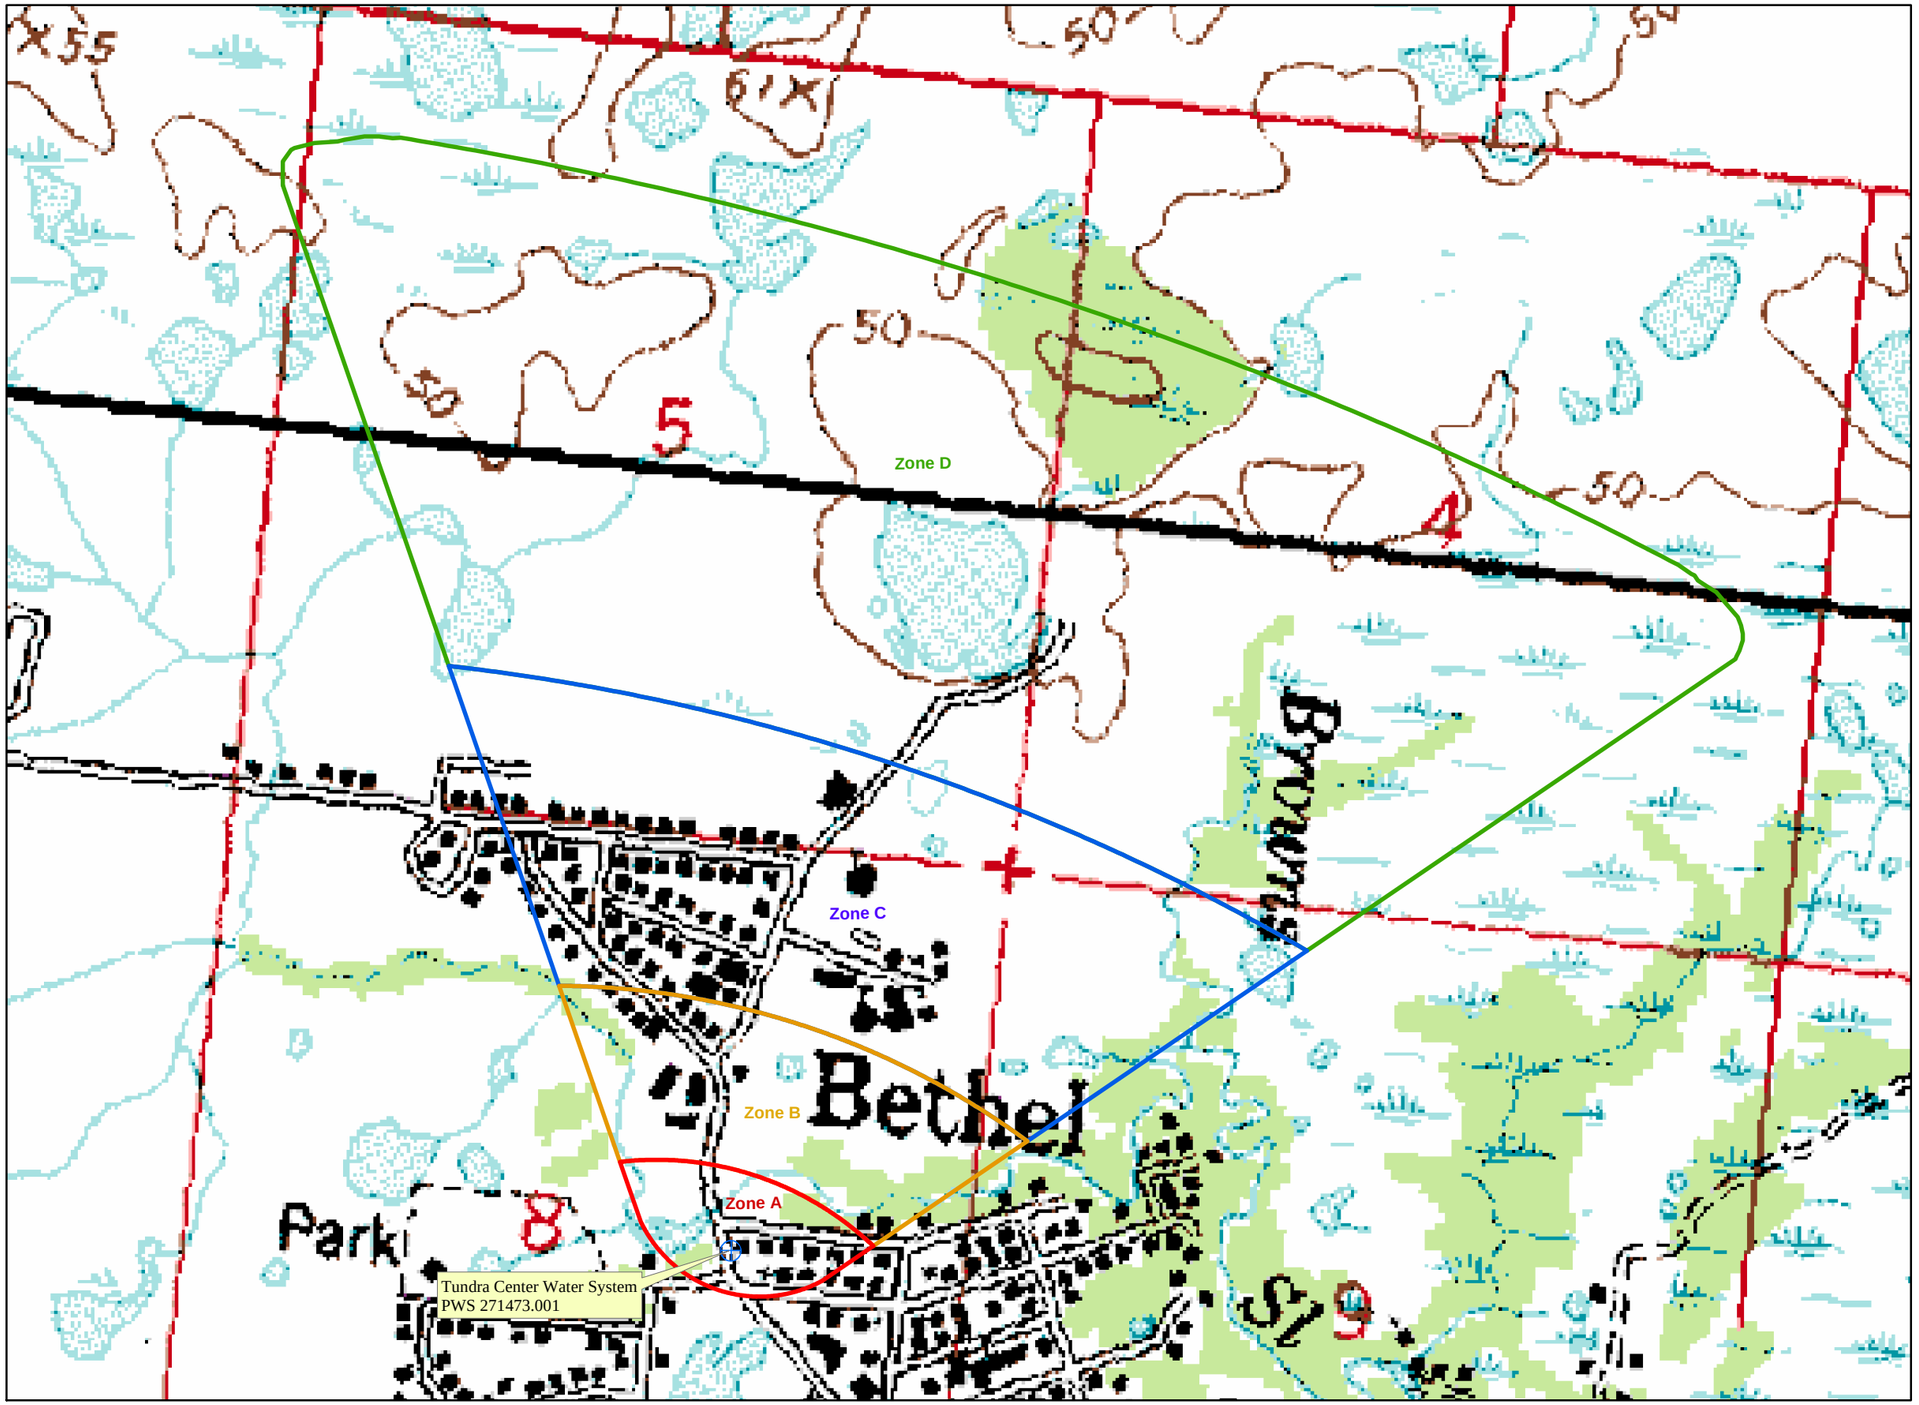
Appendix A Map A

The DWPA for the Tundra Center PWS was determined using an analytical calculation and includes Zone A through D (See Map A of Appendix A).

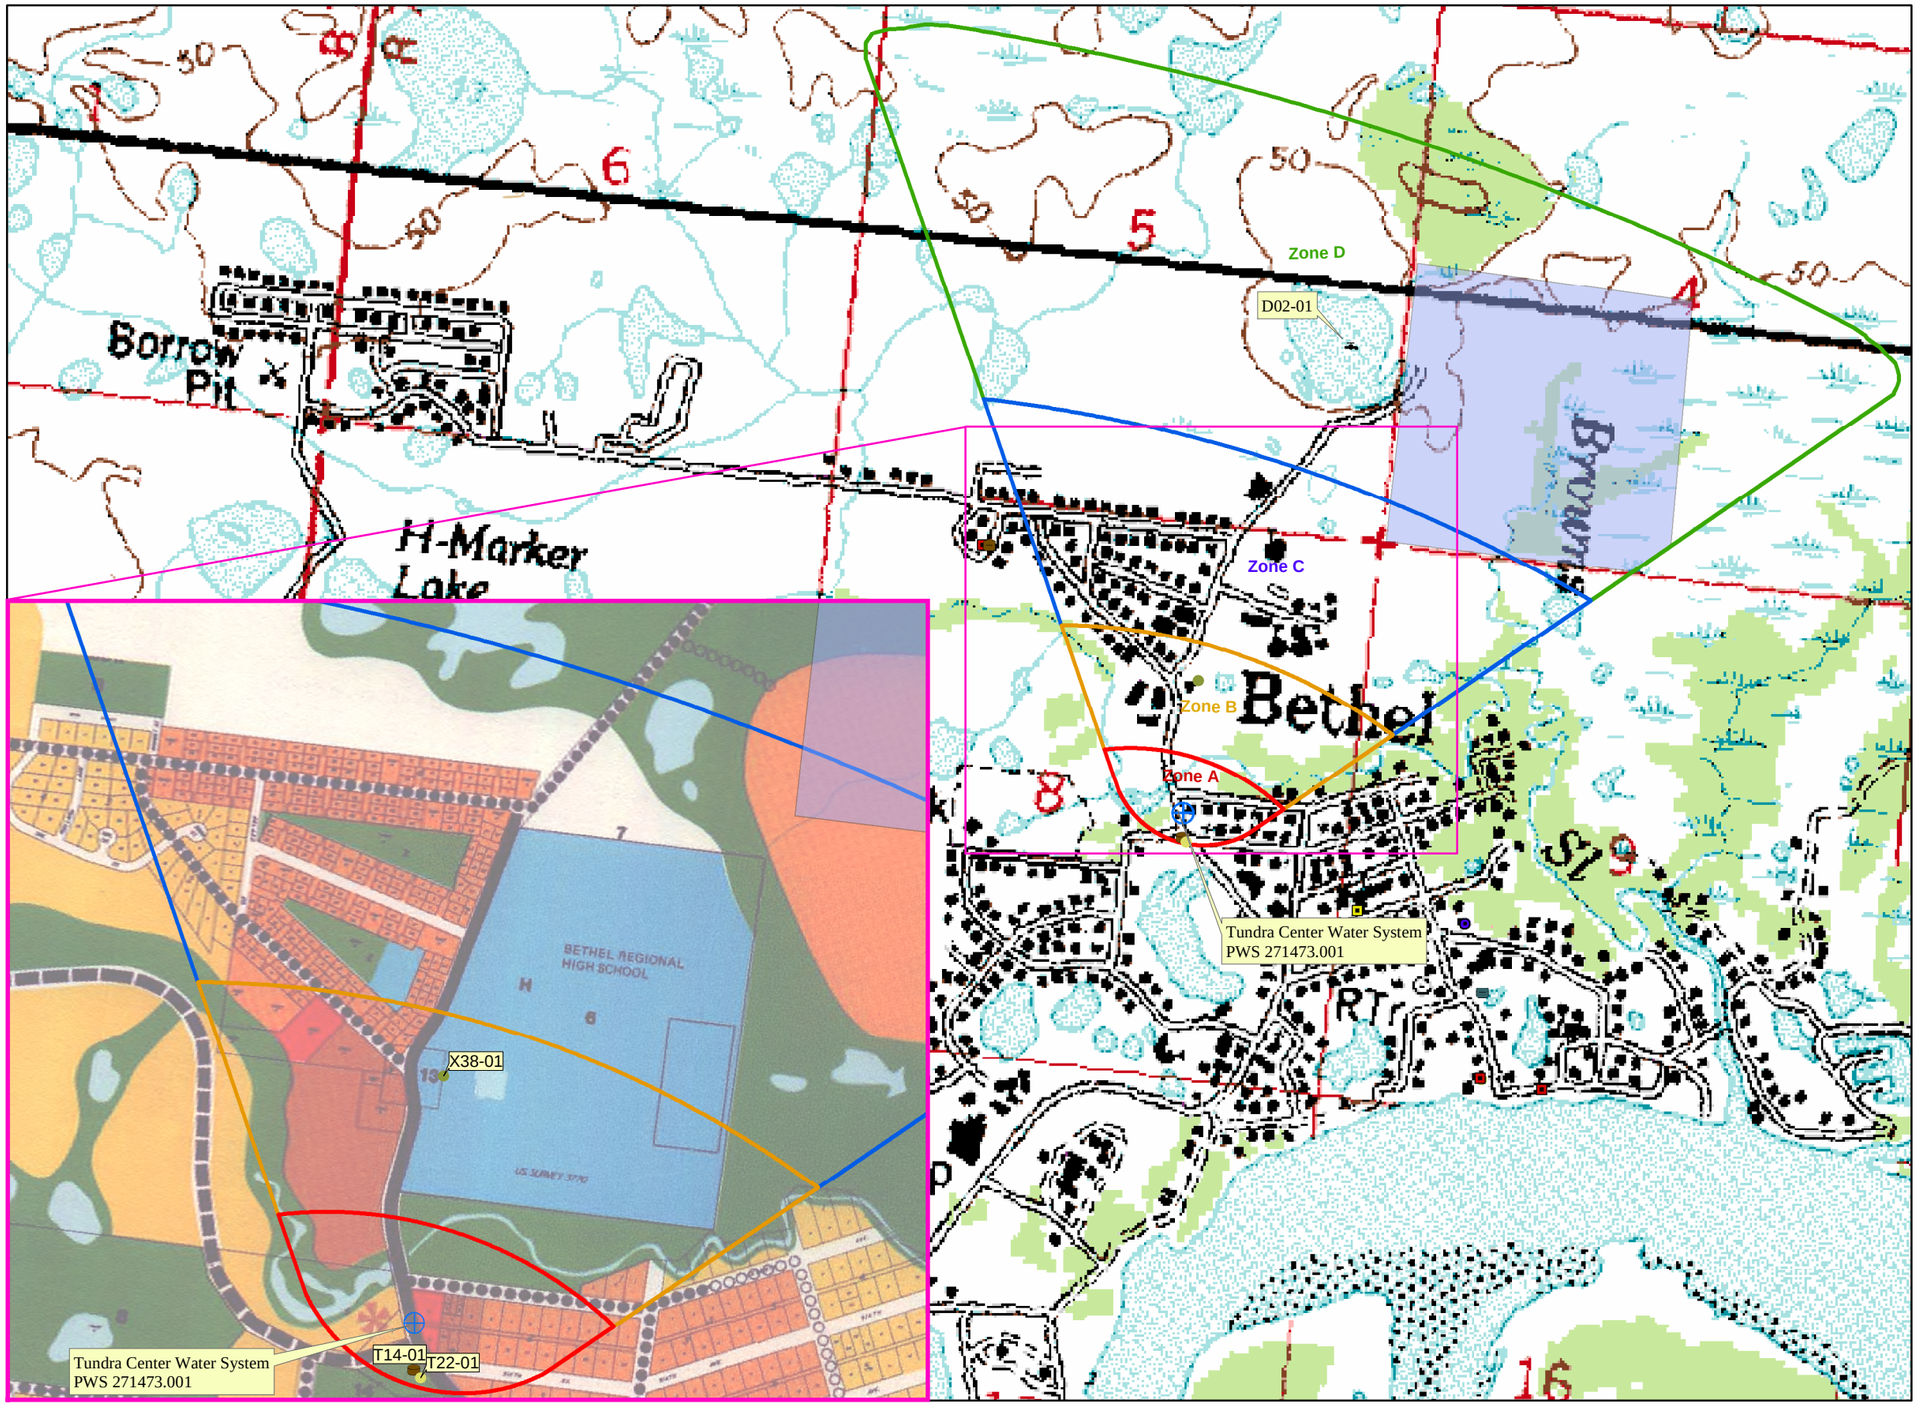
Appendix C Map C

The sources are displayed on Map C of Appendix C and summarized in Table 1 of Appendix B.

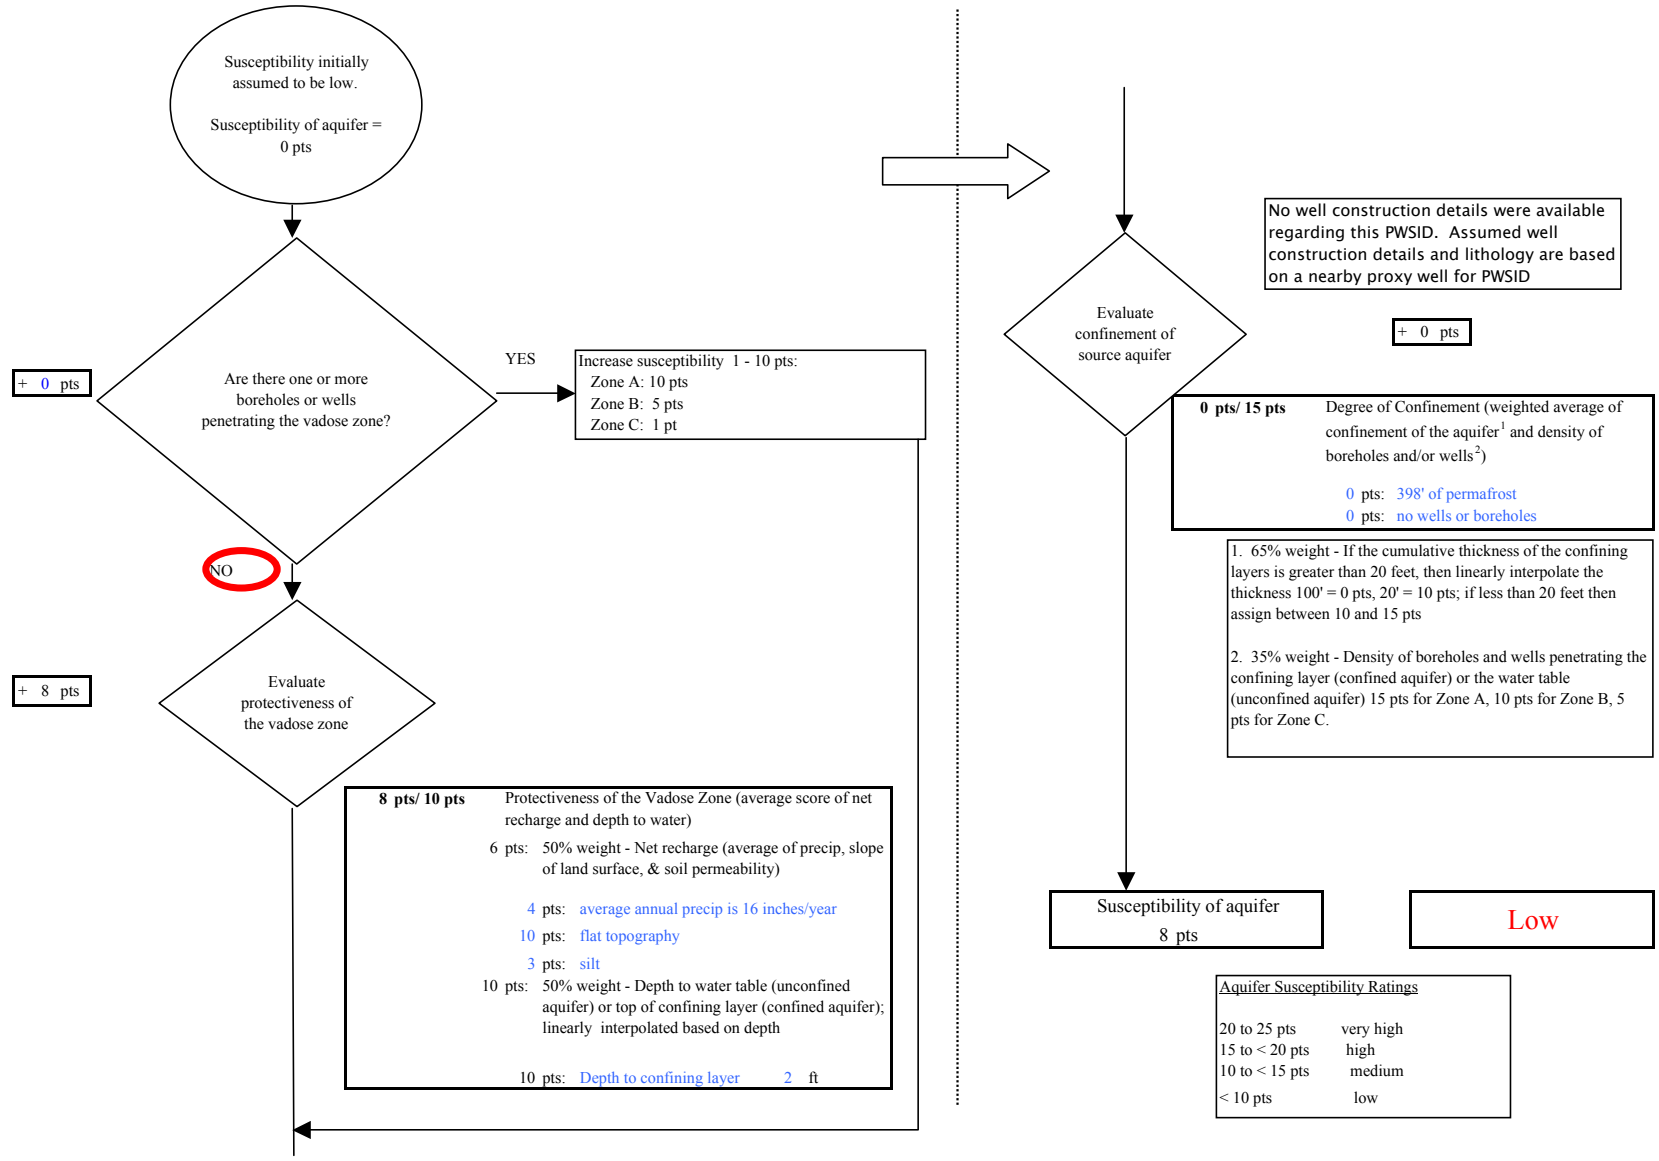
Chart 2. Susceptibility of the aquifer Tundra Center (PWS No. 271473.001)

The Tundra Center's water well is in a confined aquifer. Confined aquifers are less susceptible to potential groundwater quality impacts posed by the migration of surface water contaminants downward from the surface. Table 2 shows the Susceptibility scores and ratings for both wells in this PWS.

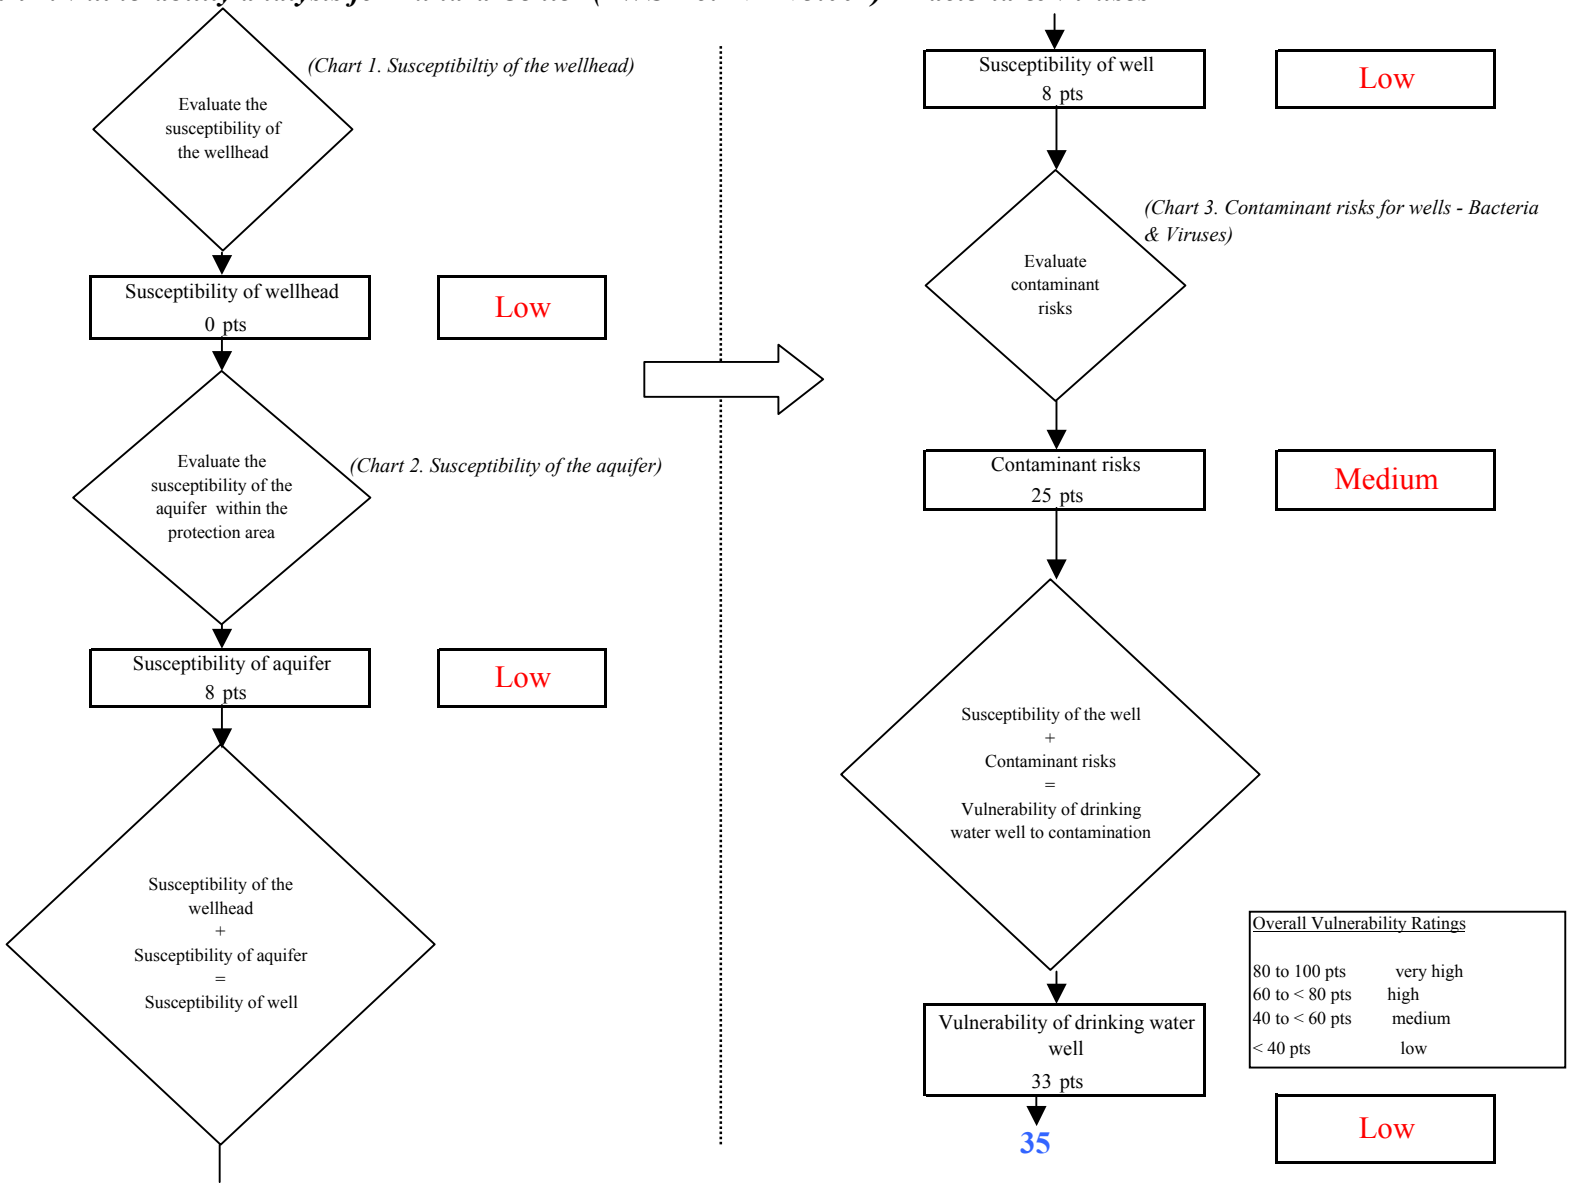
Chart 4. Vulnerability analysis for Tundra Center (PWS No. 271473.001) - Bacteria & Viruses

After combining the contaminant risk for bacteria and viruses with the natural susceptibility of the well, the overall vulnerability of the well to contamination is **Low**.

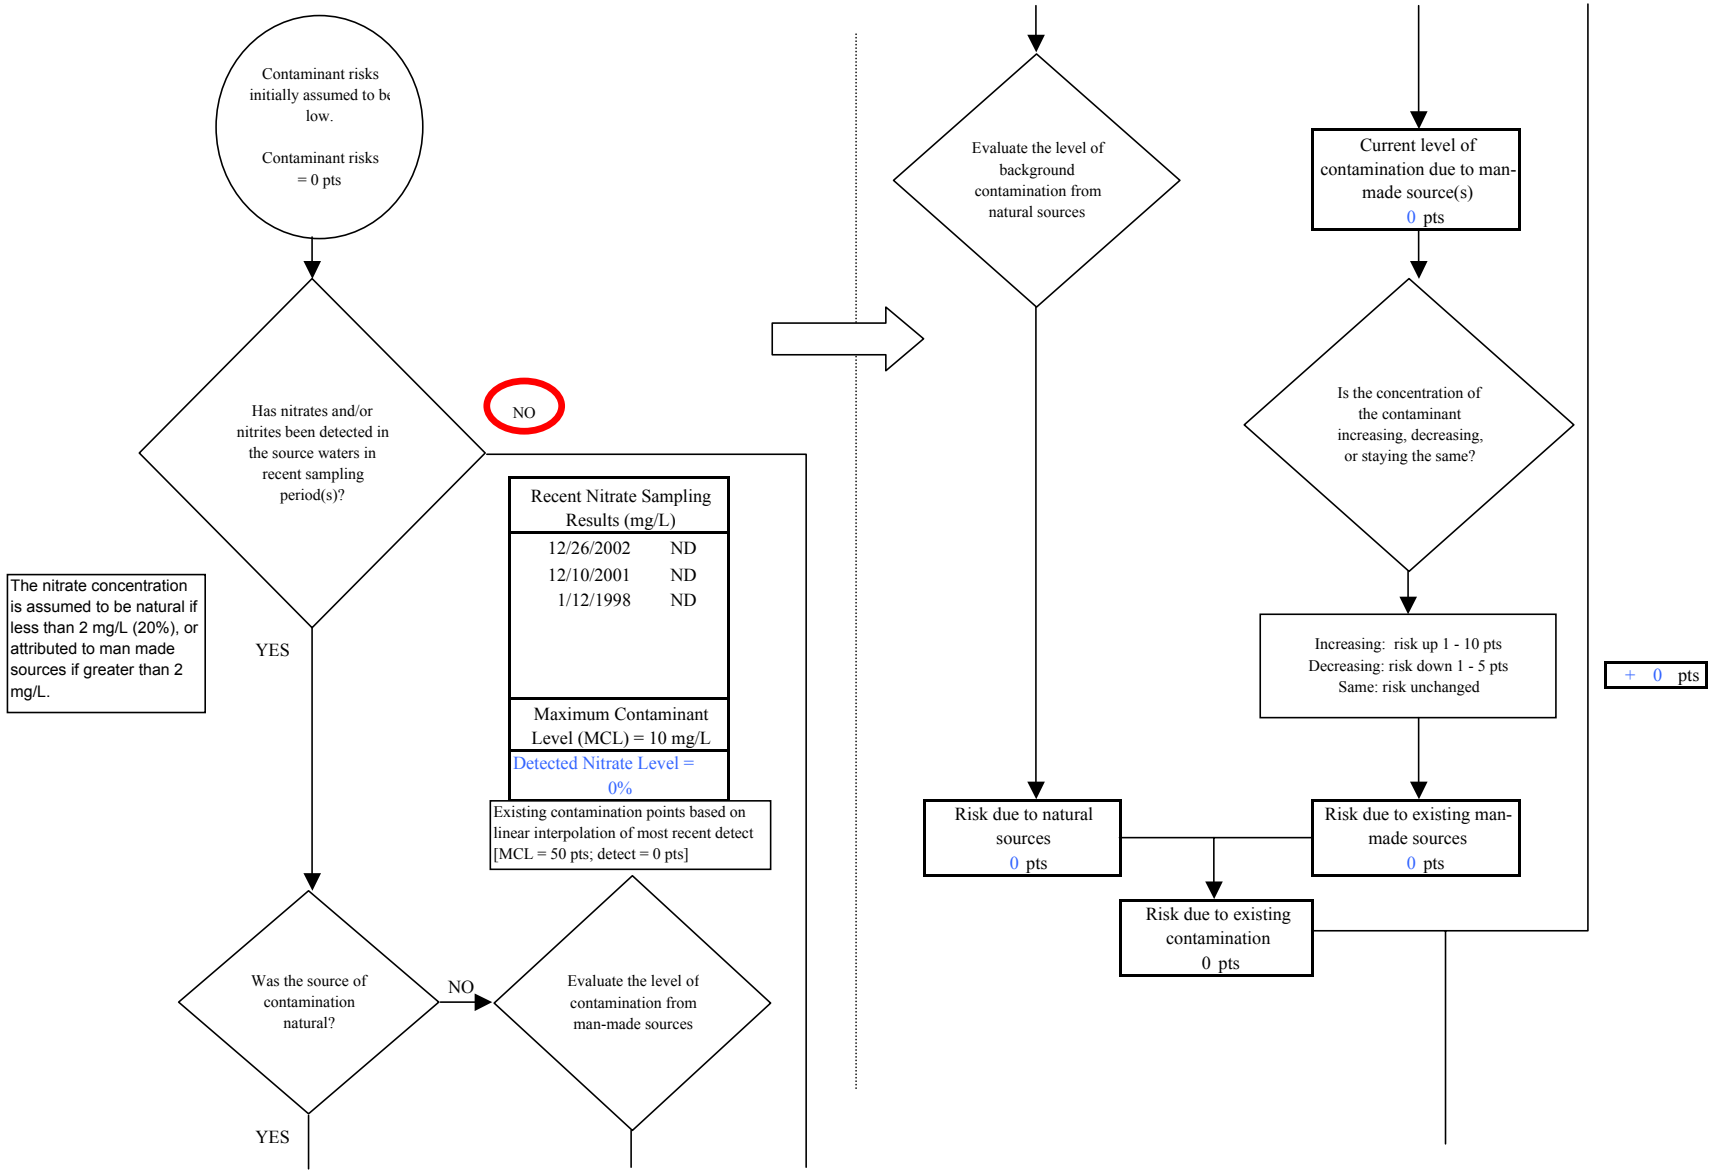
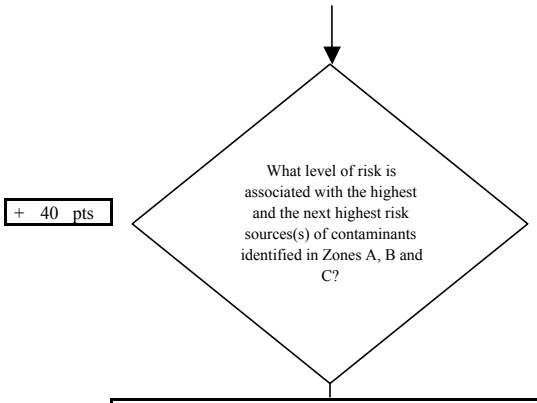
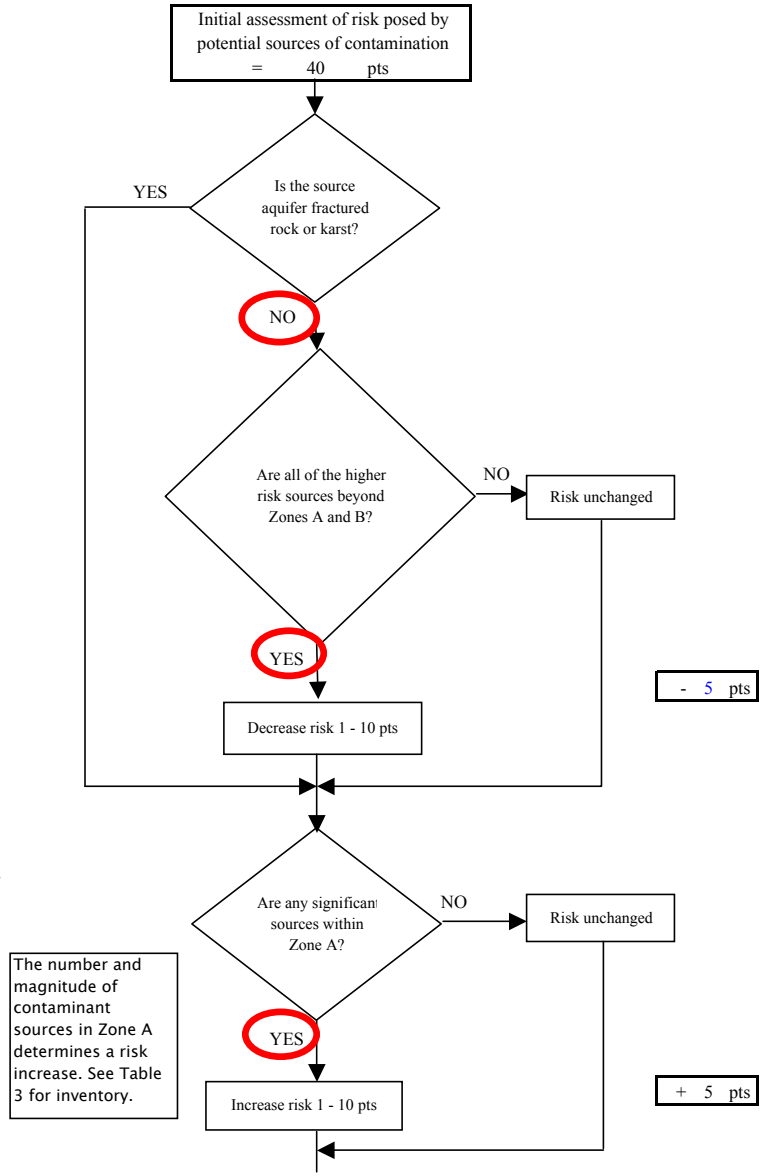
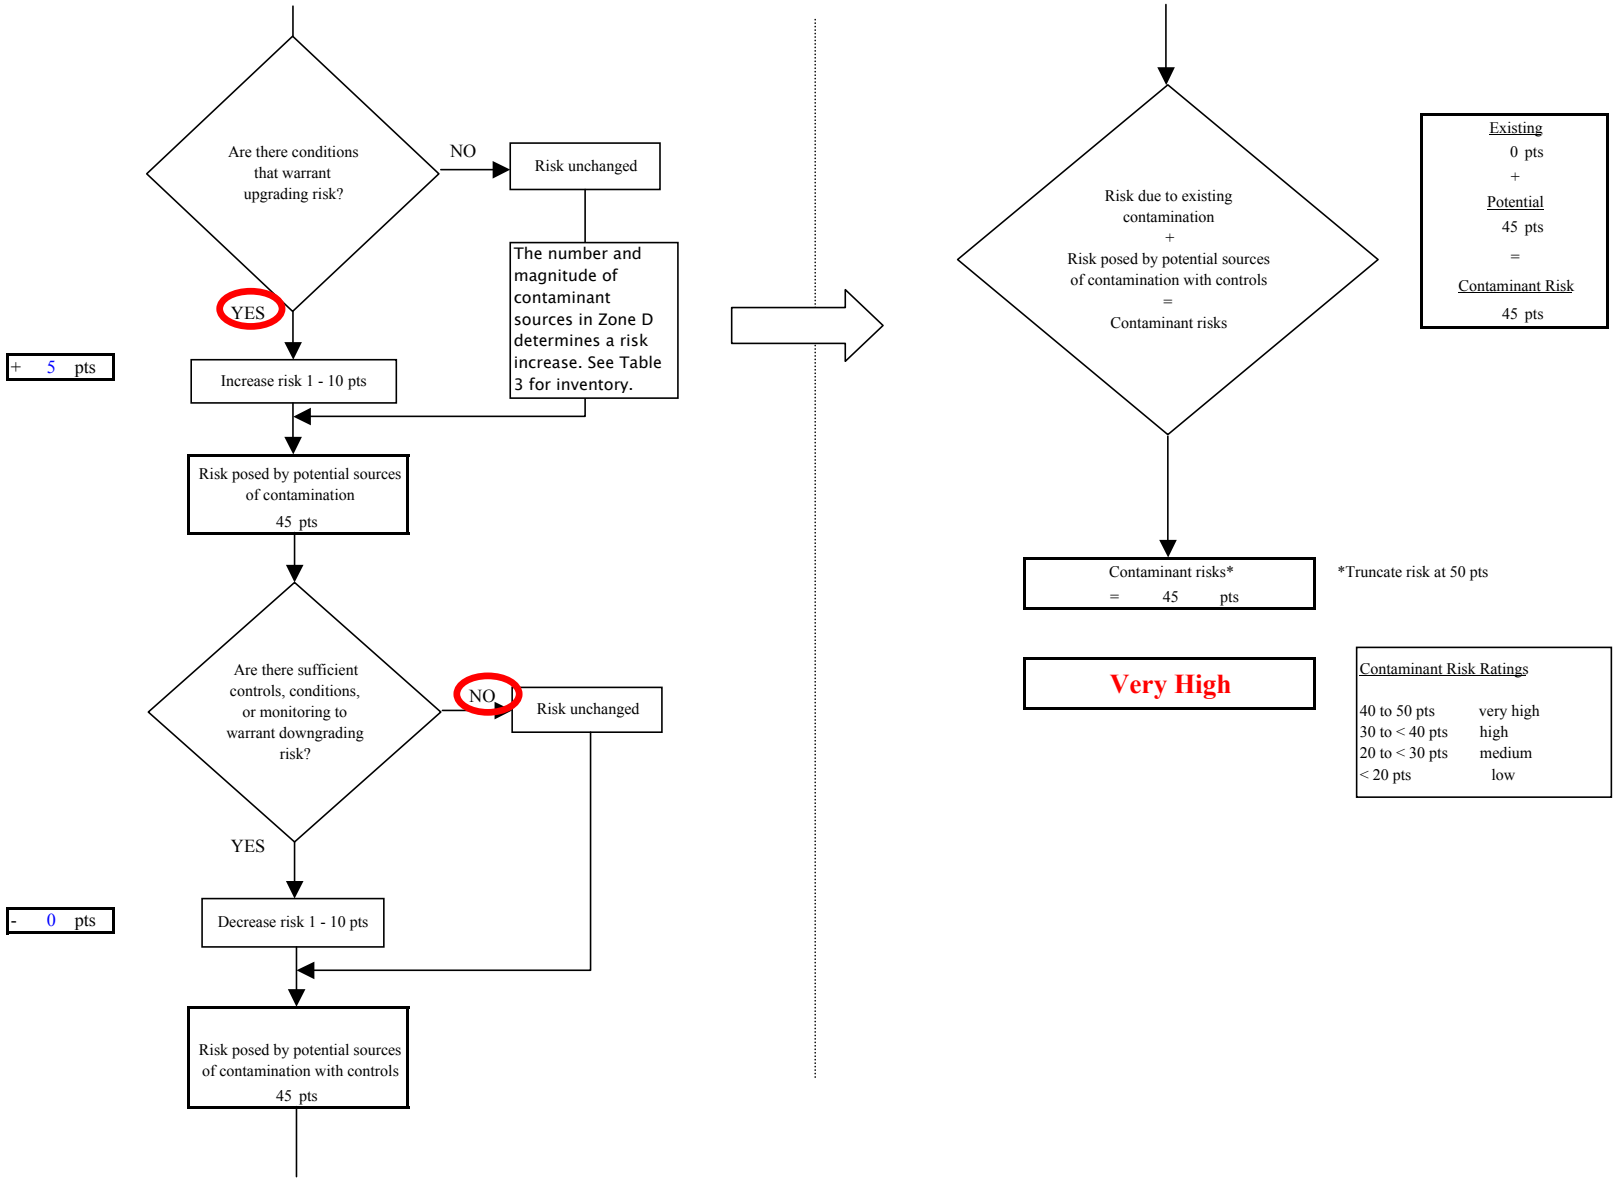
Chart 5. Contaminant risks for Tundra Center (PWS No. 271473.001) - Nitrates and Nitrites

The contaminant risk for nitrates and nitrites is **Very High**. The risk to this source of public drinking water is attributed to the presence of domestic wastewater collection systems in Zone A and a domestic wastewater treatment plant disposal pond/lagoon and landfills in Zones C and D (See Table 3 – Appendix B).

Nitrates are very mobile, moving at approximately the same rate as water. The sampling history for this well indicates that nitrates have not been detected in recent sampling events. Nitrate concentrations in uncontaminated groundwater are typically less than 2 mg/L; therefore, nitrate concentrations above 2 mg/L may be indicative of man-made sources (See Chart 5 - Contaminant Risks for Nitrates and/or Nitrites in Appendix D).

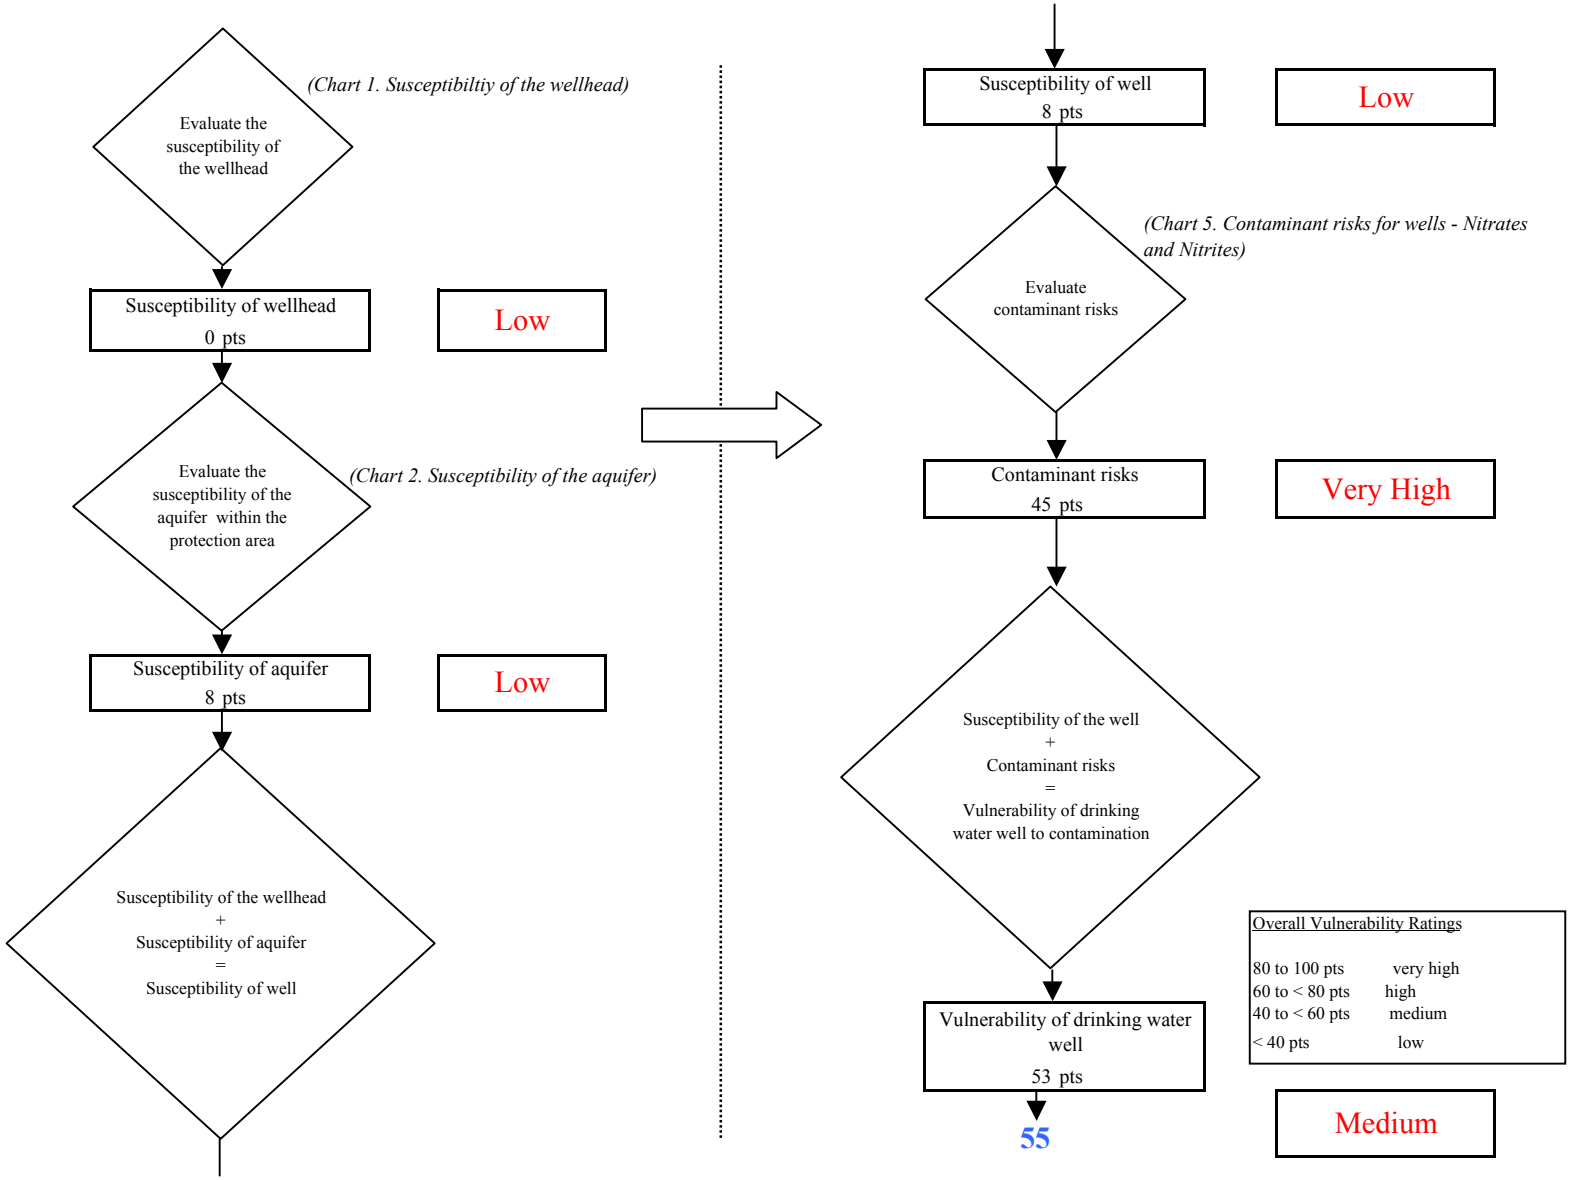
Chart 6. Vulnerability analysis for Tundra Center (PWS No. 271473.001) - Nitrates and Nitrites

After combining the contaminant risk for nitrates and nitrites with the natural susceptibility of the well, the overall vulnerability of the well to nitrate and nitrite contamination is **Medium**.

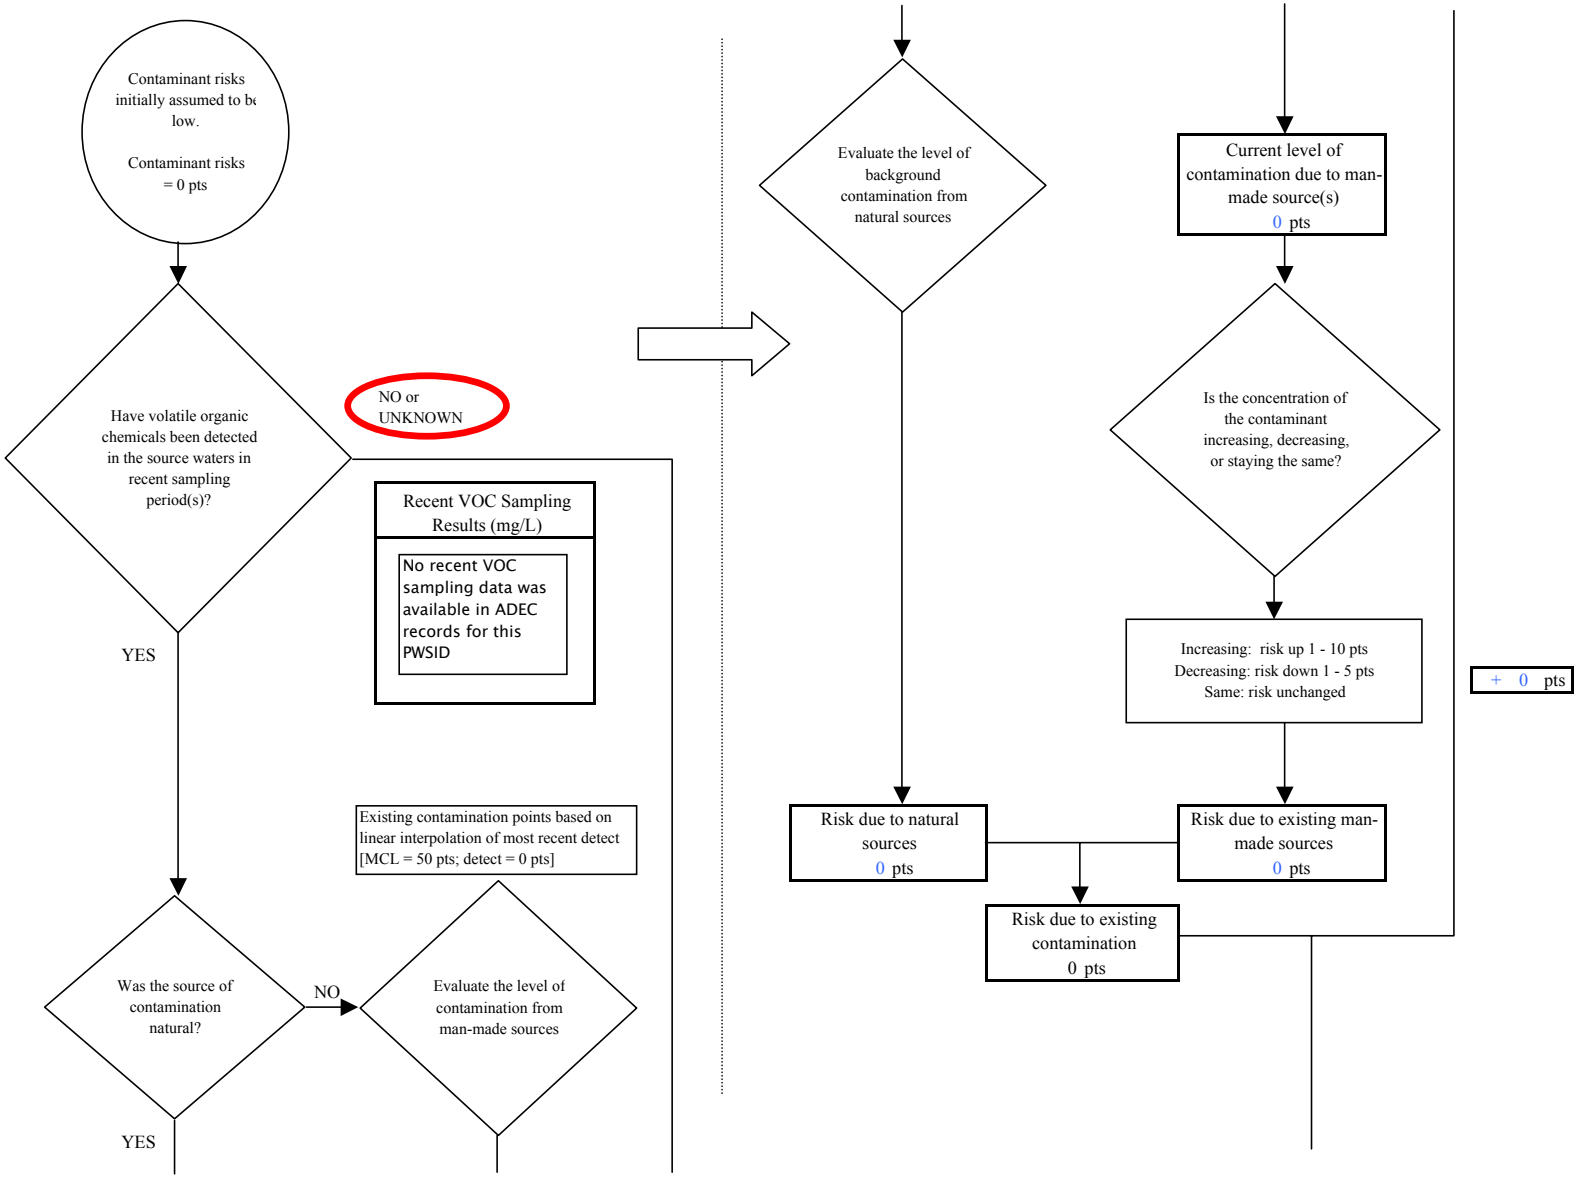
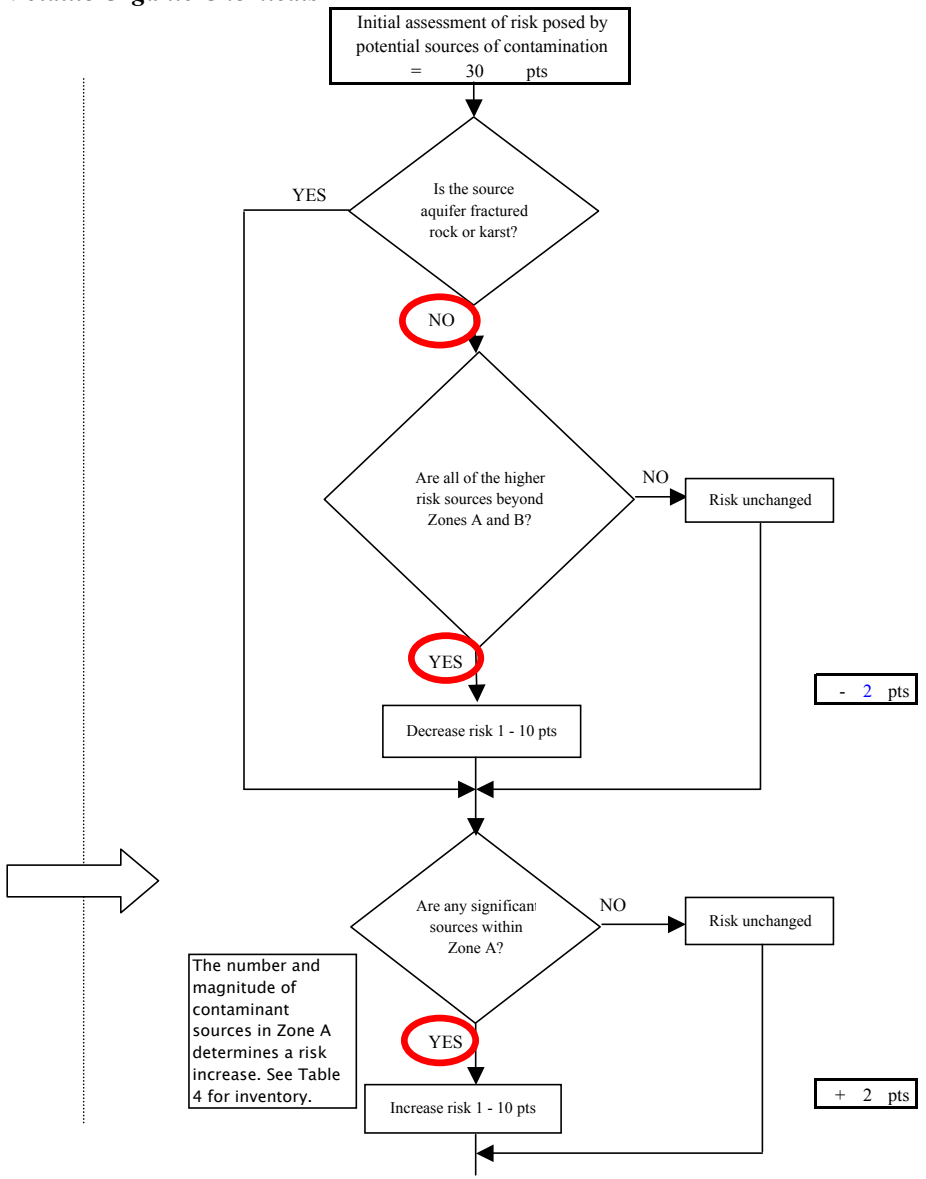
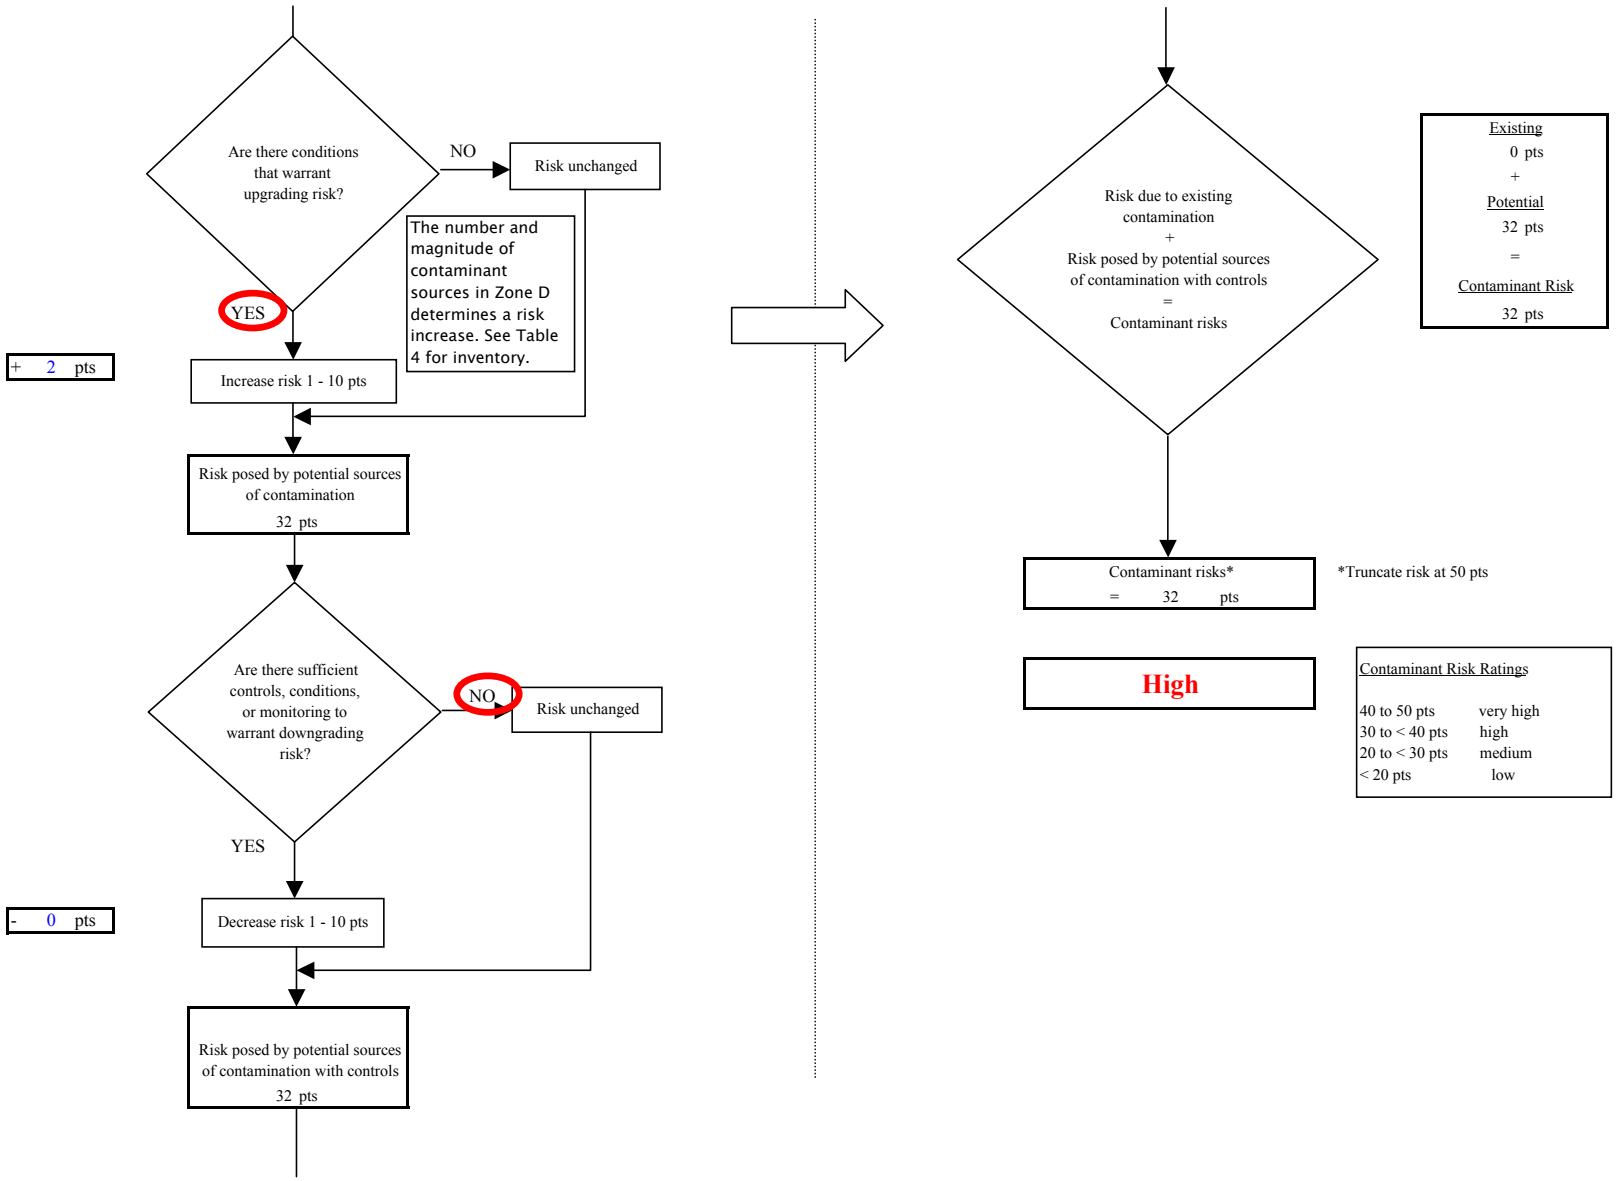
Chart 7. Contaminant risks for Tundra Center (PWS No. 271473.001) - Volatile Organic Chemicals

The contaminant risk for volatile organic chemicals is **High**. The risk is primarily attributed to the presence of landfills in Zones C and D (see Table 4 – Appendix B).

No recent sampling data was available in ADEC records for the Tundra Center (See Chart 7 – Contaminant Risks for Volatile Organic Chemicals in Appendix D).
