Source Water Assessment

A Hydrogeologic Susceptibility and Vulnerability Assessment for Butte Stop Inn and Trailer Court Public Drinking Water System, Butte, Alaska PWSID # 226795.001

DRINKING WATER PROTECTION REPORT 1692

December, 2008

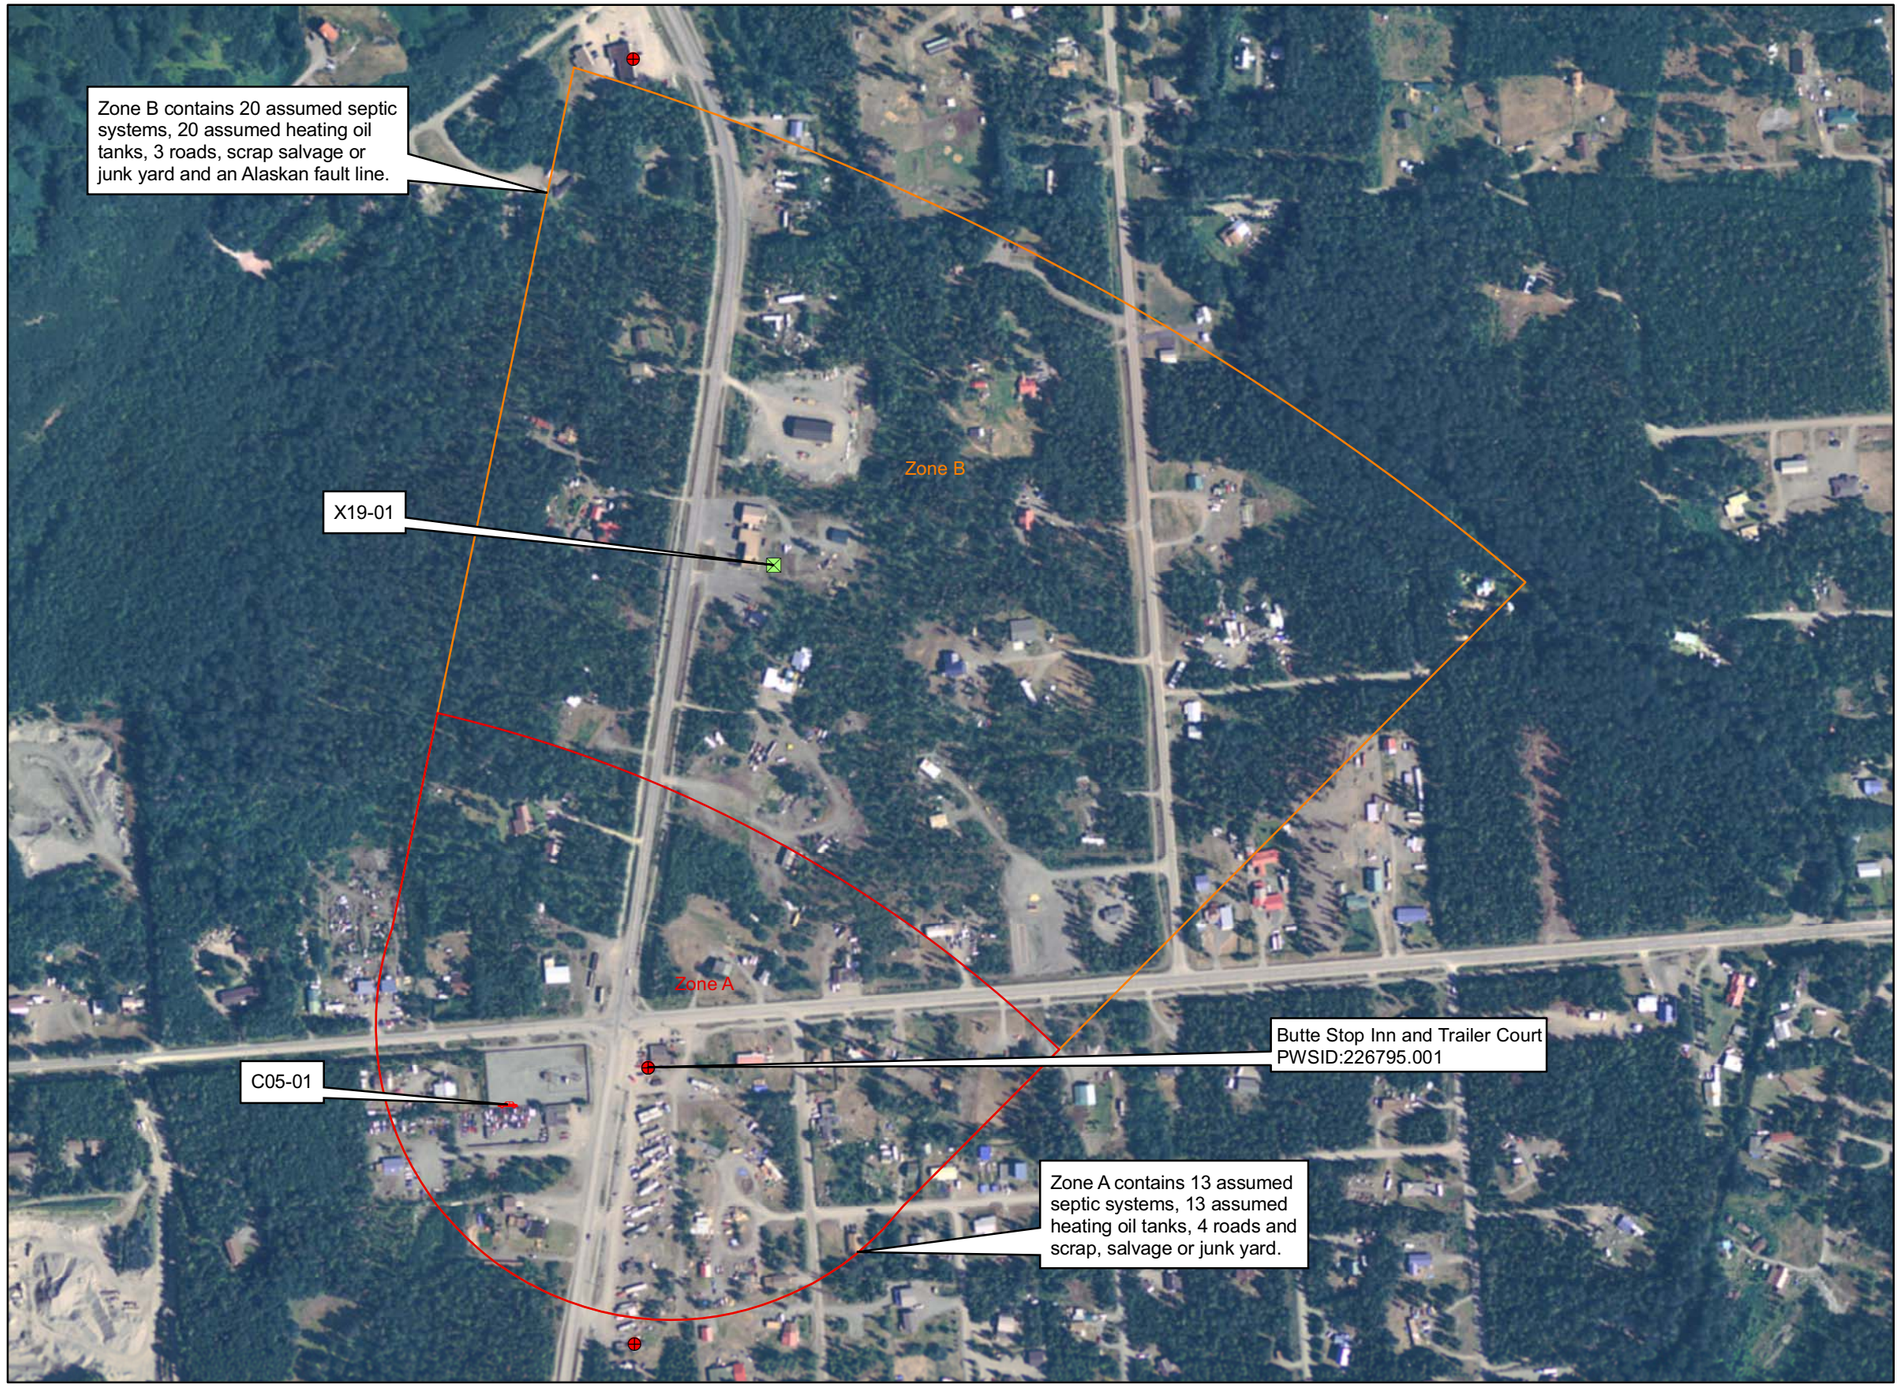
Appendix C Map C

The sources are displayed on Map C of Appendix C and summarized in Table 1 of Appendix B.

The contaminant risk for volatile organic chemicals is **High**, with a body shop, a junk yard, septic systems, heating oil tanks, a government vehicle maintenance facility, and roads contributing to the risk to the drinking water well.
