A Hydrogeologic Susceptibility and Vulnerability Assessment for Christ Temple Apostolic Church Public Drinking Water System, Chugiak, Alaska PWSID # 213506.001

DRINKING WATER PROTECTION REPORT 1610

Alaska Department of Environmental Conservation

December, 2008

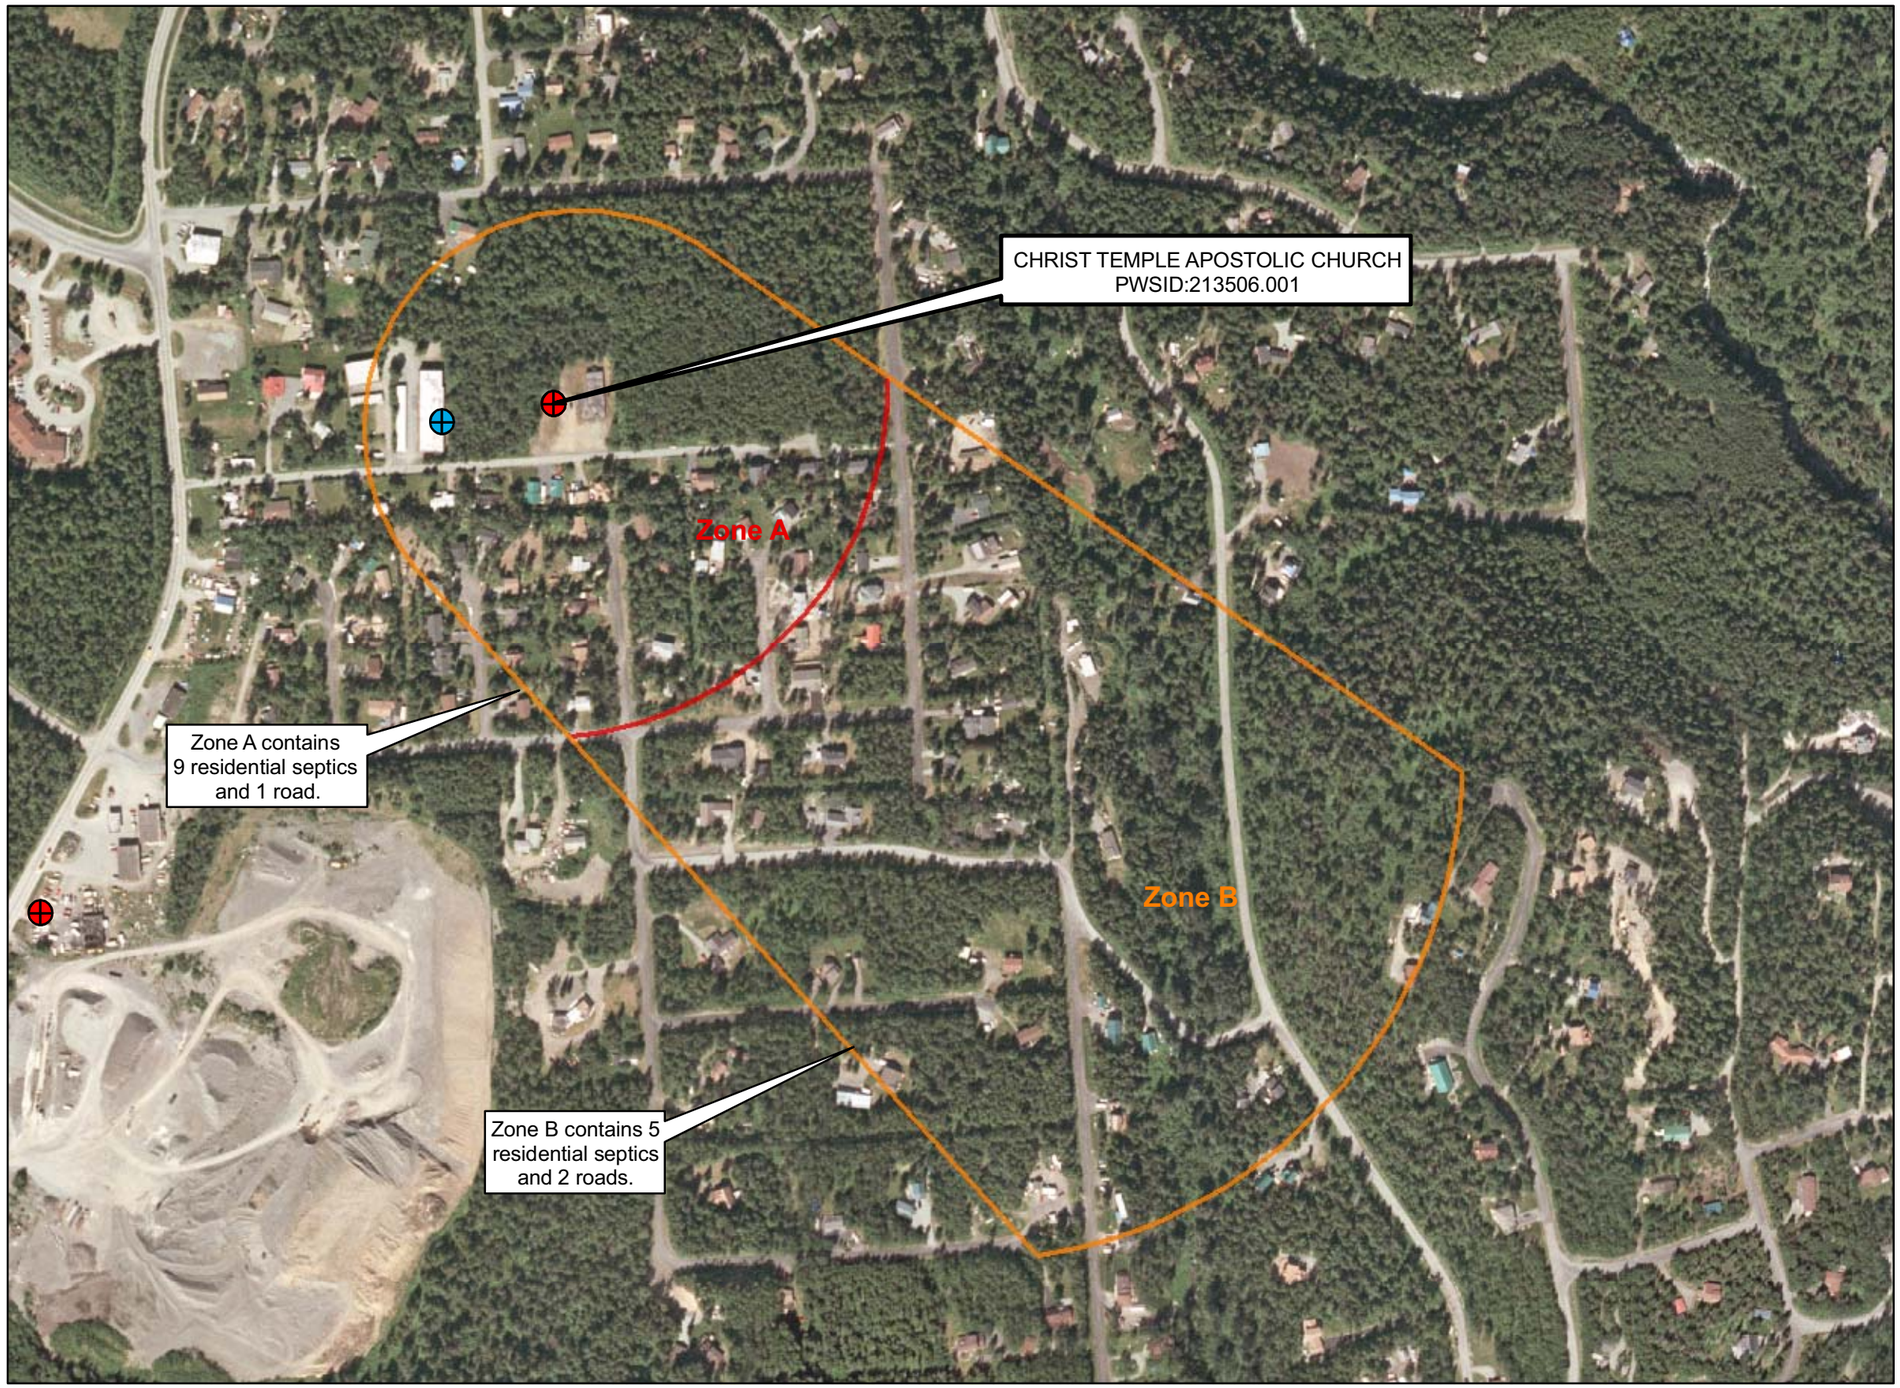
Appendix C Map C

The sources are displayed on Map C of Appendix C and summarized in Table 1 of Appendix B.

Contaminant Source Type	*Contaminant Source ID*	*CS ID tag*	*Zone*	*Map Number*	*Comments*
Septic systems (serves one single-family home)	R02	R02	A	C	9 Inferred Septics
Highways and roads, dirt/gravel	X24	X24	A	C	1 Road
Septic systems (serves one single-family home)	R02	R02	B	C	5 Inferred Septics
Highways and roads, dirt/gravel	X24	X24	B	C	2 Roads
