Source Water Assessment

A Hydrogeologic Susceptibility and
Vulnerability Assessment for
Church of Jesus Christ, Latter Day Saints
Drinking Water System,
Dillingham, Alaska

PWSID # 263019.001

DRINKING WATER PROTECTION PROGRAM REPORT 1215
Alaska Department of Environmental Conservation

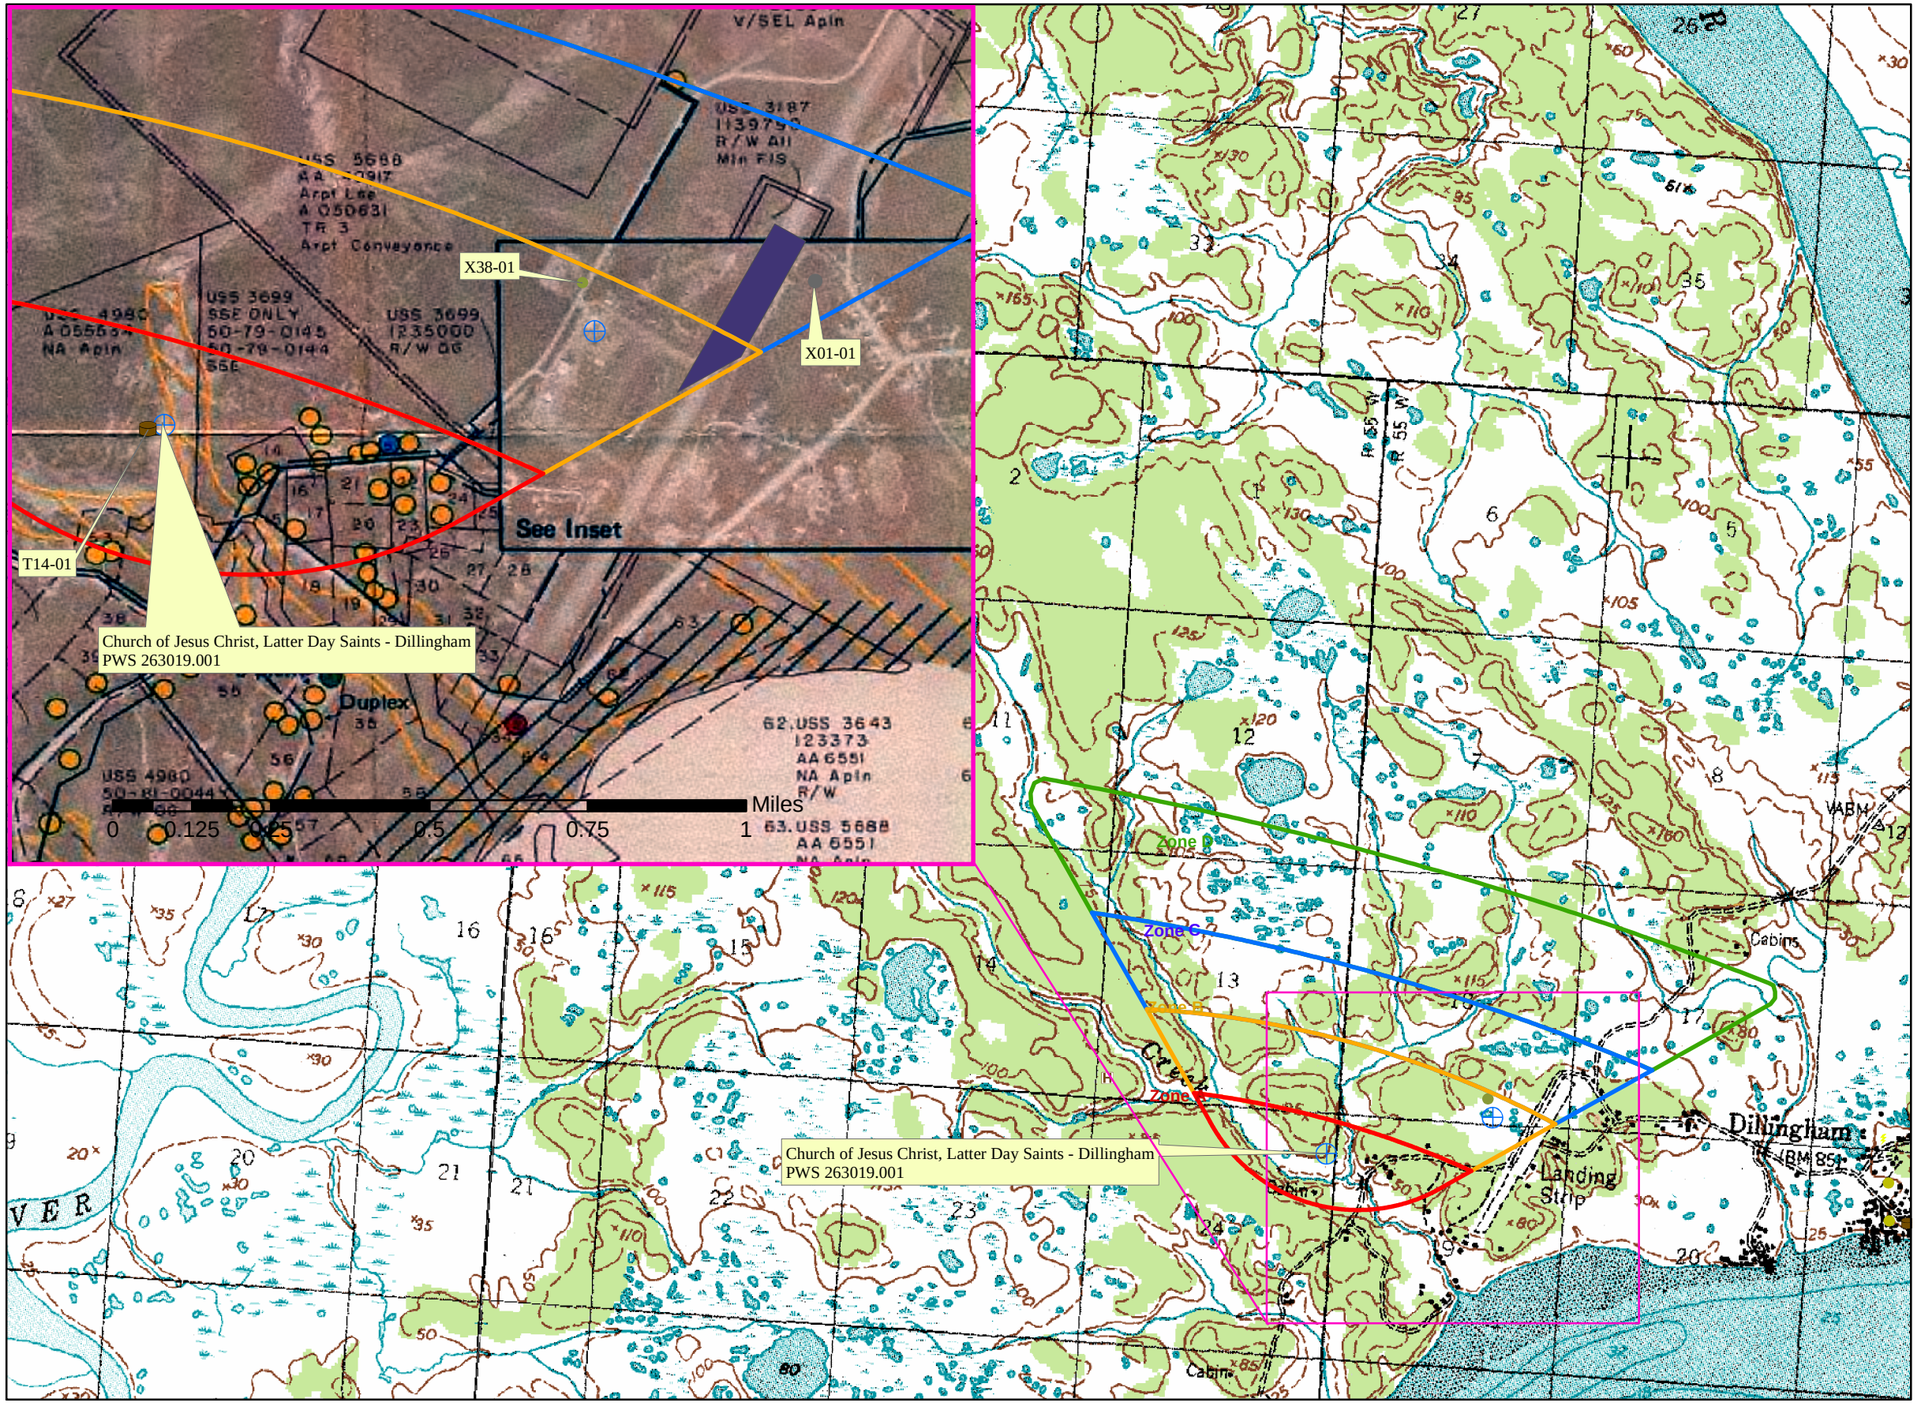
Appendix C Map C

The contaminant risk for volatile organic chemicals is **Very High**. The risk is primarily attributed to the presence of aboveground fuel tanks and two airports located in Zones A, B, and C. Numerous other potential contaminant sources are also found within the protection area (see Table 4 – Appendix B).

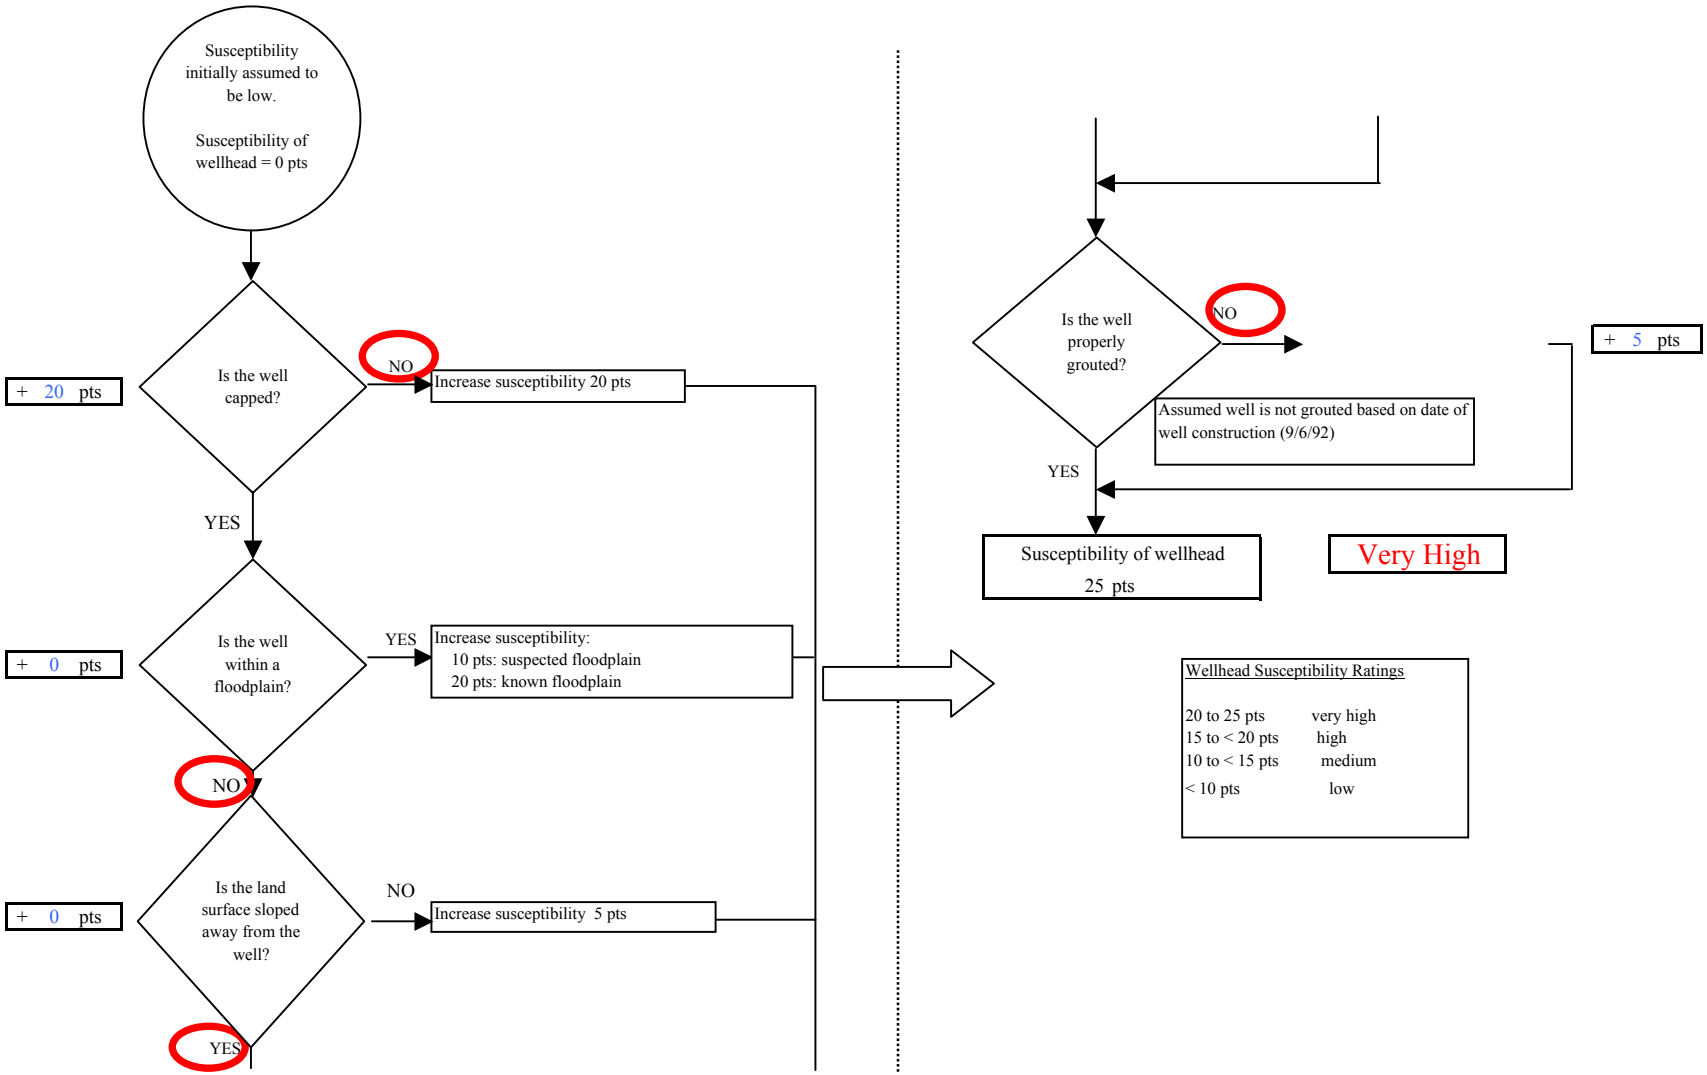
Chart 1. Susceptibility of the wellhead - LDS Church Dillingham (PWS No. 263019.001)

Score	Rating
Susceptibility of the Wellhead	25	Very High
Susceptibility of the Aquifer	18	High
Natural Susceptibility	43	Very High

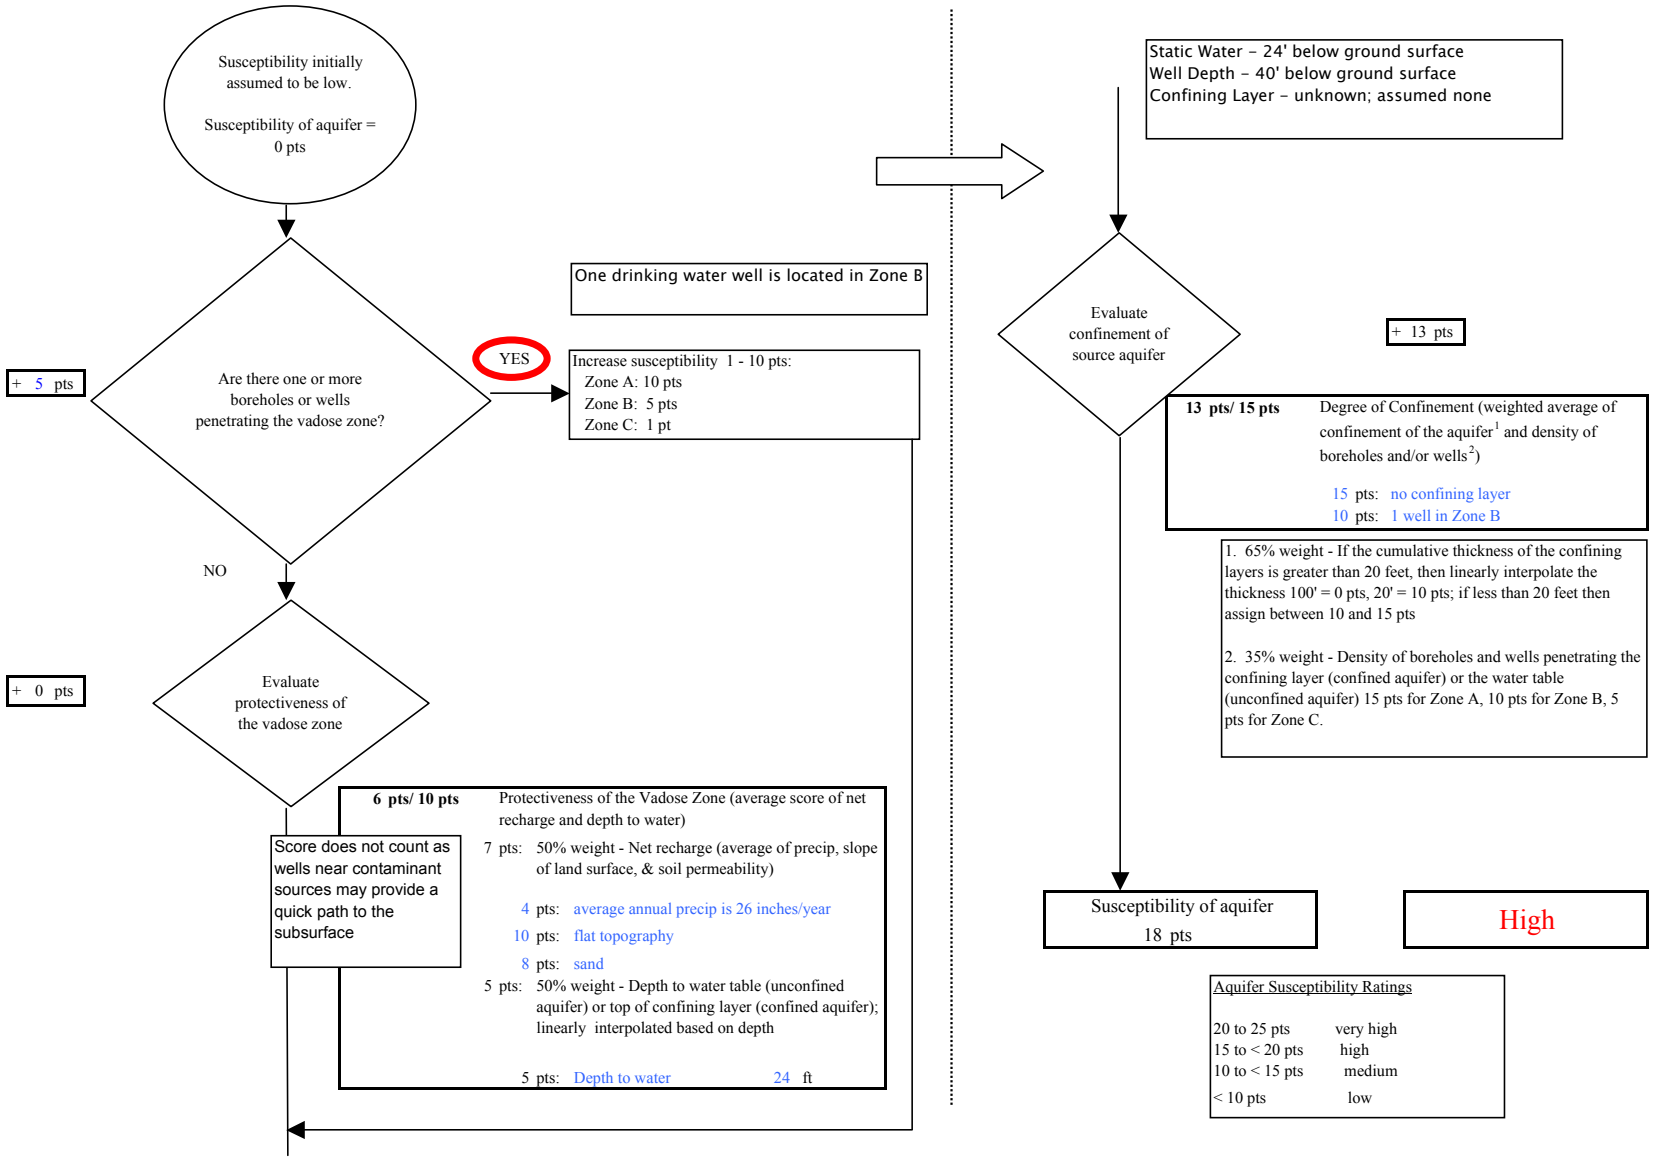
Chart 2. Susceptibility of the aquifer LDS Church Dillingham (PWS No. 263019.001)

The Church of Jesus Christ, Latter Day Saints' water well is in an unconfined aquifer. Unconfined aquifers are more susceptible to potential groundwater quality impacts posed by the migration of surface water contaminants downward from the surface. Table 2 shows the susceptibility scores and ratings for this PWS.

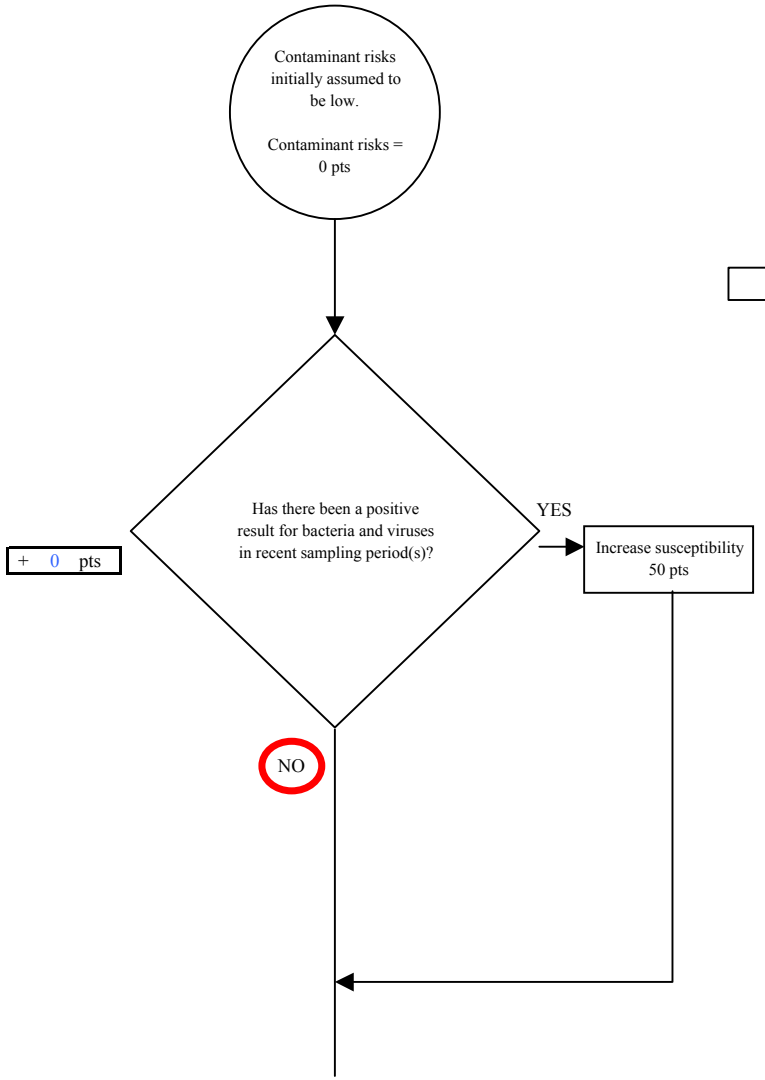
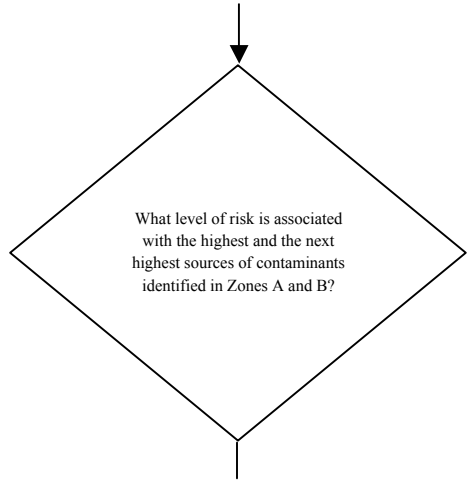
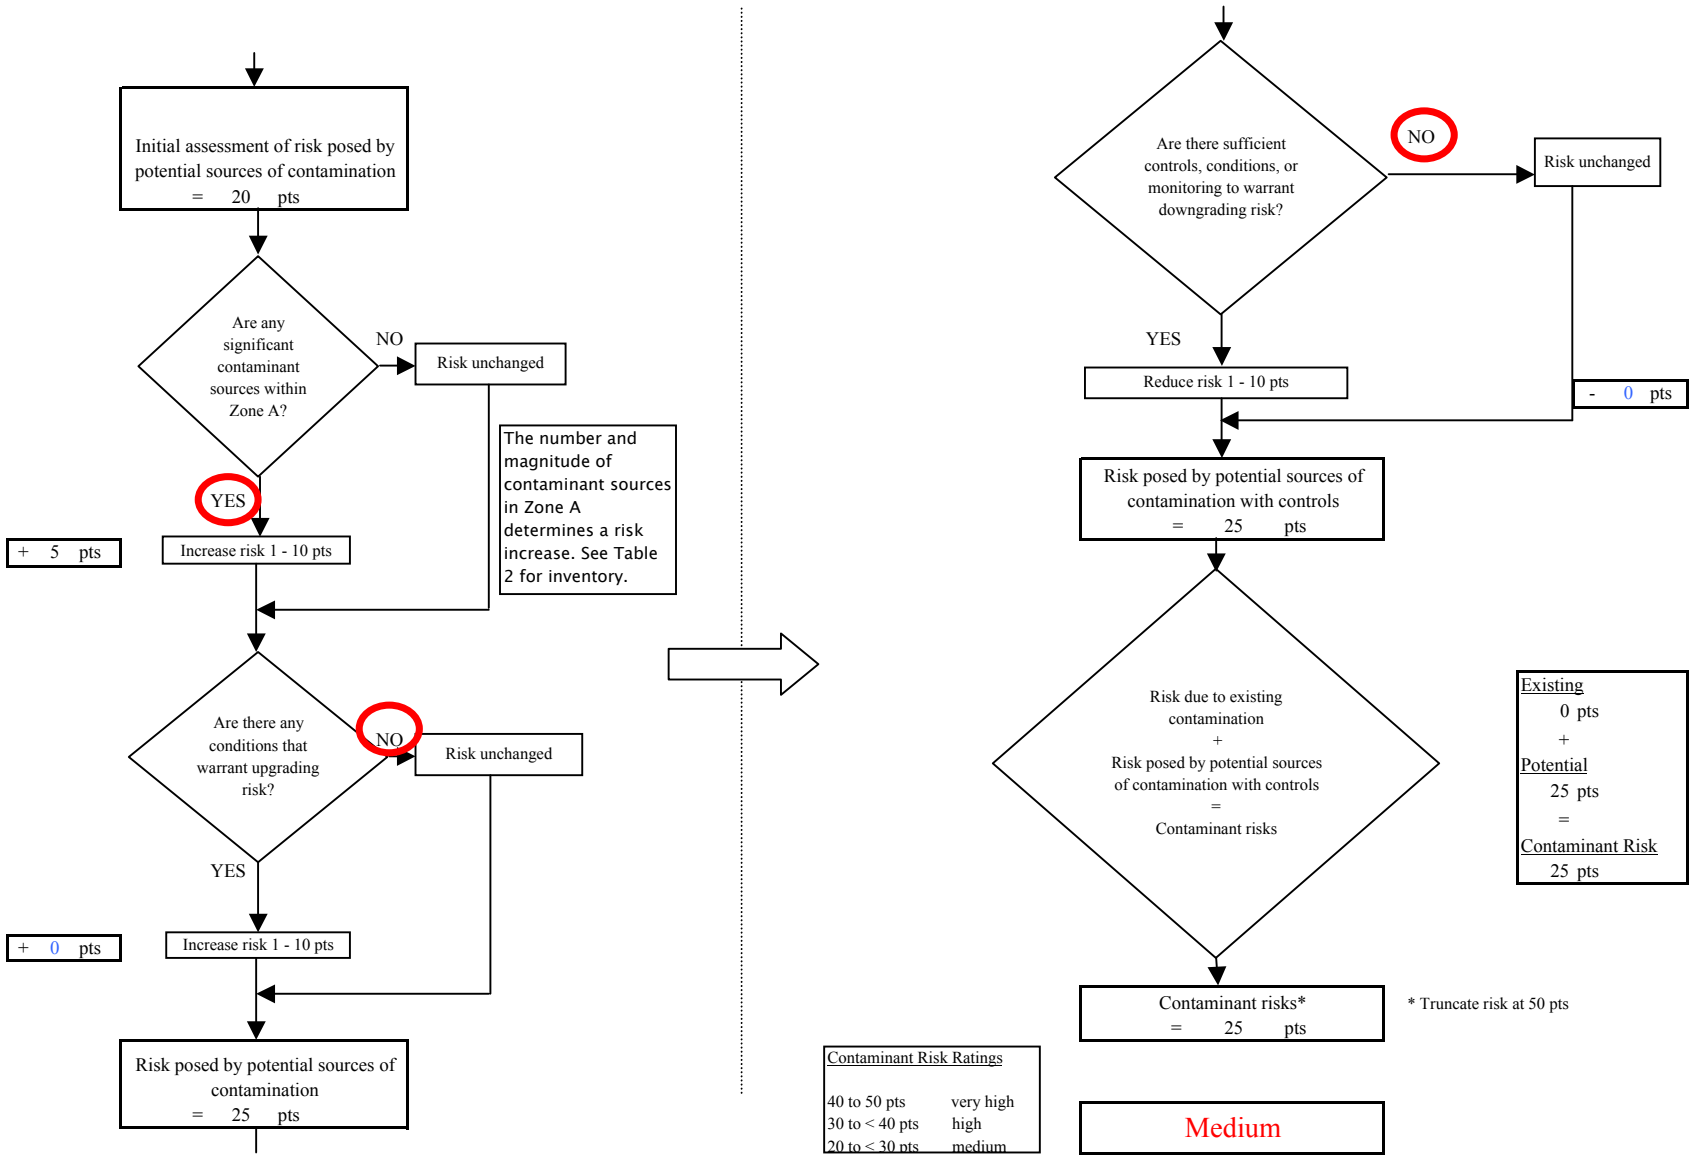
Chart 3. Contaminant risks for LDS Church Dillingham (PWS No. 263019.001) - Bacteria & Viruses

The contaminant risk for bacteria and viruses is **Medium**. The risk is primarily attributed to the presence of domestic wastewater collection systems in Zone A (see Table 2 – Appendix B).

No positive bacteria counts have been reported in recent (within five years) sampling events (See Chart 3 – Contaminant Risks for Bacteria and Viruses in Appendix D). Only a small amount of bacteria and viruses are required to endanger public health.

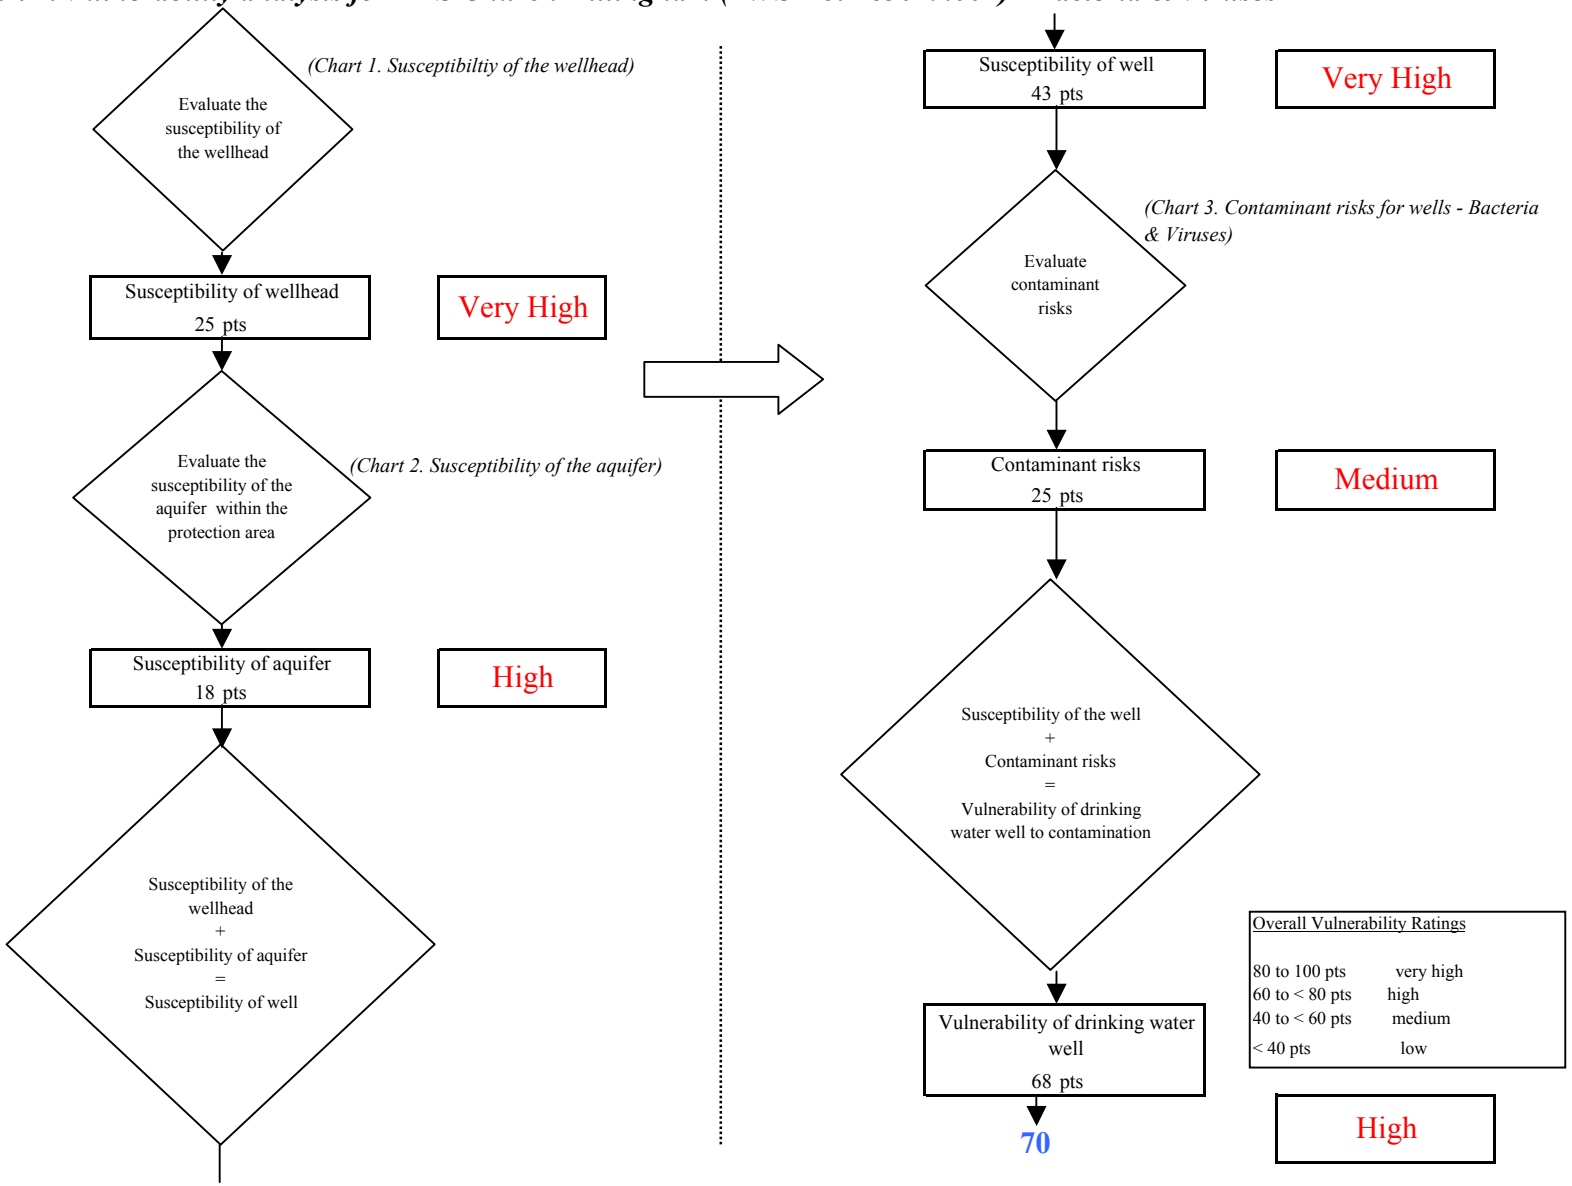
Chart 4. Vulnerability analysis for LDS Church Dillingham (PWS No. 263019.001) - Bacteria & Viruses

After combining the contaminant risk for bacteria and viruses with the natural susceptibility of the well, the overall vulnerability of the well to contamination is **High**.

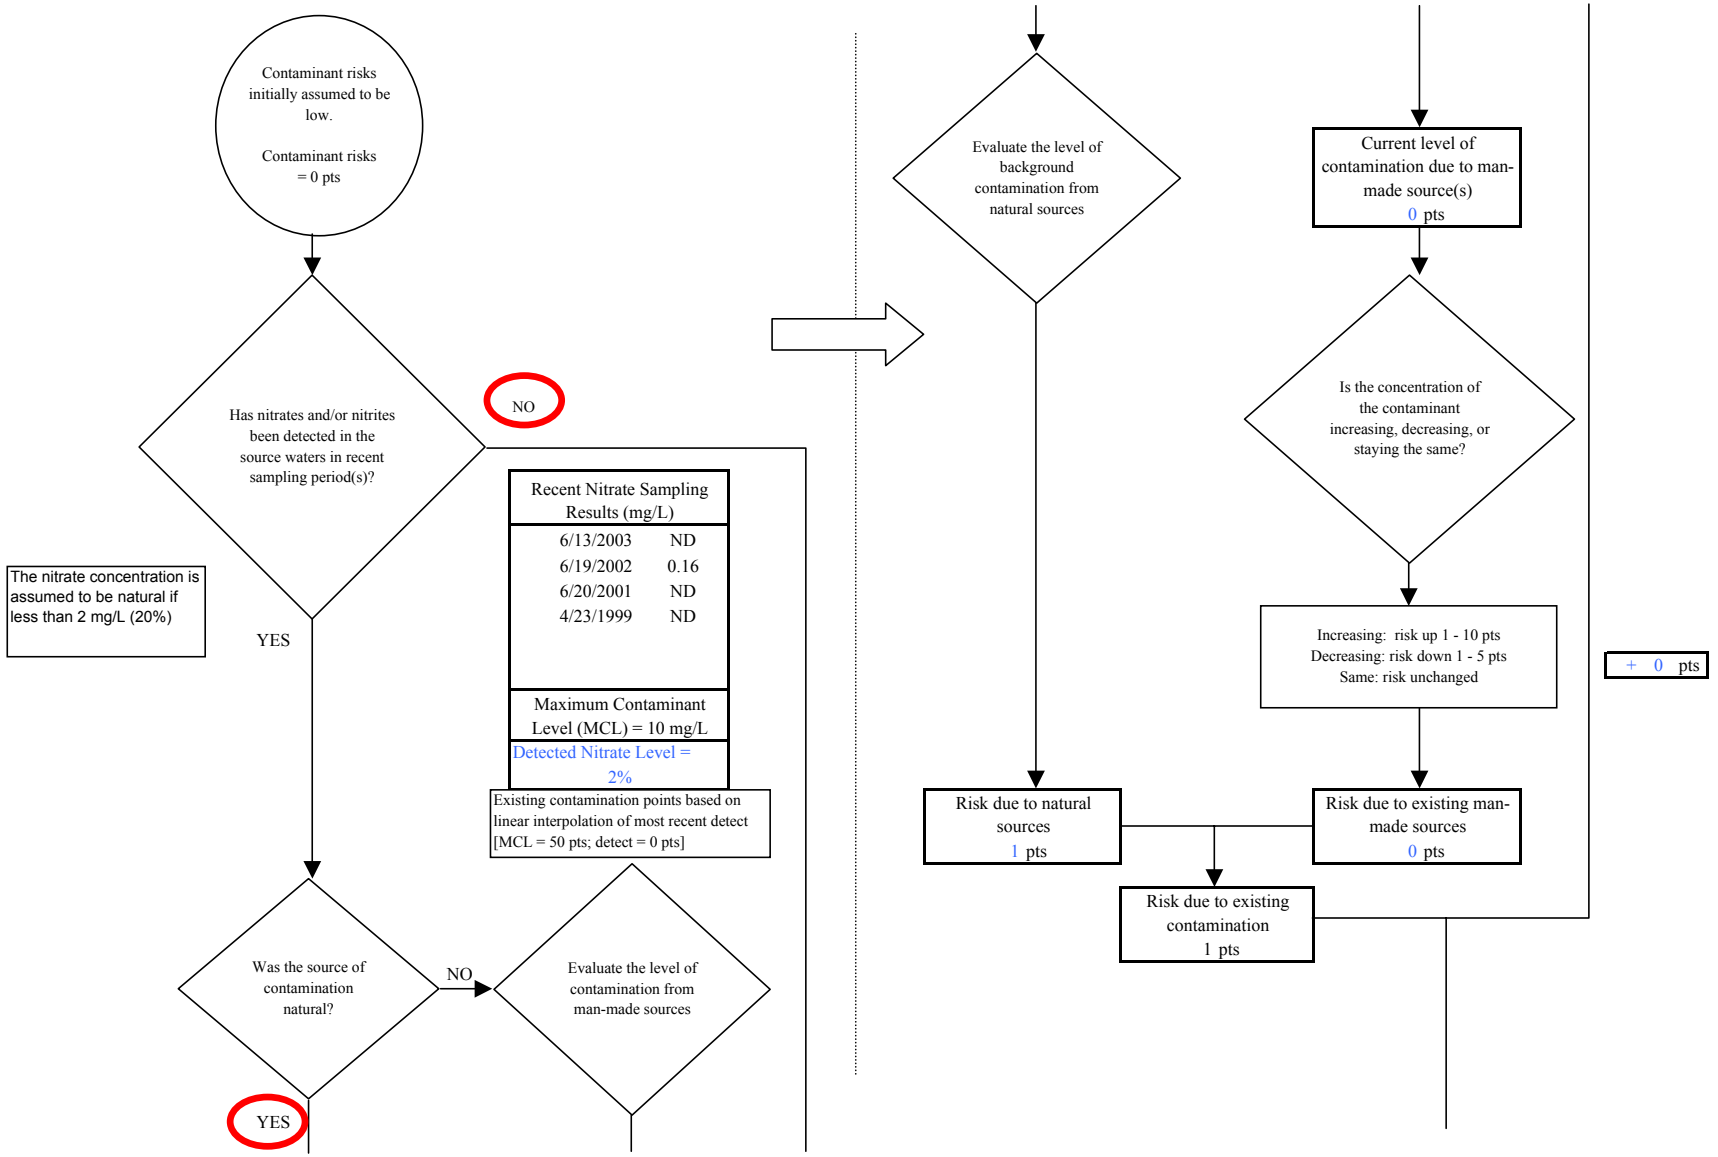
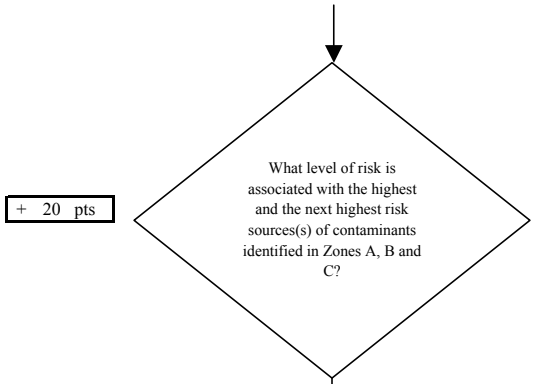
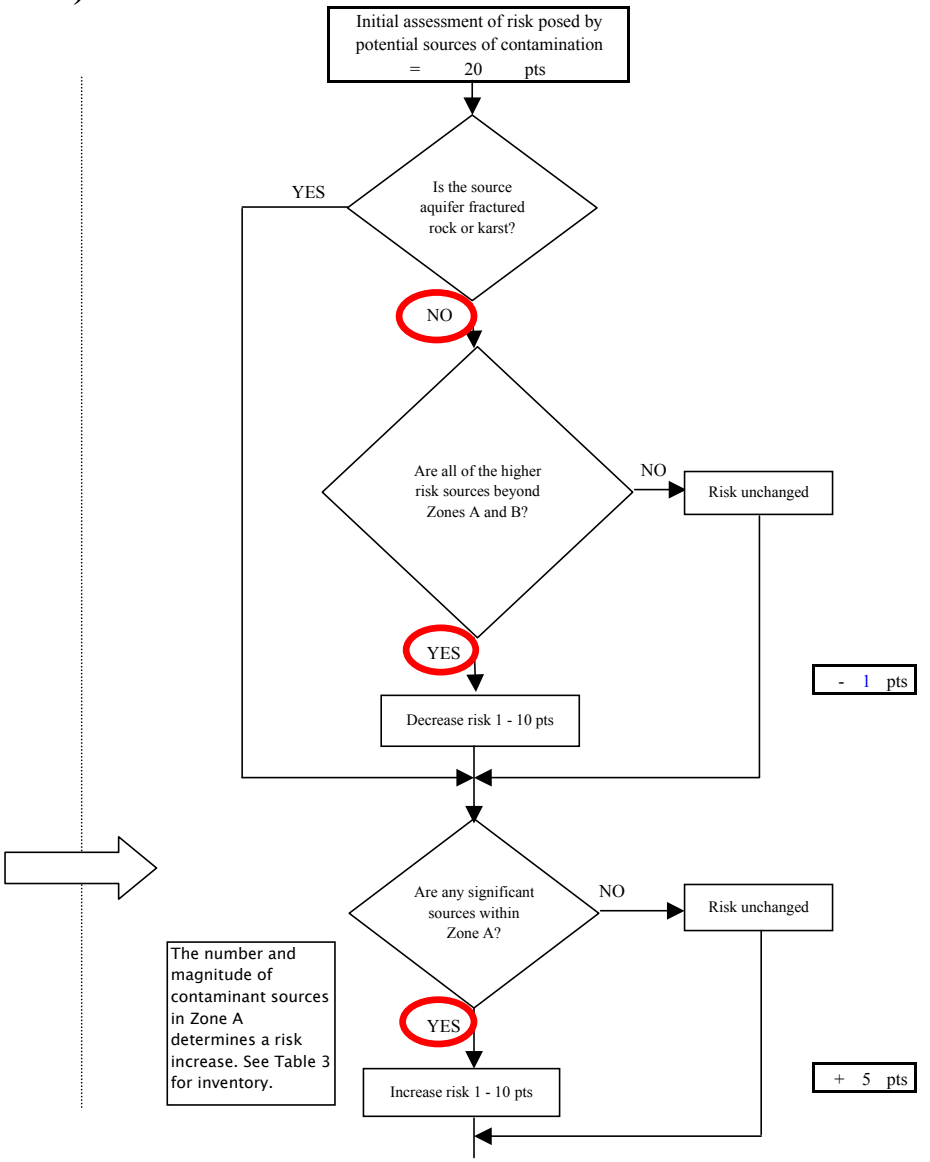
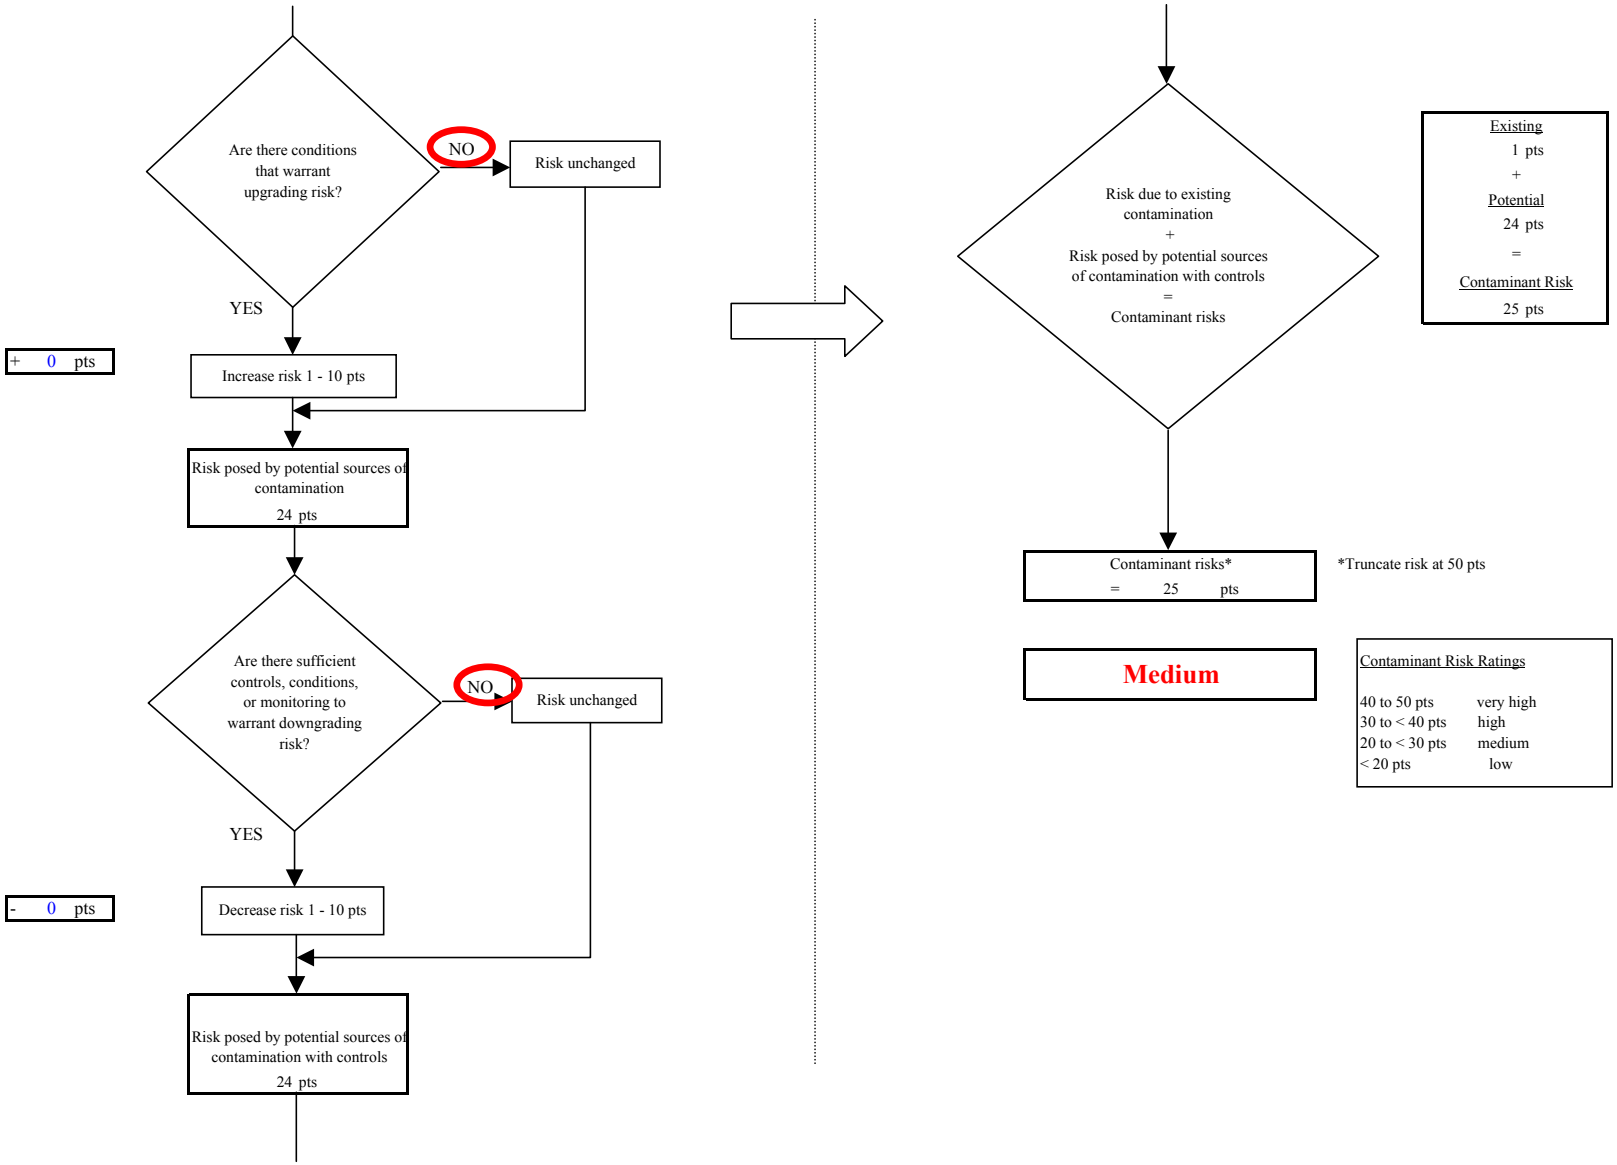
Chart 5. Contaminant risks for LDS Church Dillingham (PWS No. 263019.001) - Nitrates and Nitrites

The contaminant risk for nitrates and nitrites is **Medium**. The risk to this source of public drinking water is primarily attributed to the presence of domestic wastewater collection systems and a cemetery in Zones A and C (see Table 3 – Appendix B).

Nitrates are very mobile, moving at approximately the same rate as water. The sampling history for this well indicates that low levels of nitrates have been detected in recent sampling events. However, the reported concentrations of nitrates do not exceed the maximum contaminant level (MCL) of 10 mg/L. Nitrate concentrations in uncontaminated groundwater are typically less than 2 mg/L; therefore, nitrate concentrations above 2 mg/L may be indicative of man-made sources (See Chart 5 - Contaminant Risks for Nitrates and/or Nitrites in Appendix D).

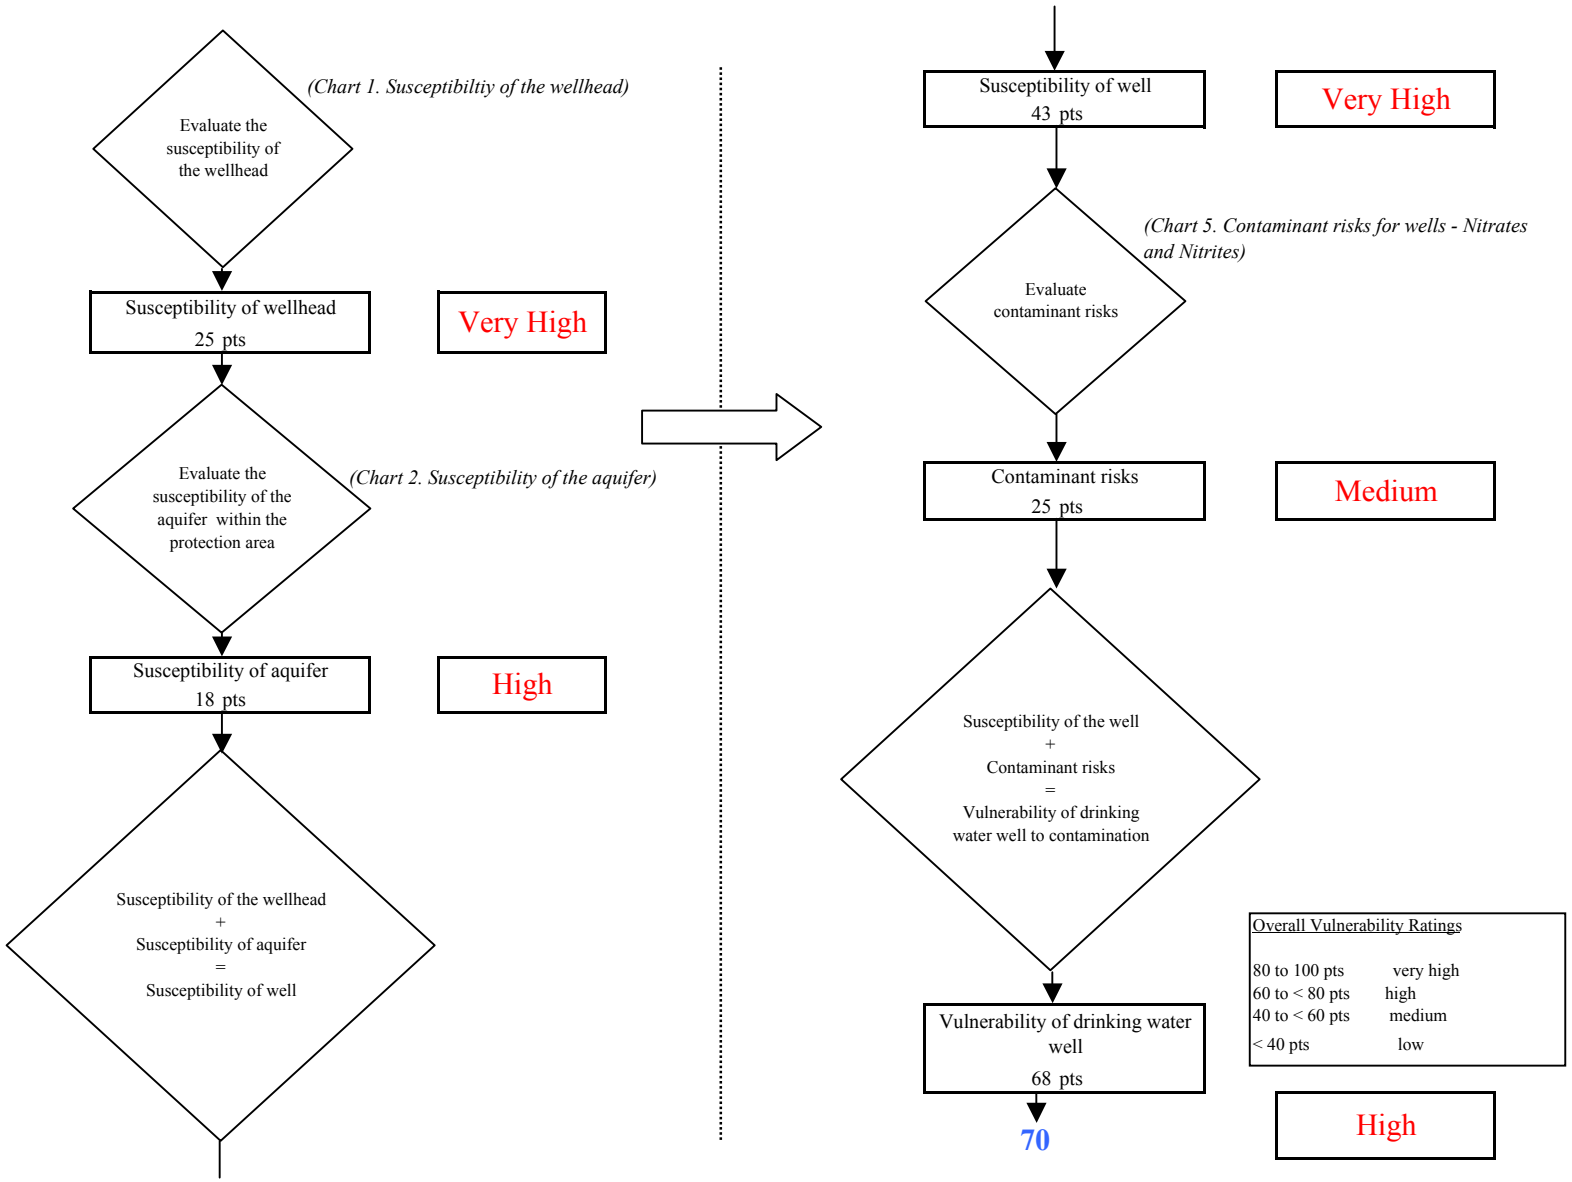
Chart 6. Vulnerability analysis for LDS Church Dillingham (PWS No. 263019.001) - Nitrates and Nitrites

Nitrate levels are often derived from the decomposition of organic matter in soils. Although the nitrate source is unknown, such occurrences may be attributed to septic systems or other sources. After combining the contaminant risk for nitrates and nitrites with the natural susceptibility of the well, the overall vulnerability of the well to nitrate and nitrite contamination is **High**.
