Source Water Assessment

A Hydrogeologic Susceptibility and
Vulnerability Assessment for
Church of Jesus Christ, Latter Day Saints
Drinking Water System,
Dillingham, Alaska

PWSID # 263019.001

DRINKING WATER PROTECTION PROGRAM REPORT 1215
Alaska Department of Environmental Conservation

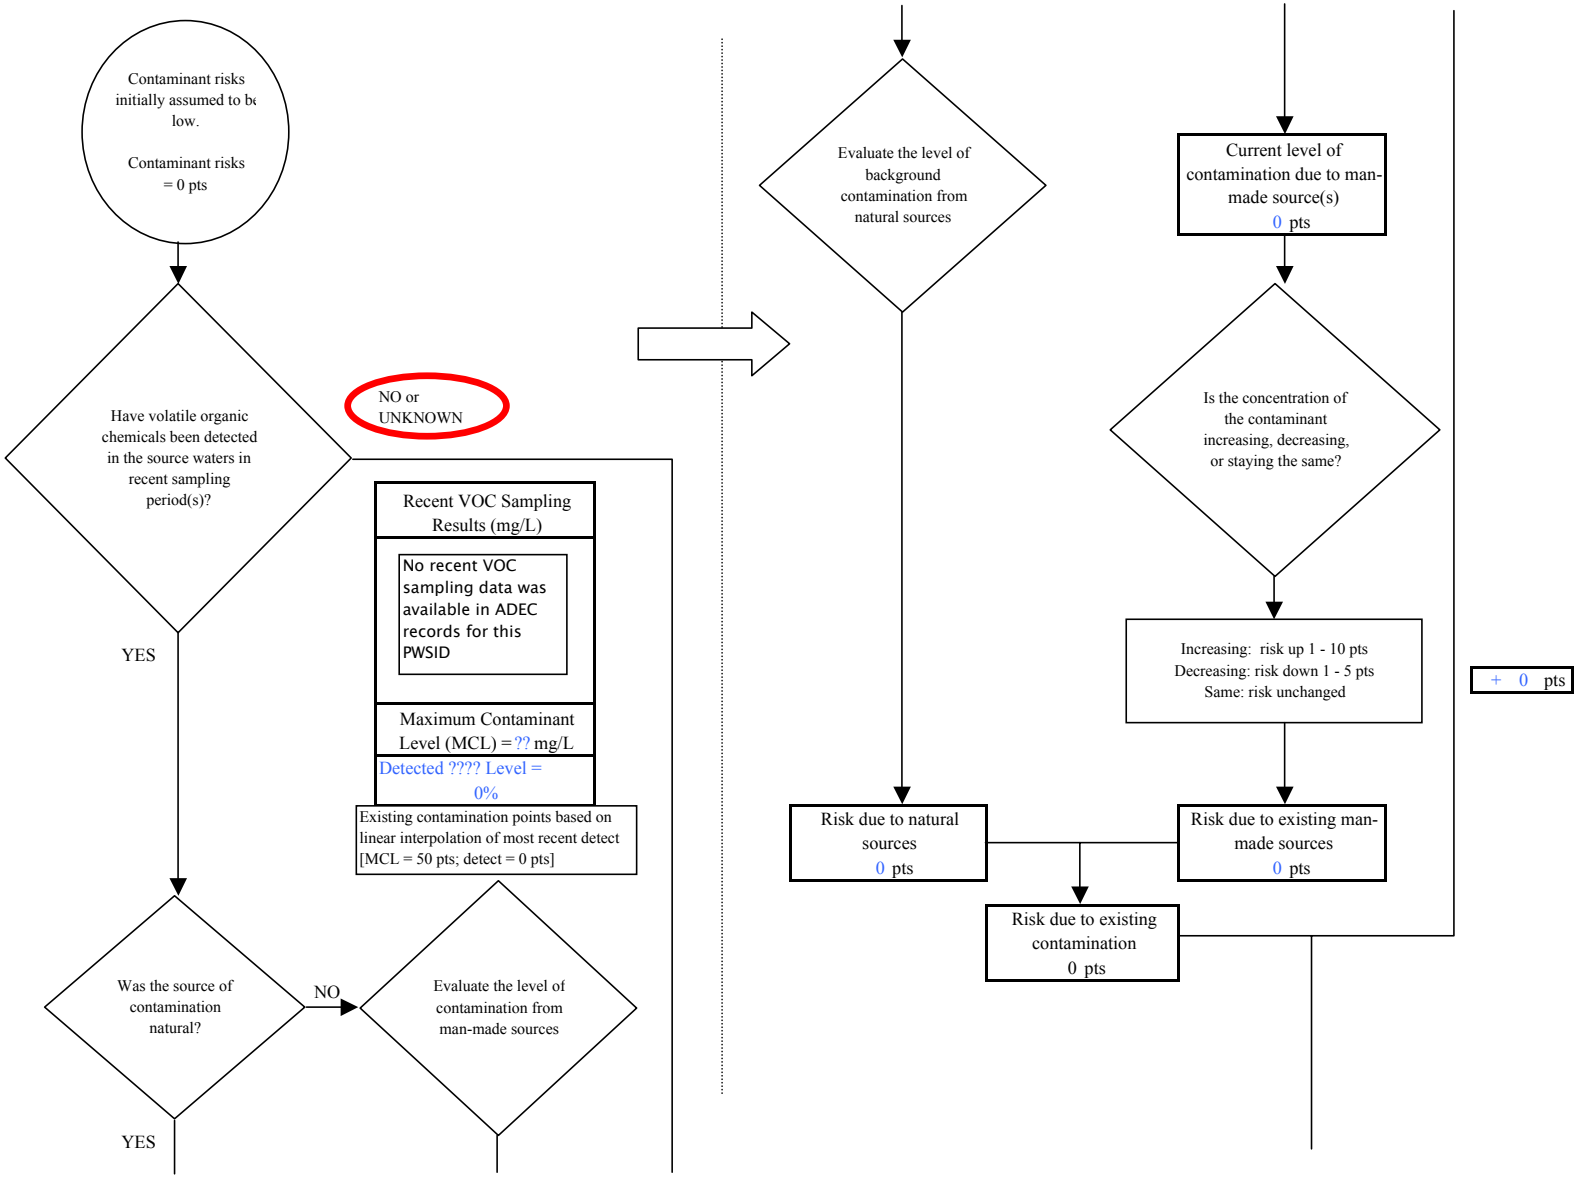
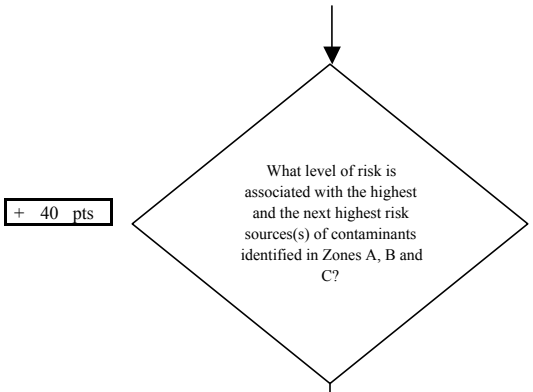
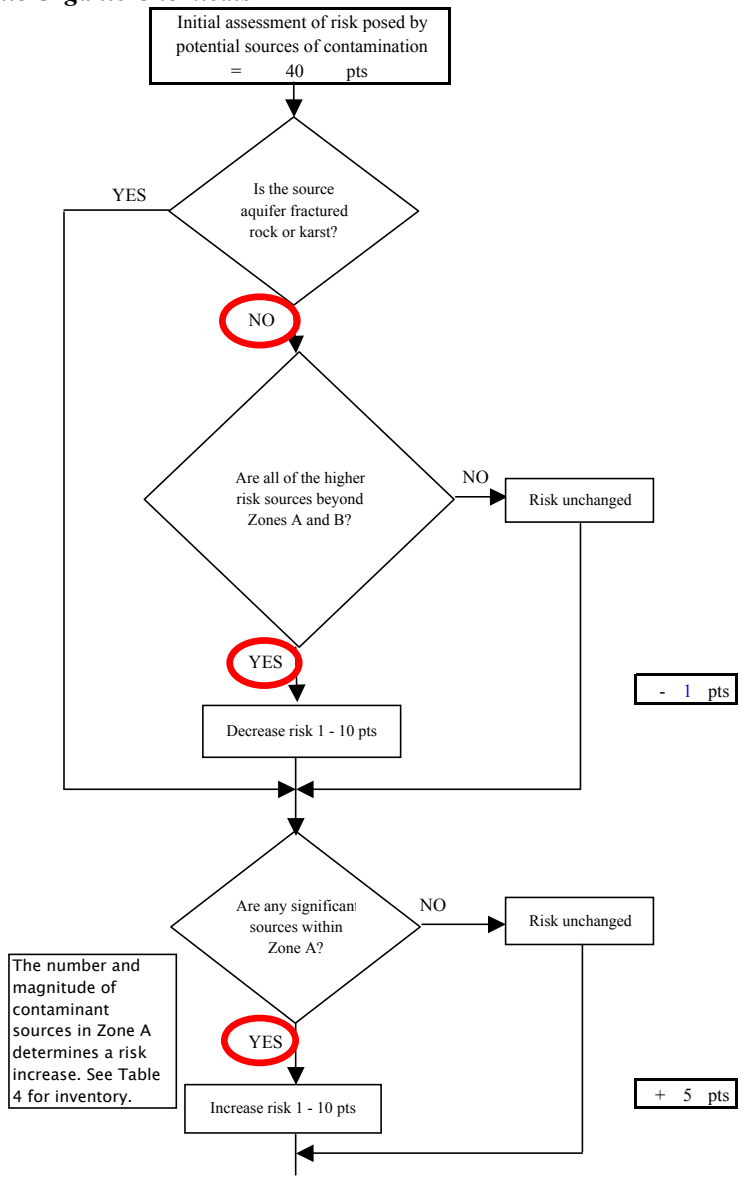
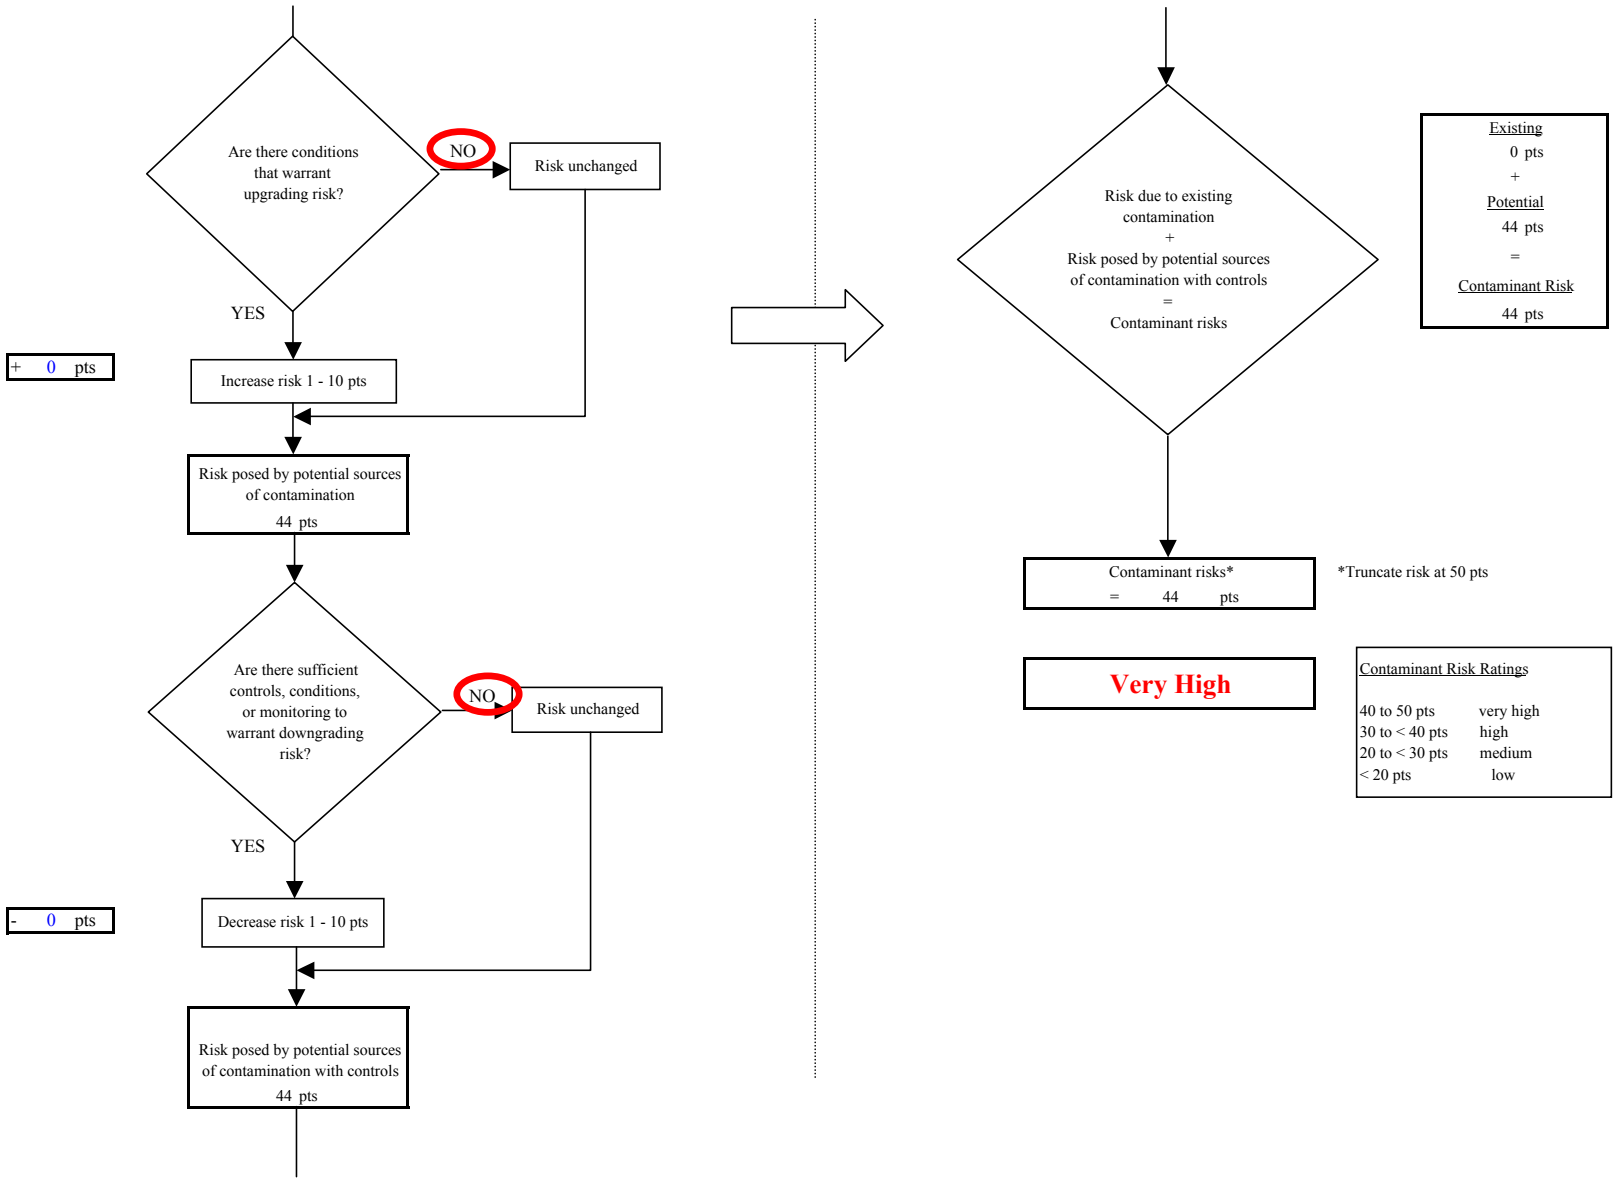
Chart 7. Contaminant risks for LDS Church Dillingham (PWS No. 263019.001) - Volatile Organic Chemicals

The contaminant risk for volatile organic chemicals is **Very High**. The risk is primarily attributed to the presence of aboveground fuel tanks and two airports located in Zones A, B, and C. Numerous other potential contaminant sources are also found within the protection area (see Table 4 – Appendix B).

No recent sampling data was available in ADEC records for the Church of Jesus Christ, Latter Day Saints (See Chart 7 – Contaminant Risks for Volatile Organic Chemicals in Appendix D).
