Source Water Assessment

A Hydrogeologic Susceptibility and
Vulnerability Assessment for
Willow Tree Inn
Drinking Water System,
Dillingham, Alaska

PWSID # 263030.001

DRINKING WATER PROTECTION PROGRAM REPORT 1220
Alaska Department of Environmental Conservation

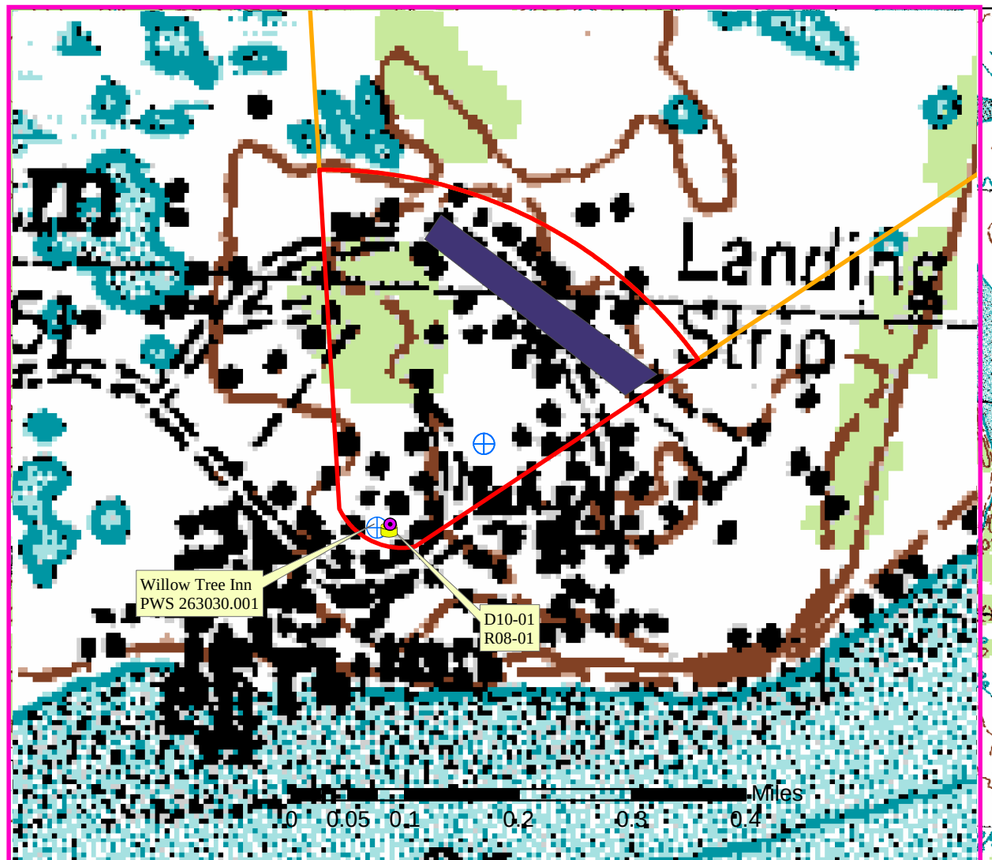
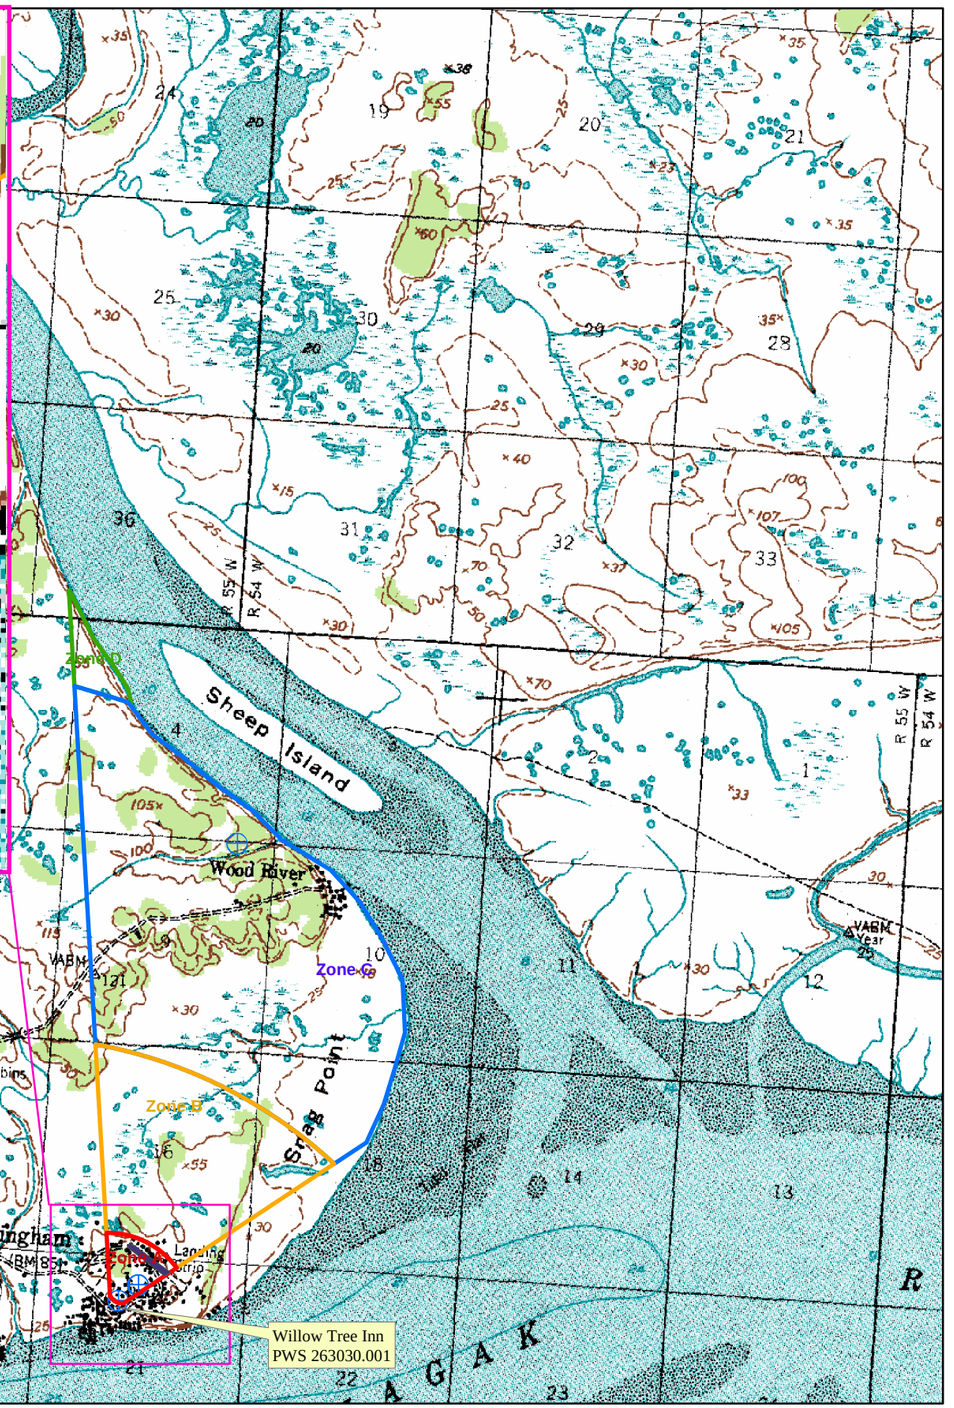
Appendix C Map C

The contaminant risk for bacteria and viruses is **Very High**. The risk is primarily attributed to the presence of an injection well in Zone A (see Table 2 – Appendix B).

The contaminant risk for volatile organic chemicals is **Very High**. The risk is primarily attributed to the presence of an airport and aboveground fuel tanks located in Zones A and B. Numerous other potential contaminant sources are also found within the protection area (see Table 4 – Appendix B).

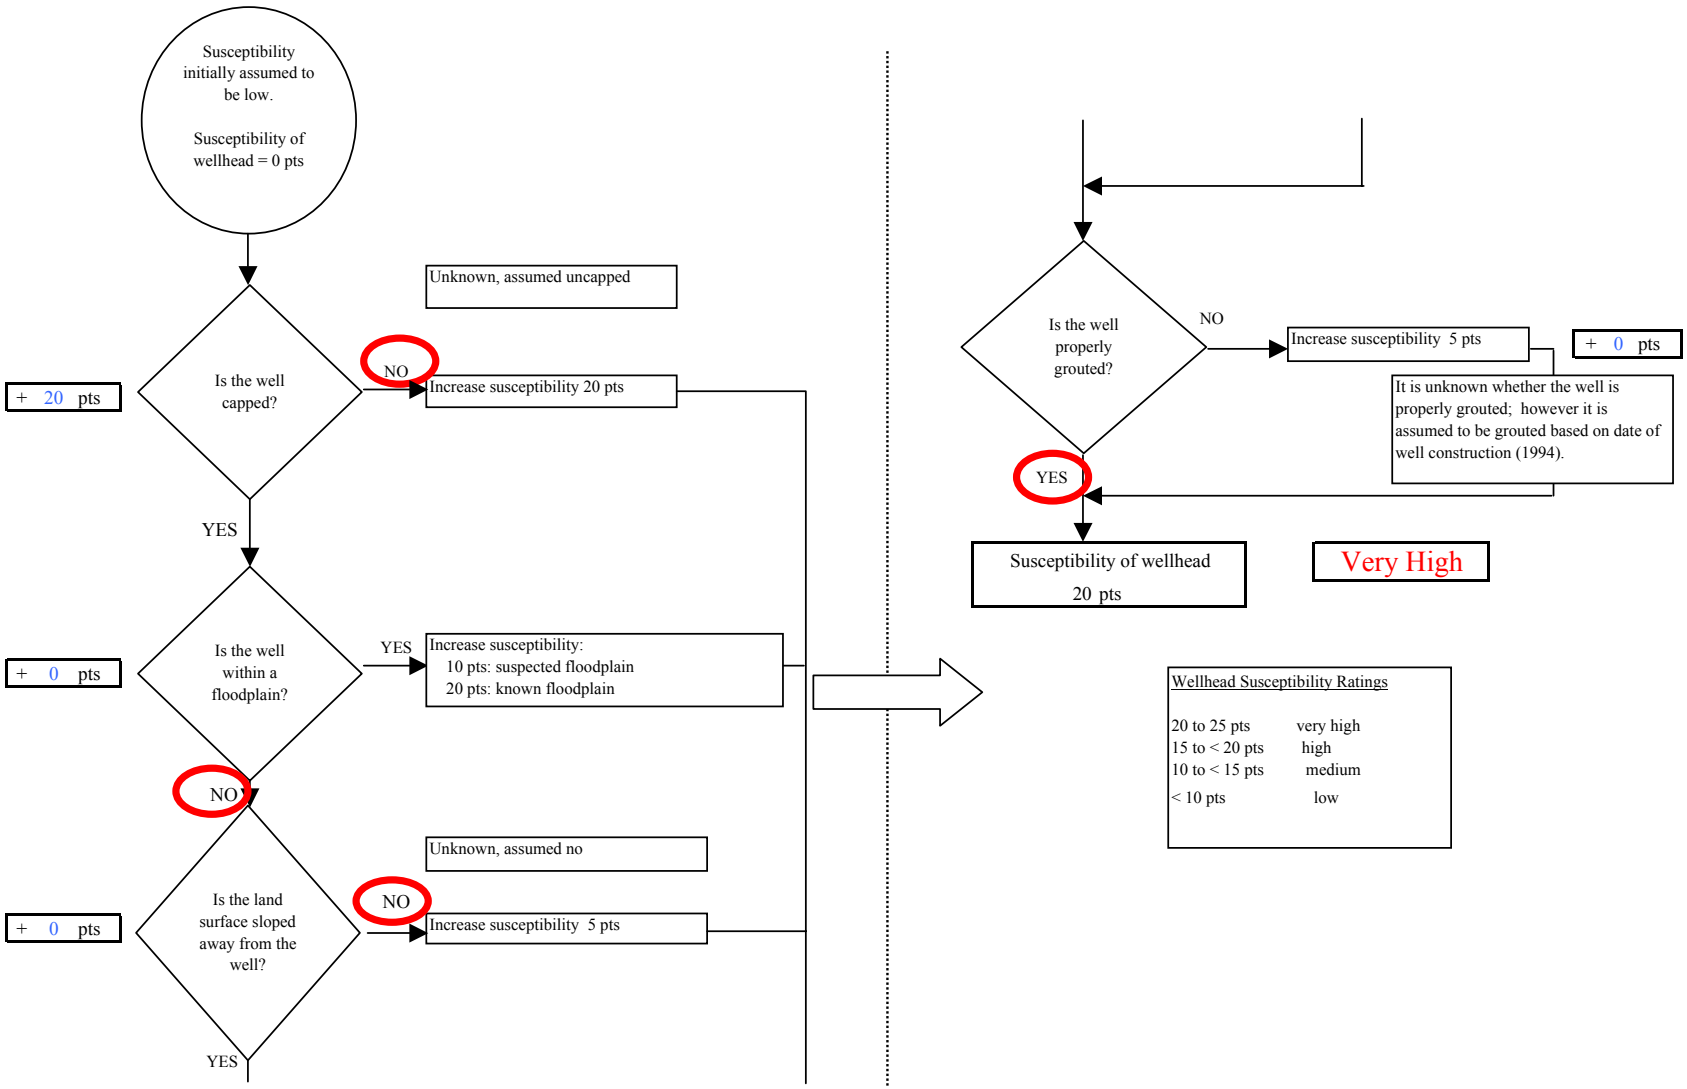
Chart 1. Susceptibility of the wellhead - Willow Tree Inn (263030.001)

Information acquired from a March 1999 sanitary survey for the public water system indicated that the land surface was not sloped away from the well. Generally, land surfaces that slope away from the wellhead promote surface water drainage, which reduces potential of contaminant migration down the well casing annulus. Based on the well construction date, it is assumed the well is grouted according to ADEC regulations. Proper grouting provides added protection against contaminants traveling along the well casing annulus and into source waters.

The Willow Tree Inn's water well is in an unconfined aquifer. Unconfined aquifers are more susceptible to potential groundwater quality impacts posed by the migration of surface water contaminants downward from the surface. Table 2 shows the susceptibility scores and ratings for this PWS.

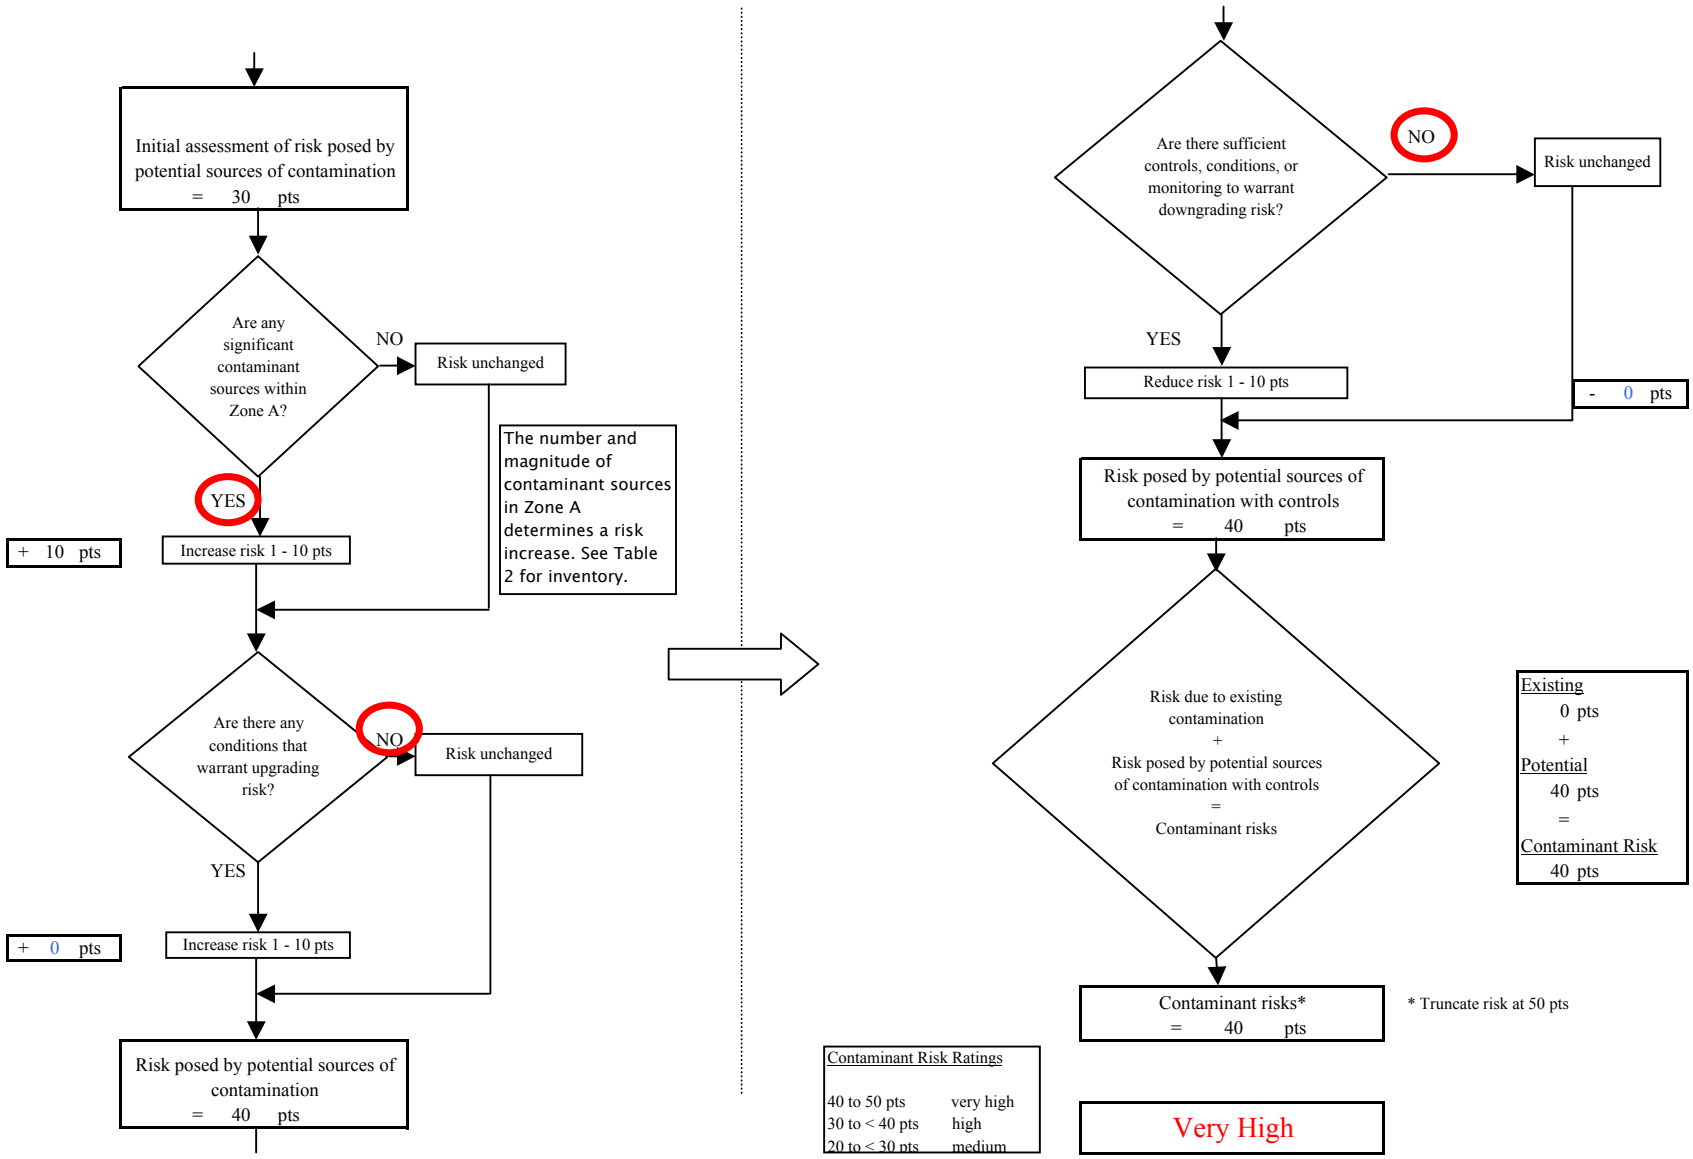
Chart 3. Contaminant risks for Willow Tree Inn (263030.001) - Bacteria & Viruses

No positive bacteria counts have been reported in recent (within five years) sampling events (See Chart 3 – Contaminant Risks for Bacteria and Viruses in Appendix D). Only a small amount of bacteria and viruses are required to endanger public health.

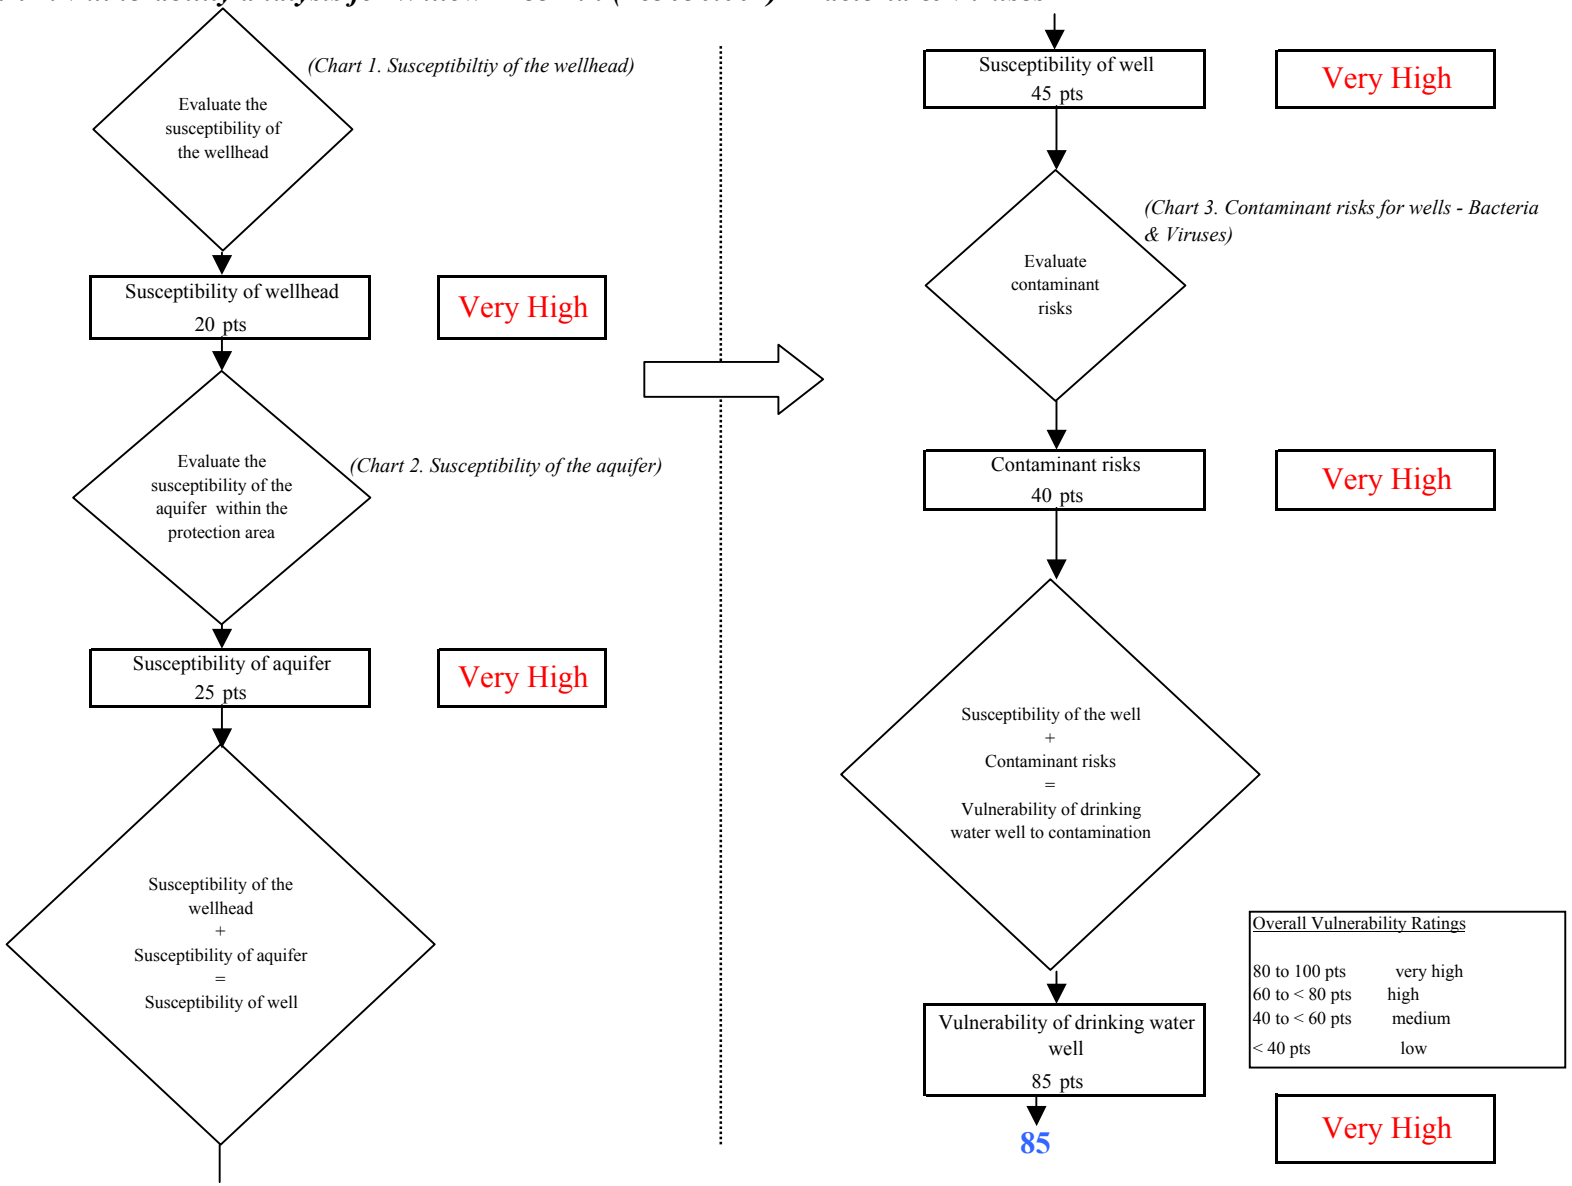
Chart 4. Vulnerability analysis for Willow Tree Inn (263030.001) - Bacteria & Viruses

After combining the contaminant risk for bacteria and viruses with the natural susceptibility of the well, the overall vulnerability of the well to contamination is **Very High**.

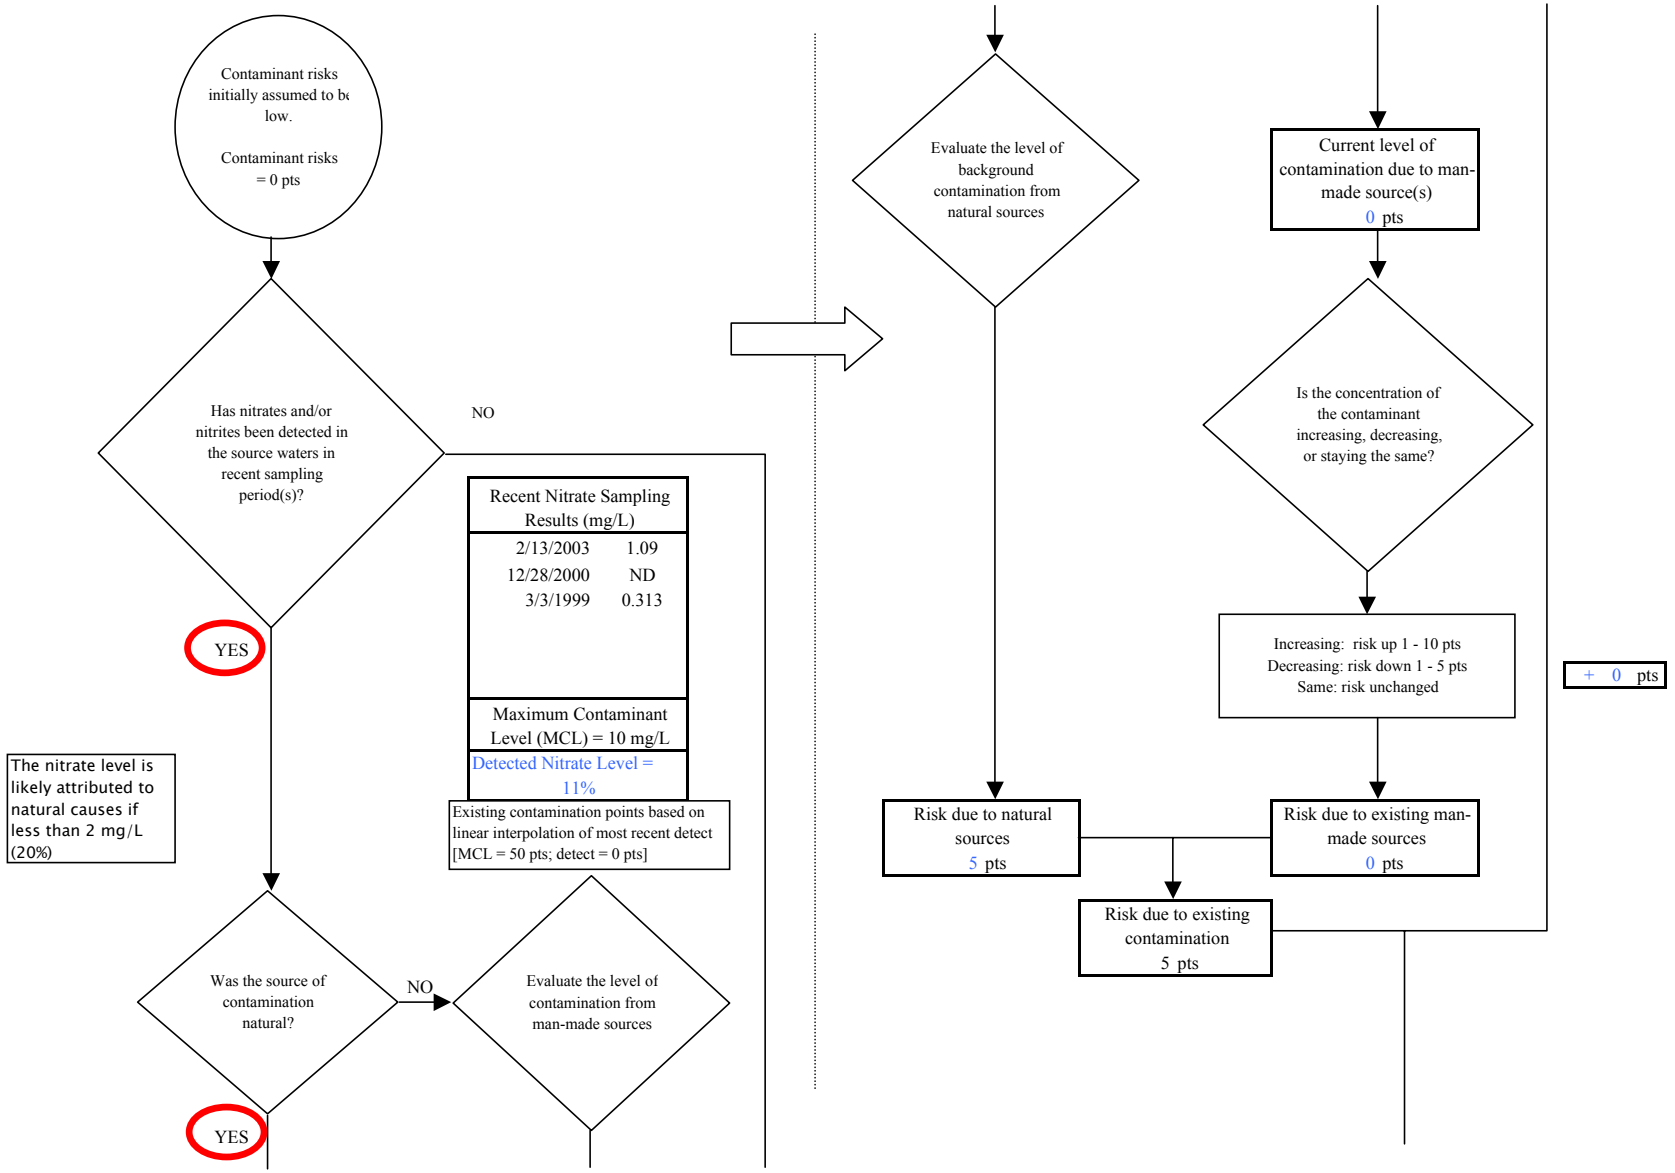
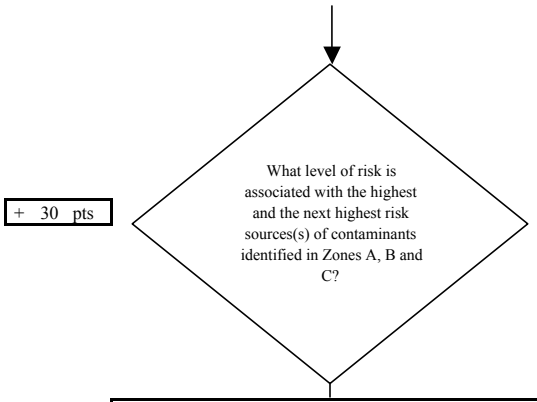
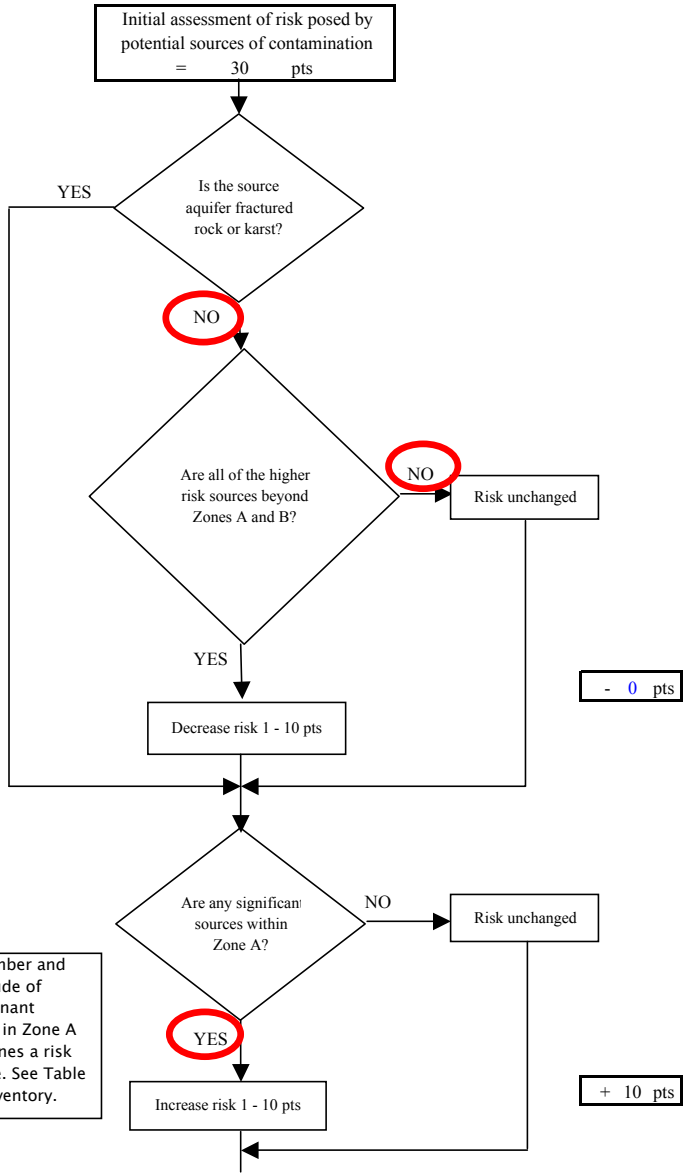
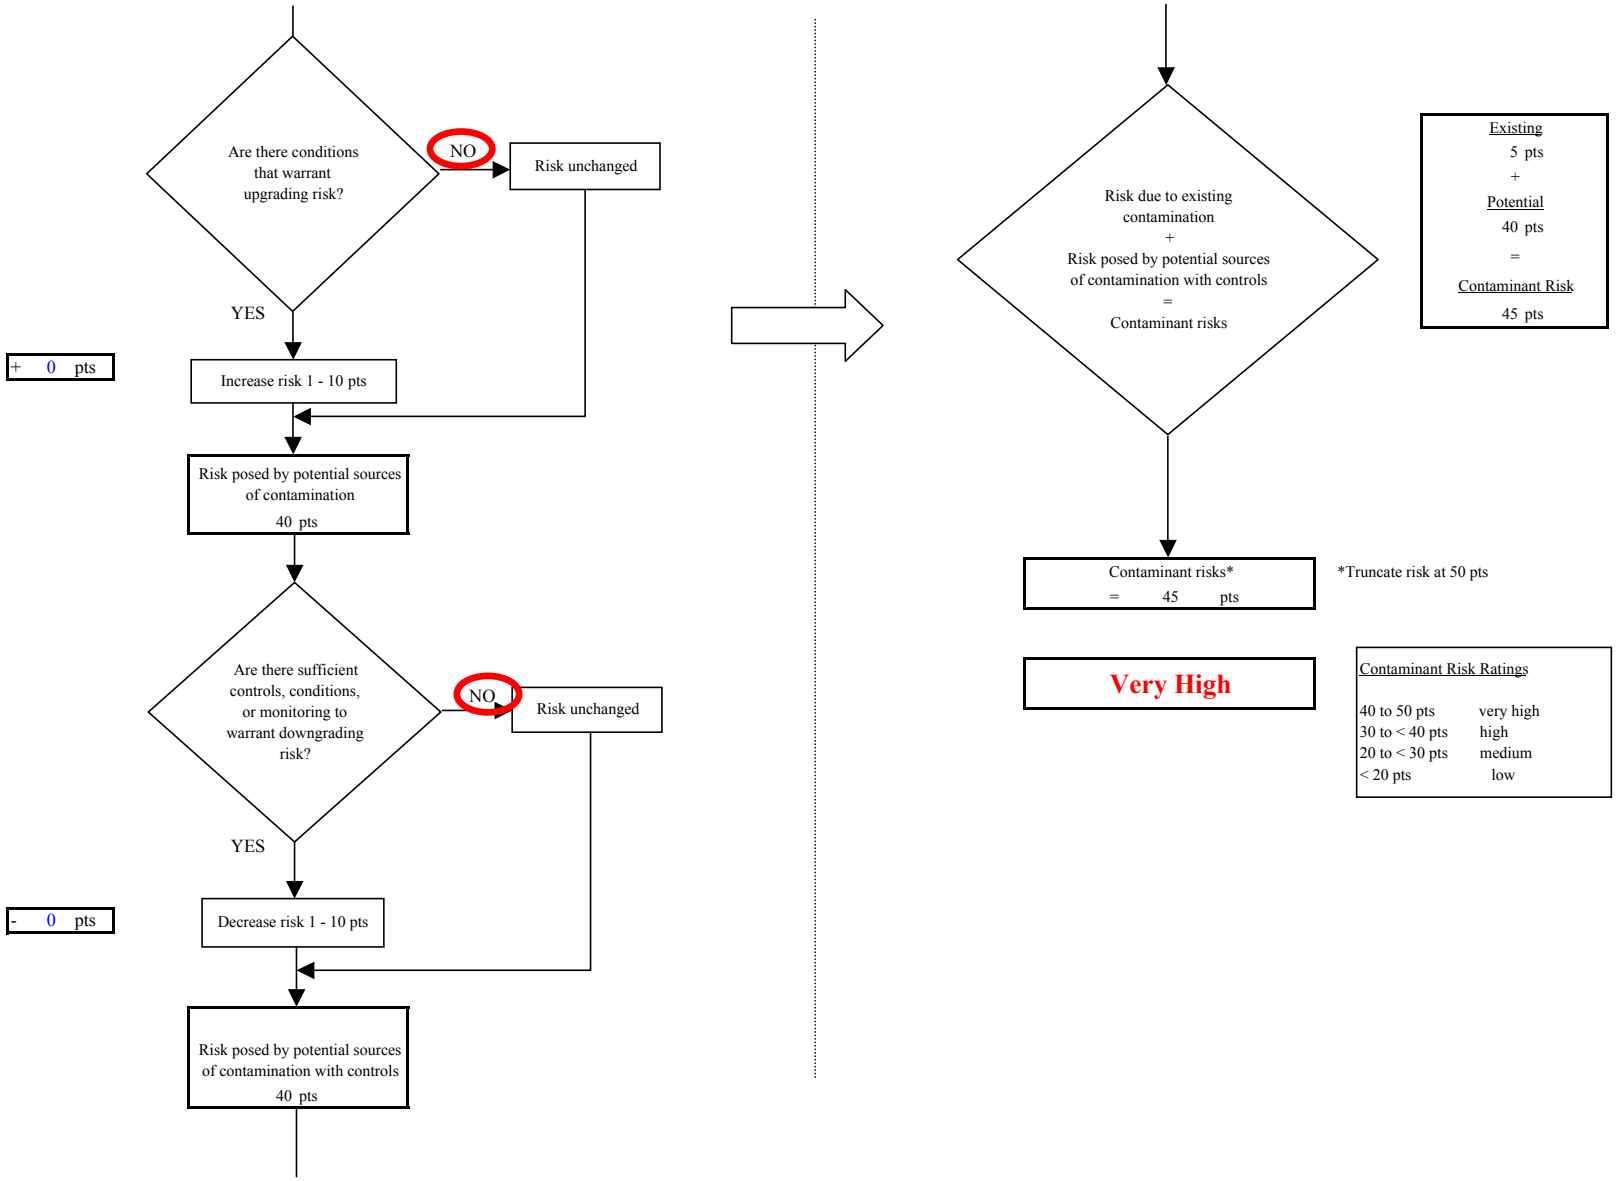
Chart 5. Contaminant risks for Willow Tree Inn (263030.001) - Nitrates and Nitrites

The contaminant risk for nitrates and nitrites is **Very High**. The risk to this source of public drinking water is primarily attributed to the presence of an injection well in Zone A (see Table 3 – Appendix B).

Nitrates are very mobile, moving at approximately the same rate as water. The sampling history for this well indicates that low levels of nitrates have been detected in recent sampling events. However, the reported concentrations of nitrates do not exceed the maximum contaminant level (MCL) of 10 mg/L. Nitrate concentrations in uncontaminated groundwater are typically less than 2 mg/L; therefore, nitrate concentrations above 2 mg/L may be indicative of man-made sources (See Chart 5 - Contaminant Risks for Nitrates and/or Nitrites in Appendix D).

Nitrate levels are often derived from the decomposition of organic matter in soils. Although the nitrate source is unknown, such occurrences may be attributed to septic systems or other sources. After combining the contaminant risk for nitrates and nitrites with the natural susceptibility of the well, the overall vulnerability of the well to nitrate and nitrite contamination is **Very High**.

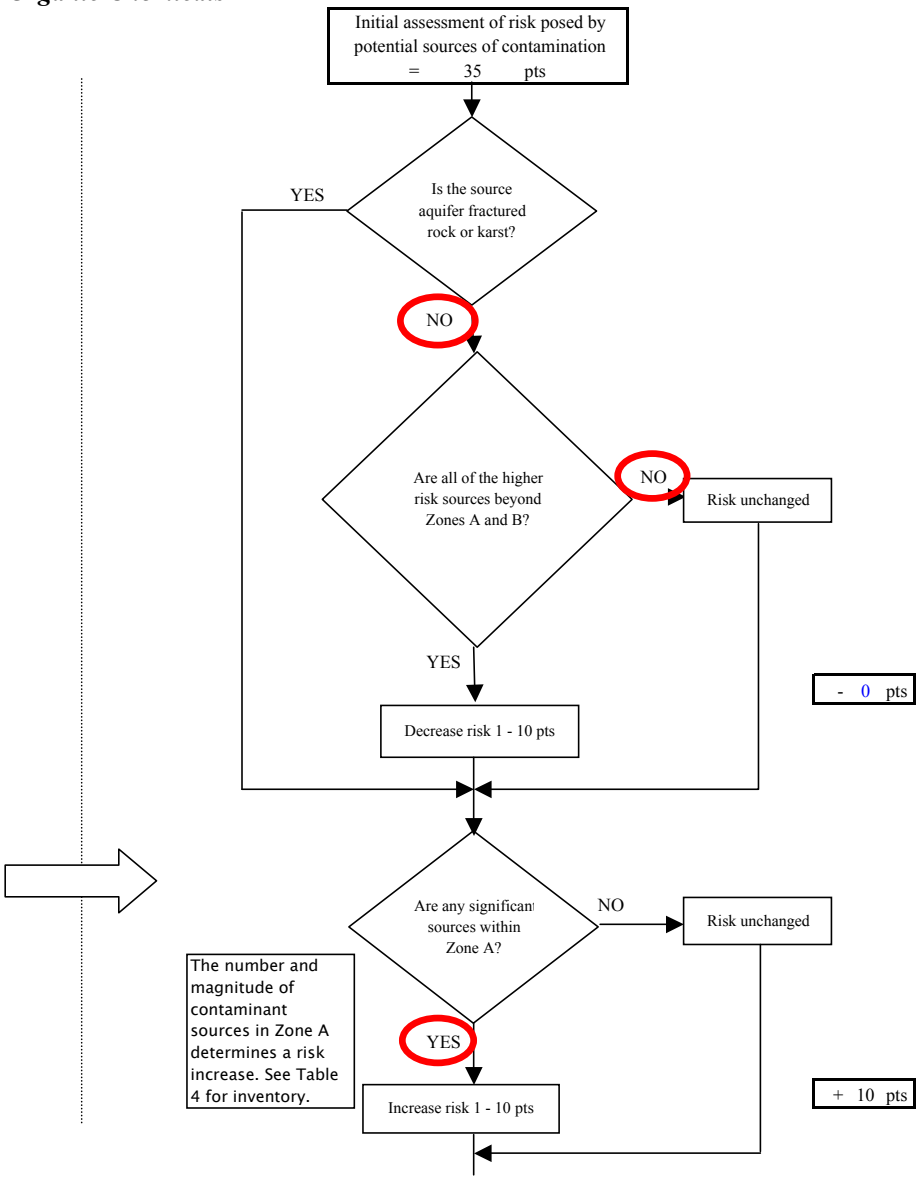
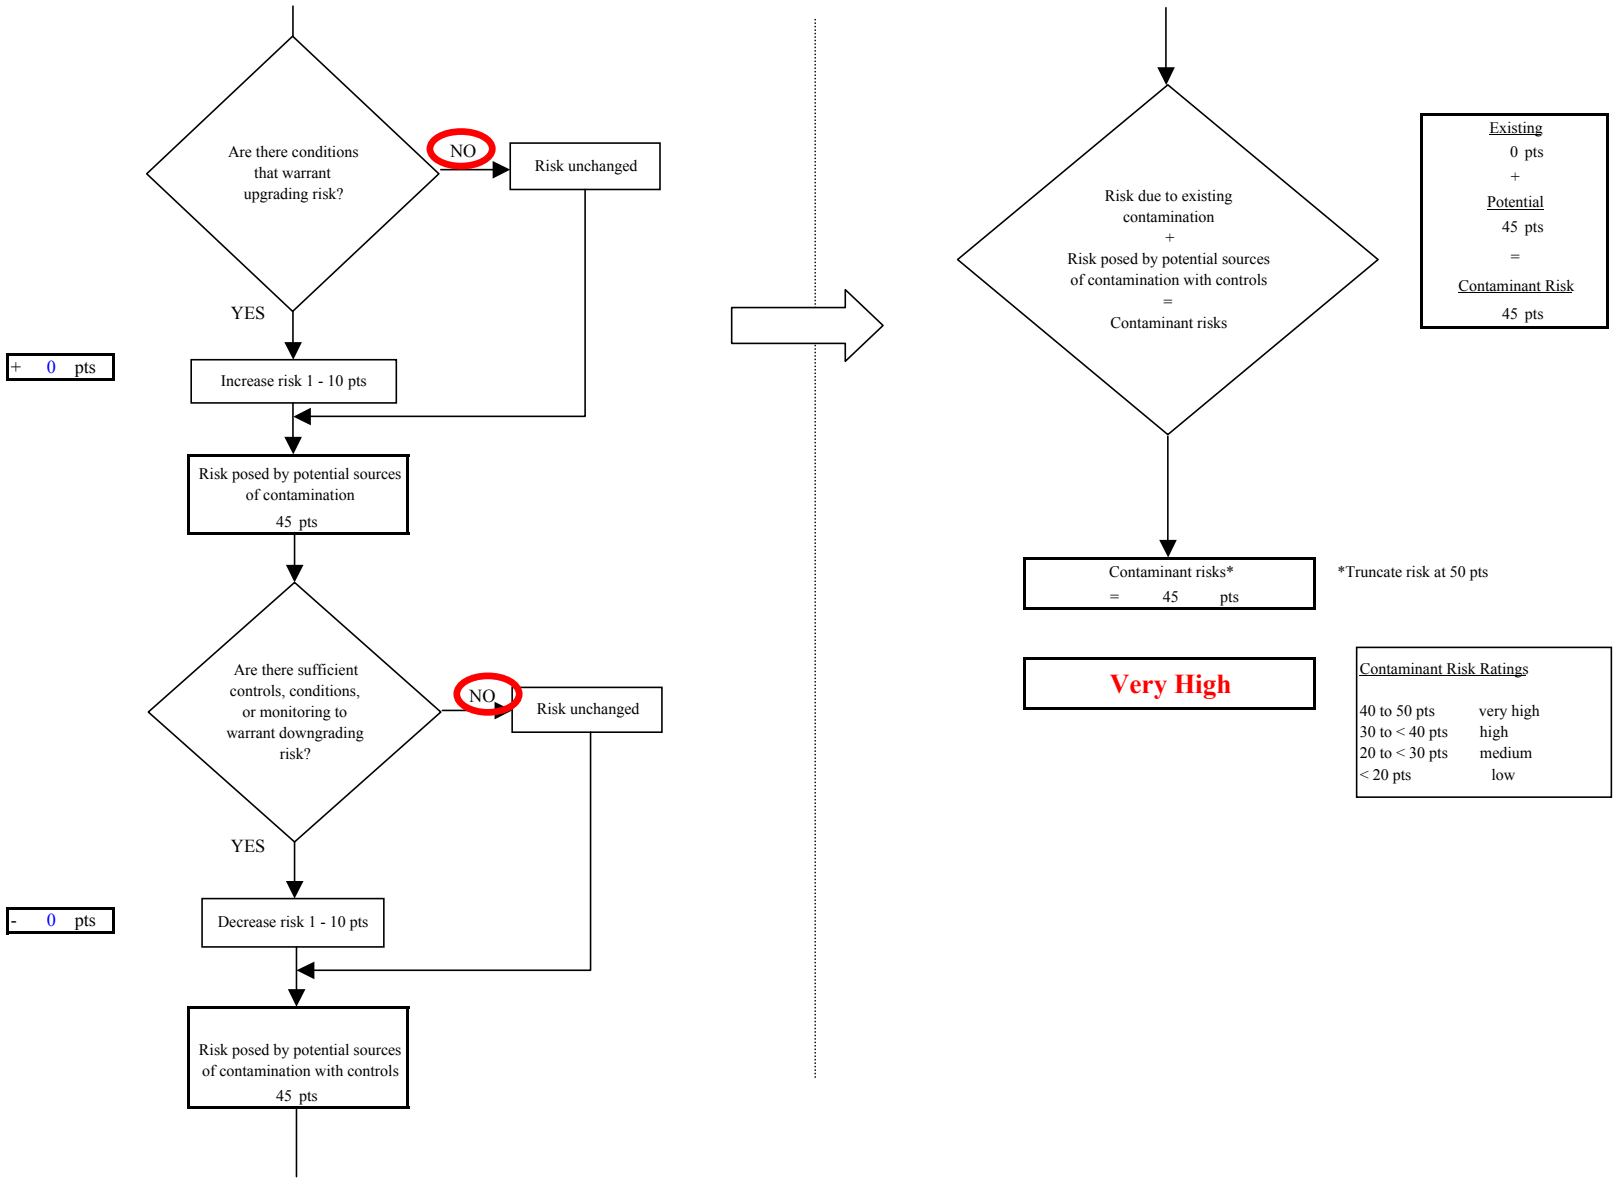
Chart 7. Contaminant risks for Willow Tree Inn (263030.001) - Volatile Organic Chemicals

No recent sampling data was available in ADEC records for the Willow Tree Inn (See Chart 7 – Contaminant Risks for Volatile Organic Chemicals in Appendix D).
